# PRELIMINARY INFORMATION:

DATE: April 4/2008.  
TIME OF INSPECTION: 9:00am.  
CLIENT: John and Jane Doe.  
INSPECTION LOCATION:

TYPE OF BUILDING: Apartment. 2 story.

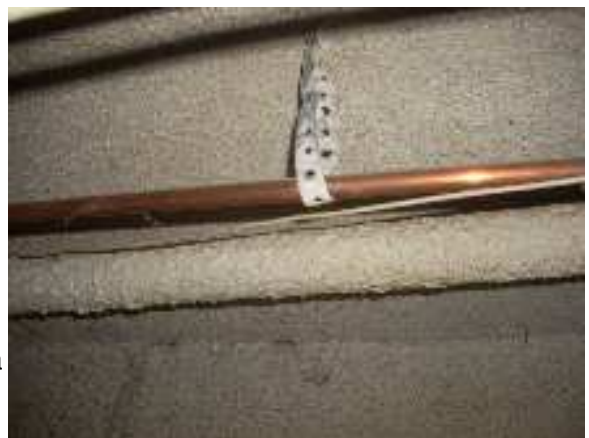
Copper to galvanized contact noted in areas without the appropriate buffer between the two metals, such as galvanized straps used to support pipe. This condition does result eventual corrosion as well as eventual leaks as these two metals are not compatible. Ideally a dielectric coupler or brass fitting would have been used at these connections.

NOTE: Client should be aware that some of the plumbing pipes for the building is of older galvanized pipe. This pipe rust and corrode from the inside resulting in drop in volume when more than one fixture is in operation. This condition, as well as other notable conditions, would indicate that current system is near or at the end of its serviceable life and replacement needs to be considered at this time.

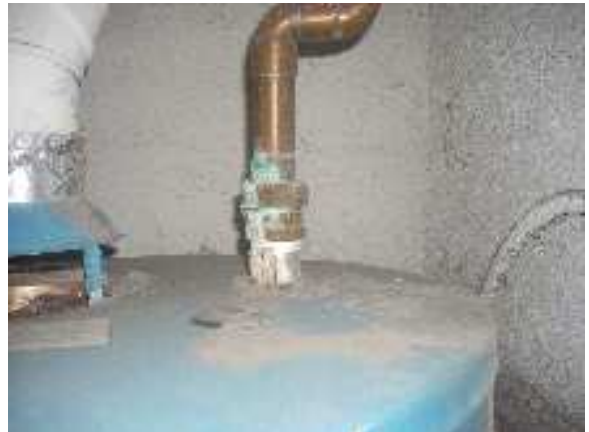
CONDITION: **Fair.** Overall condition fair. Some maintenance or repairs needed.  
NOTED

DEFECTS: There is rust and corrosion noted at the water pipes that enter and exit the top of this tank.

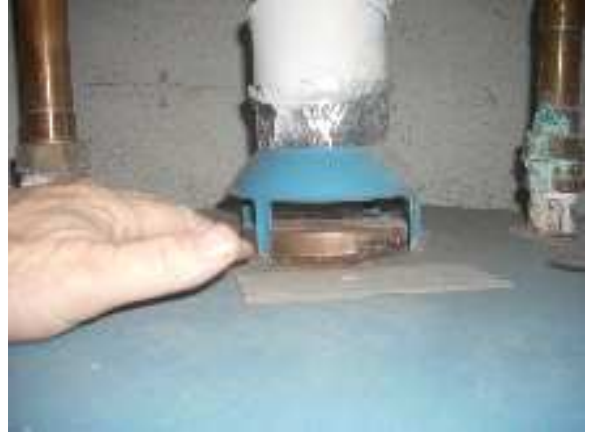
**Poor.** Bell end draft diverter not of adequate size. Evidence of gas spilling back down flue rather than drafting to exteriors.

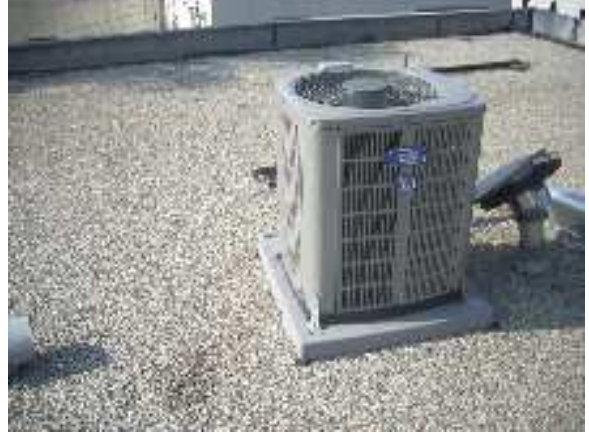
Roof top.

**TYPE:** Heat Pump. 220 3 phase, Electrical disconnect present. AMERICAN STANDARD, Ser. # Model #  
**AGE** 1 year.  
**CONDITION:** Fair overall condition- primarily due to age. Repairs and maintenance needed.  
**NOTED**  
**DEFECTS:** No adequate secondary drain installed.  
**COST:** Cost to Cure: \$ 200 to 500.

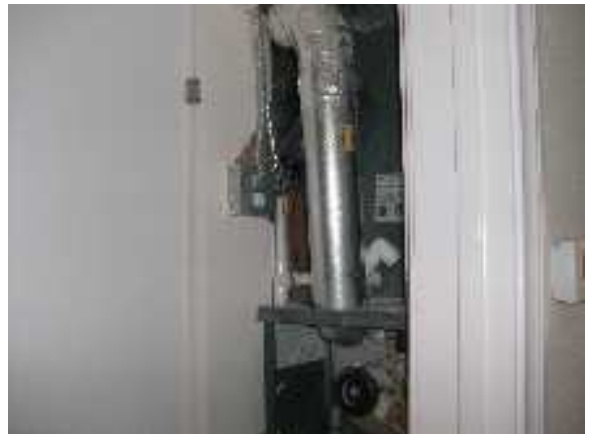
**TYPE:** Forced air furnace. Manufactured by GOODMAN Interior component. Ser # G705059627 Model # GMH80703AXAB.  
**LOCATION:** Unit 5 interior closet.  
**FUEL:** Natural Gas.  
**SIZE:** 70,000 BTUs.  
**AGE:** 2 years.  
**CONDITION:** Poor.  
**NOTED**  
**DEFECTS:** Inadequate clearance observed from front of component. This is a fire hazard and in need of correction at this time.

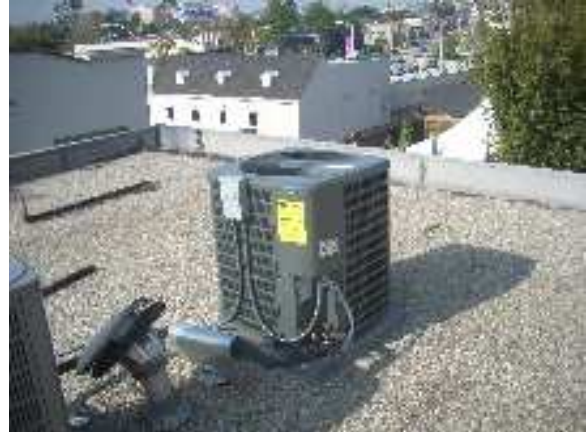
Roof top.

**Fair** overall condition- primarily due to age. Repairs and maintenance needed.

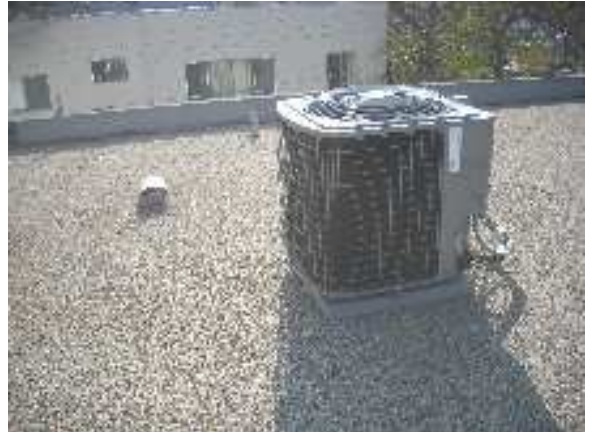
LOCATION: Roof top.

CONDITION: **Fair** overall condition- primarily due to age. Repairs and maintenance needed.

DEFECTS: No secondary drain installed. System is over area that could pose damage to structure if it were to leak. Secondary drain should route over door window or sink.

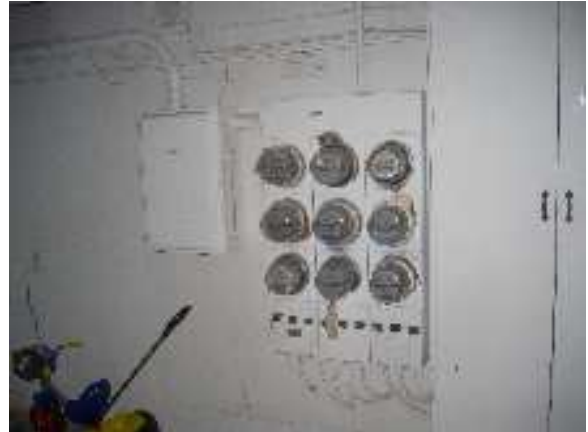
LOCATION: Laundry area.

125 amps. Panel rated for 200. Distribution of 30 amps to each unit and house sub.

Federal Pacific Electric.  
Bus fuse.  
Fair. Main panel in fair condition.

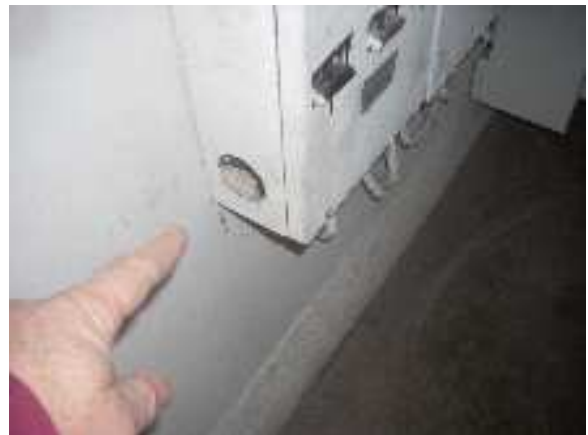
Recommend that panel cover be locked or sealed shut to prevent any access to high voltage conductors. This is a safety hazard and in need of immediate correction. Also noted knock out cover missing from meter panel. Seal as needed to prevent rodent entry which could result in a fire hazard.

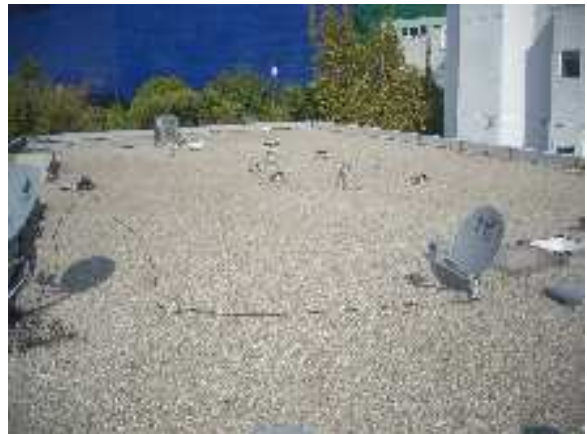
Flat/low slope.  
Built up roof with gravel ballast.

Areas of concern are: Remove foliage from roof system to prevent potential damage and leaks. Suggest annual maintenance at this time.

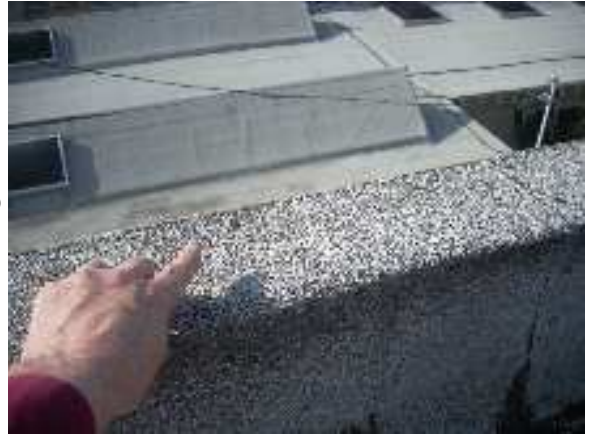
Metal.  
Poor.

Exposed nail heads noted along top portion of parapet wall. These nail heads do rust, pop up and pose leaks. Also, cap flashing missing from around top portion of parapet wall. Installation needed at this time.

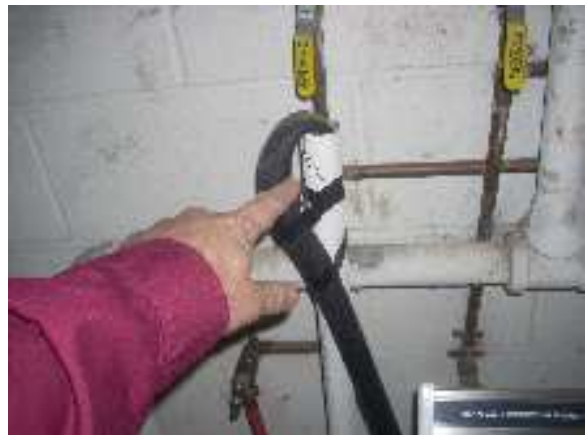
**Fair.** Diameter of drain stem of one of the clothes washers is under sized. 2 inch diameter pipe needed. Correct as needed to prevent back up.

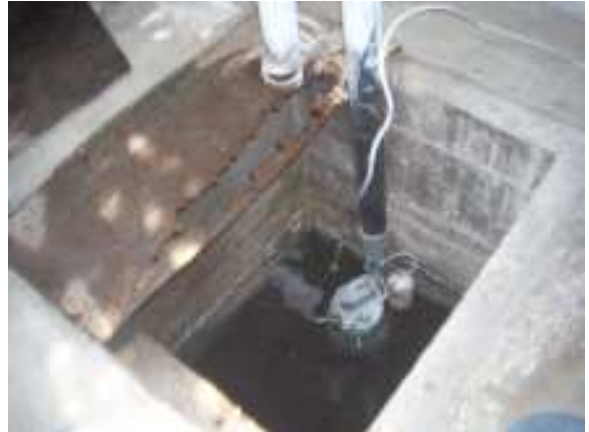
Areas of immediate action are: Sump pumps. Unit is laundry area lacks adequate cover. Corrections needed by installing safe grill cover. Also noted leak to pipe of this sump pump.

Cost to Cure: \$ 200 to 500.
