# PRELIMINARY INFORMATION:

1234 Anystreet Blvd.

TYPE OF BUILDING: Commercial. Office space.

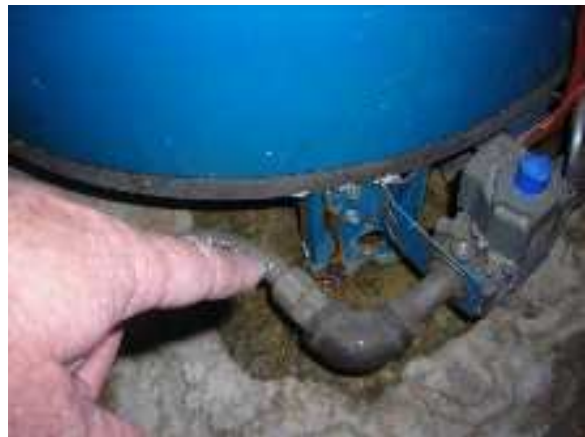
**P-36 WATER HEATER:**

CONDITION: **Poor.** Immediate repairs needed.

NOTED DEFECTS: Leakage to the unit is occurring at this time. Component may need to be replaced.

ASSESSMENT: Areas of immediate action are: Leak at water heater. Replacement of water heater should be expected. Refer to item P-36 of report.

COST: Cost to Cure: **\$ 800 to 1200.**

PROBABLE PLUMBING COST: Cost to Cure: \$ 800 to 1200.

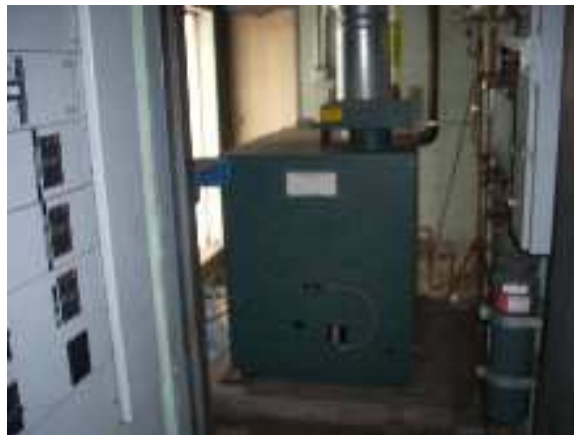
### M-52 HEATING:

**LOCATION:** Utility roof closet.  
Interior fan units located within ceiling plenum of each floor and office space.

**CONDITION:** **Good.** Overall condition appears serviceable. No notable defects at time of inspection.

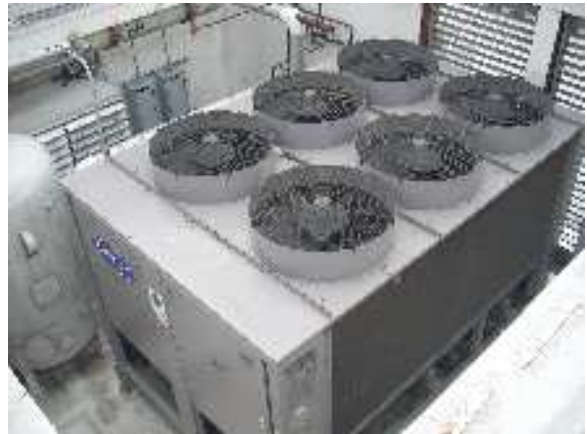
### M-53 AIR CONDITIONING:

TYPE: Chiller/Cooling Tower. Unit manufactured by CARRIER. Ser. # CGDD 120 100 Model # NNN-FGH-1324.

CONDITION: **Good.** Unit in overall good condition.

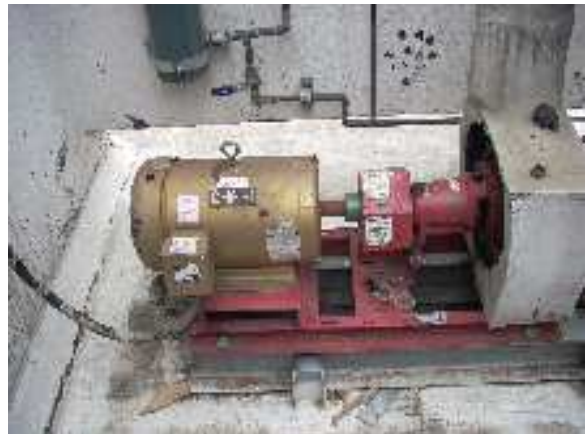
NOTED DEFECTS: No notable defects at time of inspection. Pump well maintained.

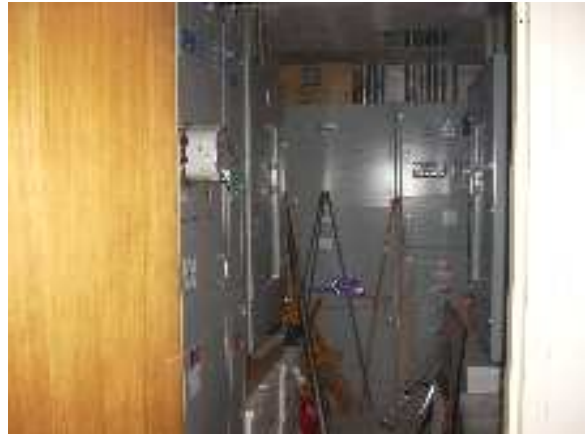
**Good.** Main panel in good appearance. Do not store items in closet area.

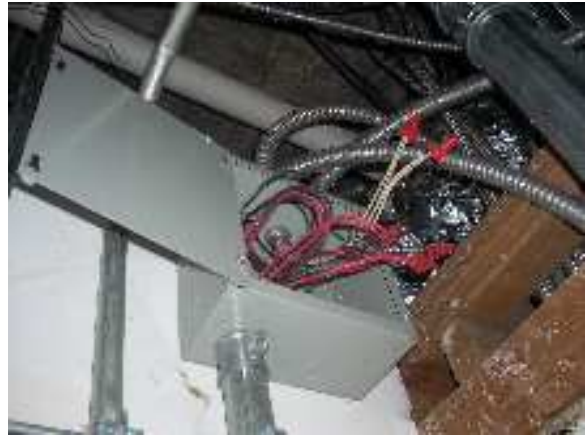
**E-90 BRANCH WIRING:**

CONDITION: **Fair.** Overall condition of visible and accessible wiring fair with some repairs needed however, See notes

Pull or J box covers missing in areas leaving wires exposed. Seal as needed.

ASSESSMENT: Areas of concern are: Open electrical boxes. Contact licensed electrician for corrections. Refer to item E-90 of report.

Cost to Cure: \$ 200 to 500.

PROBABLE COST: Cost to Cure: \$ 200 to 500.

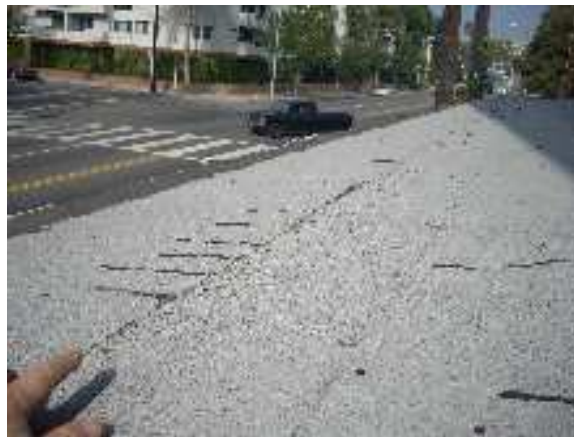
### R-96 ROOF:

**Fair.** Workmanship of roof material installation is only fair at each building.

Exposed nail heads observed in general areas. Primarily along lower front entry roof. These nail heads pop up and pose potential leak issues.

ASSESSMENT: Areas of immediate action are: Front entry roof cover. Contact licensed roofing contractor for repairs. Refer to item R-96 of report.

COST: Cost to Cure: \$ 1500 to 2000.

PROBABLE COST: Cost to Cure: \$ 1,500 to 2,000.

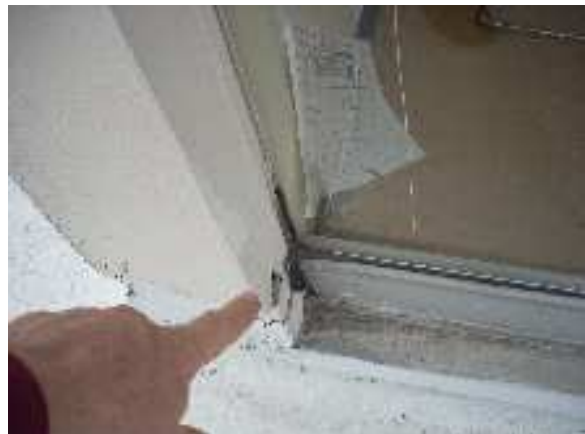
### S-105 WINDOWS:

TYPE: Aluminum. Mostly fixed windows.  
CONDITION: **Good**. Overall appearance shows windows are maintained.  
DOORS: **Fair**. Some repairs needed. Refer to notes.  
NOTED DEFECTS: Evidence of water intrusion from roof top slider. Repair as needed.

ASSESSMENT: Areas of immediate action are: Improvements needed at exterior roof top slider to reduce potential water intrusion. Refer to item S-105 of report.

PROBABLE COST: Cost to Cure: \$ 200 to 500.

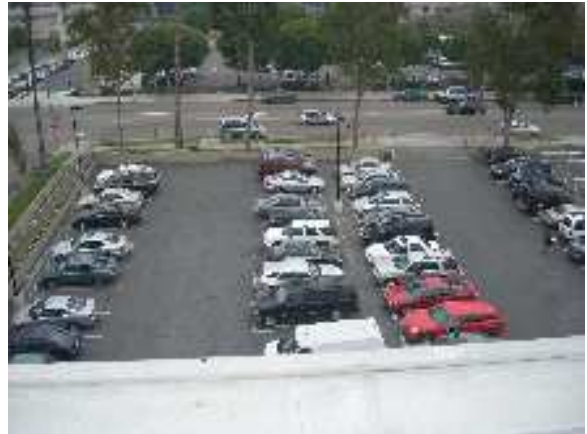
### G-118 PARKING AREA:

Overall condition serviceable. Some cracks noted at time of inspection though cracks do not appear significant. Expect future resurfacing.
