Alliance Inspections

Report: Sample Condo Report, 19231 Anywhere Avenue, Reseda, CA 91335

Confidential Inspection Report 19231 Anywhere Ave. Reseda, CA 91335

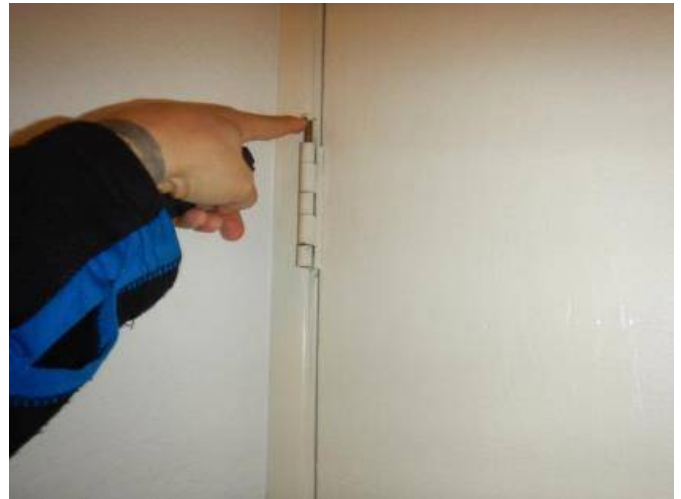
Satisfactory, however the top pin is loose.

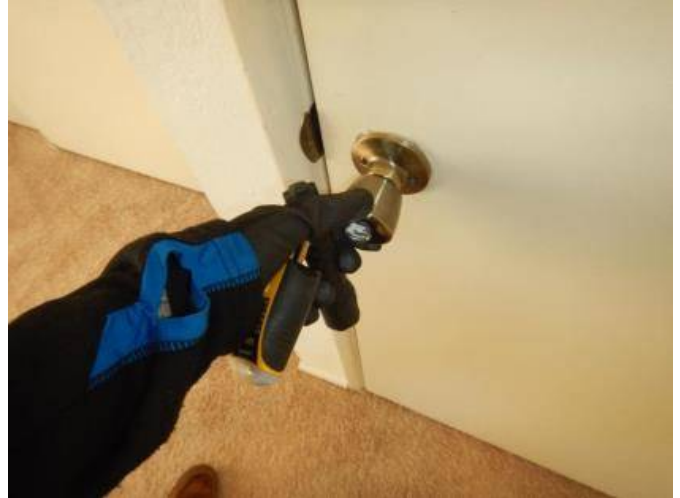
A representative sampling of doors was achieved. Those operated were in serviceable condition. However, at least one of the of the door handles was loose. Secure as needed.

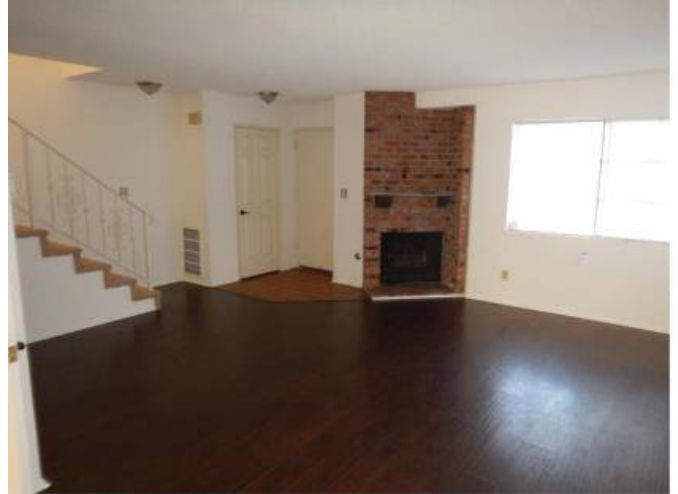
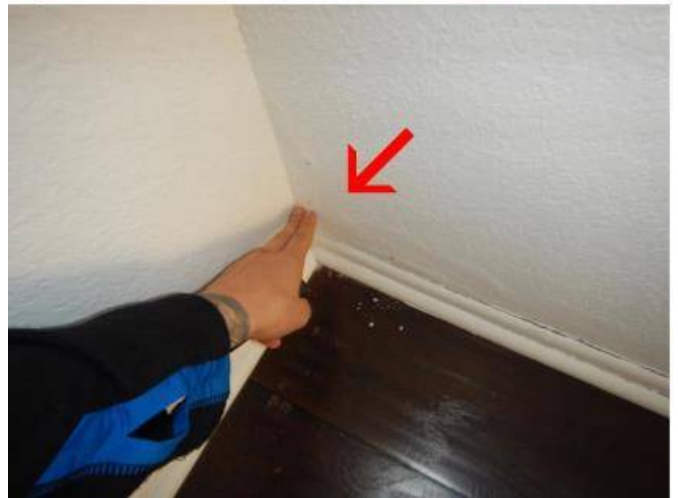
Attention Needed- Peeling paint and evidence of apparent water intrusion seen at Northeast corner. Further evaluation is advised by an appropriate specialist.

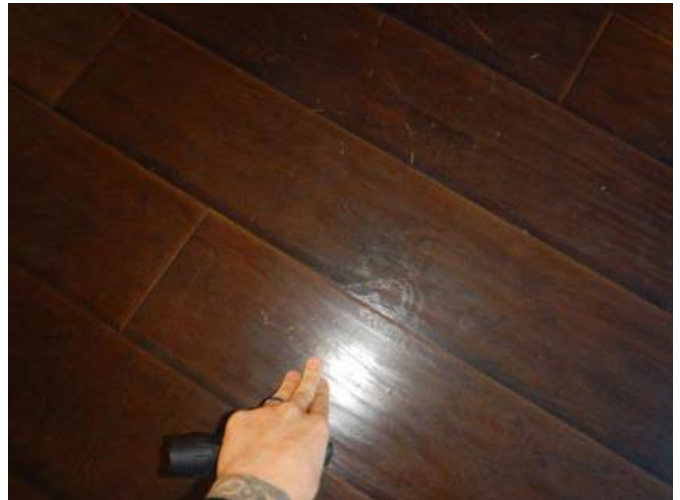
3.12 CONDITION:

Attention Needed- Some scratch marks seen at the laminate flooring material in the living room.

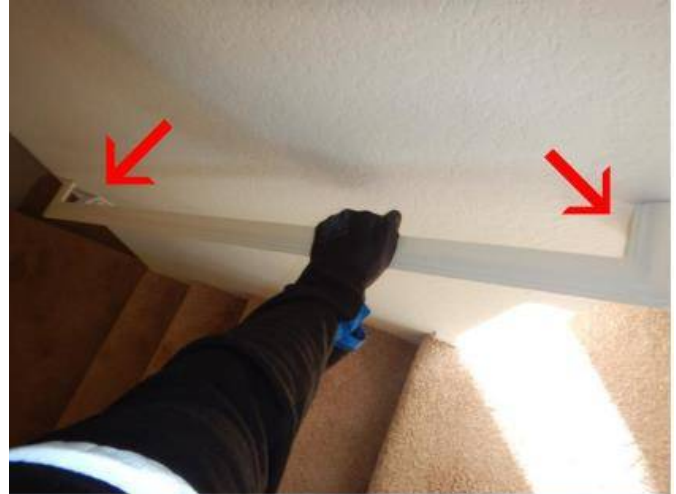
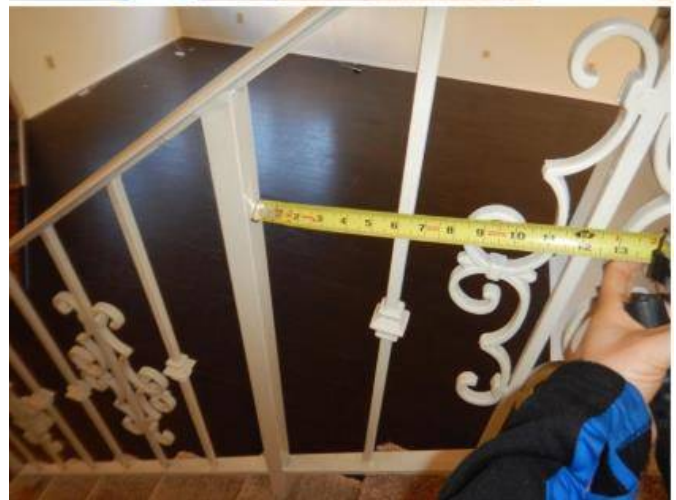
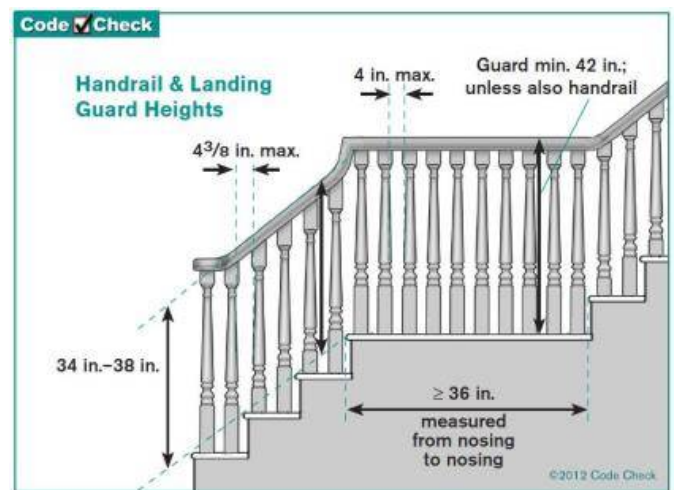
3.13 CONDITION:

Attention Needed- Loose railing noted, such as the upper one. Repairs needed to ensure safe stair use. Client should be aware that the spacing between rails is not to the child safety standards of 4 inches apart. Consider improvements.

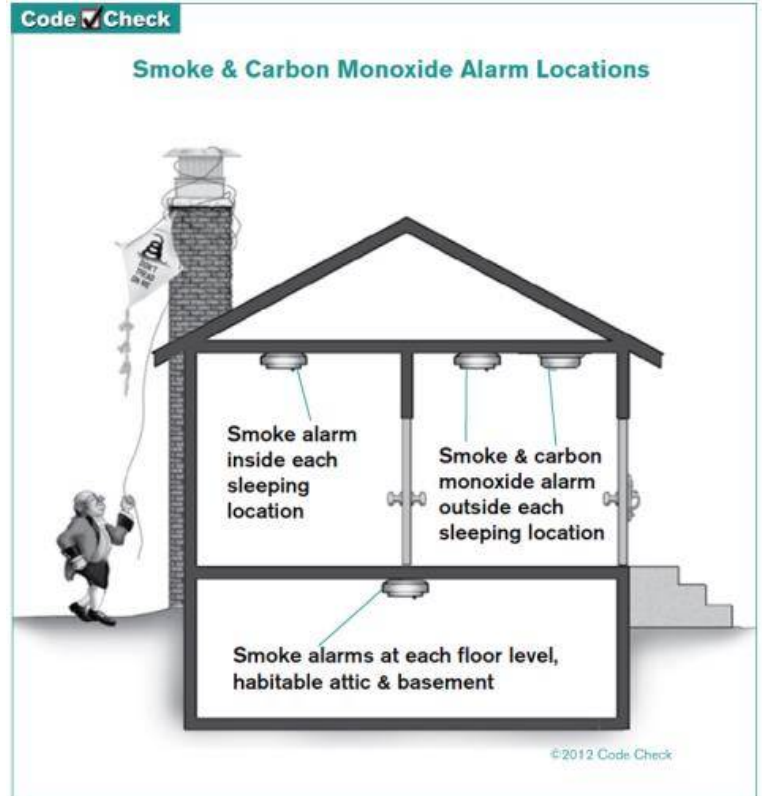
3.14 NOTE:

Detectors are noted in areas however, some are older and at the end of their serviceable life. Replacements needed. Testing should be achieved by retrofitting agency and continual testing should occur at least two or three times a year. Smoke detectors are usually required, depending on the municipality, in each sleeping area, hallways outside sleeping areas and kitchen or basements. Consult a retrofitting specialist as to your area. Carbon monoxide detectors are required in hall areas upper and lower floors.

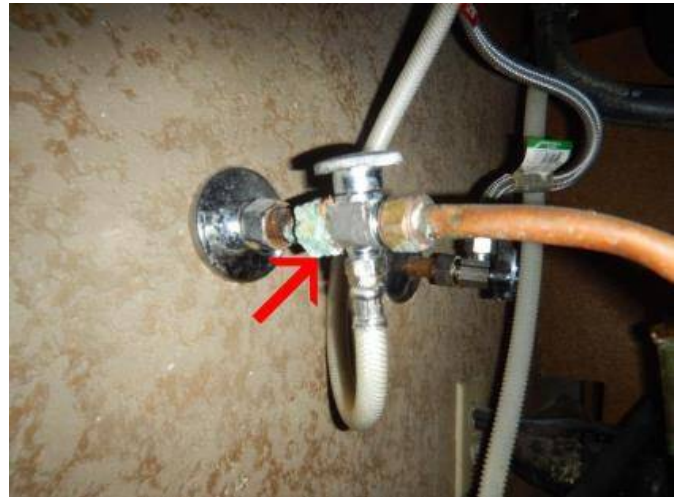
4.2 FAUCET:

Attention Needed- Rust or corrosion seen on one of the water shut off valves under the sink.

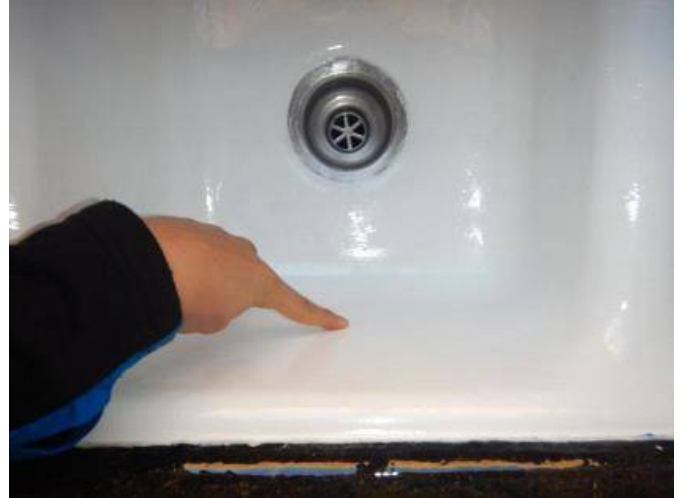
4.3 SINK & DRAIN:

Attention Needed- The sink surface is chipping.

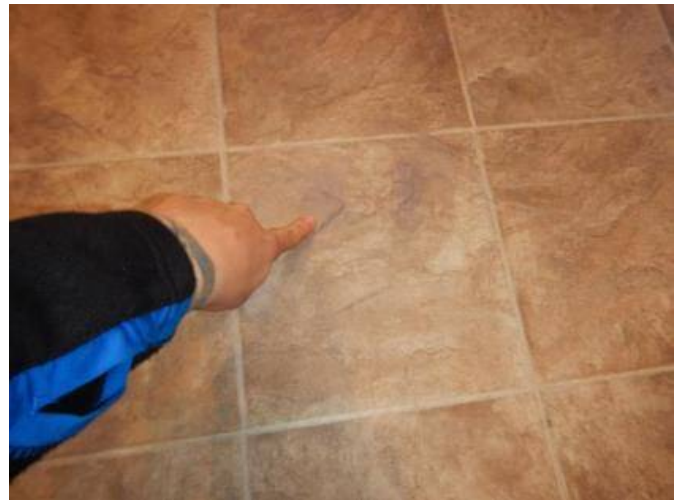
4.6 CONDITION:

Attention Needed - Damage seen to the flooring material, replacements should be expected.

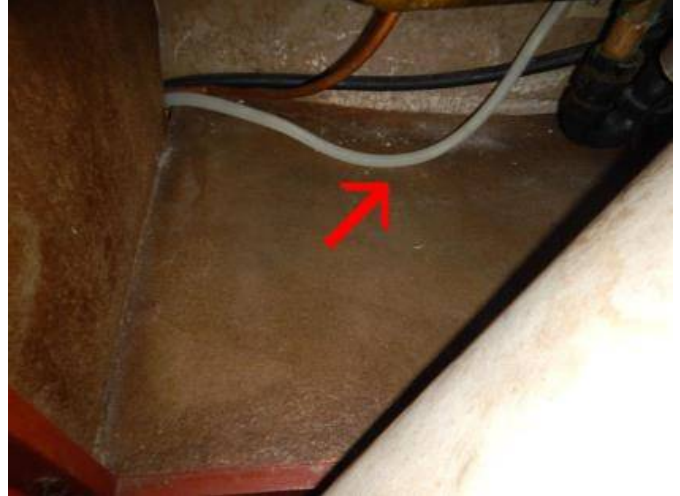
4.7 CABINETRY:

Attention Needed- Water damage is noted within cabinet under sink. Expect repairs or replacement.

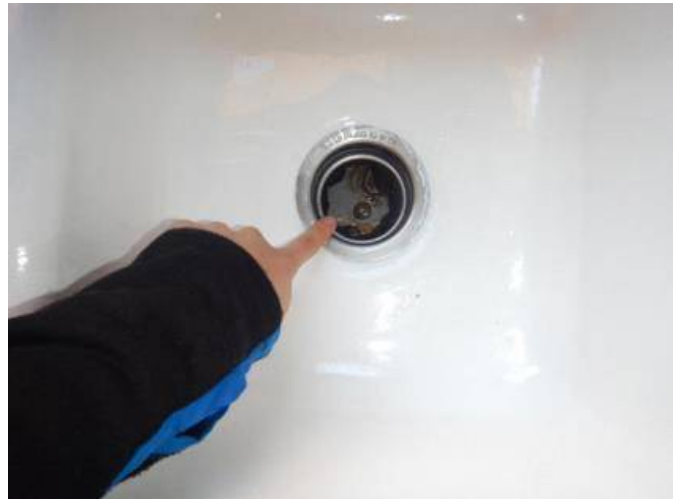
4.8 DISPOSAL:

Attention Needed- The cover is missing at sink, replacement cover needed.

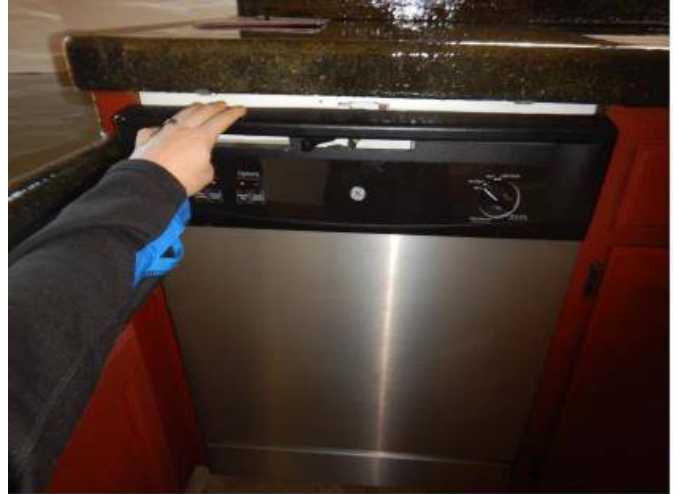
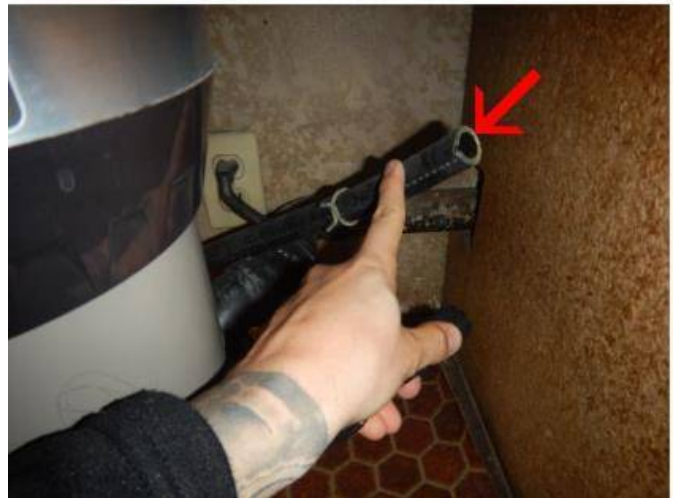
4.9 DISHWASHER:

Attention Needed- The dishwasher does not fit well within its niche, it appears oversized. Also, there is an abandoned hose located under the sink that should be removed.

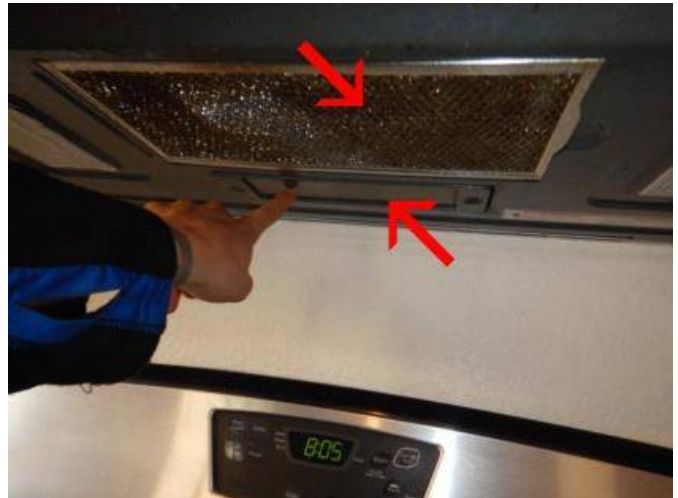
4.10 RANGE HOOD:

Attention Needed- The range hood light did not turn on using normal controls. Repair may be as simple as replacing the light bulb. The range hood filter(s) are dirty and need to be cleaned. This should be done periodically. The accumulated grease can be a fire hazard.

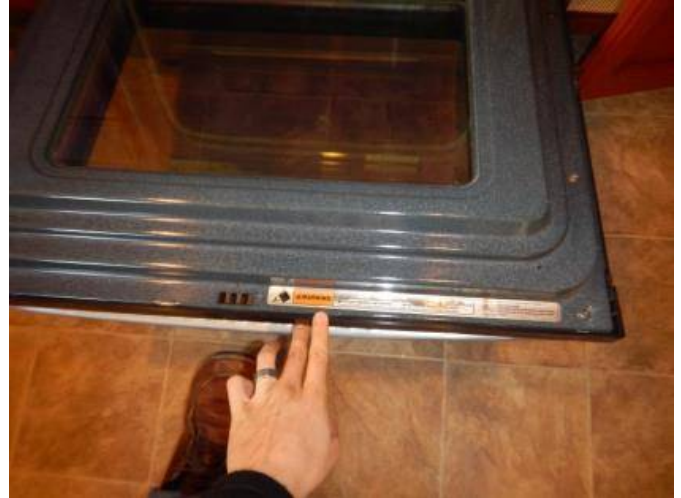
4.11 RANGE/OVEN:

Attention Needed- Stove has not been secured as required by manufacturer's installation instructions. A tip-over hazard exists for small children. Stove should be properly secured.

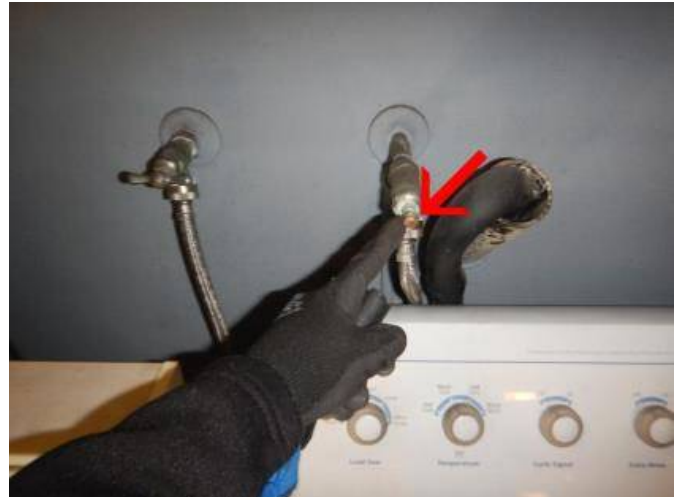
5.2 WASHER HOOK UPS:

Washer hook ups provided. These valves are not tested. Inspector simply notes the presence of fill valves and drainage. **Attention Needed-** One of the shut off valve handles are missing, replacement needed.

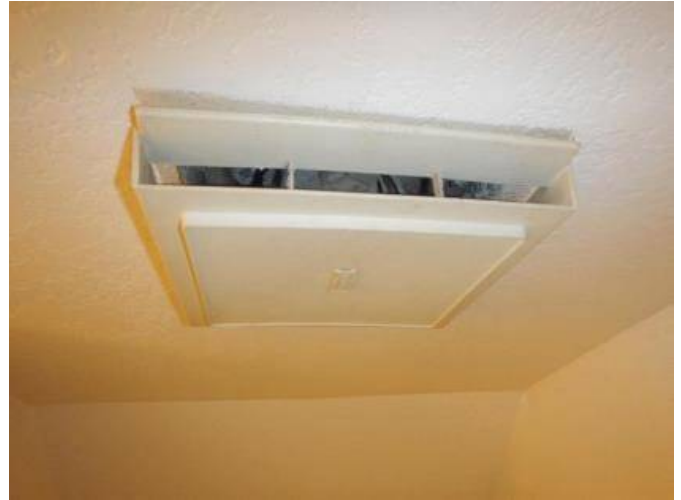
There is an exhaust fan installed in this bathroom, however it is dirty and noisy. Maintenance needed.

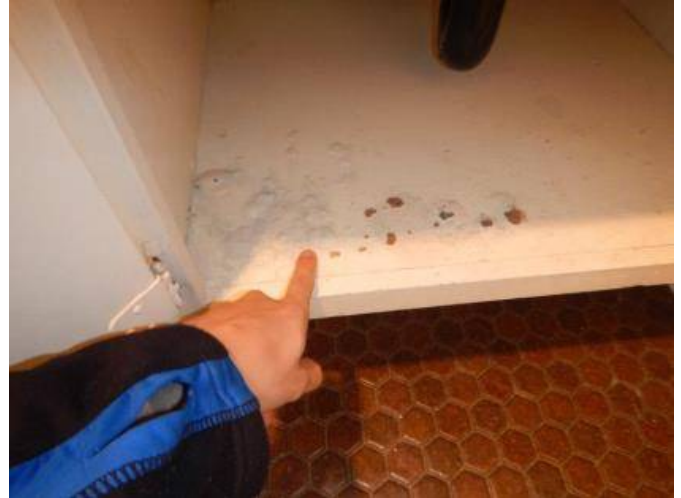
6.12 VANITY CABINET

Attention Needed - Water damage noted within cabinet under sink.

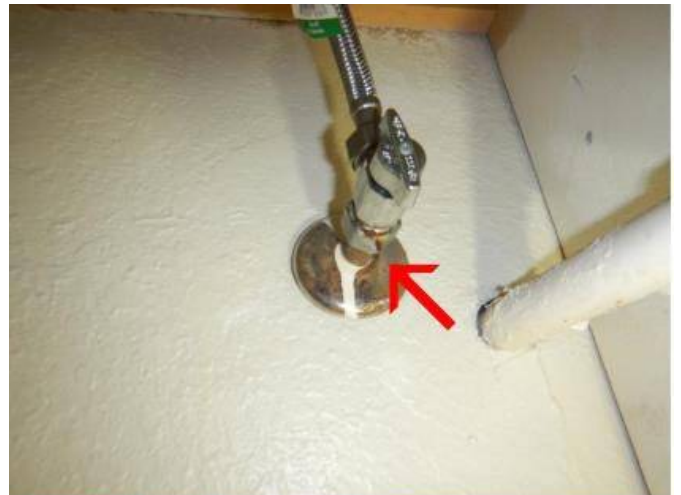
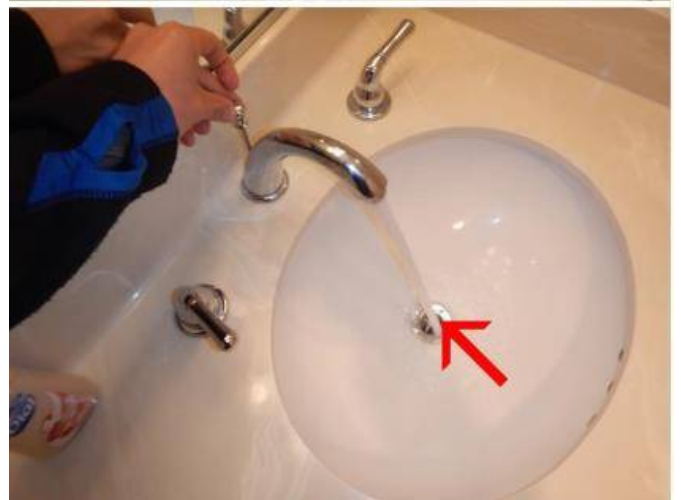
Attention Needed - Some rust and corrosion seen on the right shut off valve under sink. The stopper valve does not stop water from draining or is missing. Contact a licensed plumber for repairs/ replacement at this time.

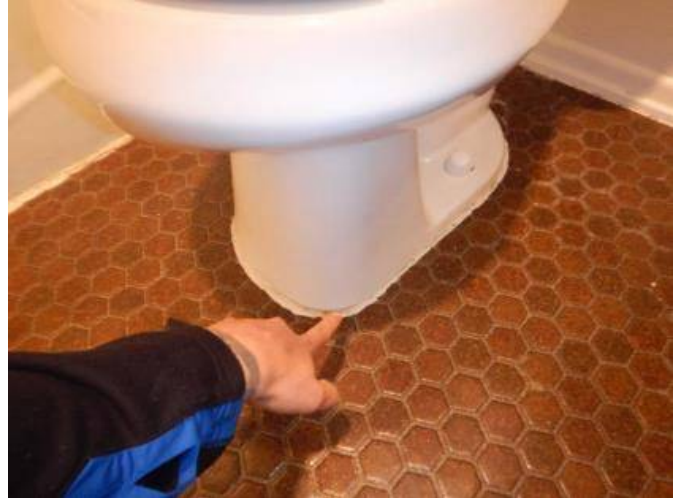
6.15 TOILET:

Attention Needed- The toilet is not secure to the floor, allowing it to wobble and possibly leak. Action should be taken to re-secure it to the floor.

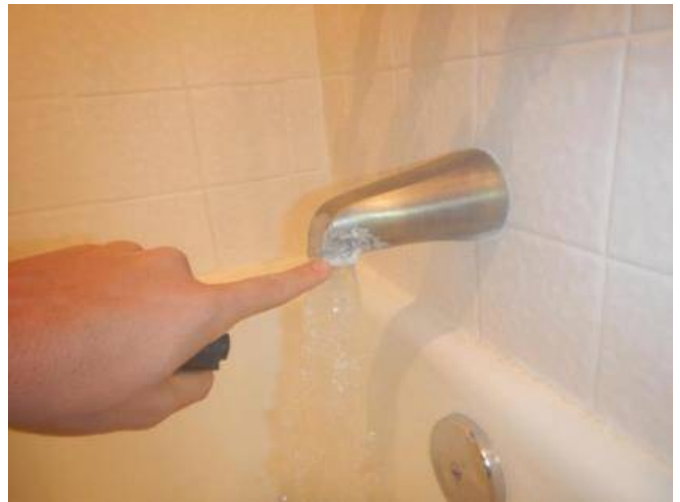
6.16 TUB:

Attention Needed- The tub faucet is corroding and the tub stopper is missing.

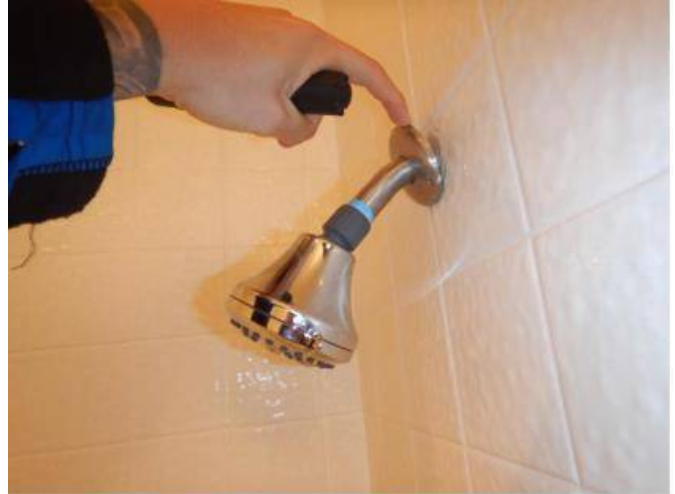
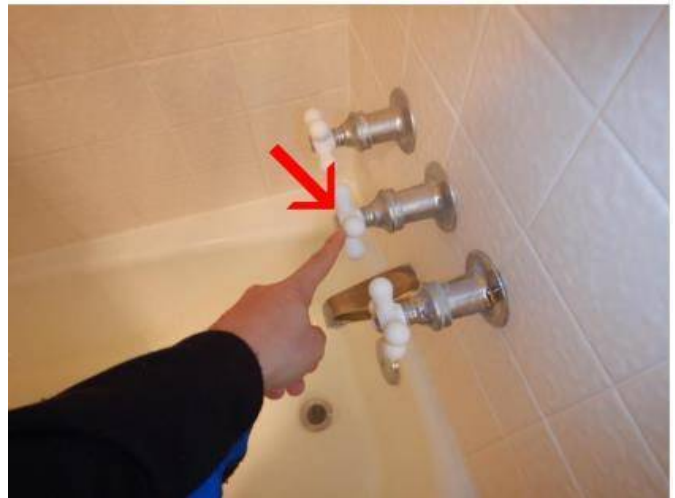
6.17 SHOWER FIXTURES:

Attention Needed - Escutcheon is loose. Secure at this time to conceal gap. Shower diverter does not fully divert water from tub to shower.

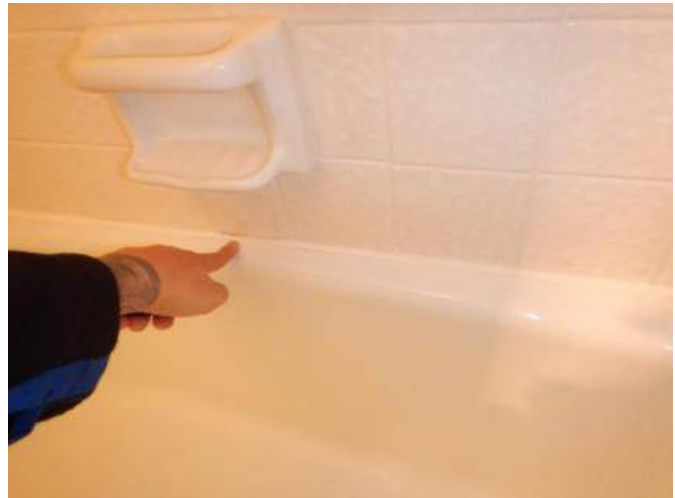
6.18 TUB & SHOWER WALLS:

Attention Needed - Seal along where tub meets wall tile is in poor repair. Improvements are needed at this time.

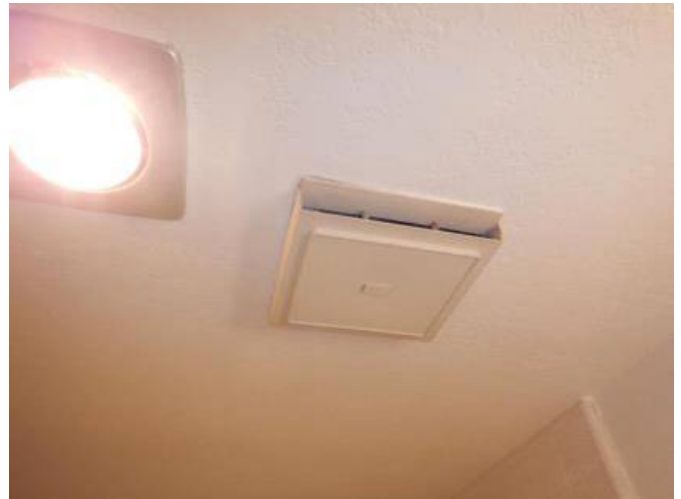
There is an exhaust fan installed in this bathroom, however it is dirty and noisy. Maintenance needed.

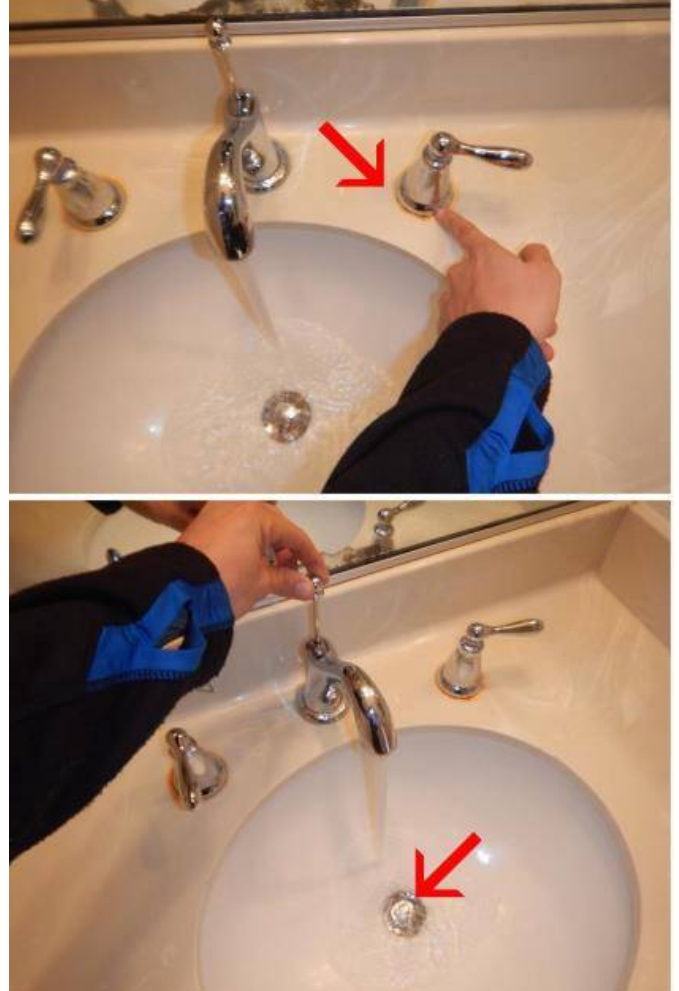
Attention Needed - The right faucet fixture is loose from the counter top and the stopper valve does not stop water from draining. Contact a licensed plumber for repairs/ replacement at this time.

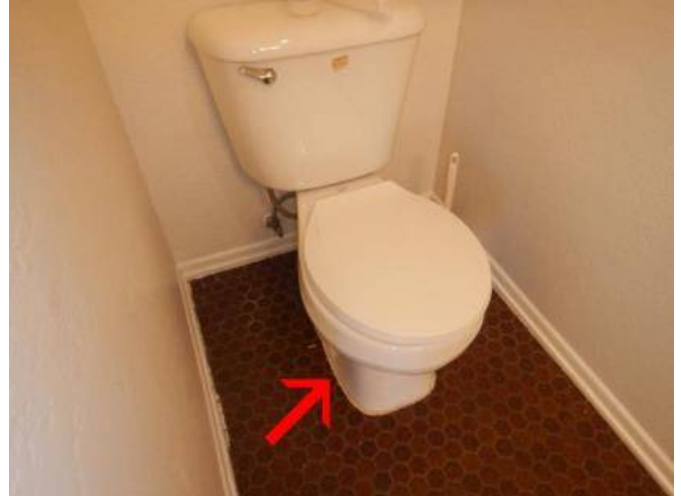
6.29 TOILET:

Attention Needed- The toilet is not secure to the floor, allowing it to wobble and possibly leak. Action should be taken to re-secure it to the floor.

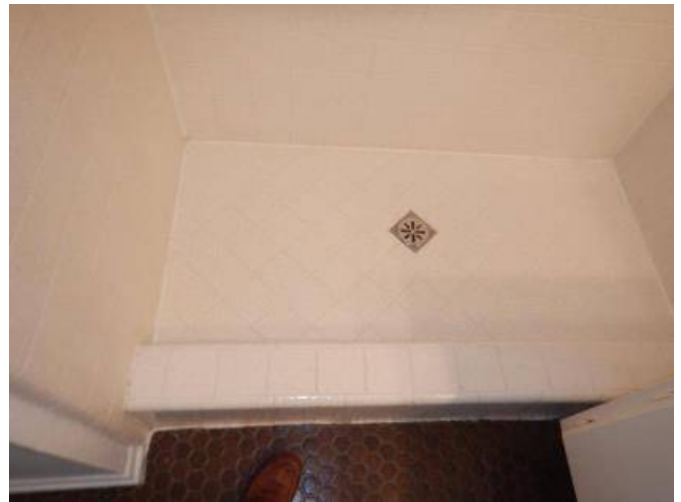
6.30 TUB & SHOWER WALLS:

Attention Needed - Seal along where tub meets wall tile is in poor repair. Improvements are needed at this time

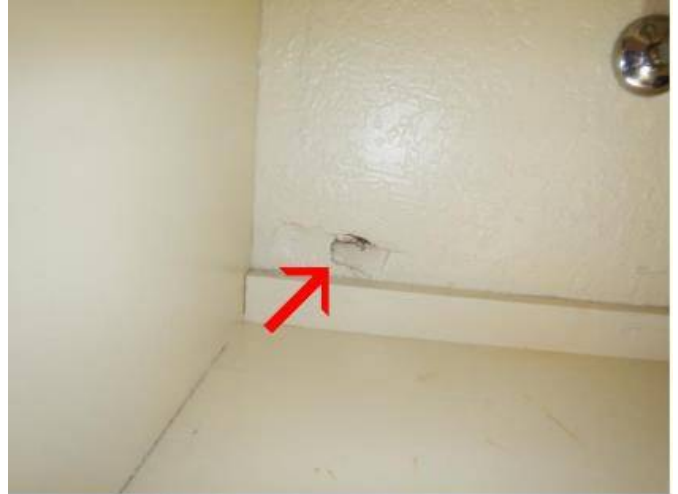
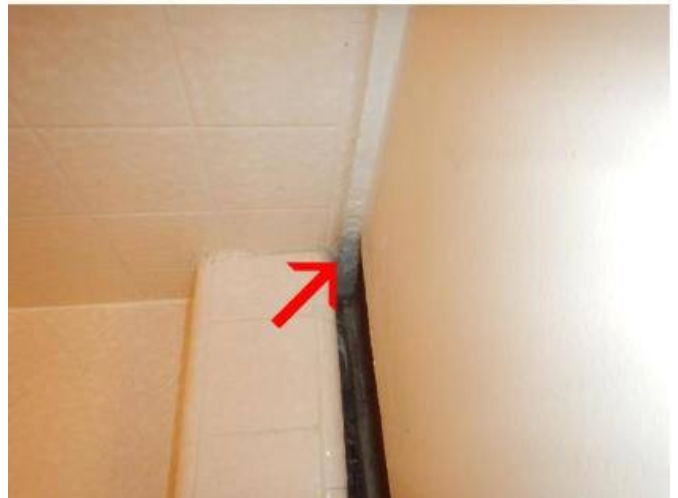
Attention Needed - Some damage seen to the wall under the cabinet sink and evidence of past water damage seen to wall to the right of the shower stall.

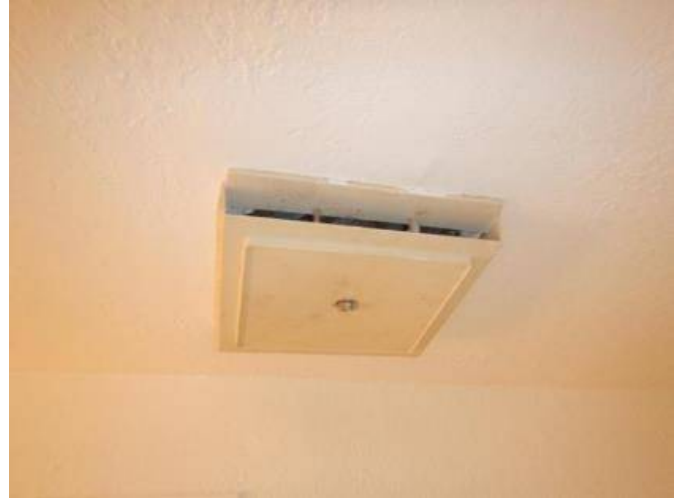
There is an exhaust fan installed in this bathroom, however it is dirty. Maintenance needed.

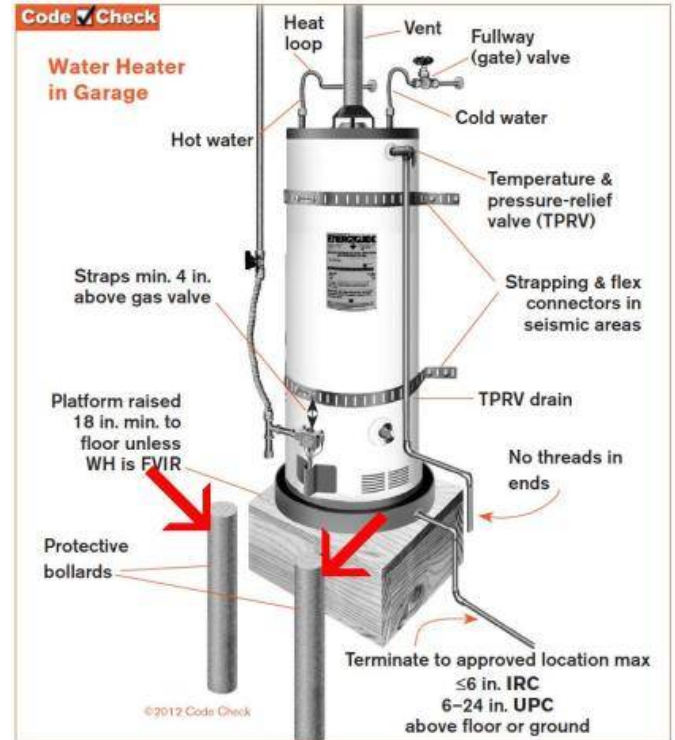
7.14 CONDITION:

Attention Needed- Ideally a bumper post would have been installed along front of water heater to prevent vehicle damage potential.

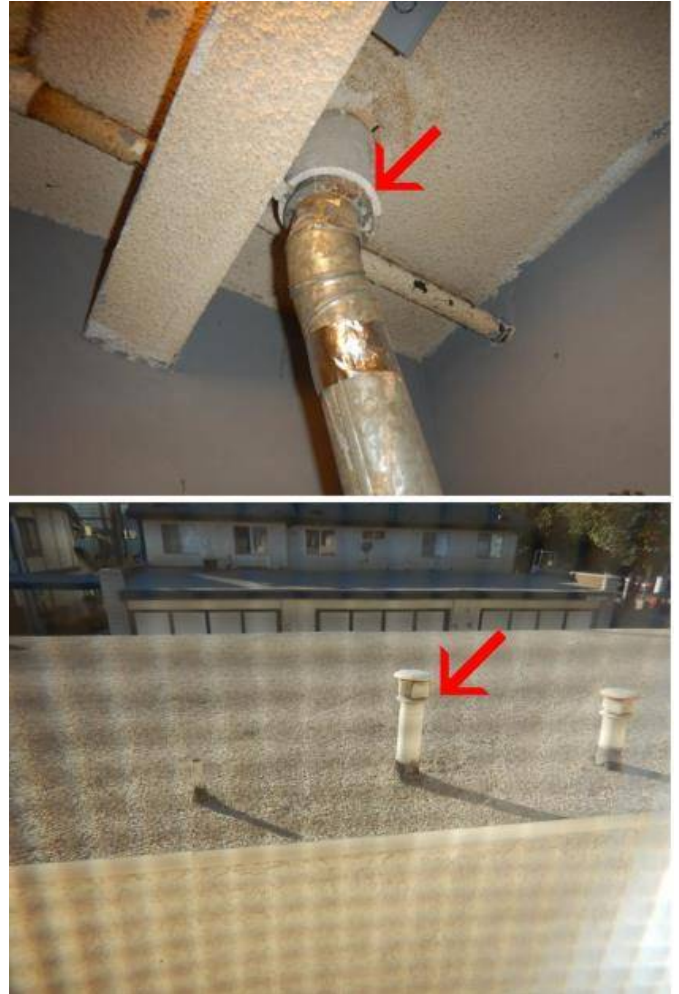
7.16 VENT PIPE CONDITION:

Attention Needed - The vent pipe is connected to an older clay transite pipe (Possibly asbestos). Manufacturers and some jurisdictions recommend that this not be done as it can affect proper drafting of gases and can pose some health risk.

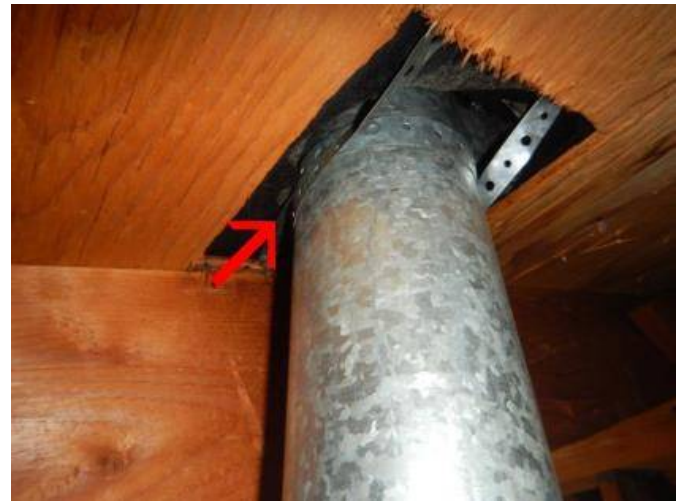
8.7 VENT CONDITION:

Attention Needed- There is inadequate clearance maintained from around the flue pipe. This can be a potential fire hazard. Immediate corrections is recommended at this time.

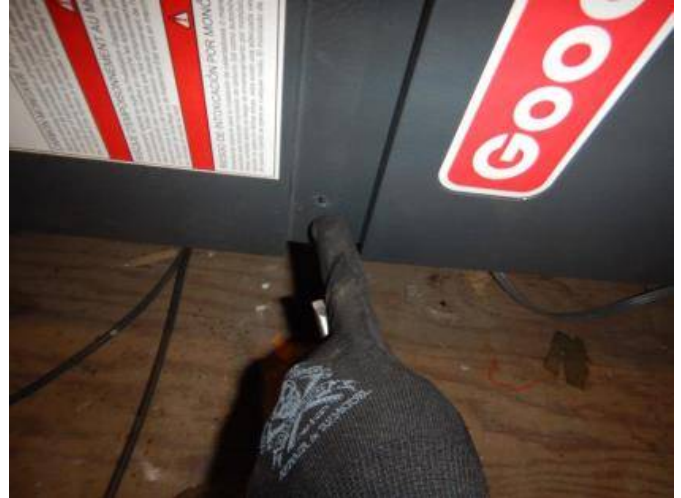
8.10 CONDITION OF UNIT:

Attention Needed- Missing screw noted at cover. Replacement screw needed. The heating unit may be undersized in relation to the square footage of this townhouse. Further evaluation is advised by a licensed HVAC contractor.

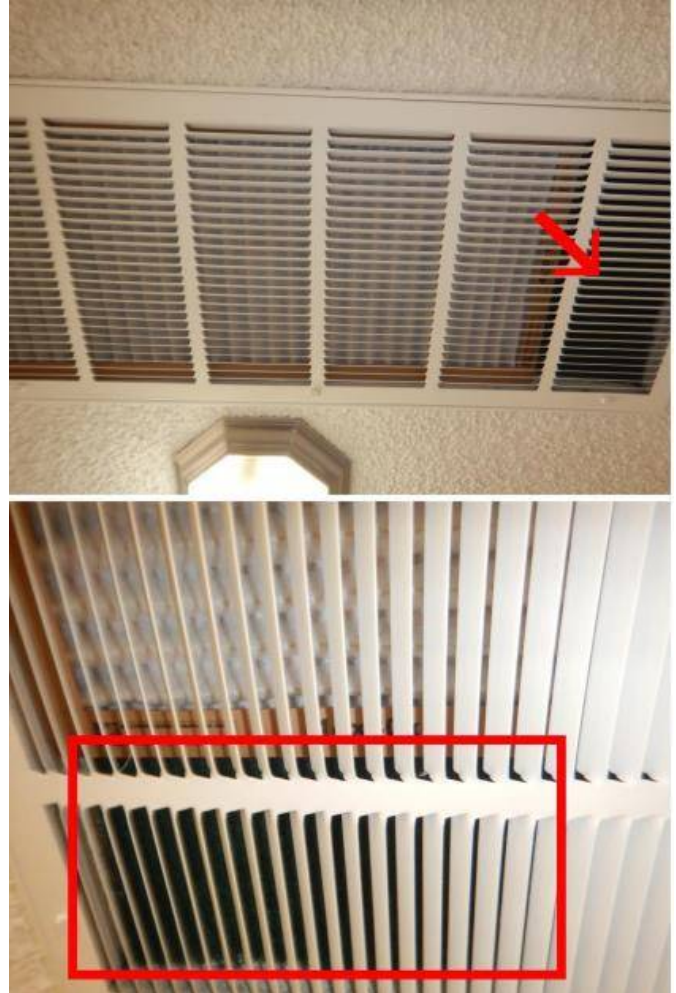
The filter at upper hall is incorrectly sized.
Improvements needed.

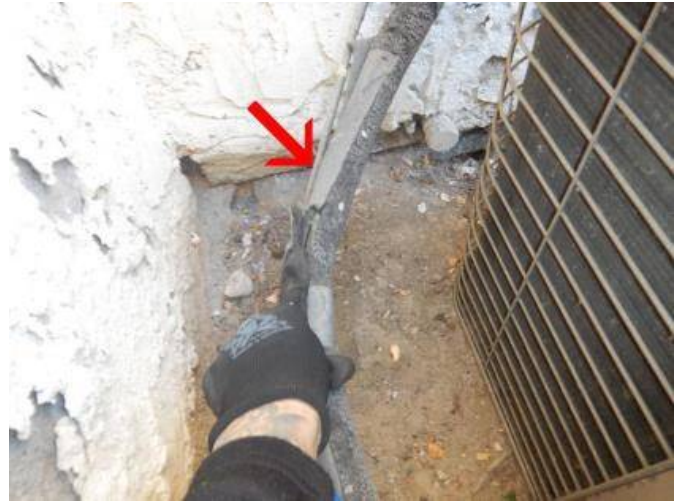
Attention Needed - The insulation wrap for the suction line to the condenser/compressor is damaged and needs replacement. This condition affects the efficiency of the cooling system.

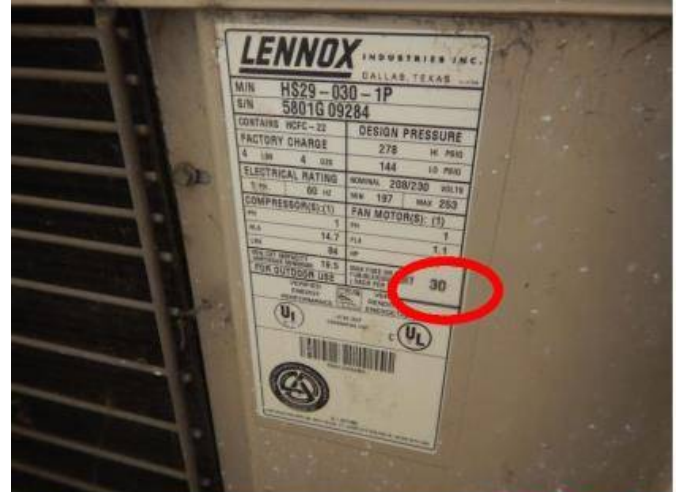
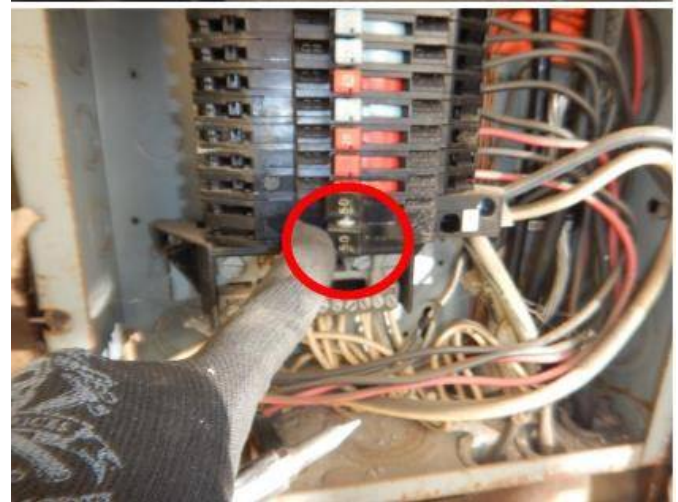
Attention Needed- Maximum Fuse or HACR type Breaker: specifies the maximum overcurrent protection or **MOP** to be used to protect the equipment. The permitted ampacity of the equipment electrical circuit protection (fuse or circuit breaker amps) expressed as MOP or Maximum Overcurrent Protection. If MOP is specified, the breaker or fuse protecting the equipment should match this number. A hermetic compressor draws varying amounts of current as its internal pressure changes during operation. Current draw is higher when starting the motor, and highest if the motor is starting against its highest back pressure such as when a unit is turned off and then back on in the middle of operation. Because fusing an air conditioning compressor at the minimum level can result in blown fuses or tripped breakers during these intervals of heavy current draw during compressor startup, compressors are either protected by a slow-blow fuse or a somewhat larger than minimum circuit breaker.]

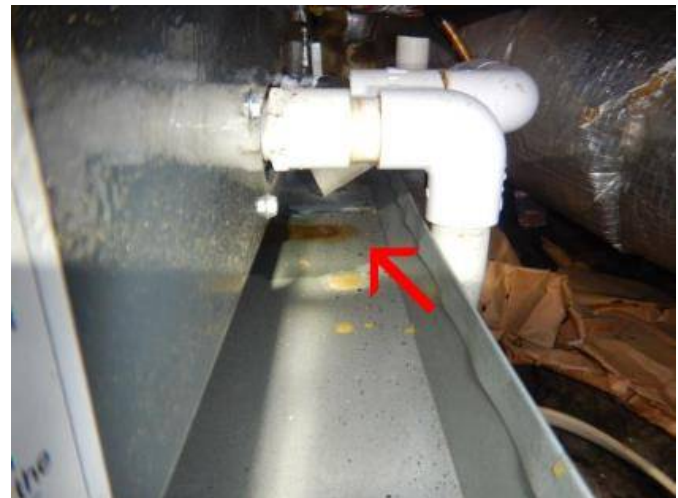
8.25 CONDENSATION DRAIN:

Attention Needed- There is condensation seen within the drip pan in the attic space. This usually indicates a problem with the system. Recommend further evaluation and repairs if necessary.

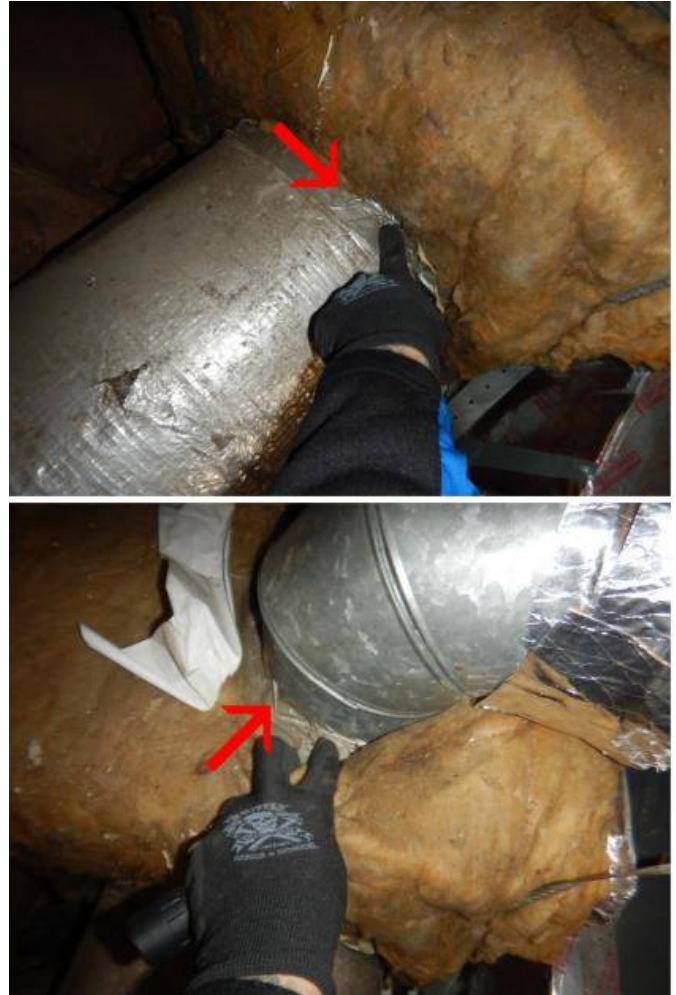
8.26 CONDITION:

Attention Needed - Hardware store "duct tape" is no longer an approved method of sealing ducts. Recommend corrections at this time.

Client should be aware that as of October 2005 the new rules are that when ever a major upgrade was achieved, such as replacing furnace or air conditioner, the duct work would be pressure tested by a third party. After achieving desired pressure test a certificate would be issued and filed with the local building department. Consult seller for this records or whether or not a permit was obtained when upgrades were done.

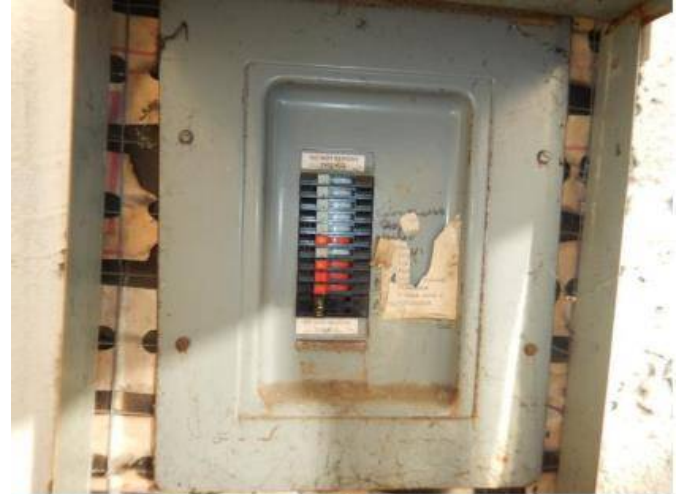
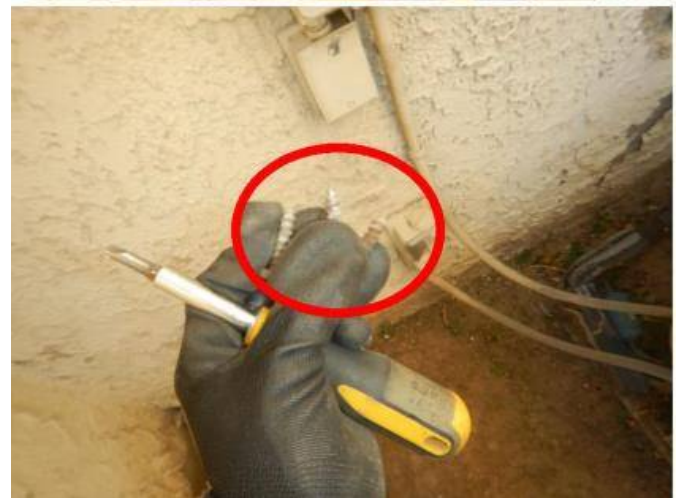
9.9 PANEL CONDITION:

Attention Needed- Many electricians and home inspectors have discovered that certain Zinsco panels often can fail to operate properly and prone to some adverse conditions. These panels can work fine for years, but as homes have increased energy demands, these panels may overheat and portions of it melt.

Sharp ended screws are used to fasten the dead front cover to this main panel. Sharp ended screws are not intended for this purpose as they could damage internal wiring and pose a shock or electrocution hazard. Dull ended screws should be used.

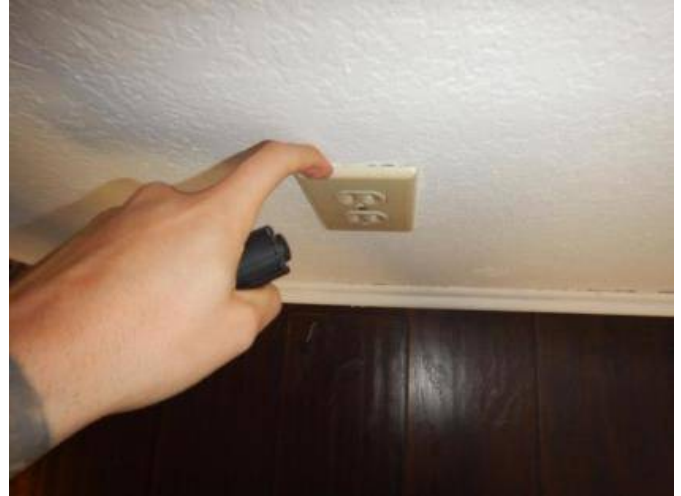
Attention Needed- Loose receptacles noted in areas, repairs are needed. Repeated use of loose receptacles can result in damage to the wiring at the junction box.

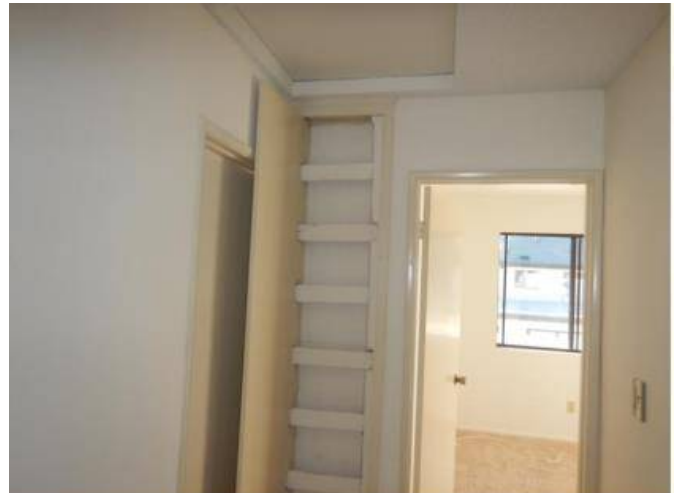
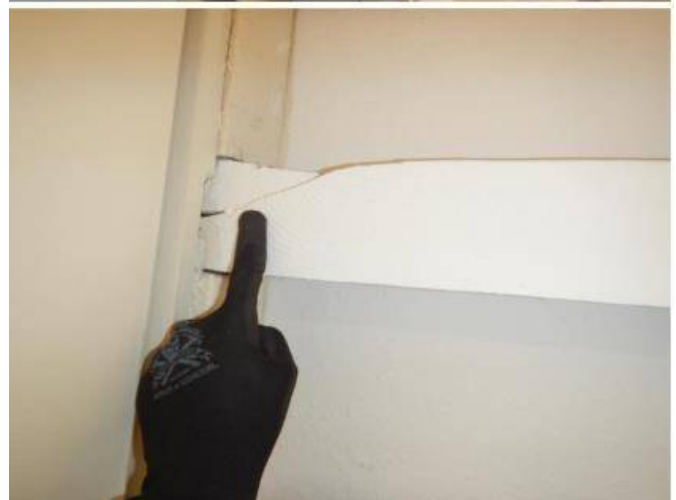
Hallway ceiling with built in ladder installed.
Attention Needed- One of the ladder rungs is damaged and needs replacement before use. Use caution!

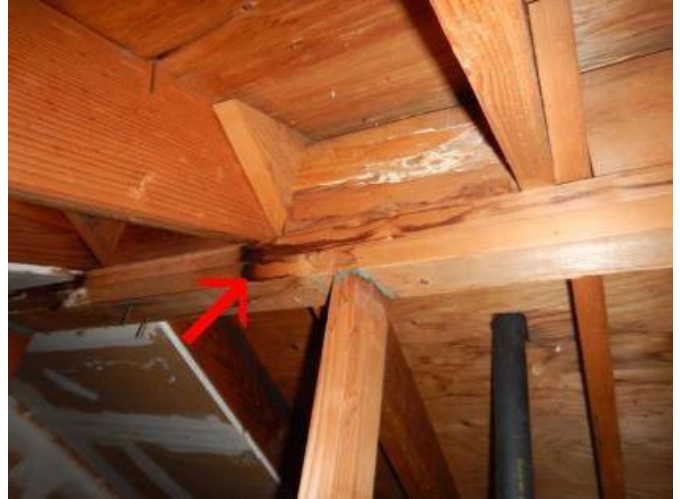
10.4 FRAMING CONDITION:

Attention Needed- Water Stains are seen in areas. Inspector can not make any determination on whether or not these stains are from active leaks.

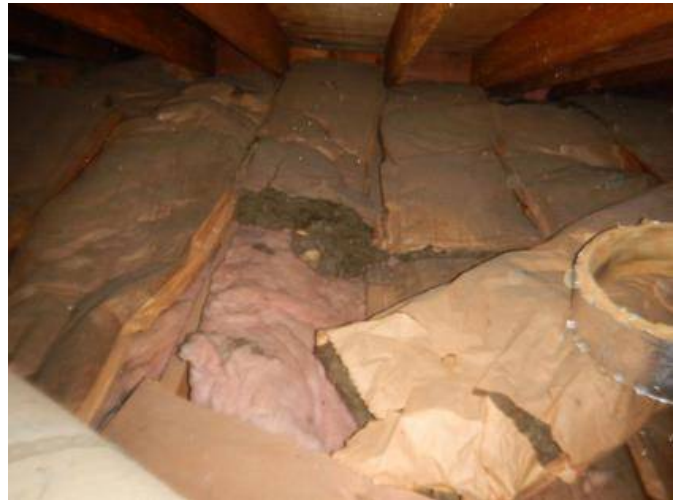
10.7 INSULATION CONDITION:

Attention Needed - The insulation is installed upside down. Vapor barrier should face living space.

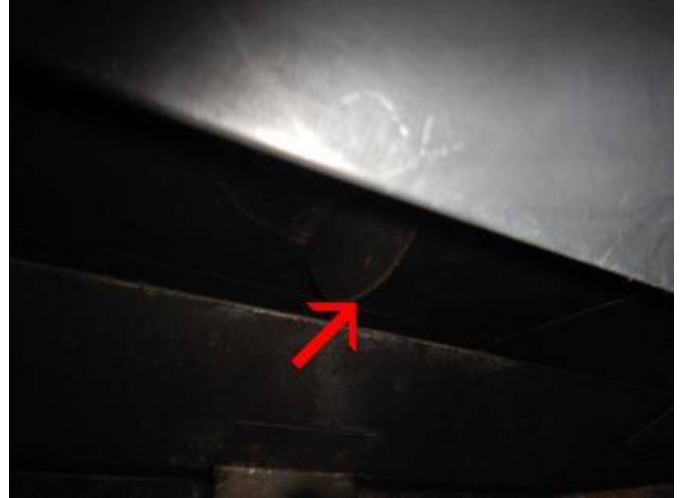
11.5 DAMPER CONDITION:

There is no damper clip installed. All fireplaces with a gas connection should have a clip installed that will allow a small airflow up the chimney.

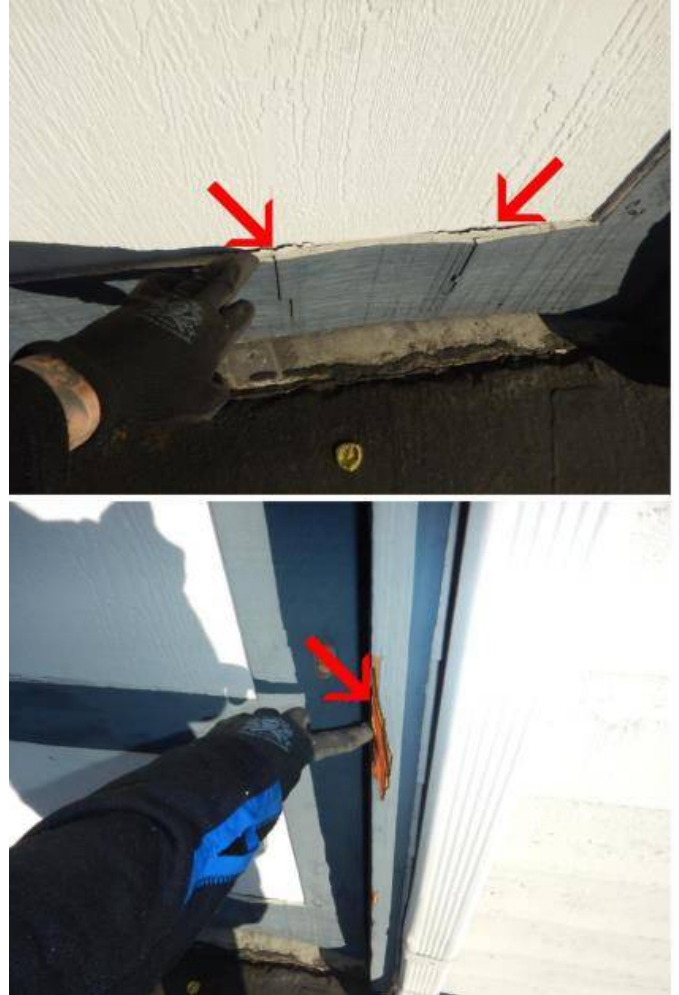
12.4 CONDITION:

Attention Needed- Water damage seen in areas to the exterior portion of the door and frame. Repairs may be needed.
