Alliance Inspections

Report: Sample Condo Report, 19231 Anywhere Avenue, Reseda, CA 91335

Confidential Inspection Report 19231 Anywhere Ave. Reseda, CA 91335

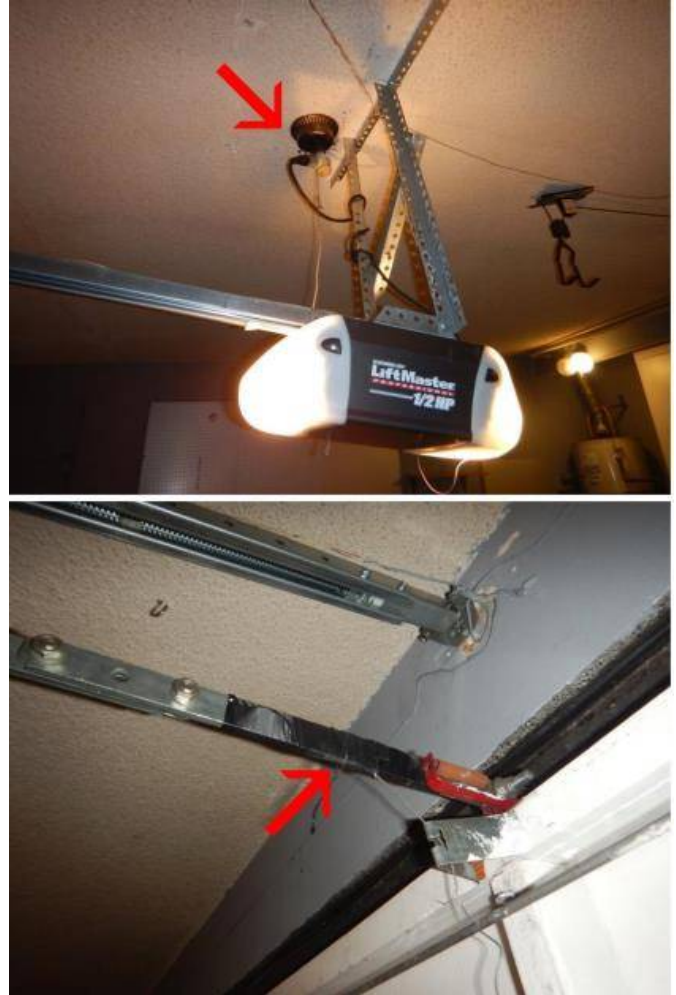
12.5 AUTOMATIC GARAGE DOOR:

Attention Needed - Do not have unit power cord plugged into light outlet. Recommend that a licensed electrician install designated receptacle to power garage door opener. There appears to be some kind of repair seen to the opener. Further evaluation is advised. All garage door and automatic garage door opener adjustments or repairs should only be attempted by a qualified garage door installer.

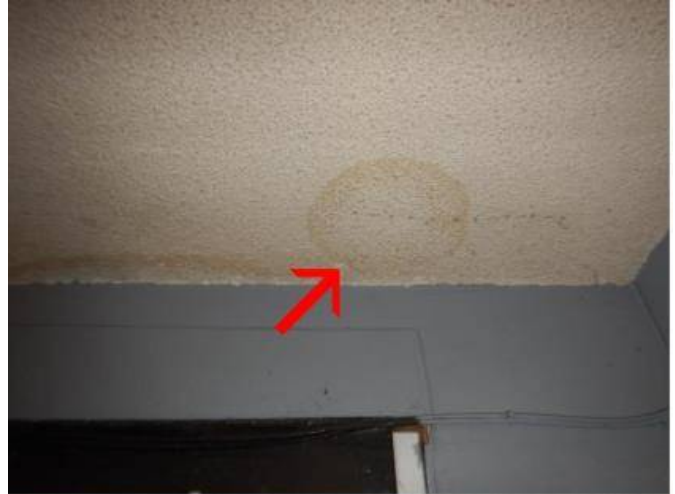
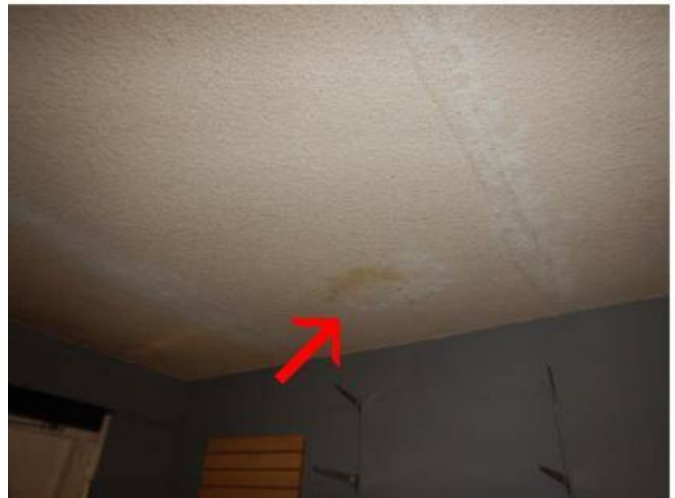
Attention Needed- Water Stains are seen in areas. Inspector can not make any determination on whether or not these stains are from active leaks.

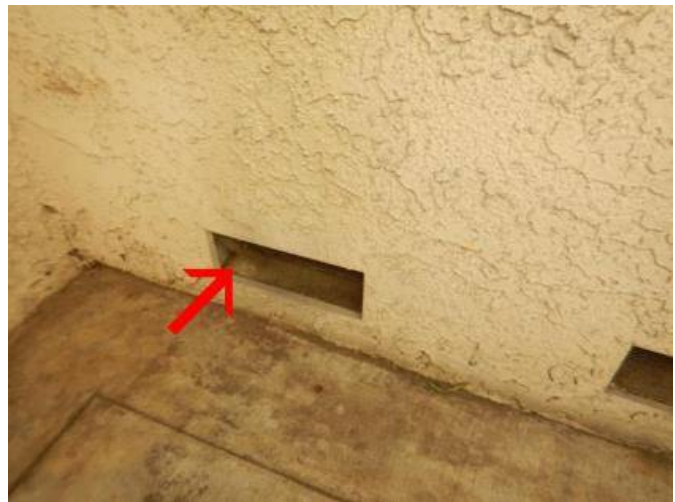
One of the vent covers at the garage is damaged and should be replaced.
