INSPECTION CONDITIONS

DATE OF INSPECTION: October 28/2008.
TIME OF INSPECTION: 1:00.
CLIENT NAME: Mr. & Mrs. Smith.
INSPECTION LOCATION:

INSPECTOR: Robert Gaudreault.
1234 Any Street, My Town, California.

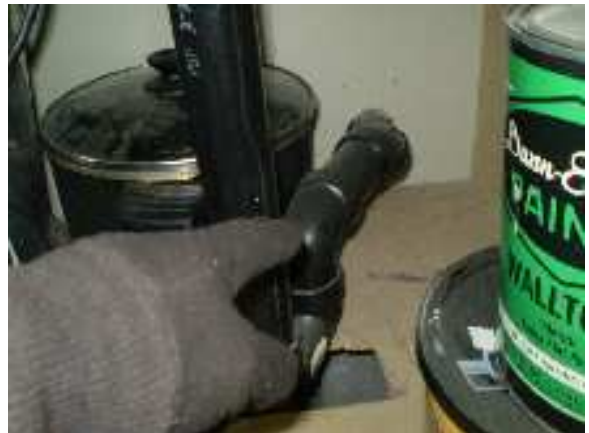
Needs Attention. Drain trap assembly at laundry sink drain is not installed per industry standards. This could result in waste siphoning from the trap thus allowing waste vapors to emit into interiors.

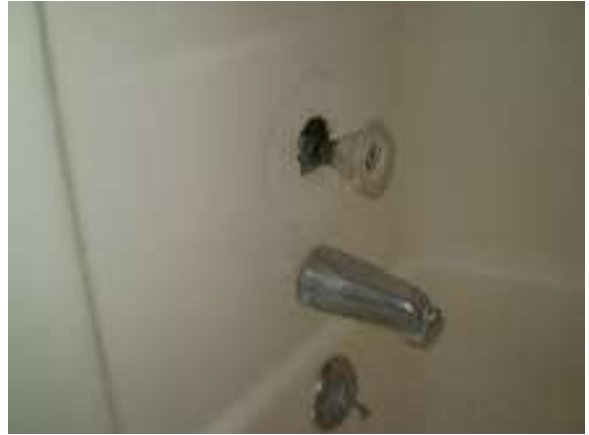
Functional.
Needs Attention.
Fixtures are not operational at this time. Also, seal around tub spout poor. Prolonged water infiltration into substrate may be present and result in water damage in areas that are not visible in this type of inspection.

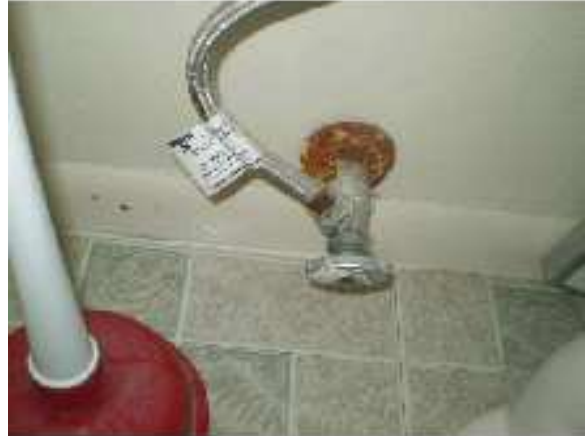
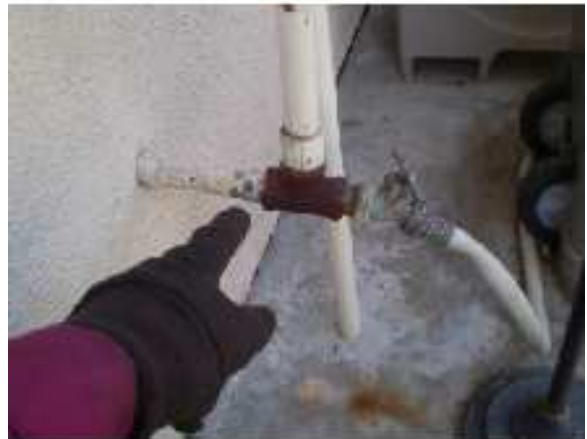
Needs Attention.
Overall visible sections of water pipes appear serviceable however, older angle stop shut off valves noted to interior plumbing fixtures. Client should understand that these older type valves do tend to leak, especially when operated. Consider upgrades. Also, Copper to Galvanized piping contact is noted in areas without the appropriate buffer between the two metals, such as exterior hose bib. Corrections to these areas is recommended. This can cause corrosion as the two types of material are not compatible.

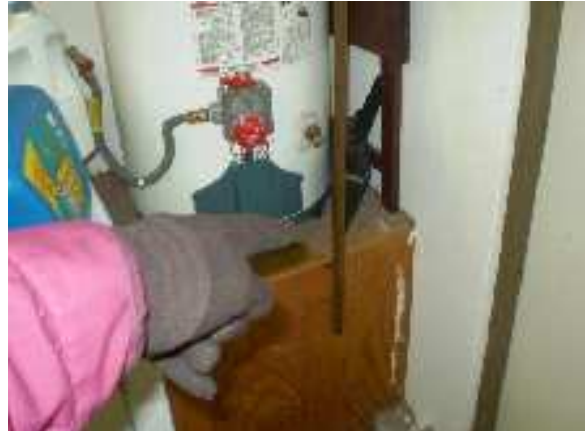
LOCATION: Garage.
TYPE: Gas.
SIZE: 40 Gallons.
AGE: 3 years.
CONDITION: Needs Attention. The pressure relief valve drain line is missing or ends prematurely. This is a safety issue. It is recommend that this drain line be extended to a safe and required location.

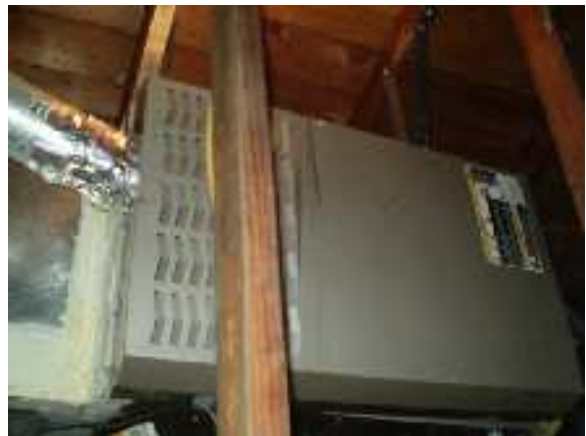
Needs Attention. Areas of concern are: This unit lacks adequate working platform from along the front to prevent ceiling damage when system is being serviced, unit cover does not fit and is loosely placed at this time. Flue pipe prevents it from fully closing, component should not be anchored from truss system as these framing units are not designed for additional weight and opening into attic space does not appear to be large enough to remove largest part of heater.

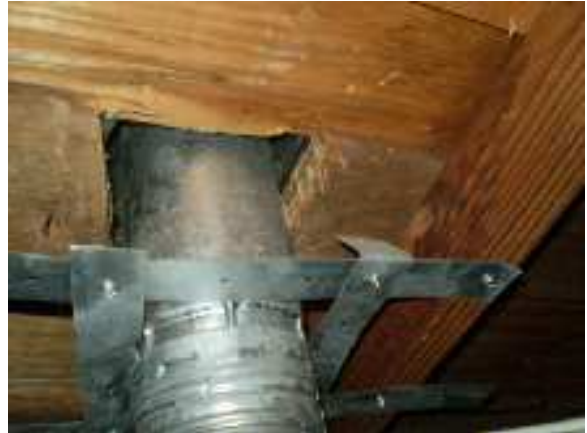
Functional.
Non Functional due to safety concerns: There is inadequate clearance observed from around the vent flue pipe to combustible material that is nearby. In other words the vent pipe, which gets very hot, is touching or is too close to a combustible product. This is a fire hazard and should be corrected at this time.

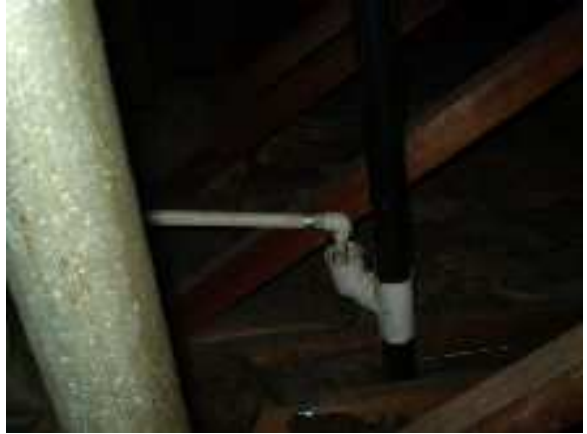
Non Functional due to health concerns. Improper installation of condensate drain pipe observed. Condensate drain line exiting the evaporator unit in attic space empties into a PVC drain line. When connected with the sanitary sewer, the possibility of bacterial contamination is present. Waste fumes from the sewer system could enter the unit. This situation contributed to Leigonaires disease some years ago in Philadelphia.

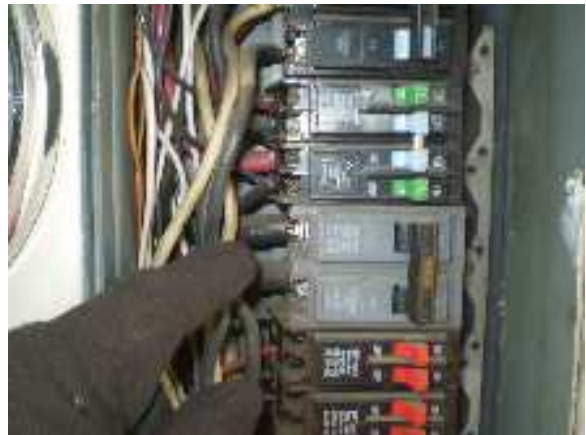
LOCATION: Exterior right side.
AMPERAGE: 100.
CONDITION: Non Functional due to safety concerns. There is more than one wire connected to a single breaker. This is referred to as double tapping, which can result in a poor connection between the wiring and the breaker lug. It can also cause over-loading of the circuit to the breaker. Corrections are recommended by a licensed electrical contractor at this time to prevent any possibility of future malfunctions. The conductors that are double tapped are under sized in ratio to over current protector which could cause electrical wires to overheat and pose a fire hazard.

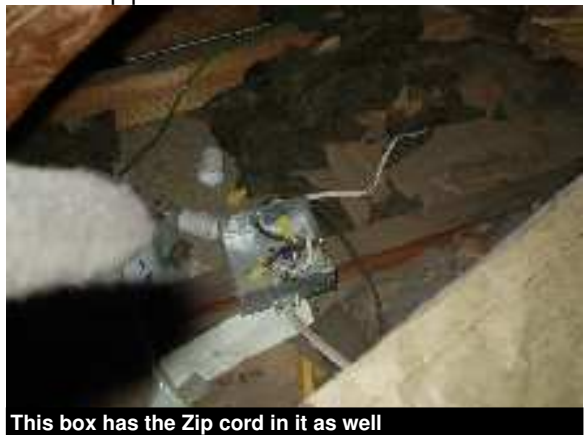
Non Functional. Due to safety concerns. For the most part supply wiring appears serviceable however, Junction box or pull box cover(s) missing at some of the electrical boxes leaving wires exposed, such as attic space and Z power cord, which is simply a lamp extension cord, such as in attic space, is used to provide permanent 110 power.

This is a fire hazard and should be corrected at this time by a licensed and insured electrician.

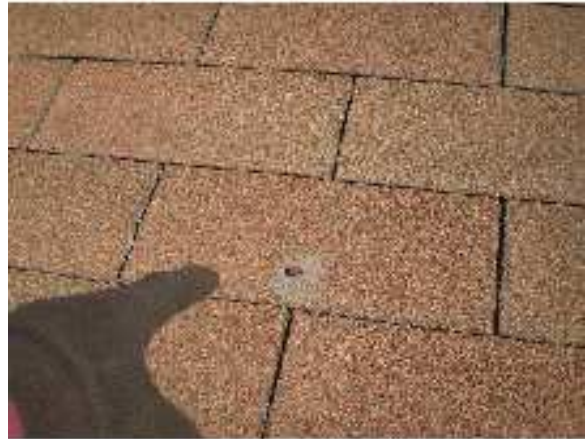
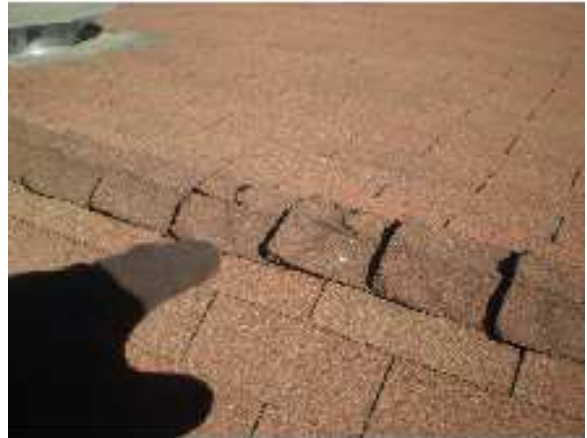
Needs Attention.
Areas of concern are as such: Deteriorated ridge cap observed. The ridge cap is that portion of roof material that folds over the uppermost section of roof system. In its current state it is damaged and deteriorated and poses potential leakage, cracked shingles noted throughout system and Nail heads/ Fasteners are protruding from the roof surface in general areas. These nail heads can eventually rust and pop up and pose a future leak issue. A licensed roofing contractor should be consulted to make further evaluation and/or repairs as needed.

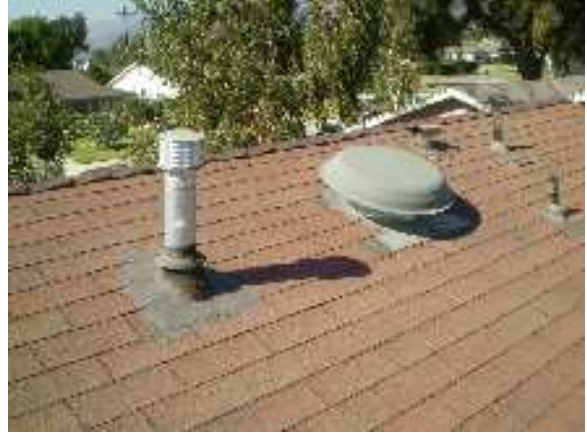
Non Functional. Overall collar flashings are poorly installed or constructed and more than likely not a water tight seal.

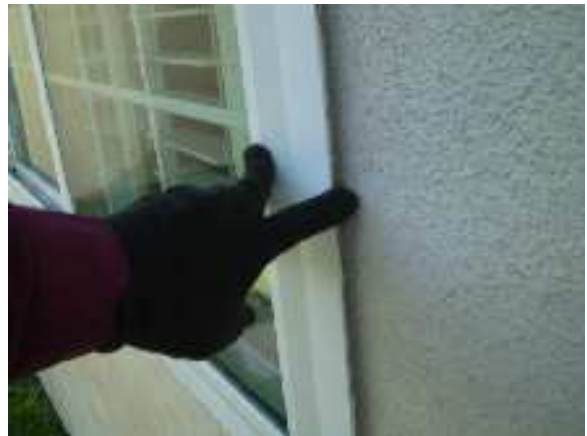
CONDITION: Needs Attention. Flush fin windows are not adequately sealed and may be a source of water infiltration. Consult a qualified licensed window installer for improvements.

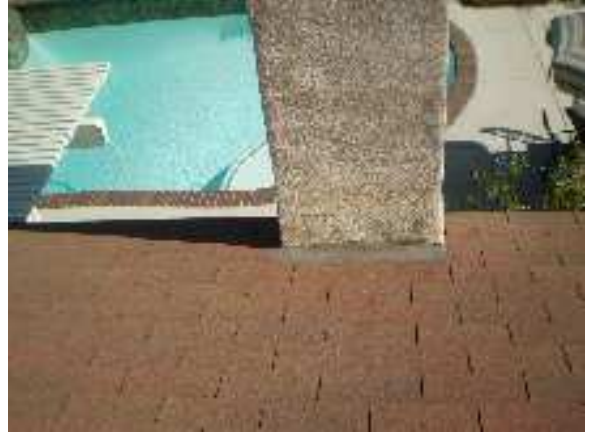
Needs Attention. Flashing around chimney where it meets roof line is in poor condition. Corrections recommended to ensure a water tight seal.

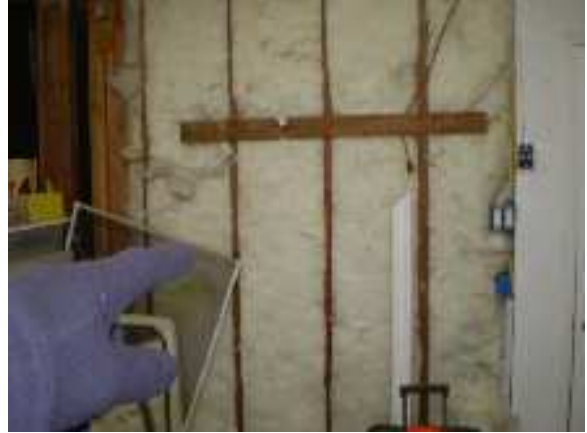
Needs Attention.
Drywall is missing from between the garage and living space thus compromising the needed fire barrier. Suggest repairs at this time.

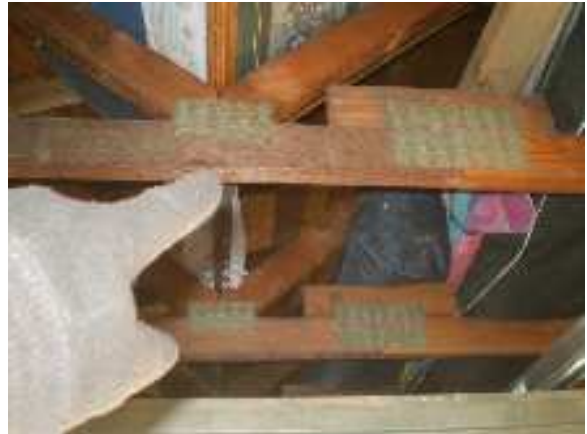
Needs Attention.
Damaged truss noted. Bottom cord appears to be split. Consult a qualified truss company for repairs. NOTE: Suggest that items not be stored on truss system as it is not designed for additional weight.

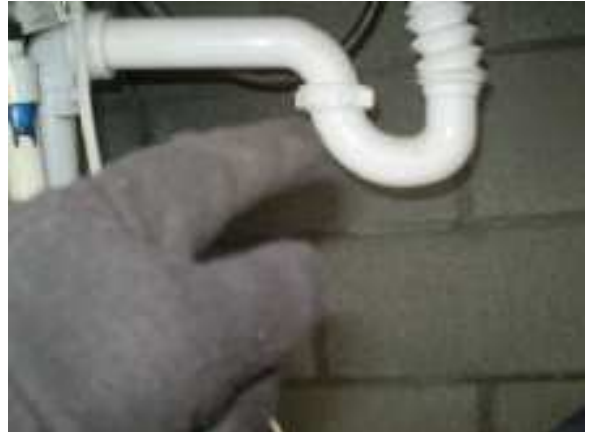
BBQs are not generally part of this inspection though it should be mentioned that there is a nonstandard drain assembly to this sink.

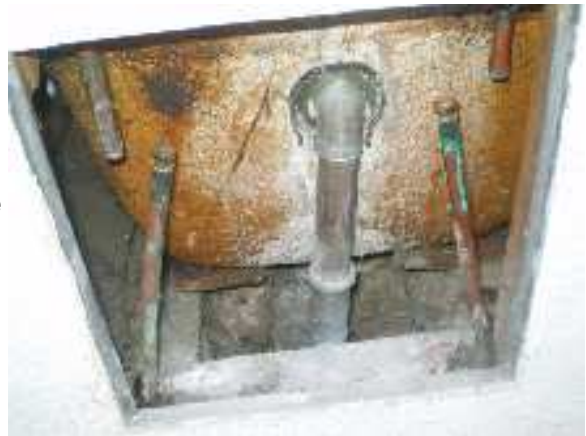
Repair any copper to galvanized contact, such as at back of dwelling, improve drainage of laundry sink and exterior sink and some improvements are needed to water heater. Also suggest upgrading angle stop valves. Contact a licensed plumber for these repairs. Fixtures pipe feed to master tub have been capped off at this time. Consult seller as to history.
