8209 Foothill Boulevard, Suite A124 Sunland, CA 91040
Report: 123 somewhere St. Unit 456 Thistown, CA. 91234

Confidential Report

**123 somewhere St. Unit
456 Thistown, CA.
91234**

Report Table of Contents

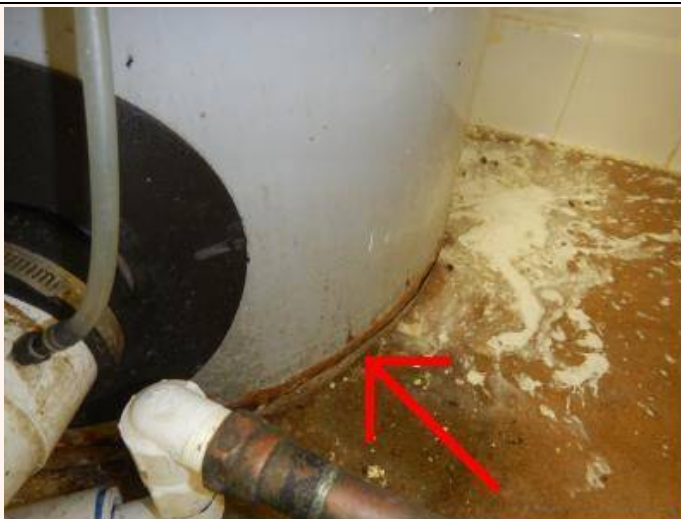
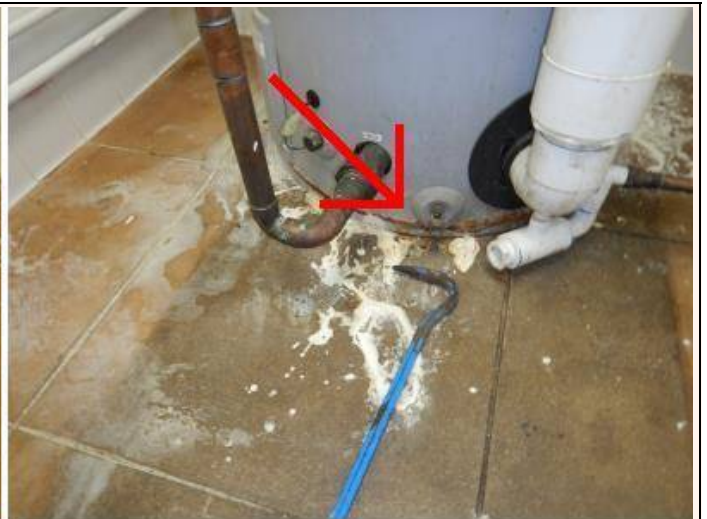
5.8 CONDITION:

Findings:	Recommendations:
Water heater is prematurely deteriorated. Possibly due to inherent condition or installation defect.	Further investigation by mechanical engineer of qualified commercial plumber. Replacement of existing more than likely needed.

Rust Noted - It shows signs of rust and some deterioration.

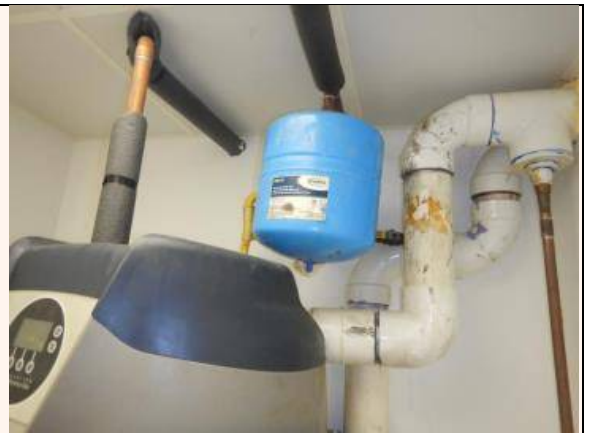
5.12 WATER PIPES:

Expansion tank should be anchored or supported.

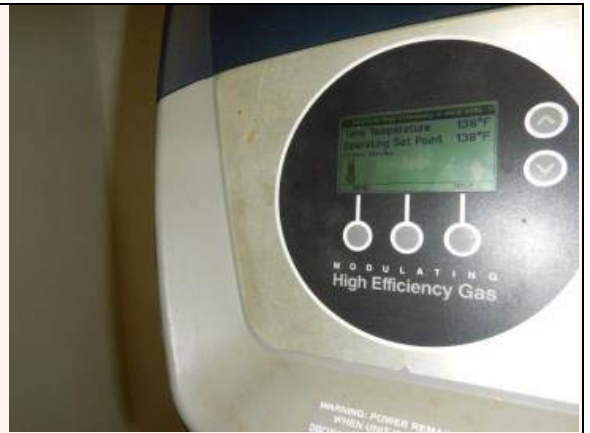
5.13 TEMPERATURE CONTROL:

Not operated or tested. Temperature set higher than standard recommended 120 degrees F.

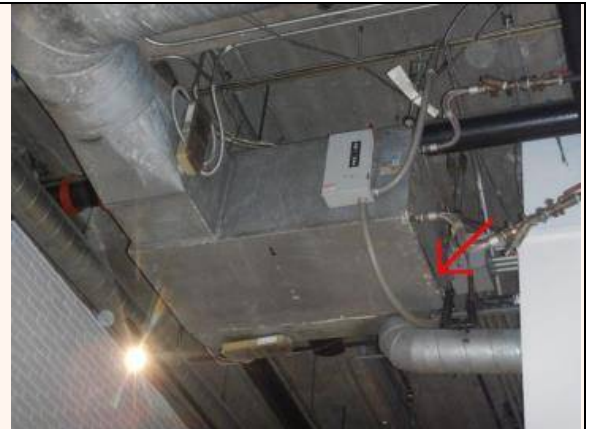
6.5 General Operation & Cabinet:

Generally operational however corrosion apparent to at least one unit indicating rusty or corroded coils. Normally due to lack of maintenance, such as simple filter change.

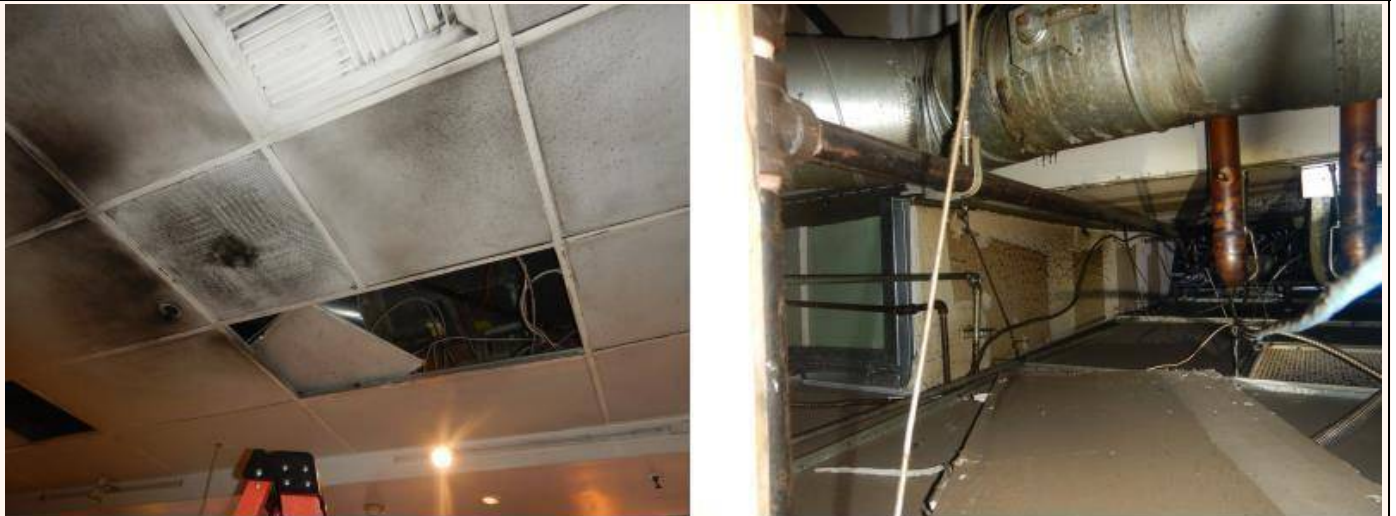
6.9 Ducts Condition:

Evidence of cross contamination of exhaust hood air and conditioned air from heat pumps located within ceiling plenum above kitchen.

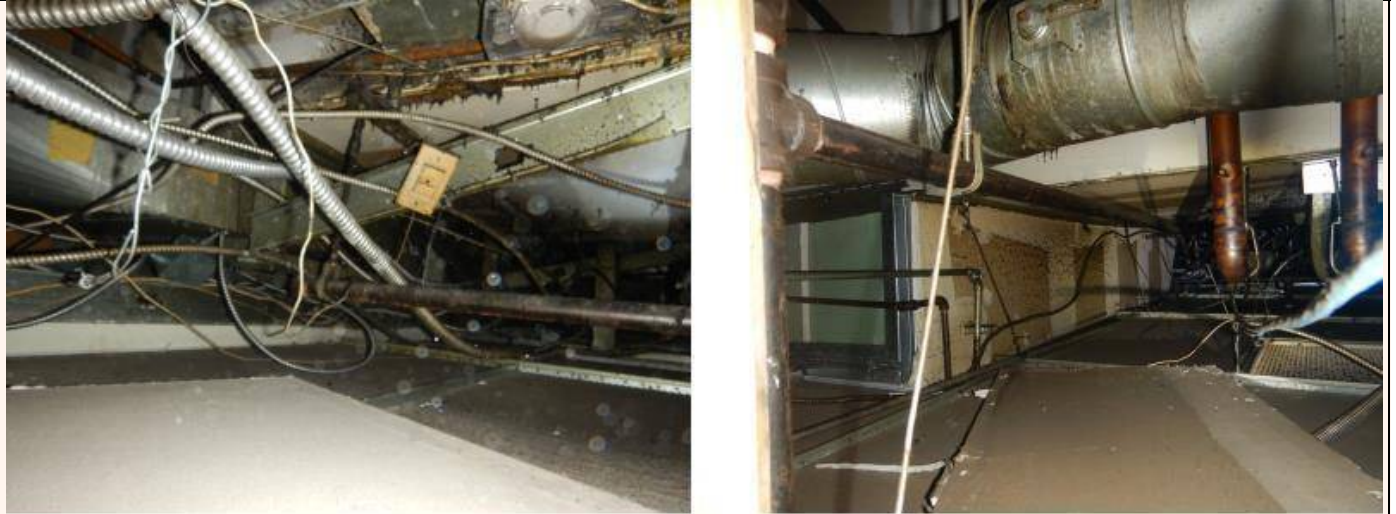
6.10 NOTE:

Exhaust hood is too closet to air returns resulting in grease flow into ceiling plenum.

Consult qualified mechanical engineer for suggestions.

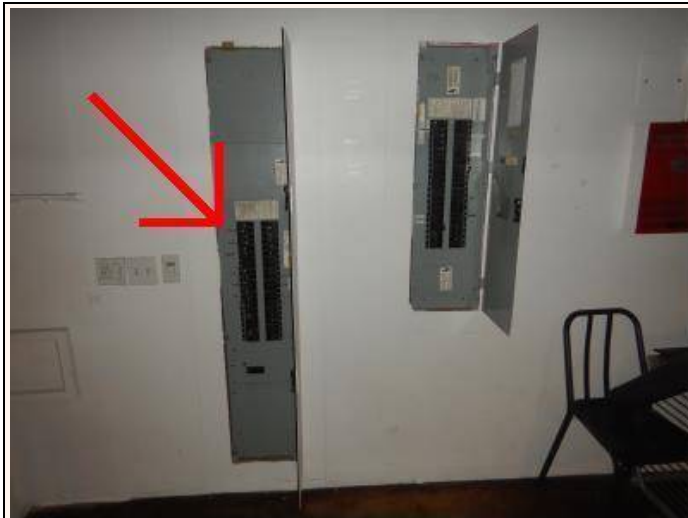
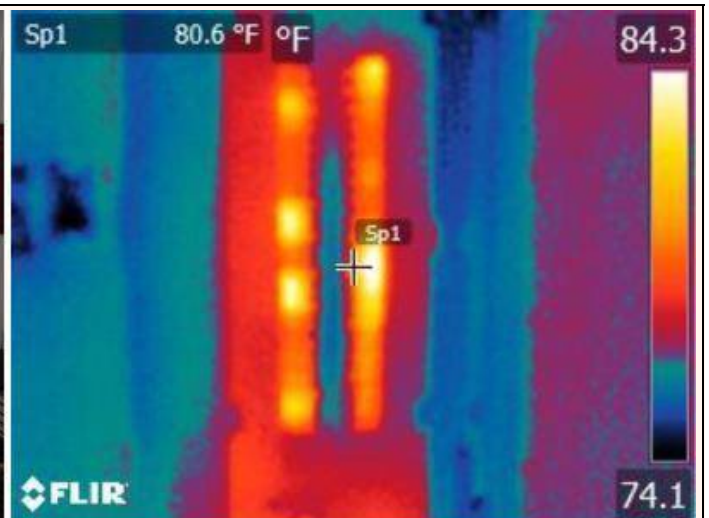
7.5 PANEL TYPE & CONDITION:

Panel A does indicate anomalies at some breakers. Further investigation needed to verify condition beyond panel. Contact commercial 3 phase electrician.

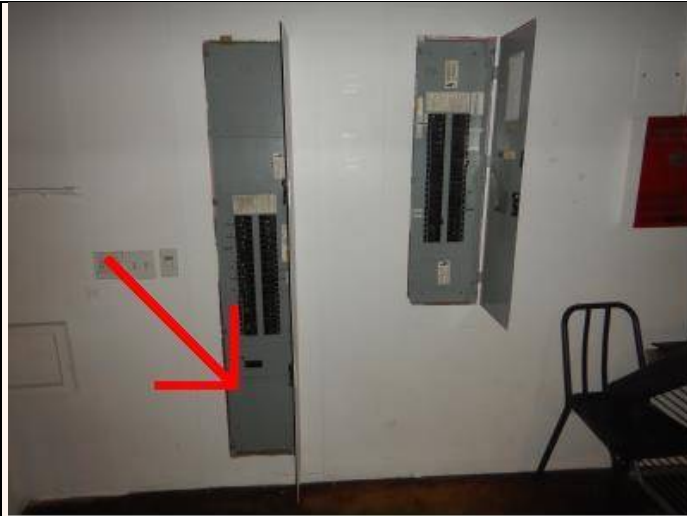
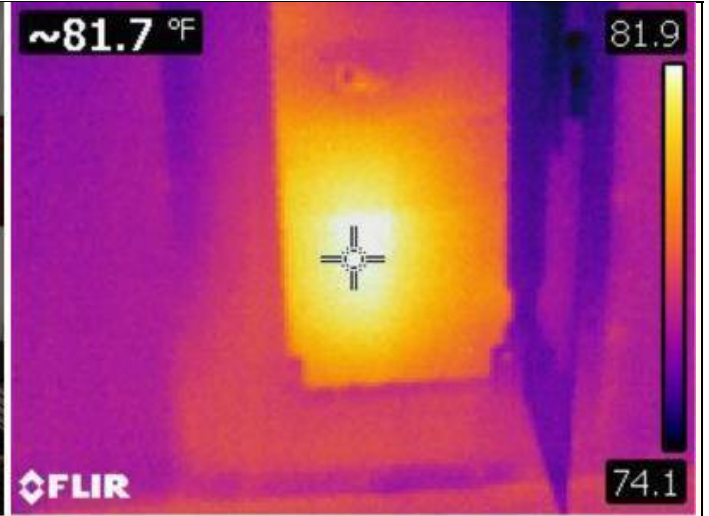
Suspected overheating of incoming feeder.

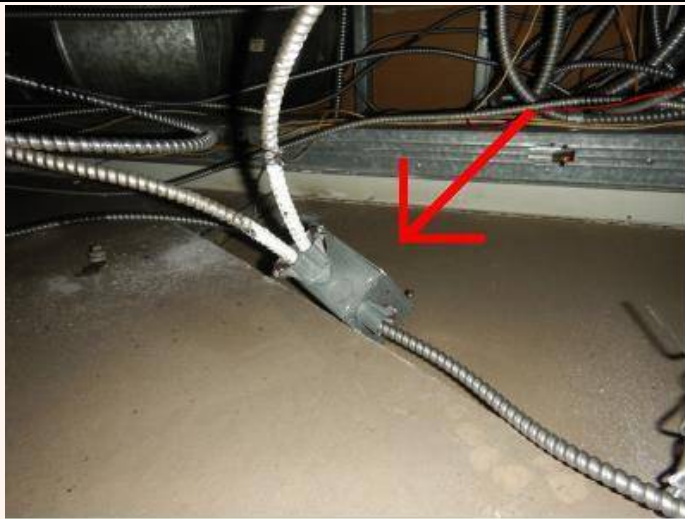
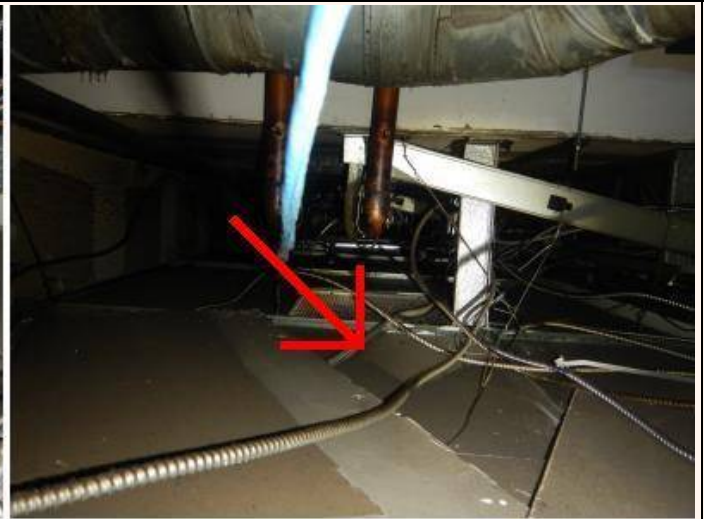
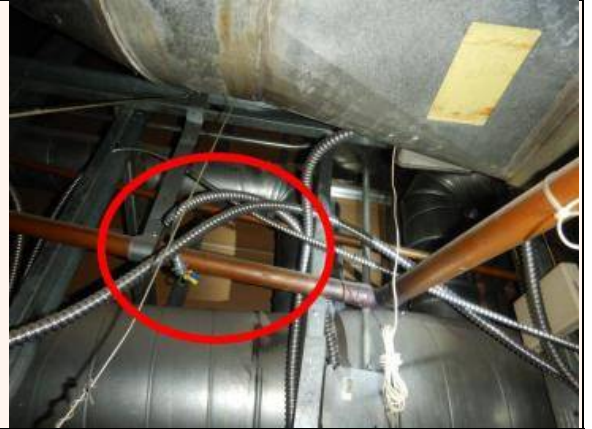
7.6 WIRING TYPE & CONDITION:

Portions of the wiring and/or electrical boxes are not adequately secured and/or supported as they should be. Corrections needed at this time to prevent damage.

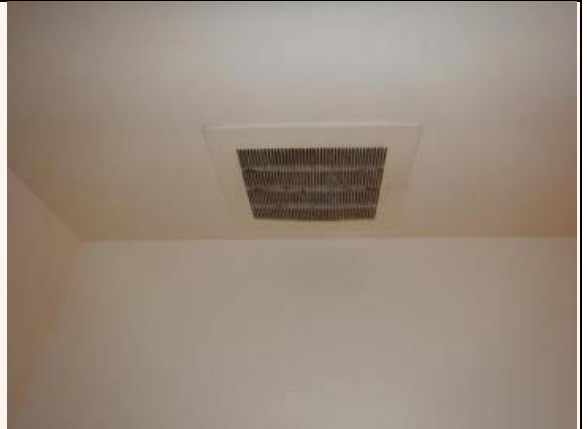
11.9 Exhaust Fan:

Exhaust needs maintenance. Clear any dust or lint.

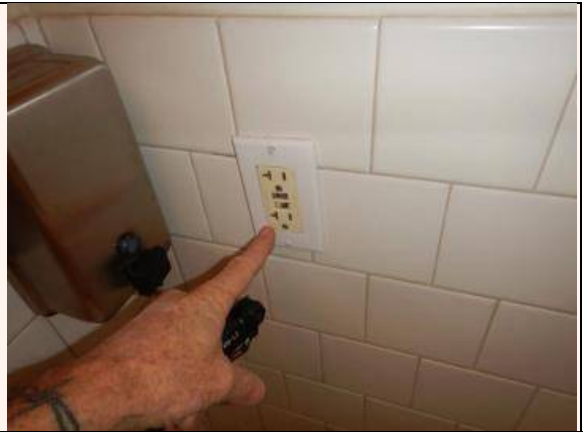
11.10 GFCI(S)

A Ground Fault Circuit Interrupt outlet installed in the area of the bathroom lavatory. However, it failed to stop the current flow or did not reset after testing. Replacement is necessary.

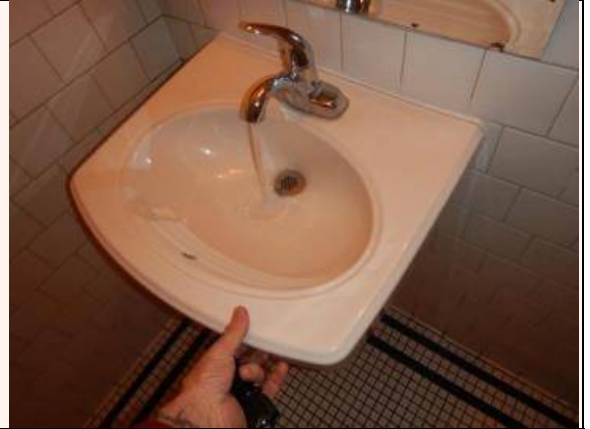
11.12 Basin & Drain:

Sink is loose from the wall. Repairs needed.

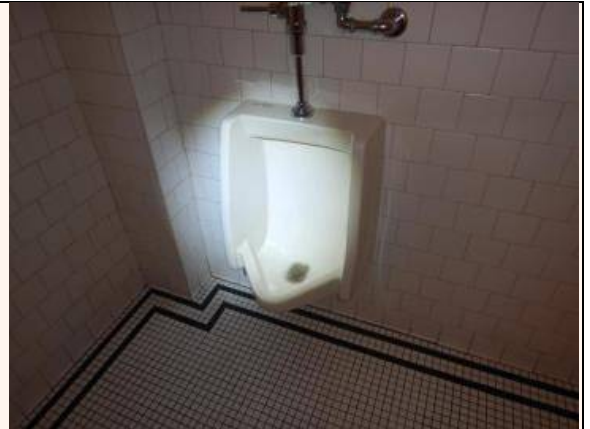
11.15 Urinal:

Slow to no flush observed.

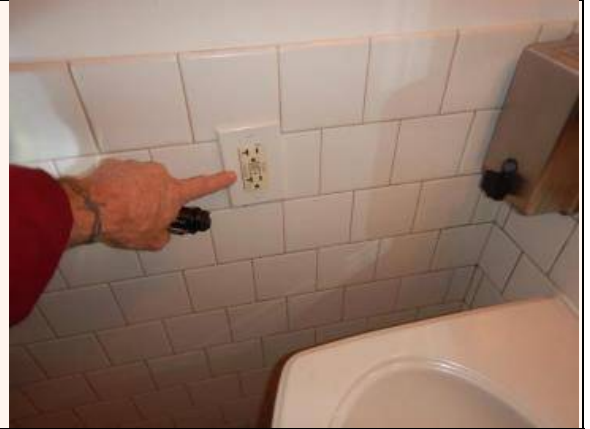
11.21 GFCI(S)

A Ground Fault Circuit Interrupt outlet installed in the area of the bathroom lavatory. However, it failed to stop the current flow or did not reset after testing. Replacement is necessary.

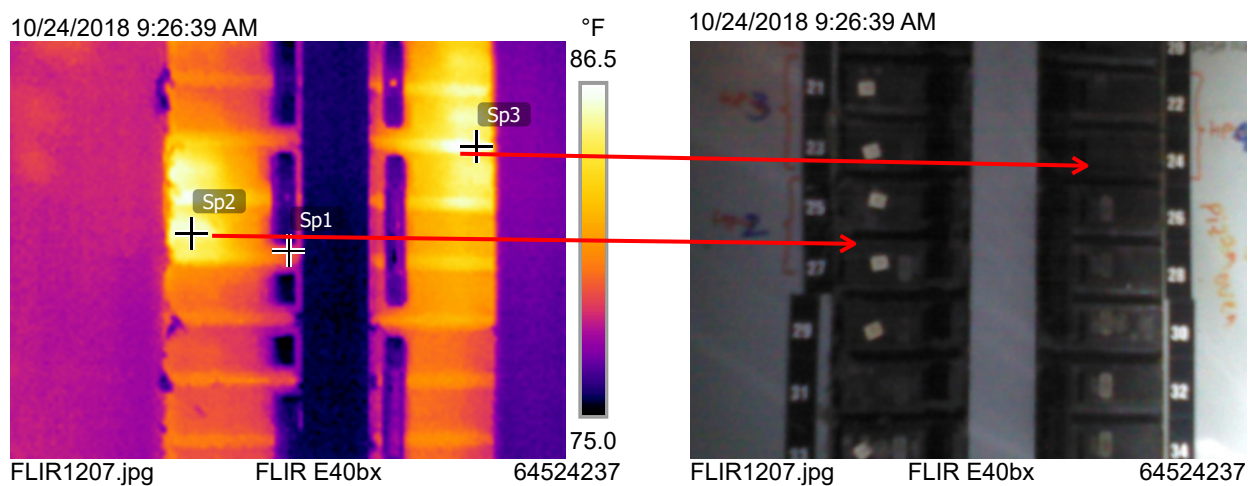
Panel A

Sp1	79.1 °F
Sp2	85.5 °F
Sp3	86.2 °F

Though temperature reading is not excessive an anomaly detected to 2 phase and three phase over current protector. Suspected imbalance, loose connection etc. Suggest further investigation.

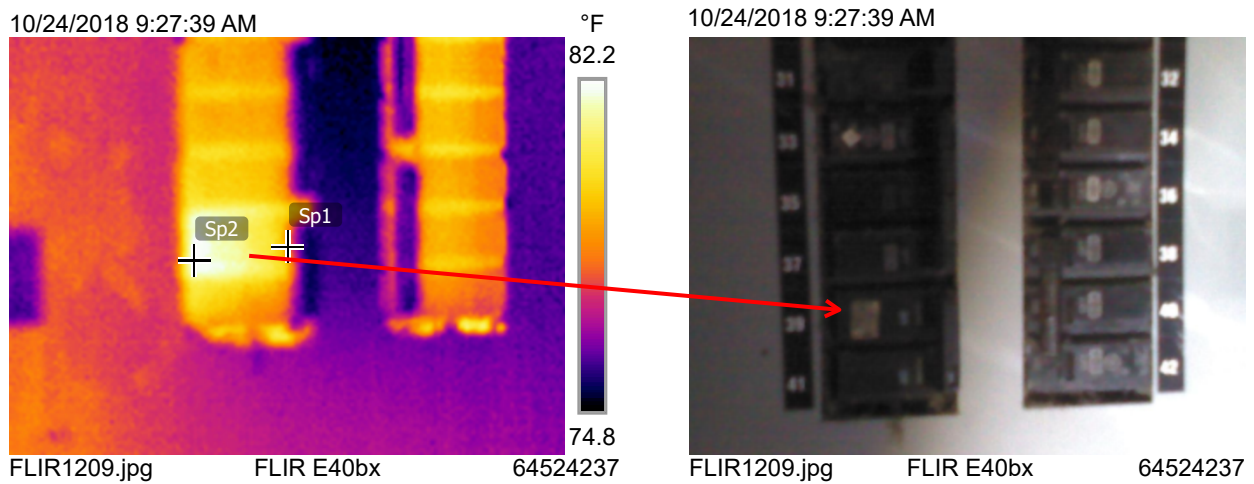
Panel A

Sp1	78.3 °F
Sp2	81.9 °F

2 phase breaker 39/41 suspected deficiency. Possible loose contact, over heating of one conductor as compared to other on same over current protection device.
