Report: Sample

Confidential Inspection Report

**1234 Sample Address
Sample City CA. 12345**

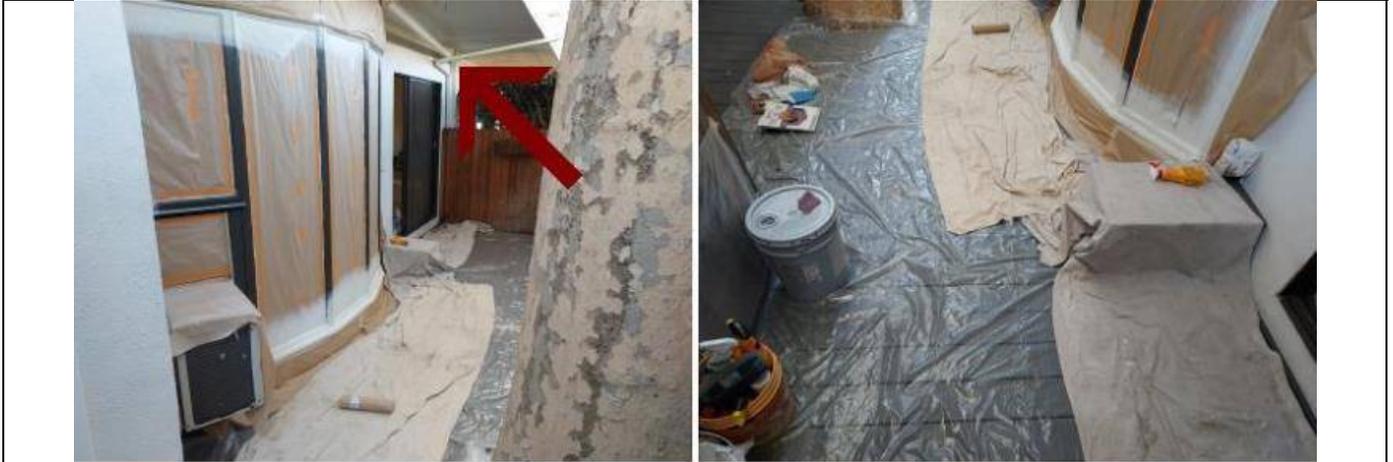
3.7 CONDITION:

Limited visibility due to painting project. Visible portions appear satisfactory. Recommend securing downspout (arrow).

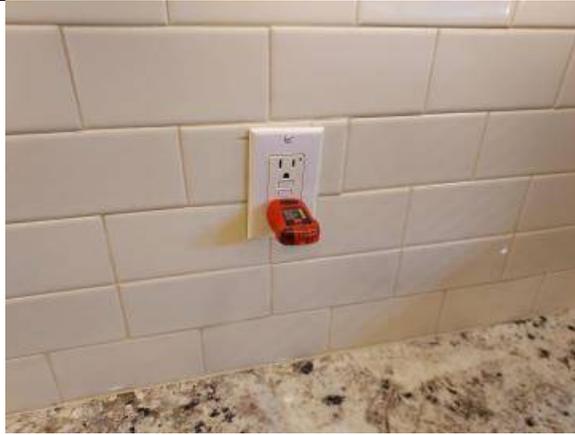
4.16 ELECTRICAL:

Attention Needed- There are Ground Fault Circuit Interrupt outlets installed in the area of the sink. However, some failed to stop the current flow, or it did not reset after testing. Replacement is needed.

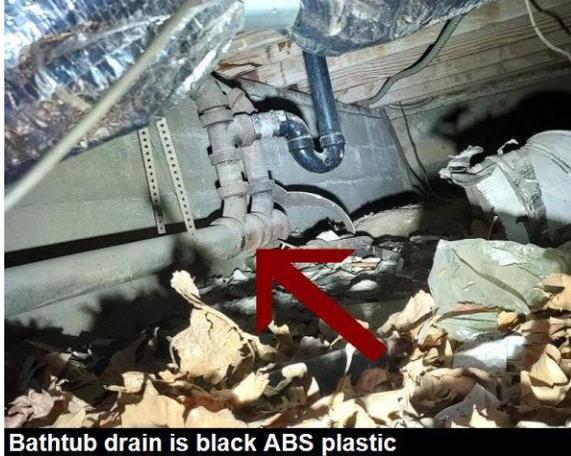
5.6 MATERIAL & CONDITION:

Only 5% of the waste disposal system is visible to the inspector. Most of the waste drainage system is within walls, into common areas and below grade and therefore can not be viewed.

Cast iron, galvanize and plastic ABS pipe are used.

Client should be aware that the normal life span of cast iron or galvanized waste pipe is generally 55 to 65 years. This older pipe tends to corrode from the inside restricting waste flow and back ups become more and more frequent. Upgrades should be anticipated. Crawlspace viewed from access only.

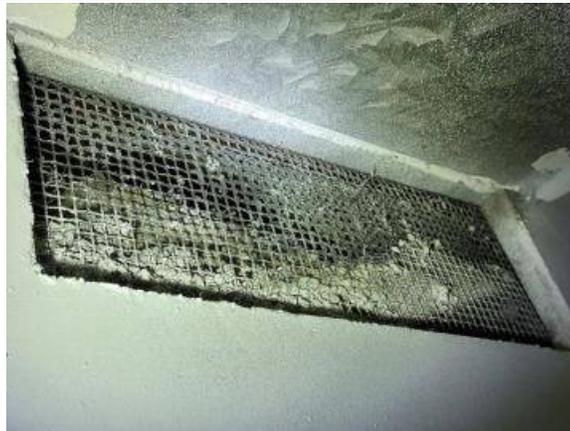
6.7 Secondary Air Adequacy:

Unsatisfactory- Inadequate, Vents blocked. **Action Necessary** - Availability of secondary air for combustion and flue draft appears to be inadequate. Services of a qualified licensed professional are required. Lack of a secondary air

source is a serious condition, and immediate action is needed. This lack of secondary air can increase the creation of carbon monoxide and/or the spillage of flue gases into the living area of the house.

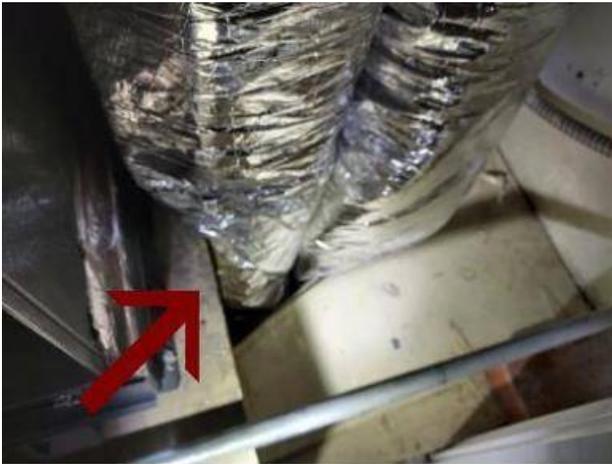
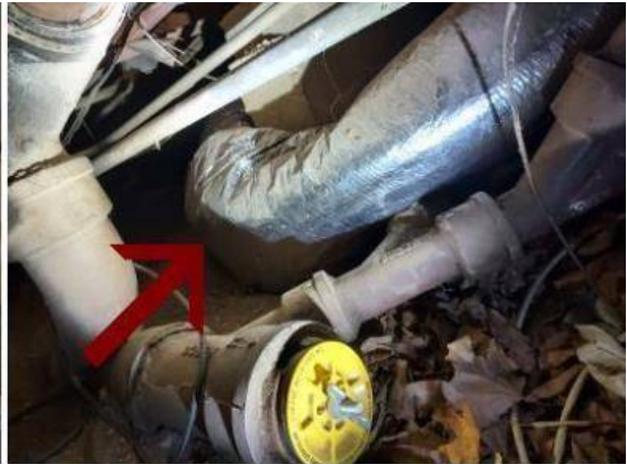
Attention Needed - Some of the duct work may be kinked too much. This can affect functional flow. Duct work in the crawl area is resting onto the soil. Duct work should be elevated at least 4 inches above dirt to prevent corrosion.

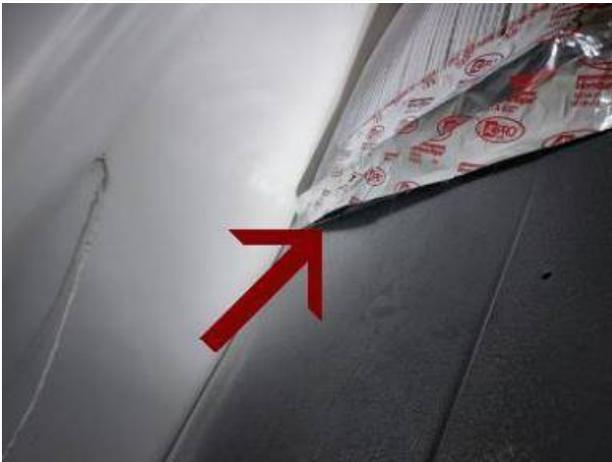
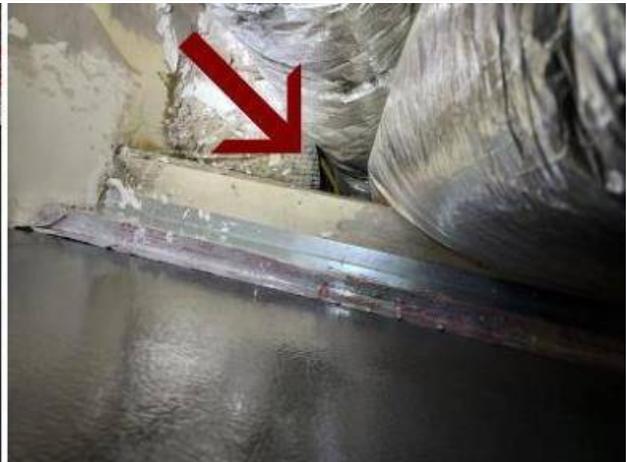
Attention Needed - Air duct leak noted inside cabinet. Open access to crawlspace noted. Recommend this area be closed off from crawlspace to help keep out animals and insects.

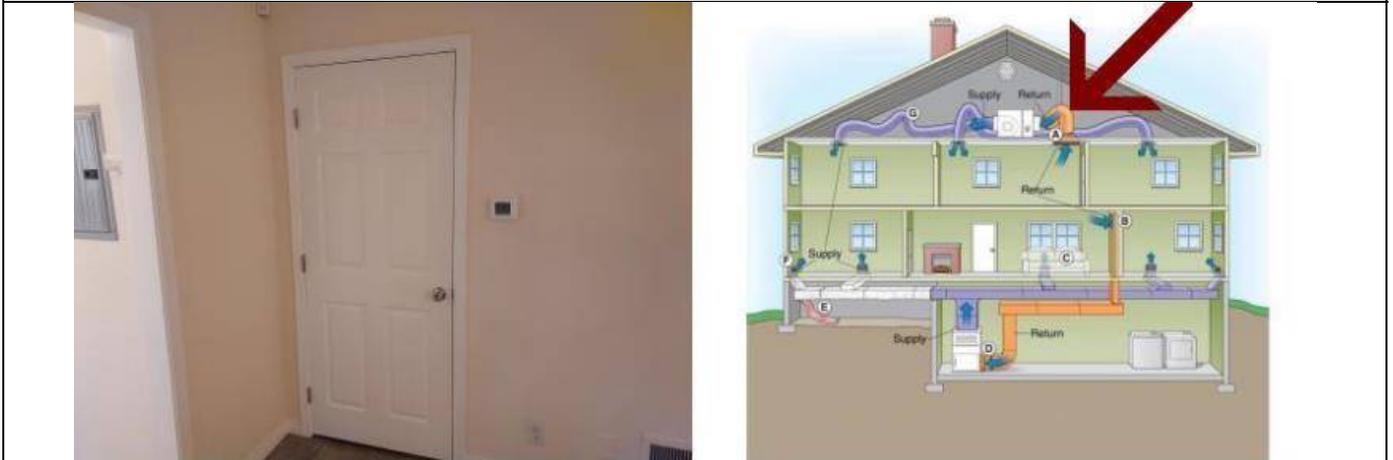
Unsatisfactory - The return air grille was not located. Further evaluation by a qualified licensed HVAC contractor needed at this time.

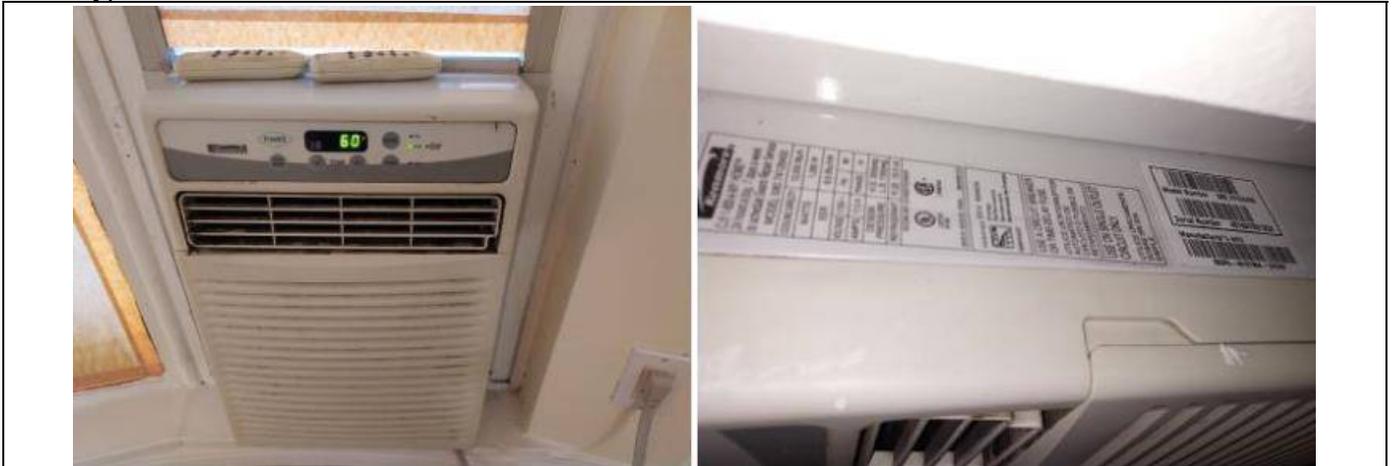
Living room. Kenmore brand; 12,000 btu; electric. Manufacture date is not decipherable. Possibly 2001 unit. Unit was functional at the time of inspection. Recommend service and/or cleaning.

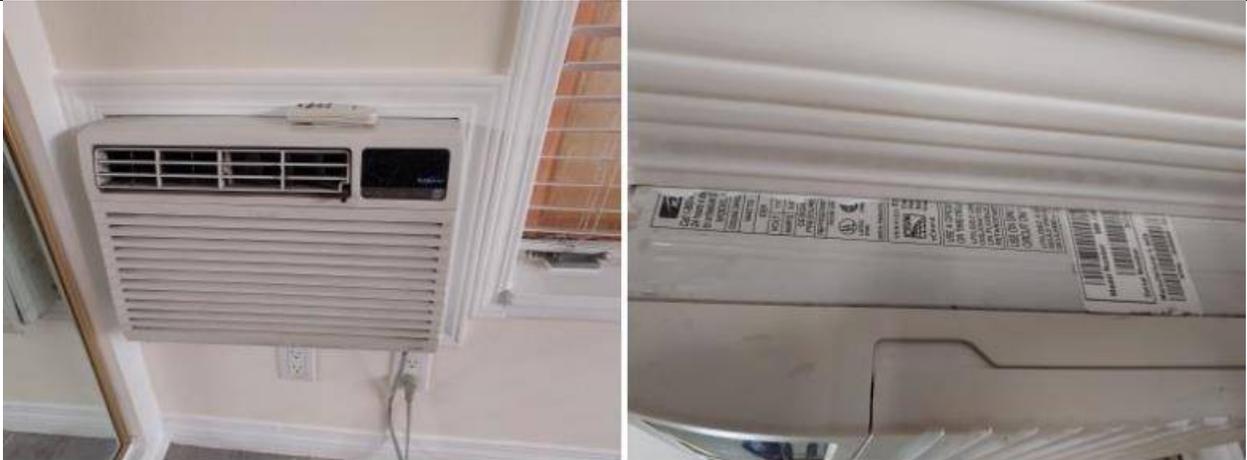
Wall unit in 2nd bedroom. Kenmore brand. Identifying label not legible.

Attention Needed - Unit did not power up using normal controls. Further evaluation needed.

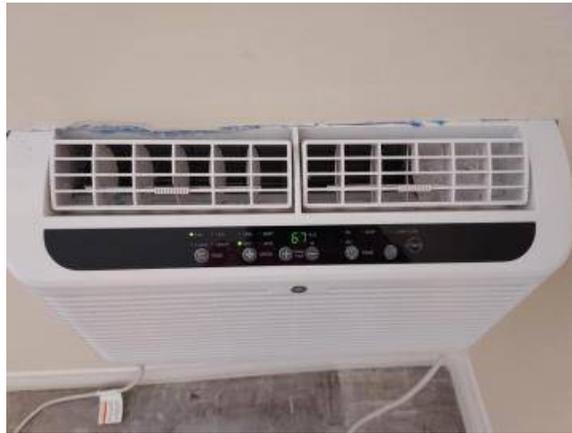
Identifying label not available. **Attention Needed** - Unit did not respond correctly to normal controls, fan would not come on. Further evaluation needed.

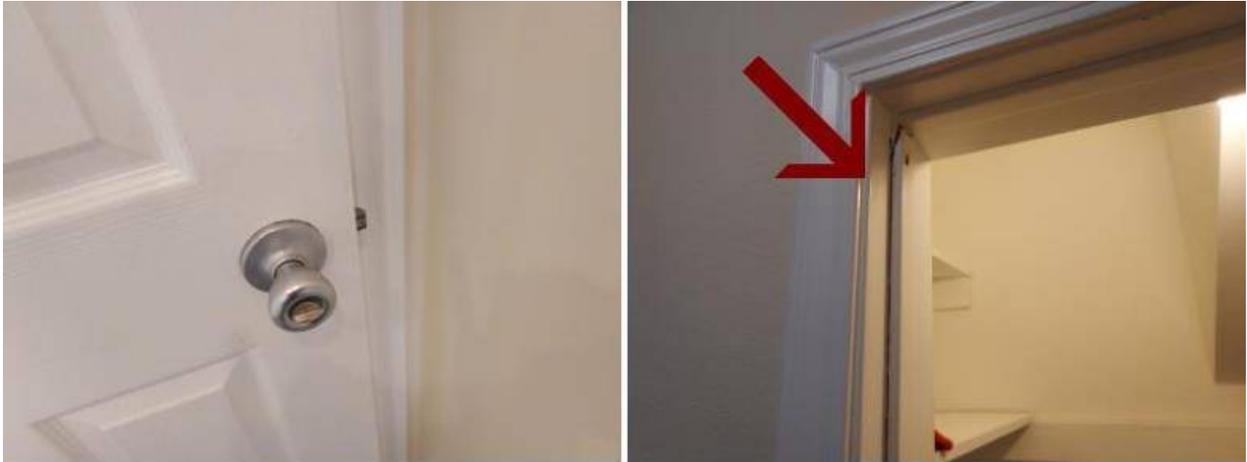
7.2 INTERIOR DOORS:

Attention Needed- Bathroom door does not close properly. Laundry door stop cracked.

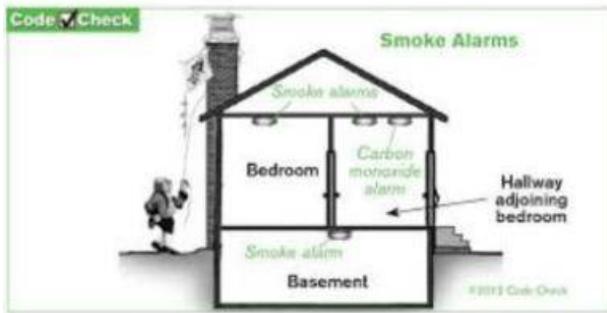
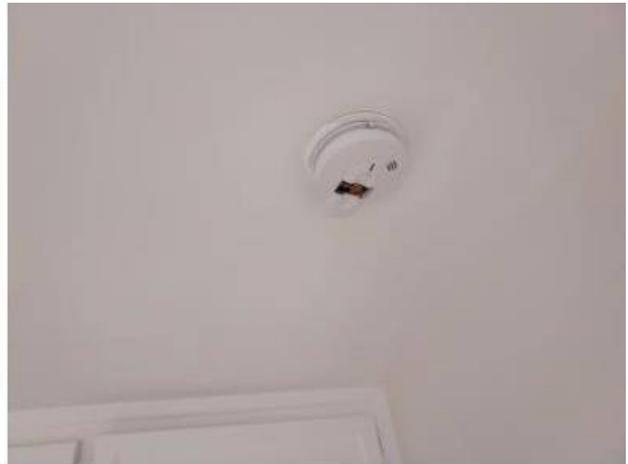
7.5 NOTE:

Unsatisfactory - Breaker for smoke alarms was off at the time of inspection. Beeping smoke detectors noted. Further evaluation is needed. Recommend a retrofit agency go through the house to check for adequate smoke and carbon monoxide alarms.

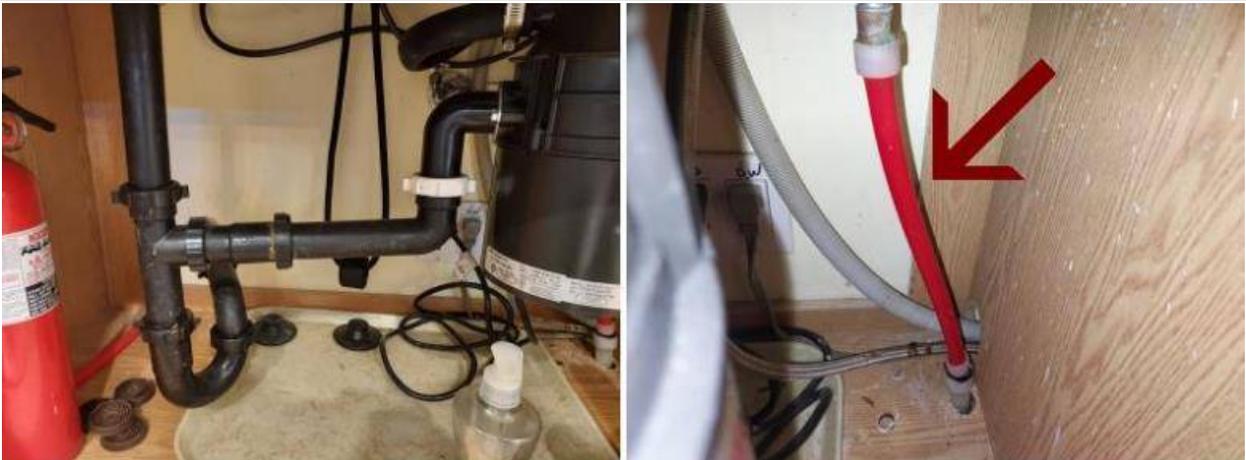
8.3 SINK & DRAIN:

Sink and drainage lines appear to be satisfactory. Note: PEX pipe under sink is not protected. Recommend some

kind of barrier for protection from undue damage.

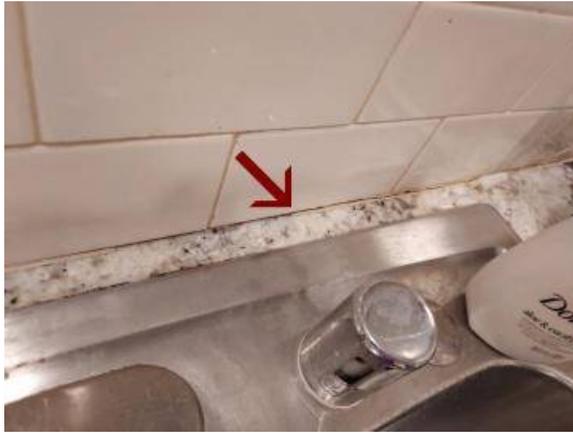
8.4 CAULKING:

Caulking in water contact areas appears to need attention, such as along where countertop meets splash wall. If left unsealed, water can cause costly damage.

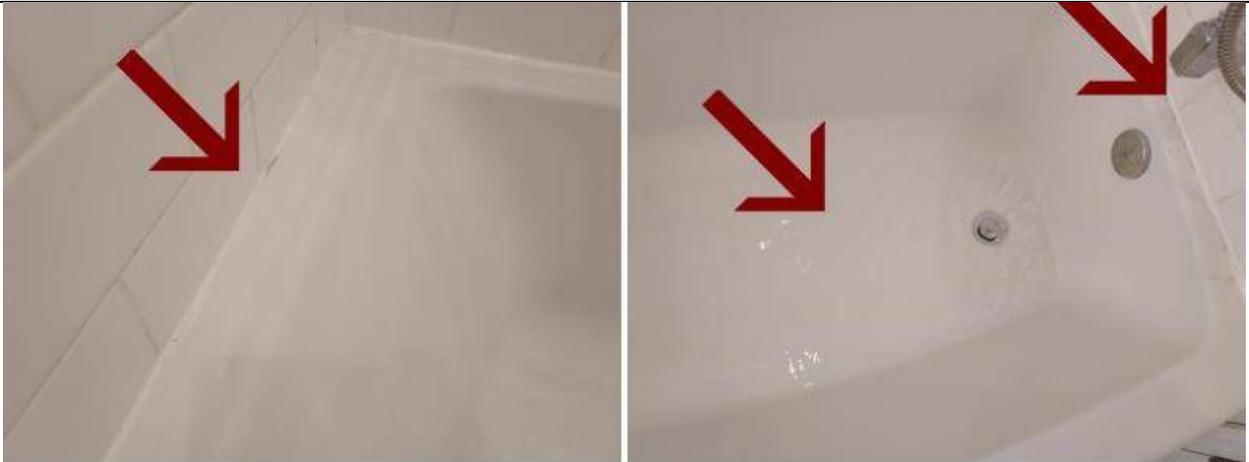
9.5 TUB:

Seal around tub has black substance which appears to be water related; further evaluation would be needed to identify. Sometimes cleaning is not adequate, in which case, removal of old, cleaning seam, and applying new anti-bacterial silicone is recommended.

Attention Needed- Tub drain is slow.

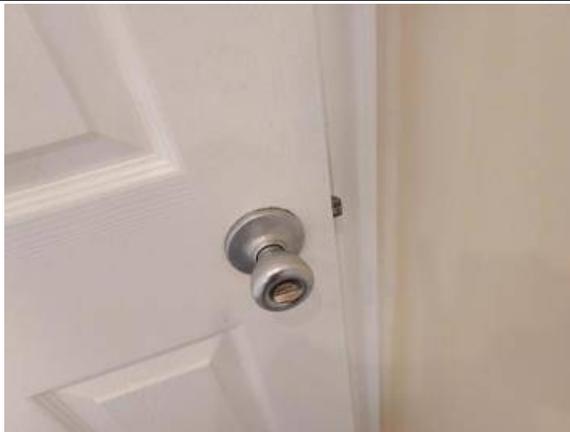
9.9 WALLS, CEILING & DOOR:

Attention Needed - Door needs adjustments in order to close properly.

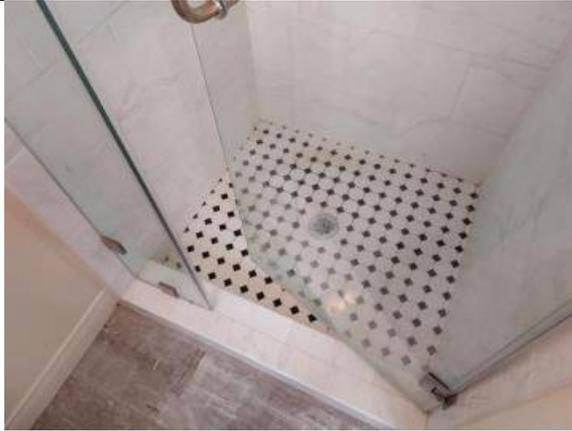
9.21 ENCLOSURE:

Shower door should not swing into stall as this one does. All shower doors need to swing out to facilitate removal of anyone in the event of an emergency.

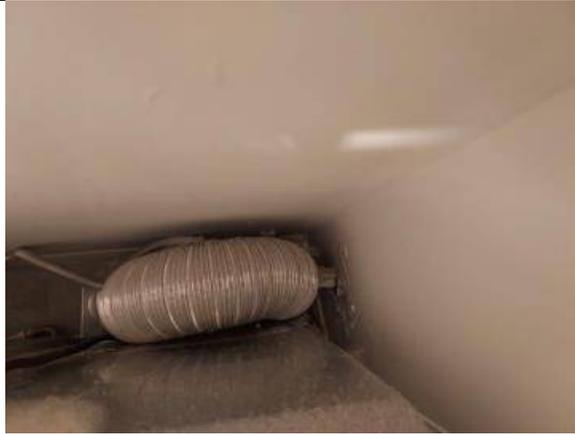
10.5 DRYER EXHAUST:

Exhaust duct for this clothes dryer is not visible for inspection as it is concealed within the structure. Inspector for this reason is disclaiming clothes dryer exhaust. Recommend having a duct cleaning company verify that exhaust duct is free of lint and is properly terminated. Termination point or duct was not seen under the unit.
