Professional Commercial & Residential Inspections

## Confidential Inspection Report

**1234 Sample Address  
Sample City CA. 12345**

**Prepared for: Sample Client  
Prepared By: Robert Gaudreault**

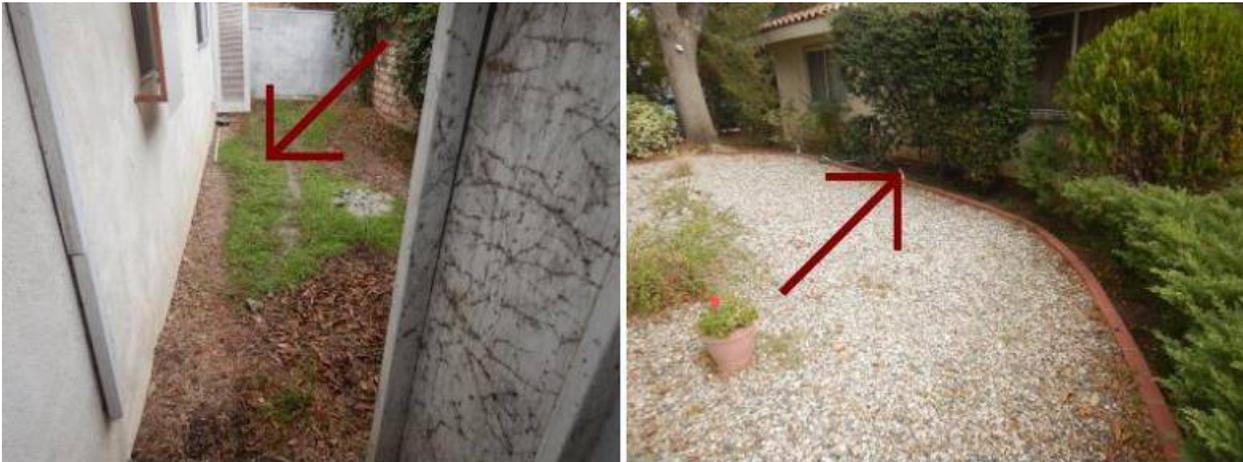
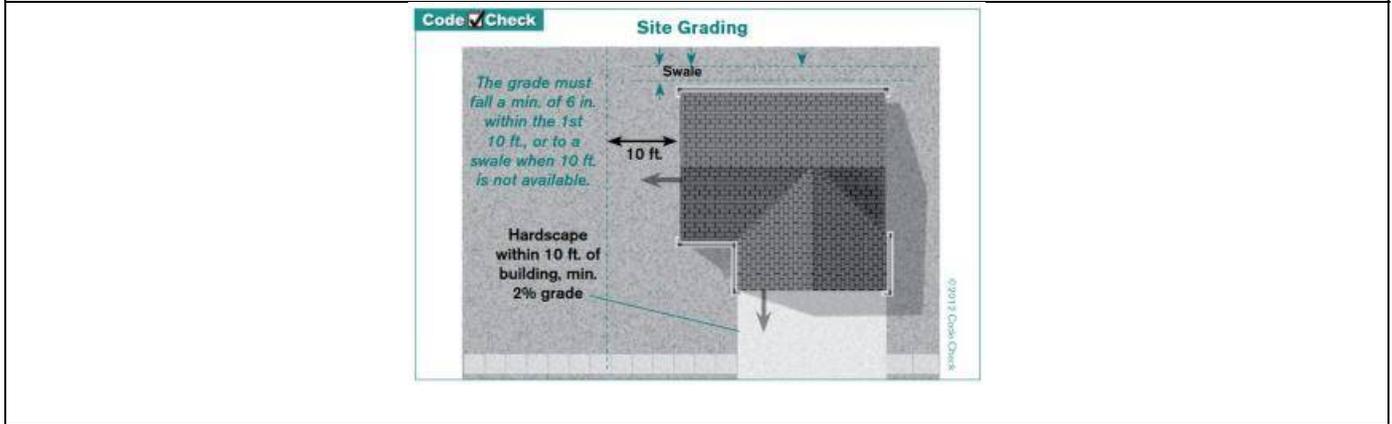
#### 3.1 SITE DRAINAGE:

**Attention Needed-** Negative slope seen at some locations. Negative slope can result in foundation settlement. Improvements are needed to shed water away from the structure, such as along front and left side of property. Improve as needed.

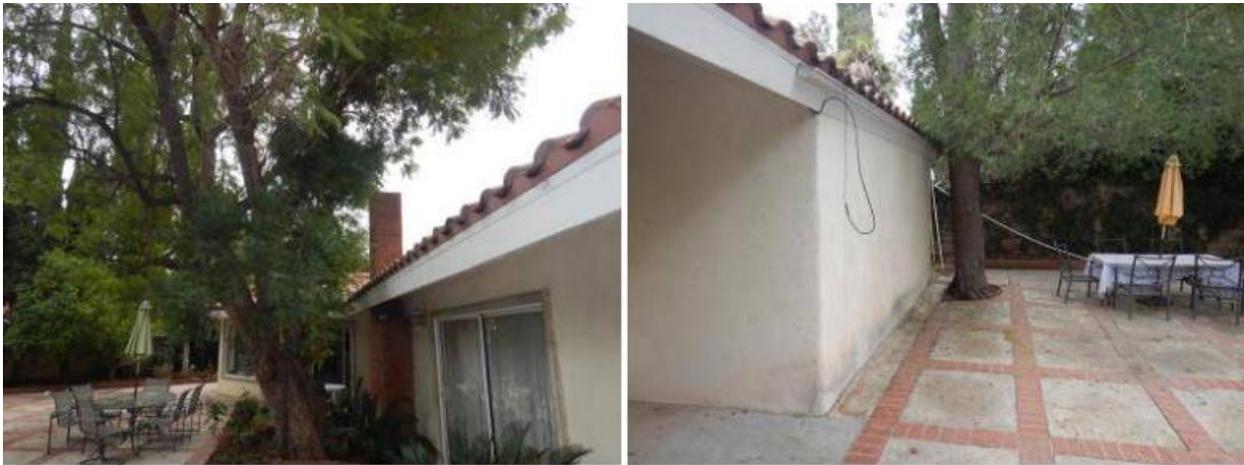
### 3.2 TREES:

**Attention Needed-** There are trees that are planted close to the structure. Client should be aware that tree roots can affect the foundation. Trees overhanging the structure need to be trimmed so that limbs, leaves, and rain will not drop off the tree onto the roof covering and clog the gutters, damage the roof, or promote moss growth. Trees that rub against the roof can cause severe damage and can drastically reduce the life of the roofing material.

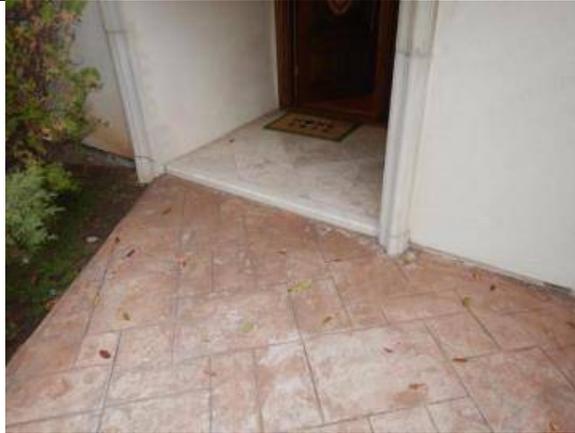
### 3.6 ENTRY STOOP::

**Attention Needed** - Steps may become slippery under wet conditions. Improvements are needed to prevent trip and fall hazards.

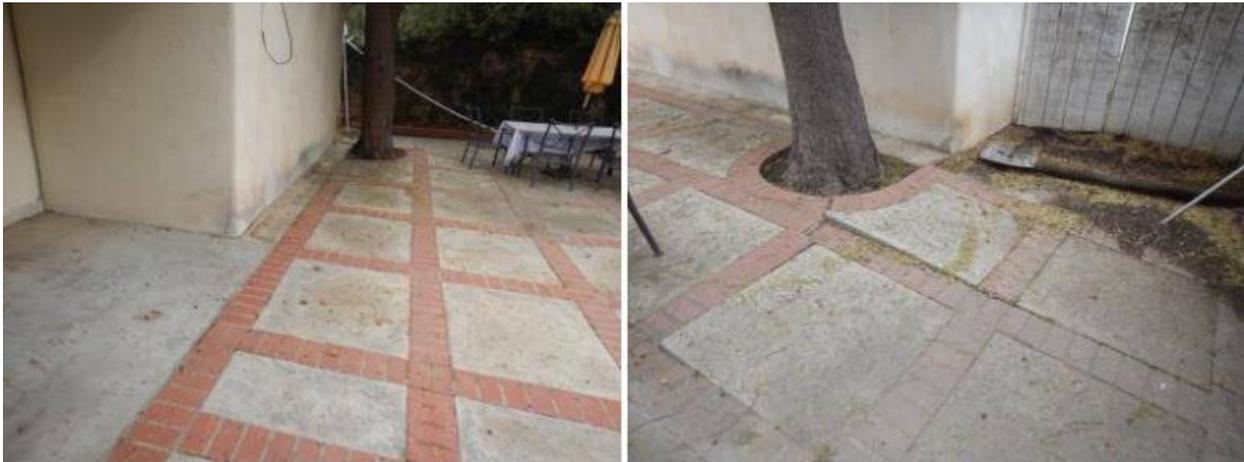
### 3.8 CONDITION:

The slab is in such a condition that repair or replacement is necessary. Tree roots causing some of the patio decking to heave.

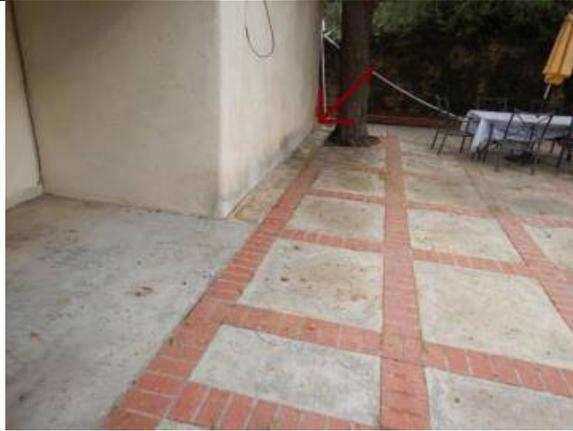
The weep screed around the perimeter of structure is not to the required clearance above slab deck or a weep screed was never installed. The purpose of this weep screed is to allow water that has permeated within stucco to shed out rather than into the structure which could pose water damage to unseen areas. Ideally the concrete deck adjacent to the structure would have been poured at least 2 inches below this weep screen to prevent this damage from occurring in the first place.

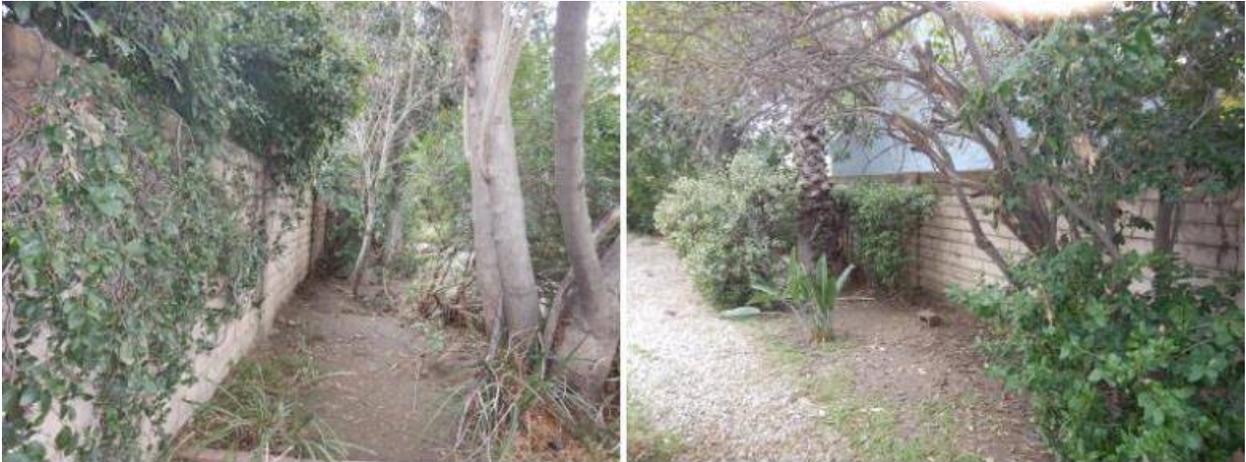
### 3.10 CONDITION:

Some lean apparent along left side of property. Monitor as needed.

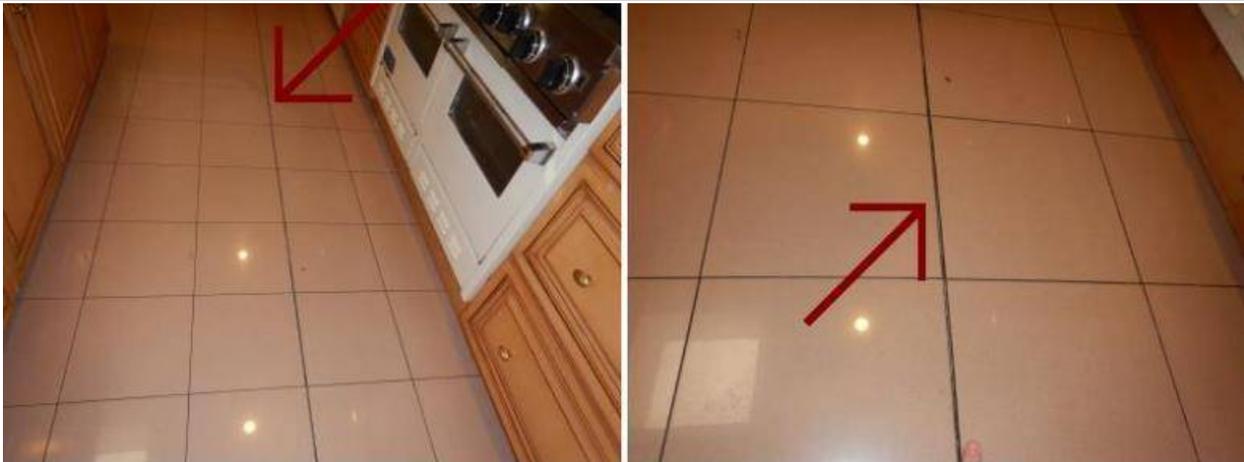
### 4.2 FOUNDATION SLAB:

**Attention Needed-** It needs to be understood that a slab foundation can not be adequately inspected due to floor coverings. There is always a possibility that significant cracks can go unseen. There may be a slab crack along kitchen floor. Further intrusive examination would be needed.

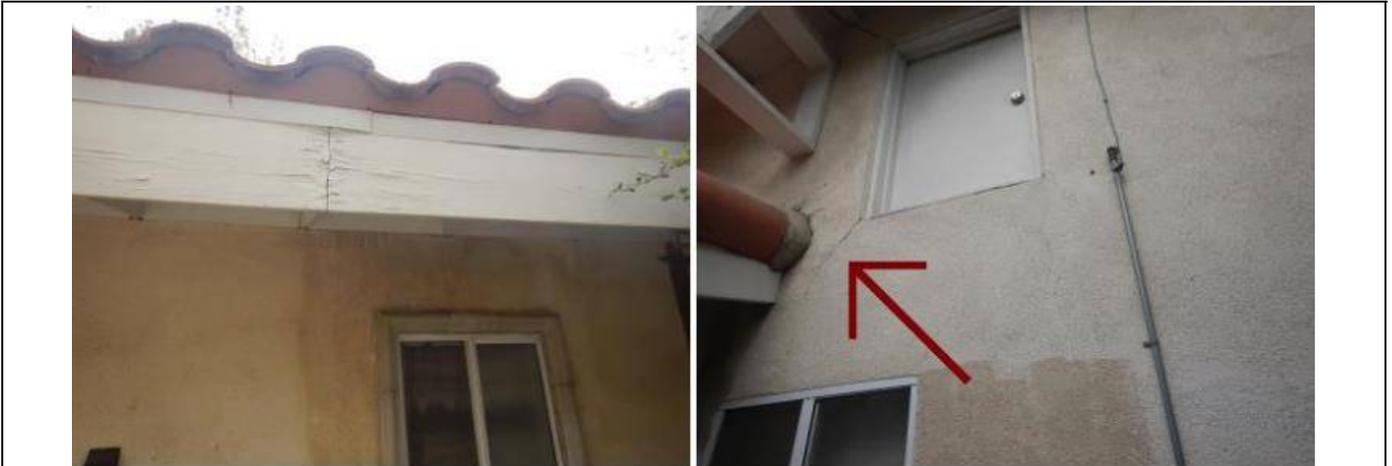
### 5.2 OBSERVATIONS:

**Attention Needed** - Stains and worn plaster noted at some locations. Such as front and right sides. Stress cracks also noted at right side.

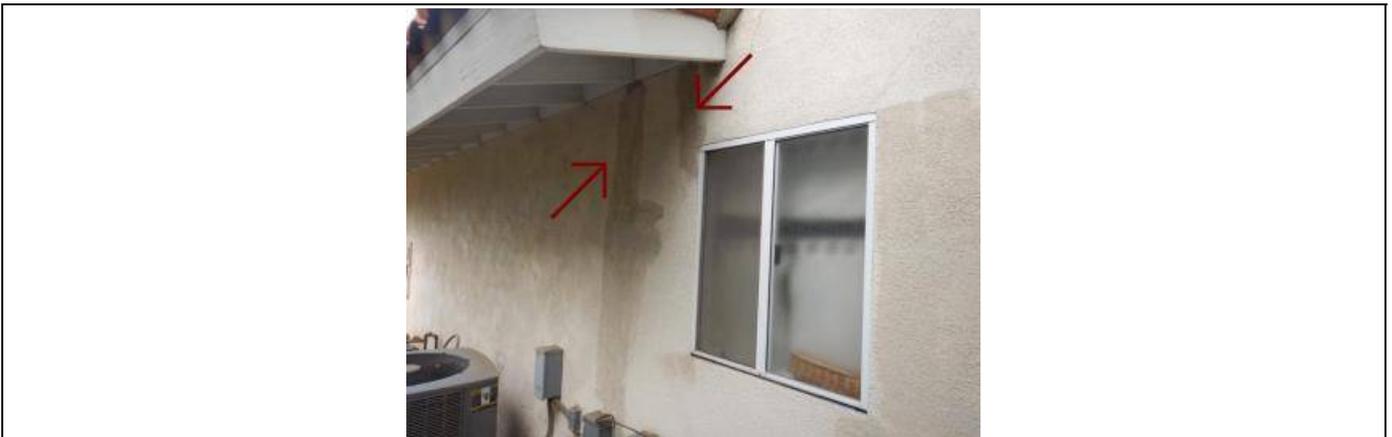
Signs of leak. At right side.

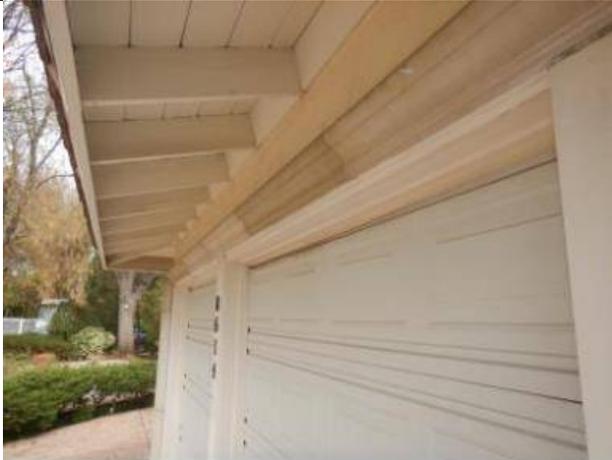
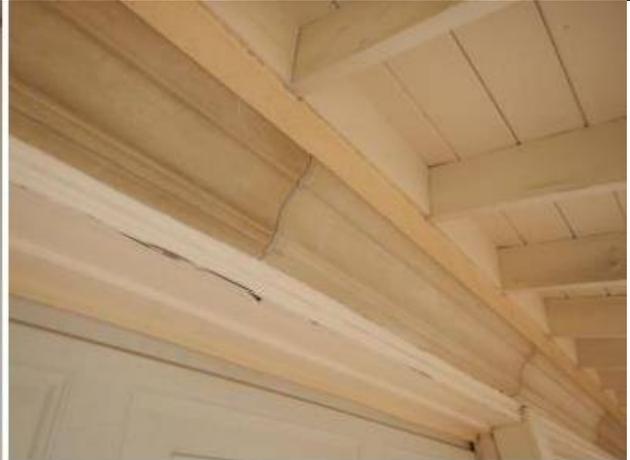
### 5.3 TRIM CONDITION:

**Attention Needed** -Evidence of some trim corbel movement. Monitor as needed.

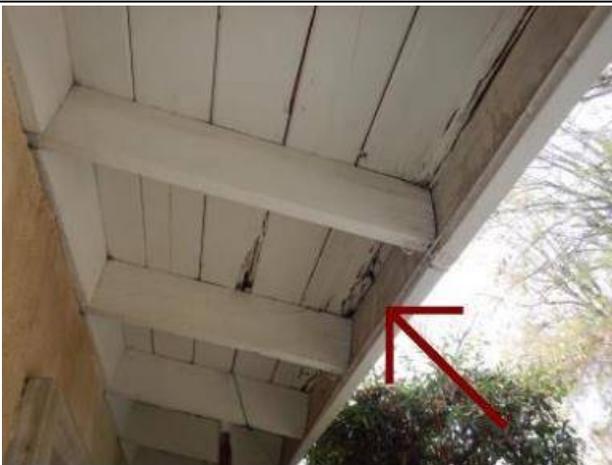
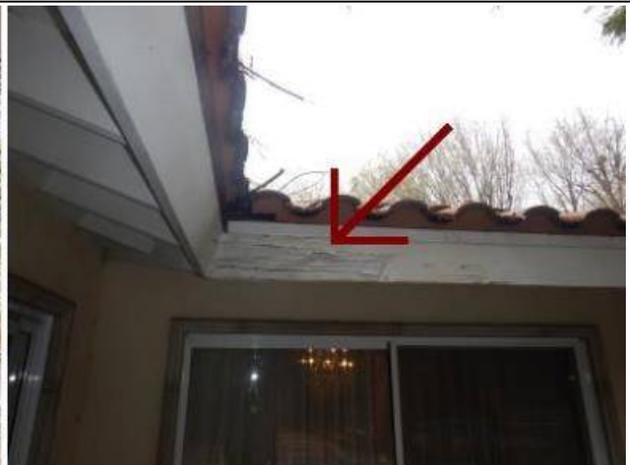
#### 5.4 SOFIT & EAVES:

**Attention Needed** - Areas of apparent water damage noted. Further investigation is needed.

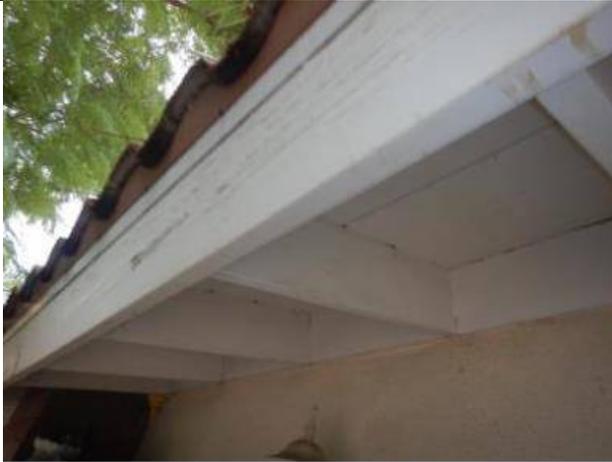
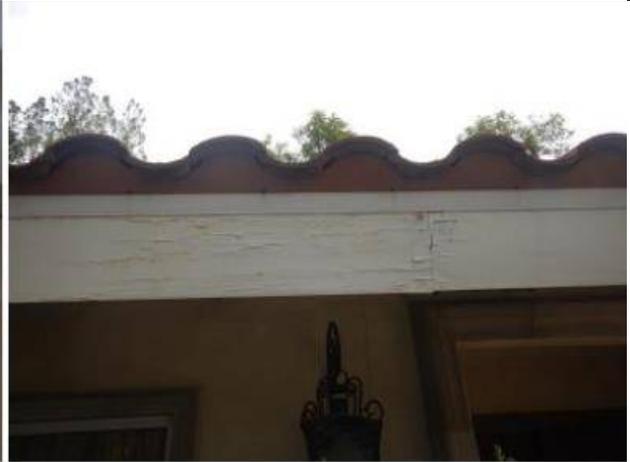
#### 5.5 FASCIA & RAKE BOARDS:

**Attention Needed** - There is/are adverse condition(s) noted, such as; fascia boards show some water damage and general wear.

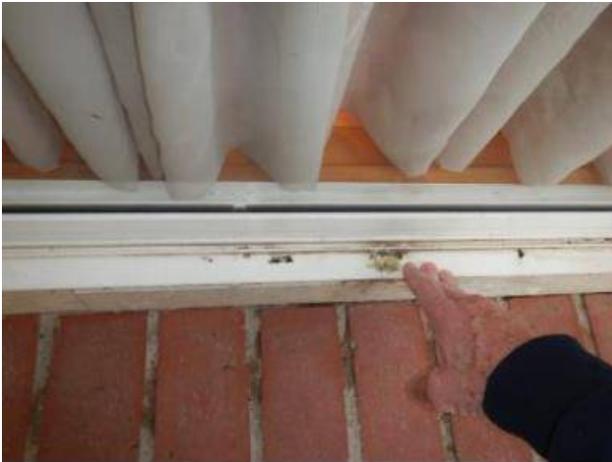
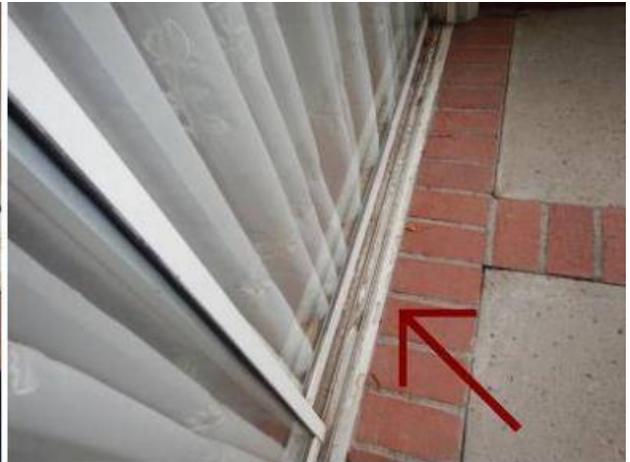
### 5.7 EXTERIOR DOORS:

**Attention Needed** - Door thresholds should be at least one inch from adjacent grade, decks or slabs to prevent water entry and corrosion. Corrosion is seen along some metal thresholds.

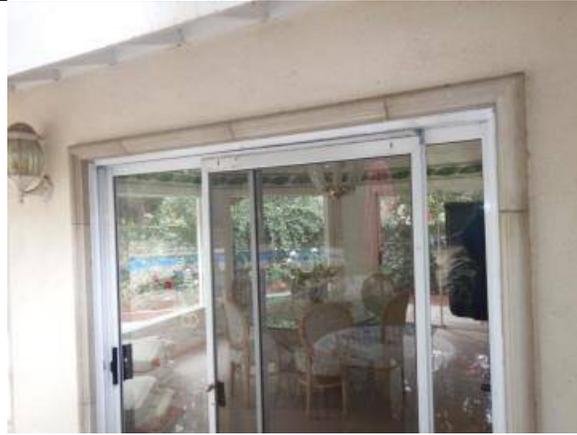
One screen door is displaced.

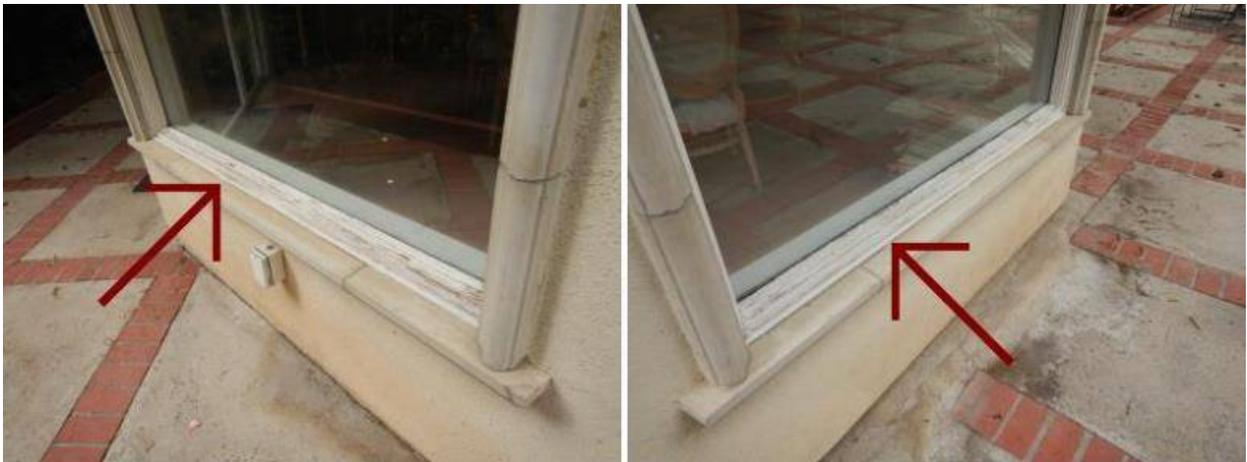
### 5.8 WINDOWS CONDITION:

**Attention Needed** - Water damage was seen to the exterior window material at bay windows. Consult a licensed termite agency for additional inspection at this time.

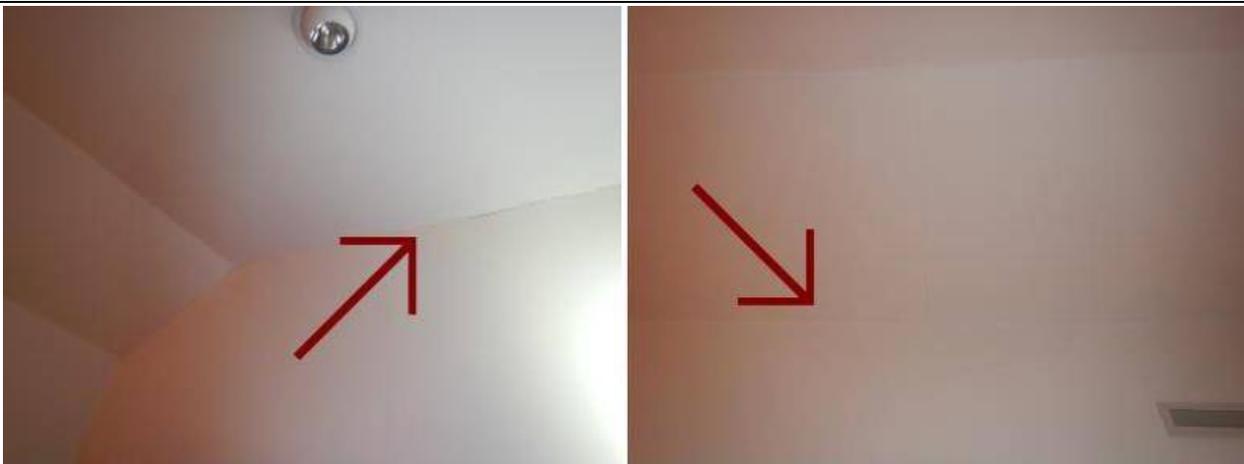
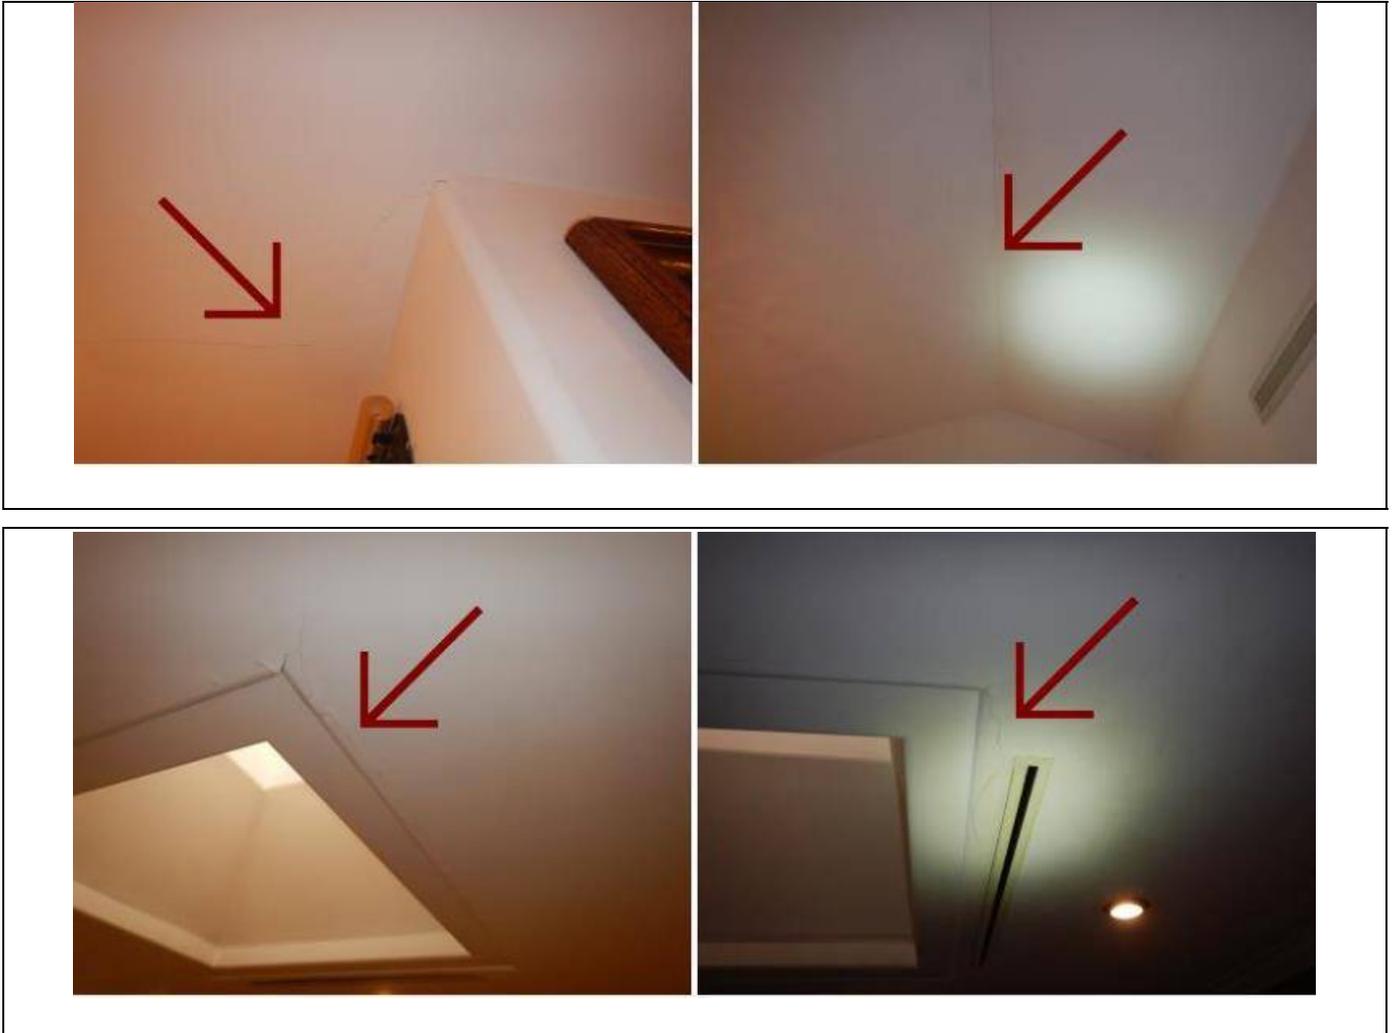
### 5.14 COMMENTS:

Stress or settlement cracks are seen throughout. This does indicate evidence of prior structural movement. Suggest further evaluation by qualified professional to determine cause and remedy.

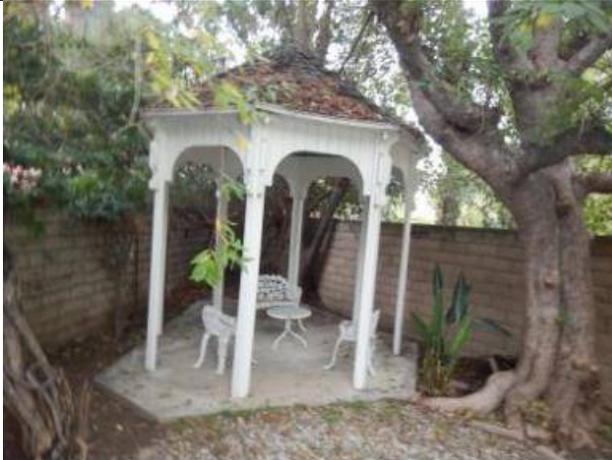
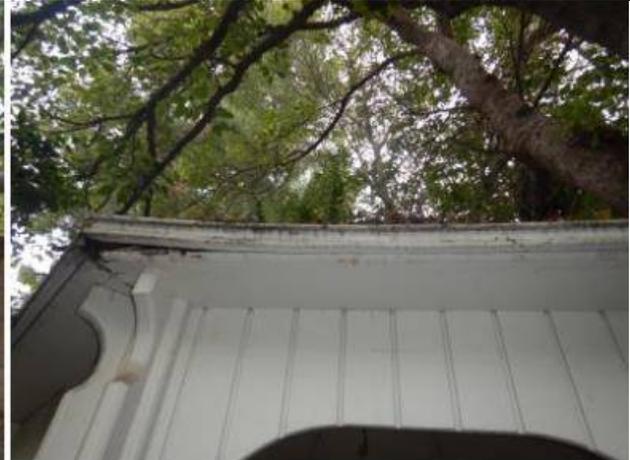
### 5.16 PATIO COVER CONDITION:

**Attention Needed** - General damage and deterioration. Anticipate removal or replacement.

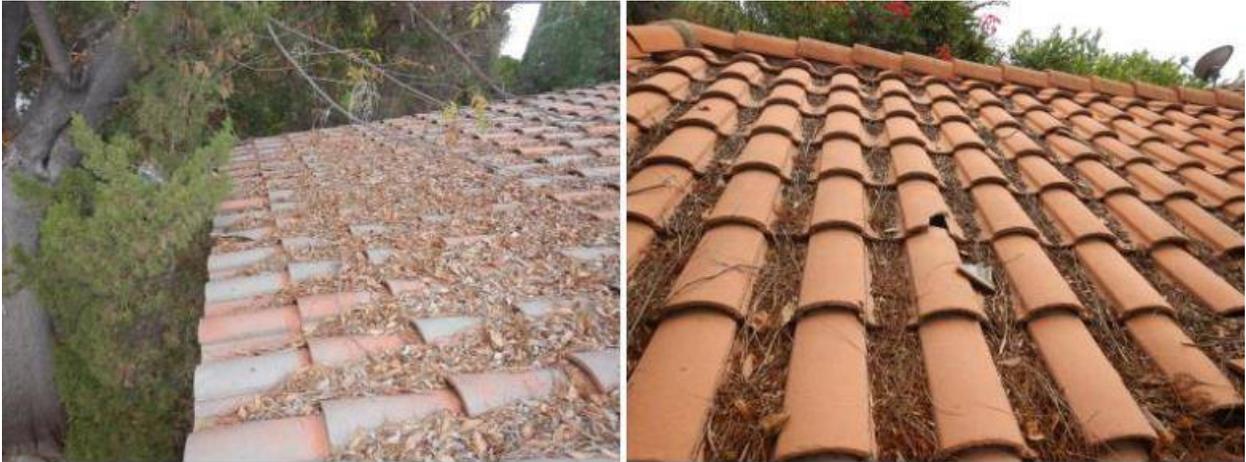
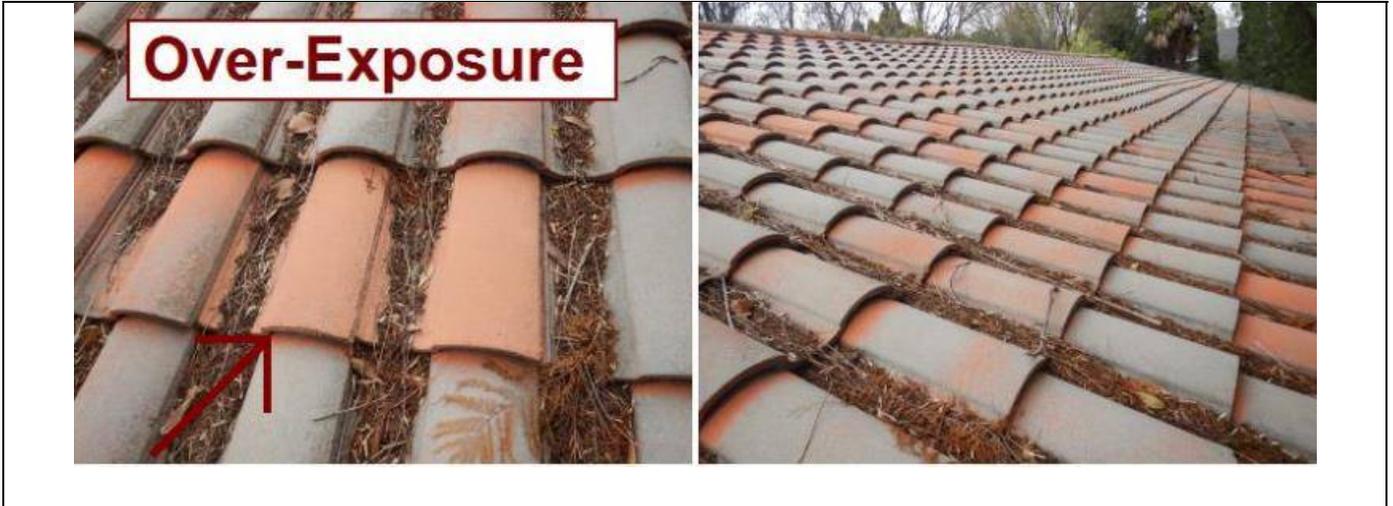
#### 6.2 SLOPE ROOF CONDITION:

**Attention Needed** -Broken tile at various locations. Some rows along back side not lapping properly. Referred to as over exposure.

Excessive foliage can promote leaks and pose damage.

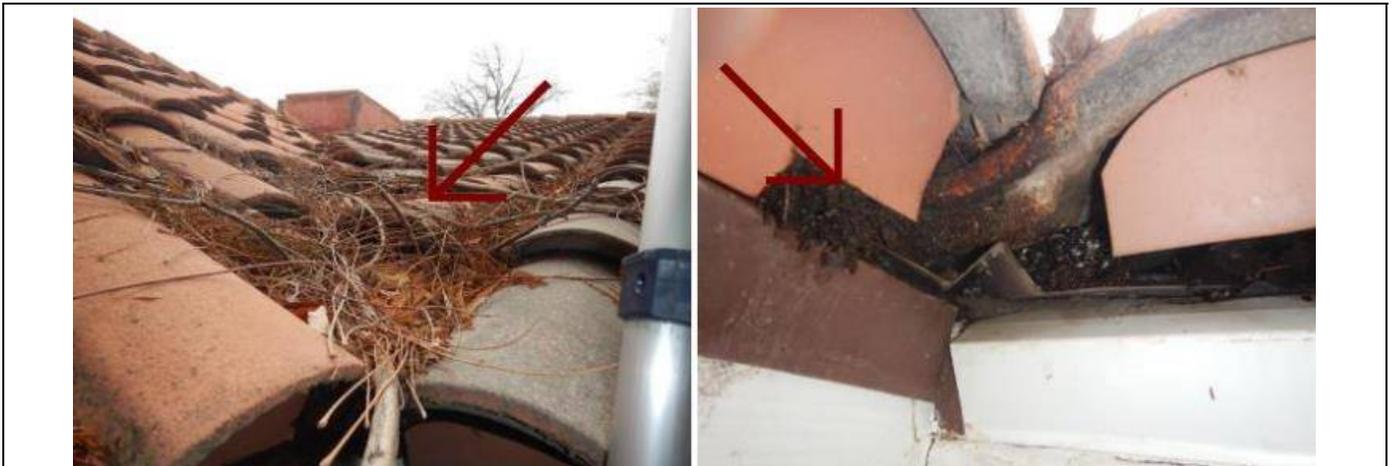
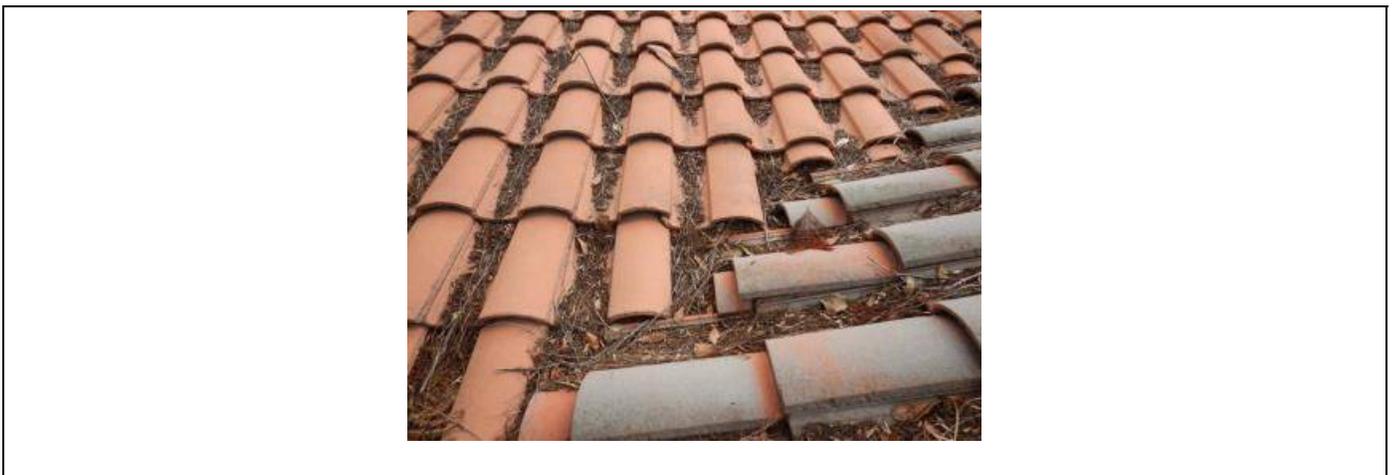
**6.3 VALLEYS:**

**Attention Needed** - The valley(s) shows wear that indicates repairs are needed. Clogging, dirt and mud. Repairs needed.

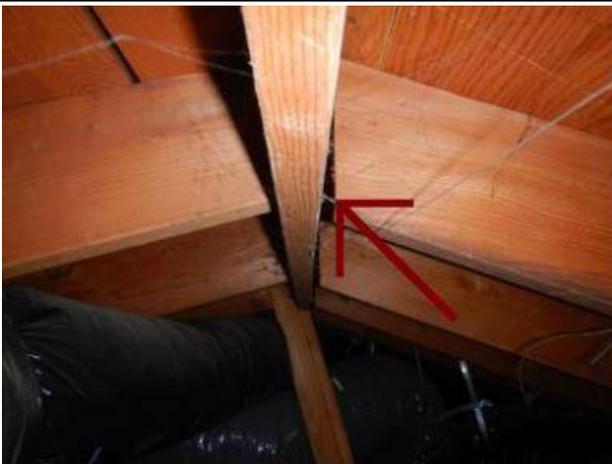
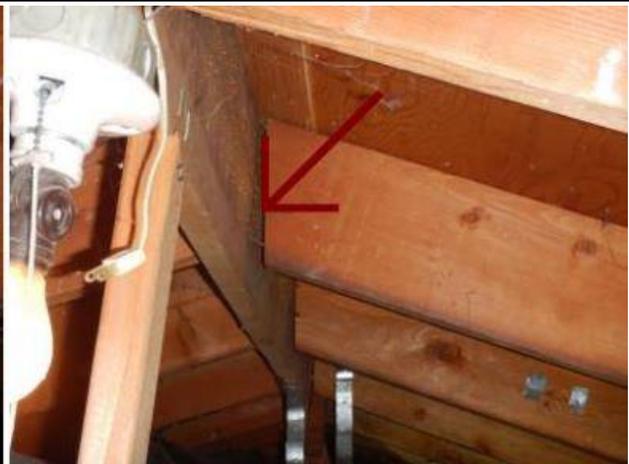
Attention Needed-Rafters are pulling apart from the ridge.

Have licensed carpenter examine and repair.

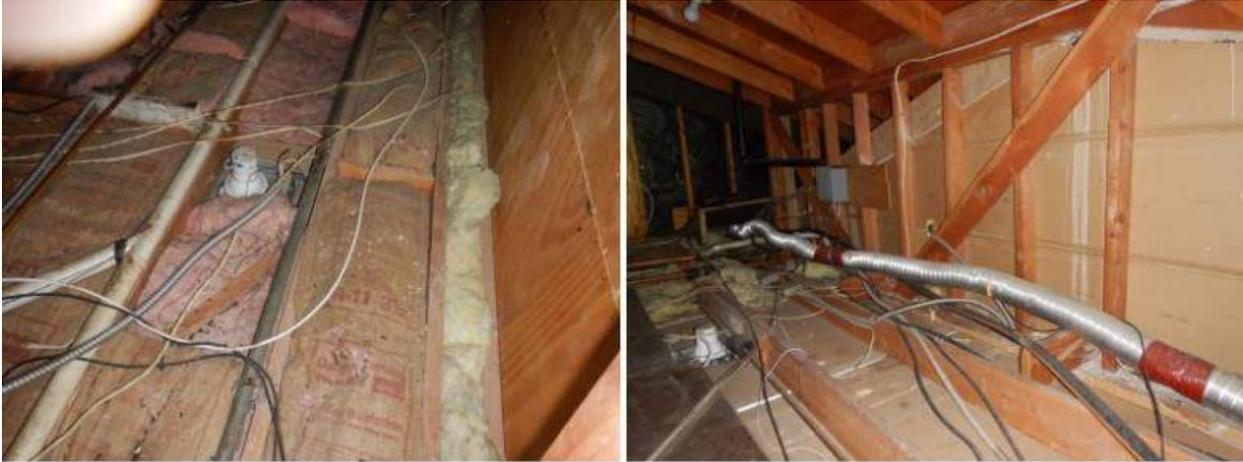
### 6.10 INSULATION:

Some of the insulation is installed upside down. Vapor barrier should face living space. Lacking at other locations.

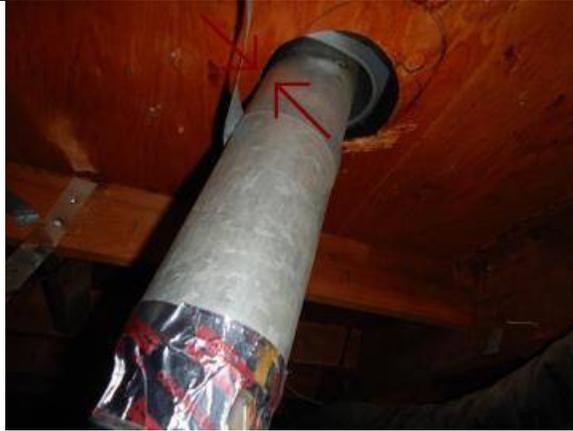
### 8.19 Flues, Vents, Plenum:

**Unsatisfactory-** There is inadequate clearance from around flue pipe. Corrections needed to reduce the risk of fire.

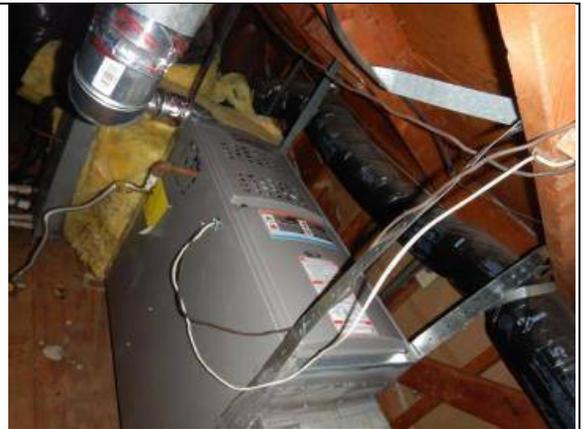
**8.20 General Operation & Cabinet:**

**Attention Needed** - Unit is laying onto its back which may go against manufacturers installation guidelines and affect safe use of the system. Further evaluation is needed. Consult qualified licensed HVAC contractor.

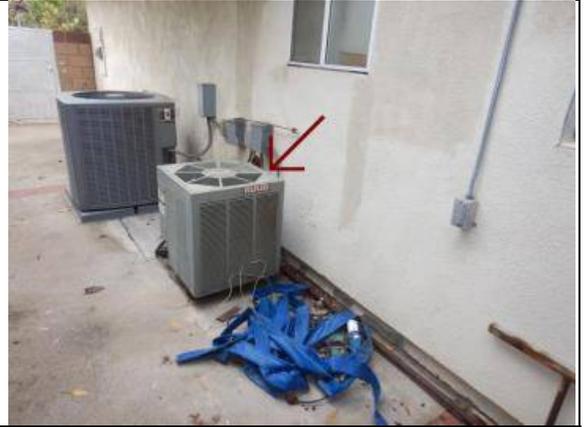
**8.24 Condition:**

**Attention Needed** - System is not cooling as intended and appears to be beyond its life cycle. Anticipate upgrades.

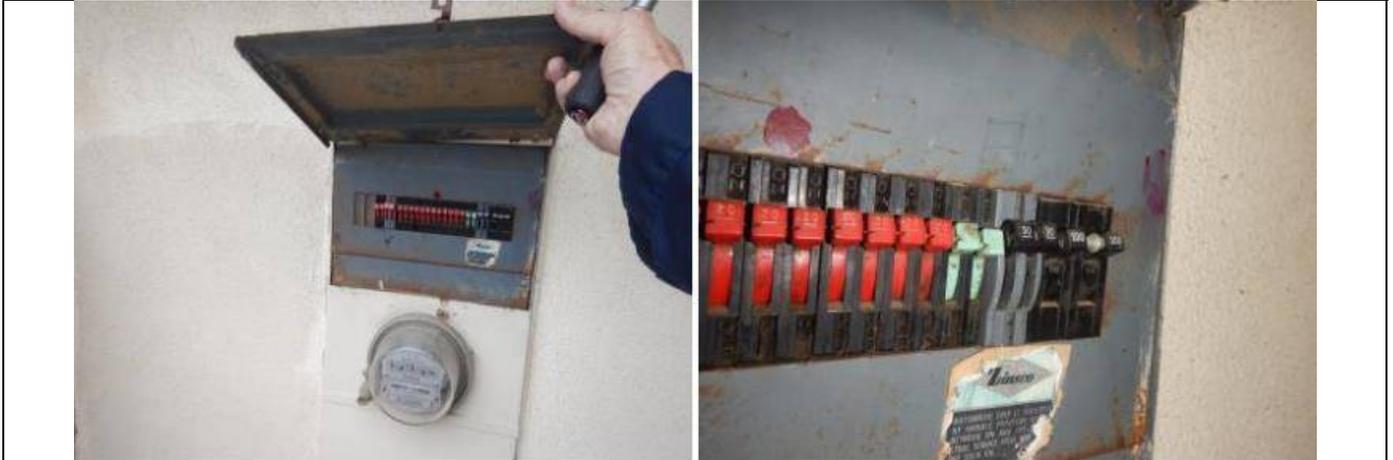
#### 9.5 PANEL TYPE & CONDITION:

**Attention Needed-** NOTE: Many electricians and home inspectors have discovered that certain Zinsco panels often can fail to operate properly and prone to some adverse conditions. These panels can work fine for years, but as homes have increased energy demands, these panels may overheat and portions of it melt.

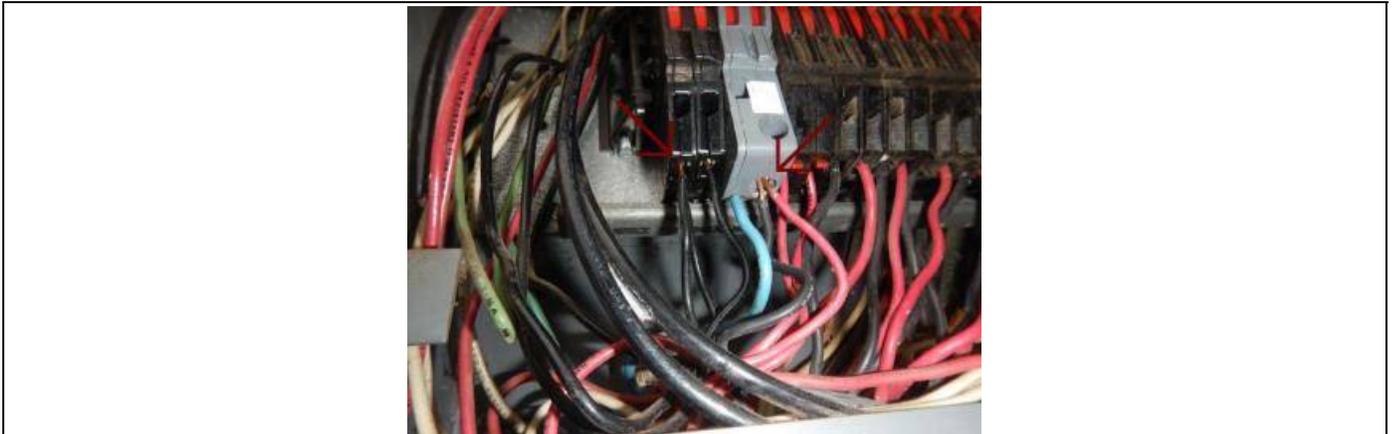
Double lugging noted. This is where there are two conductors connected to one breaker lug. This panel does not approve of this type of installation as it can affect proper contact of the conductors and affect proper function.

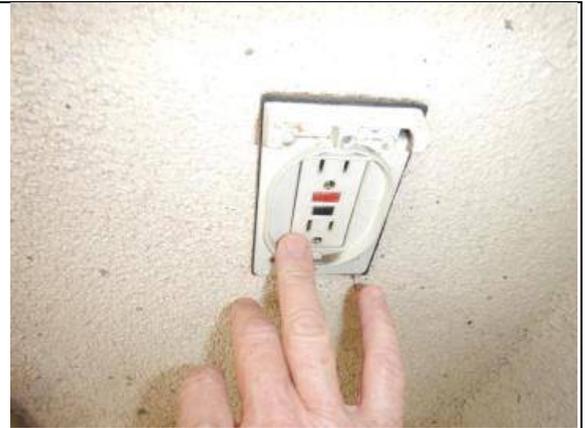
**Attention Needed-** At least one of the Ground Fault Circuit Interrupt protected outlets tested did not break the current flow or reset as required. Action is necessary to repair or replace. Such as exterior back.

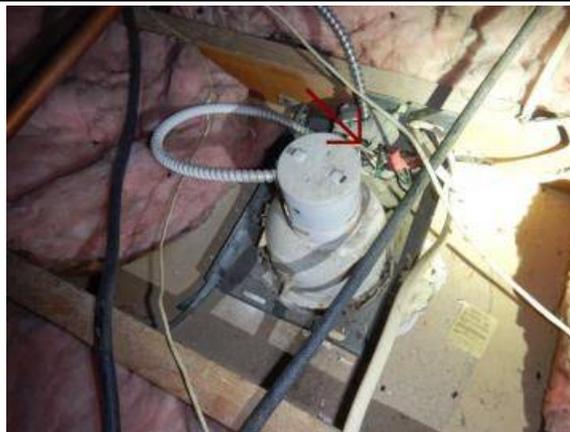
### 9.12 LIGHTING:

**Attention Needed-** Could not locate switch for exterior post lighting at back yard. Open boxes noted to some of the can lights in attic space. Repairs needed to prevent shock risk or fire hazards.

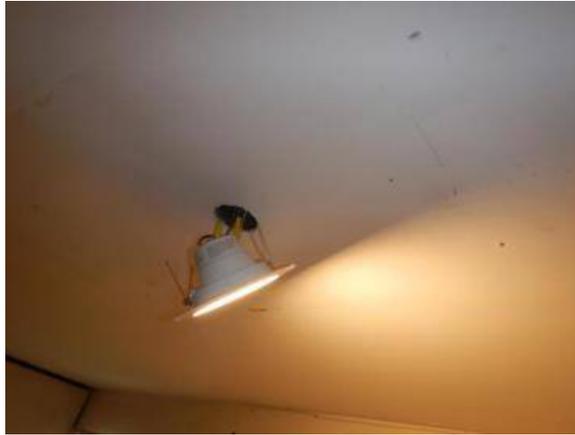
### 9.13 UTILITIES:

**Attention Needed-**One displaced light noted at ceiling. Have electrician repair.

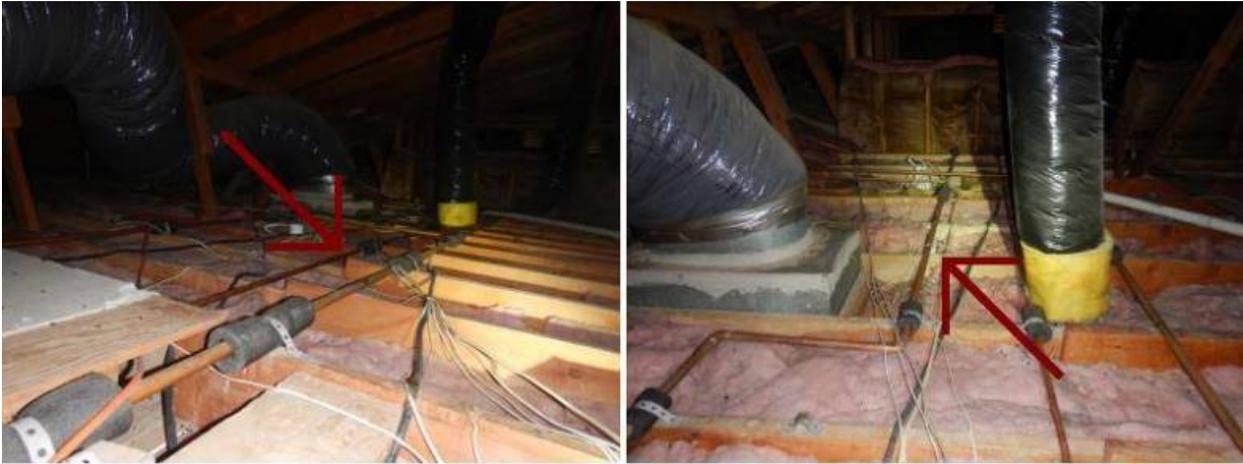
### 10.4 MATERIAL & CONDITION:

**Attention Needed-** Water hammering noted when some of the water fixtures were operated. There can be several reasons for this occurrence. For example, inadequate strapping of water pipes, air in the lines or water pressure too high. Consider insulating water pipes in attic space to improve efficient use.

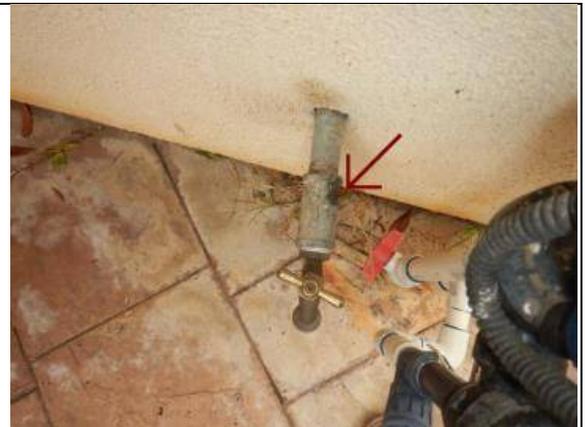
### 10.5 EXTERIOR HOSE BIBS:

**Attention Needed** -Leak noted at one of the front hose bibs.

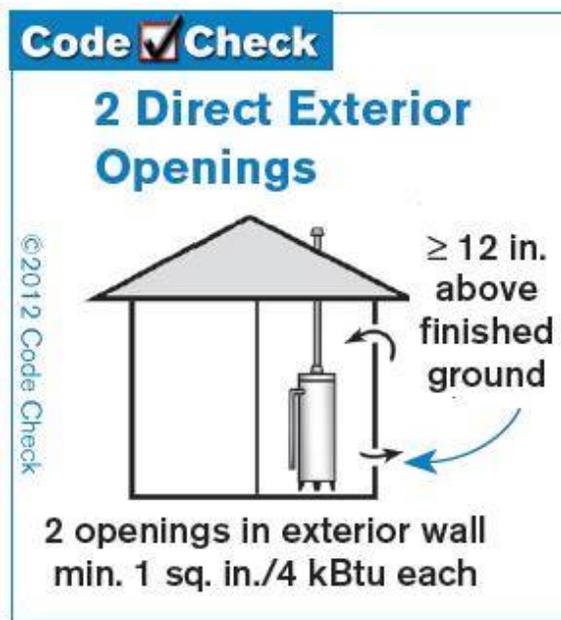
**10.14 COMBUSTION AIR:**

There is an inadequate amount of air supplied to area for complete and safe combustion. Immediate corrections are needed. Install vent openings at required locations.

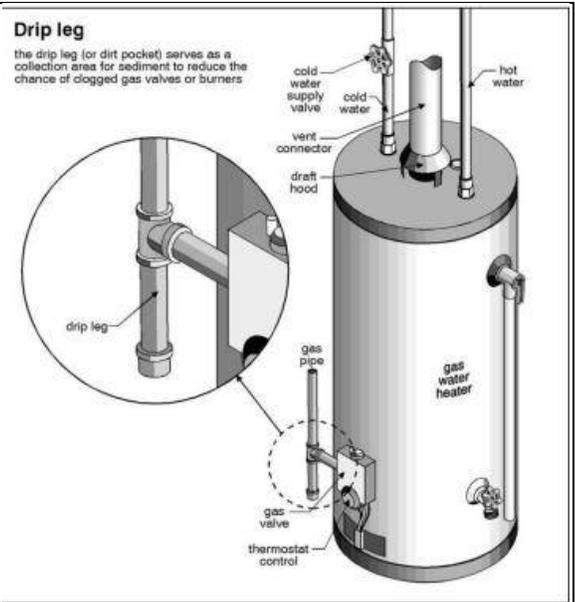
**10.15 DRIP LEG?:**

No - There is no drip leg or sediment trap installed on the incoming gas line to the water heater. Installation of a drip leg is recommended to prevent debris from getting into the gas valve.

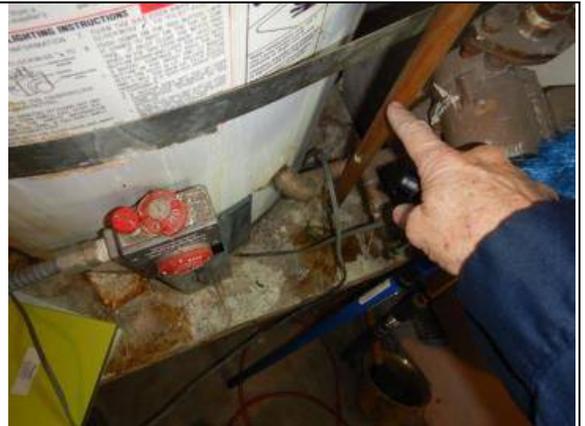
**Attention Needed-** There is an overflow pipe installed, but it does not extend to within 6" of the floor or outside the structure. The existing pipe should be replaced, not extended.

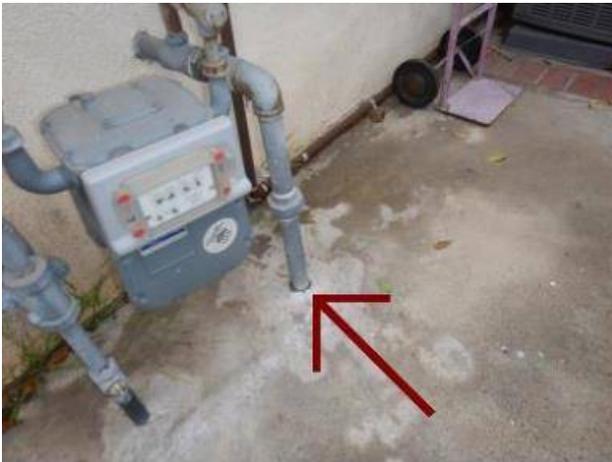
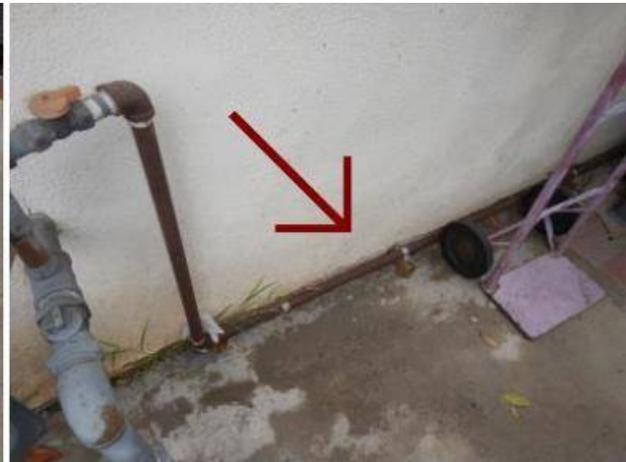
### 10.23 CONDITION:

**Attention Needed-** Rust noted to portions of the gas line piping. Recommend that rust be cleaned off and gas pipe be painted. Gas lines should be protected from any form of damage or corrosion. There is a section of gas line noted that passes through concrete without an appropriate sleeve. Gas lines should not be embedded into concrete as this could pose damage and future leaks. Contact a licensed plumber for further evaluation.

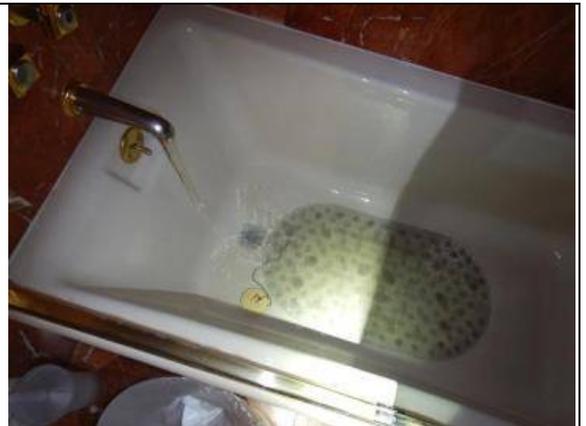
**Attention Needed**- Slow drainage observed from this tub at time of inspection. Location: Main Bedroom.

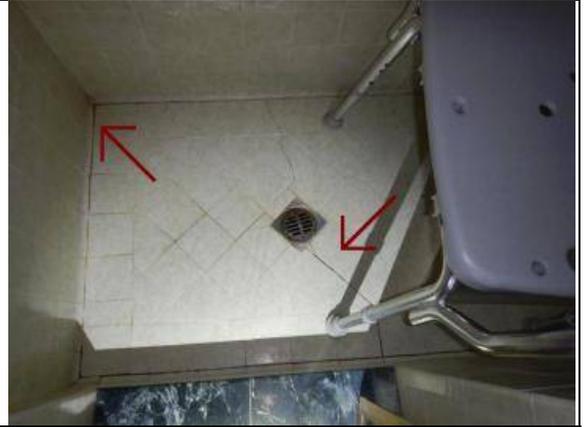
**Attention Needed** - Tile is cracked in areas of west hall shower stall.

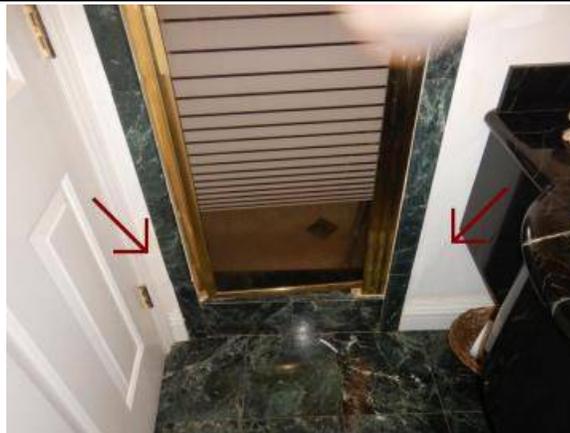
**11.10 WALLS & CEILINGS:**

**Attention Needed** - Areas of water damage noted, such as; Around the vicinity of tub and shower stall. Location: West bath.
