Professional Commercial & Residential Inspections

## Confidential Inspection Report

**1234 Sample Address  
Sample City CA. 12345**

**Prepared for: Sample Client  
Prepared By: Robert Gaudreault**

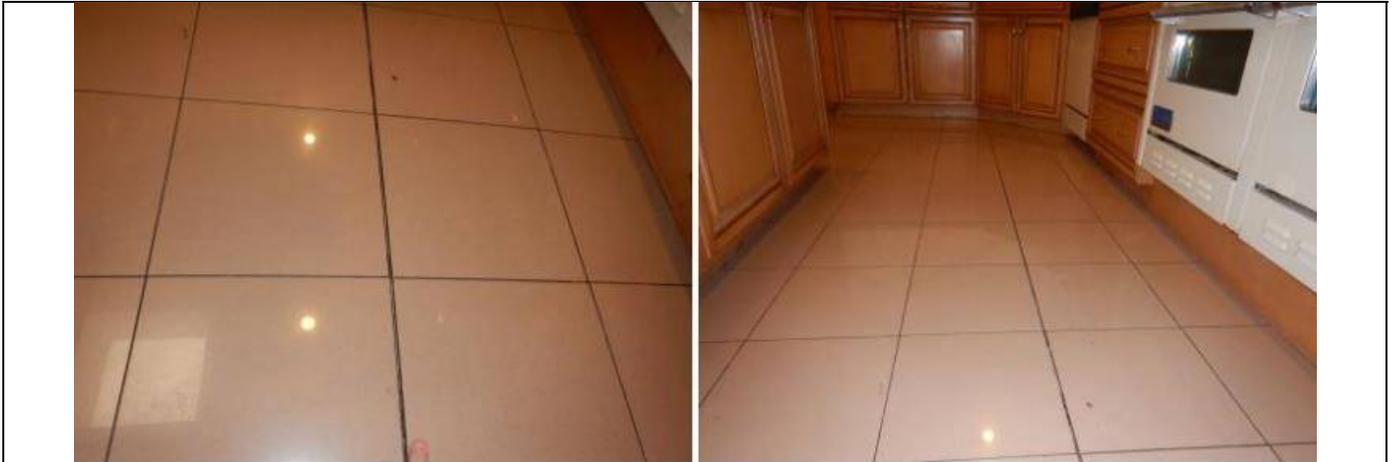
### 12.5 CONDITION & TYPE:

**Attention Needed** - Tile make a hollow sound when tapped on. This would give indication that these tile are not fully packed or adhering to subfloor. Use caution when moving heavy items over these tiles as they can crack or break as a result. Lager gap between island counter and range counter could be a slab crack.

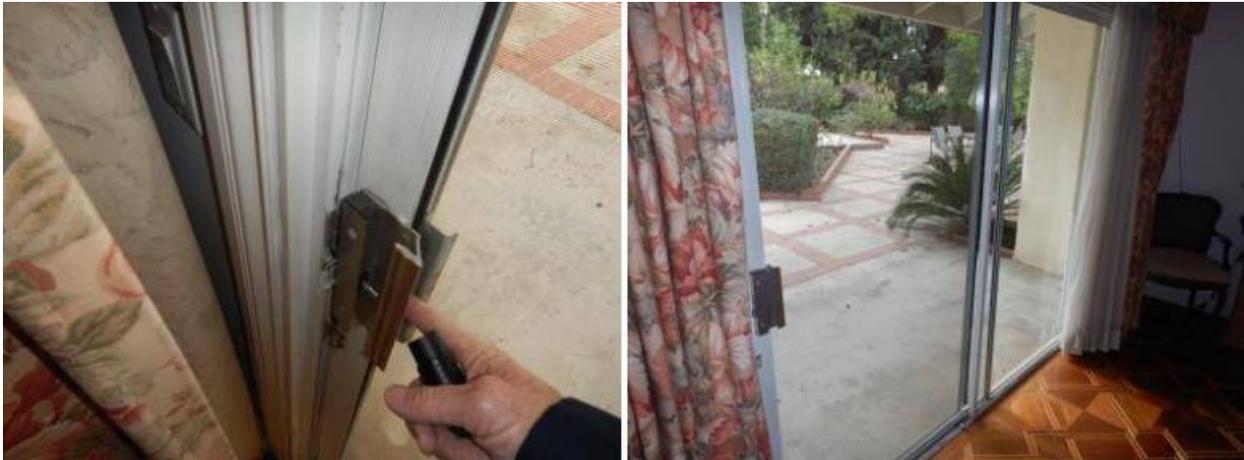
### 14.1 EXIT DOORS:

**Attention Needed-** Client should be aware that the sliding door from living room is installed to the outside. This does facilitate breaking in and entering from unwanted guest. Recommend improvements by installing some type of pin to prevent lifting of slider. Locking hardware does not function as intended.

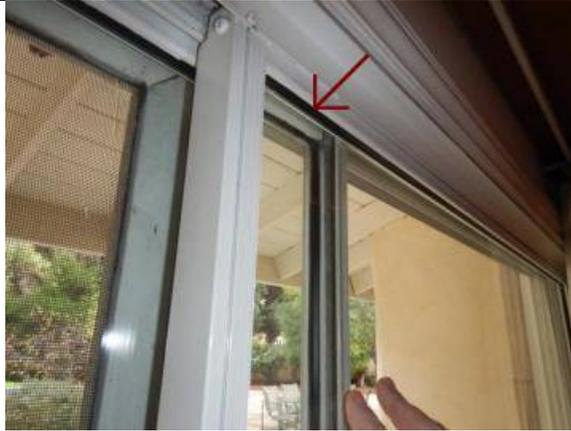
Upper frame of at least one tested slider from living room is loose or displaced. Anticipate upgrades.

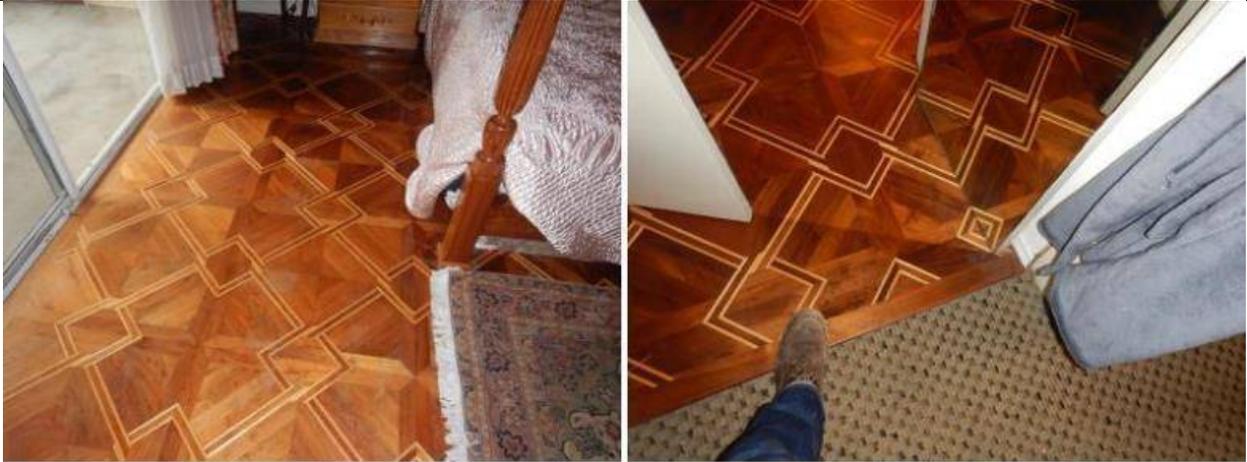
#### **14.4 TYPE/CONDITION:**

Wear noted at some locations. Otherwise satisfactory.

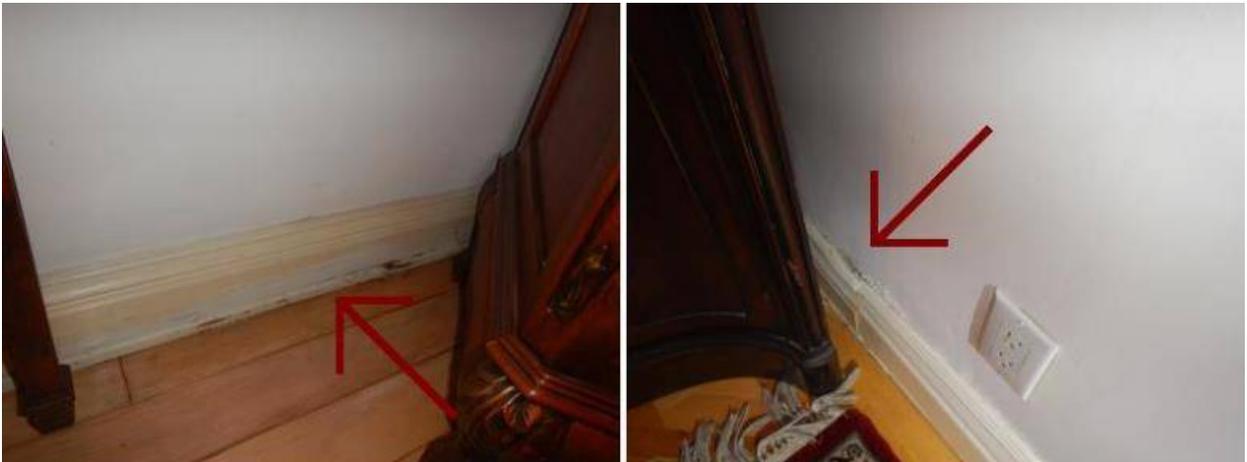
Damage is seen to some of the floor boards. Possibly water related damage. Noted at various locations. Such as dining area and front end bedroom.

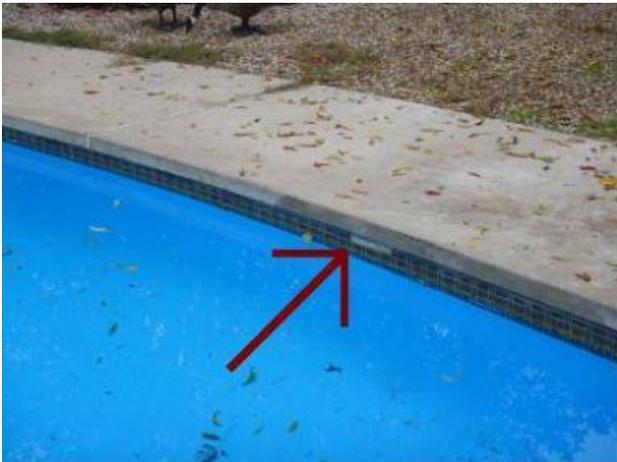
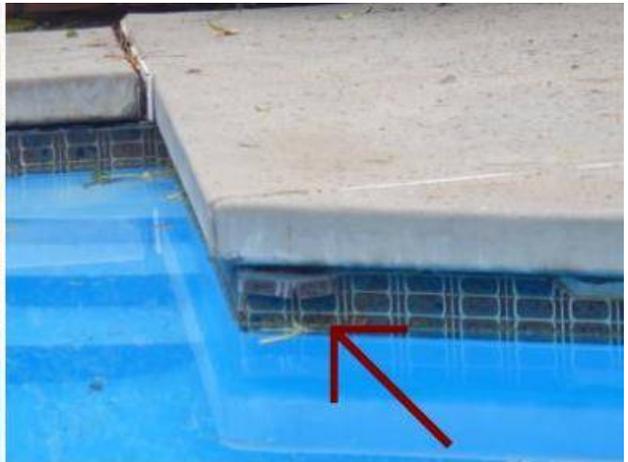
**Attention Needed**-General heaving of cantilever decking throughout pool perimeter.

Damaged or missing tile.

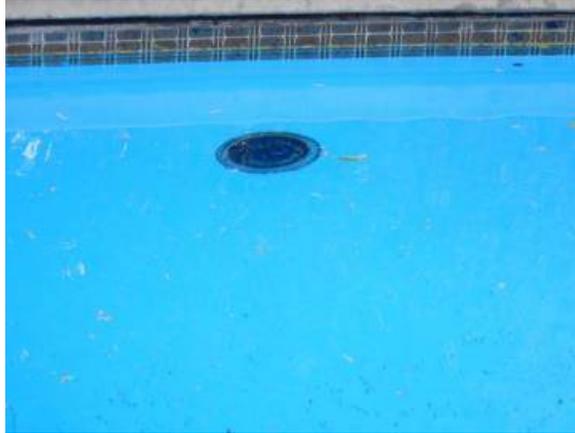
### 15.6 CONDITION:

**Unsatisfactory-** Not operable. Further evaluation and repairs will be needed by a licensed electrician. Evidence of a problem as seen visually. Blackness noted at bulb.

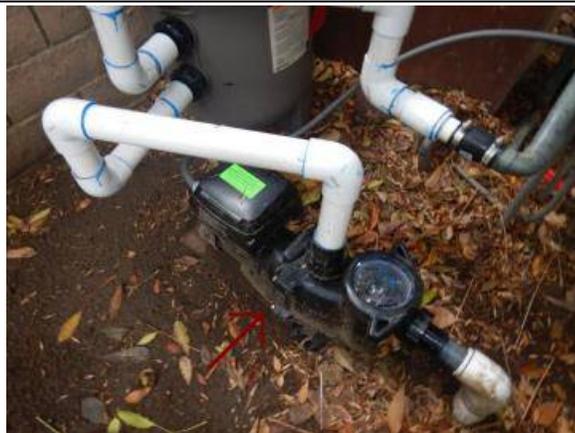
### 15.8 CONDITION:

**Attention Needed-**Pool pump should be installed onto a substantial pad.

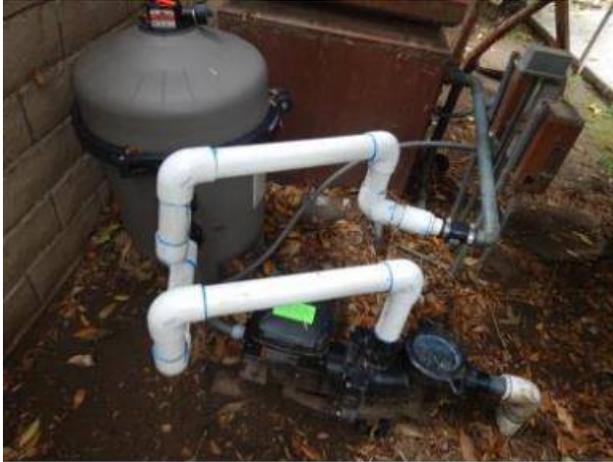
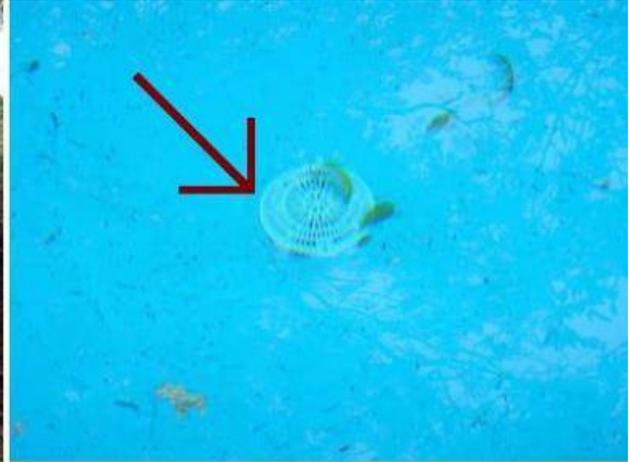
### 15.10 CONDITION:

**Attention Needed-** This pool is equipped with an older type drain cover. Recommend upgrading to a more child safe vortex type of cover. Recommend that any exposed PVC pipe be painted to prevent degradation from sun exposure.

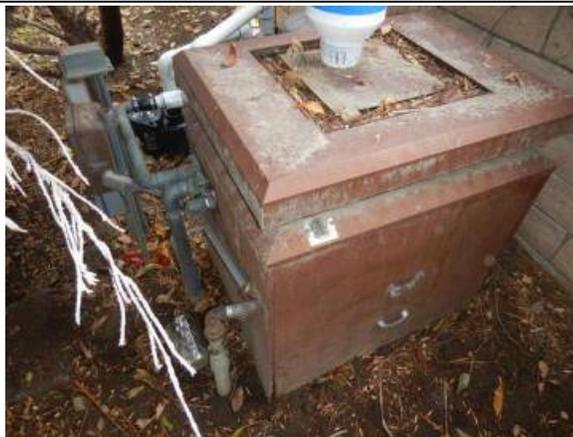
### 15.11 TYPE:

Natural gas. Heater is full of foliage and therefore not tested. However from just a simple observation it can be determined that the unit is beyond its life expectancy and should be replaced.

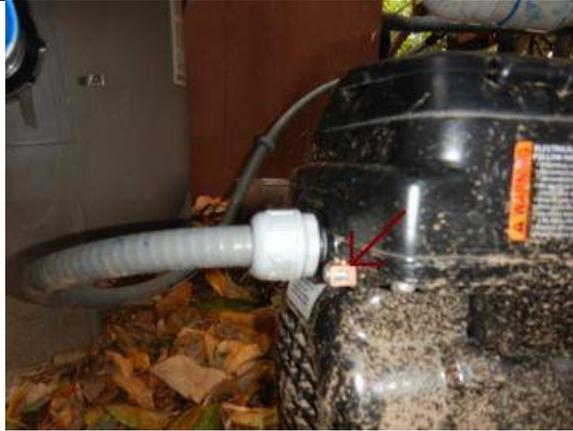
### 15.12 CONDITION:

**Unsatisfactory-** The pool equipment is not bonded with a bonding wire from pool motor to additional units, such as any heater or filter. This is an important feature and should be corrected at this time. Contact a licensed electrician for further evaluation.

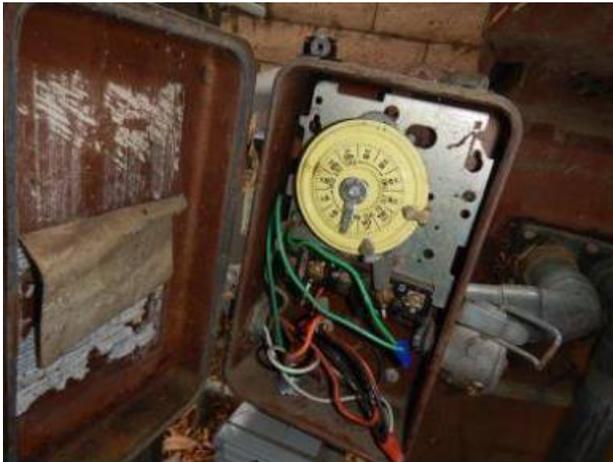
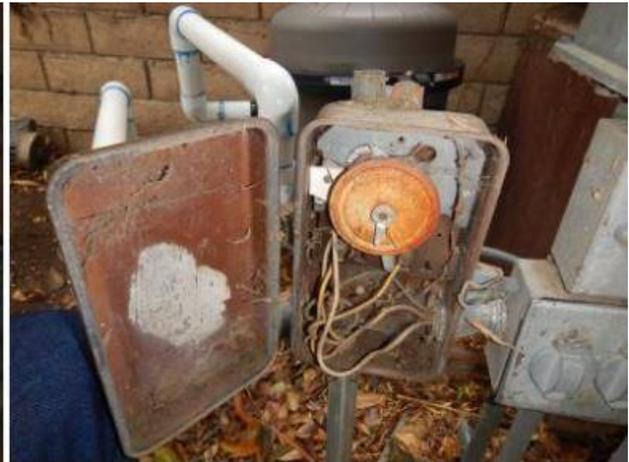
### 15.13 TIMERS:

**Unsatisfactory-** Terminal protector is missing from within timer. **SAFETY HAZARD!** Timer enclosures are in overall poor repair and not water or weather tight. Implications are greater electrocution hazards.

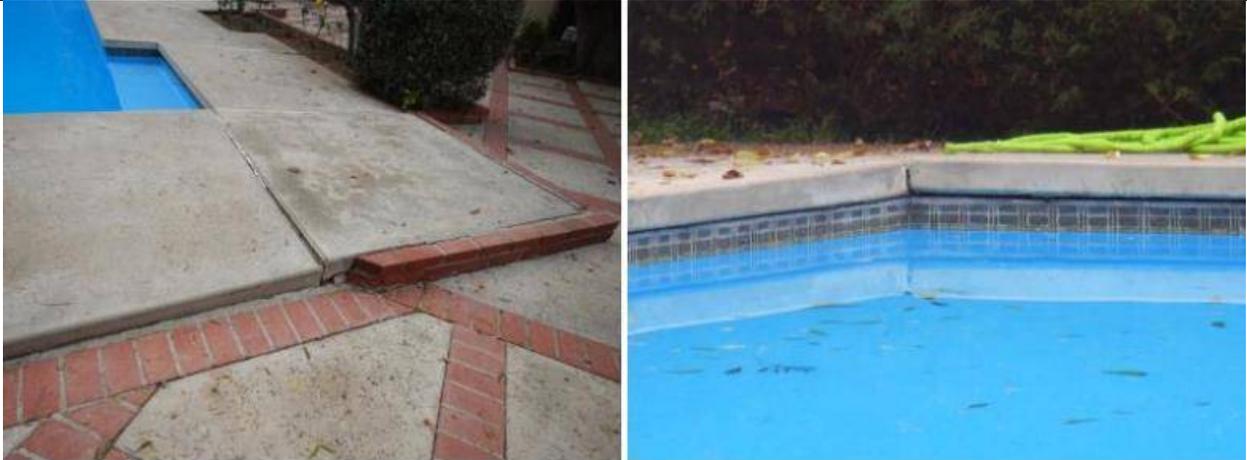
### 15.15 CONDITION:

**Attention Needed-** Some uplifted areas of decking noted. Repairs should be expected.
