Professional Commercial & Residential Inspections

Report: Sample

Confidential Inspection Report

**1234 Sample Address
Sample City CA. 12345**

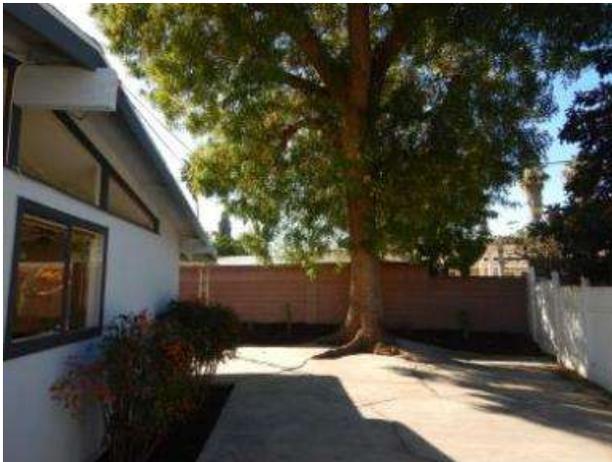
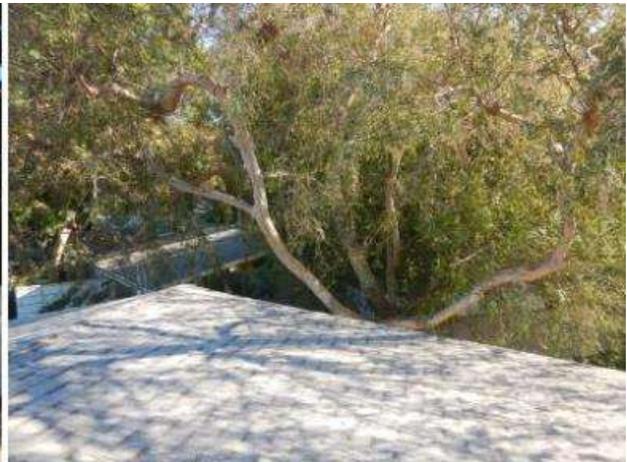
3.3 TREES:

Attention Needed- There are trees that are planted close to the structure. Client should be aware that tree roots can affect the foundation. Trees overhanging the structure need to be trimmed so that limbs, leaves, and rain will not drop off the tree onto the roof covering and clog the gutters, damage the roof, or promote moss growth. Trees that rub against the roof can cause severe damage and can drastically reduce the life of the roofing material.

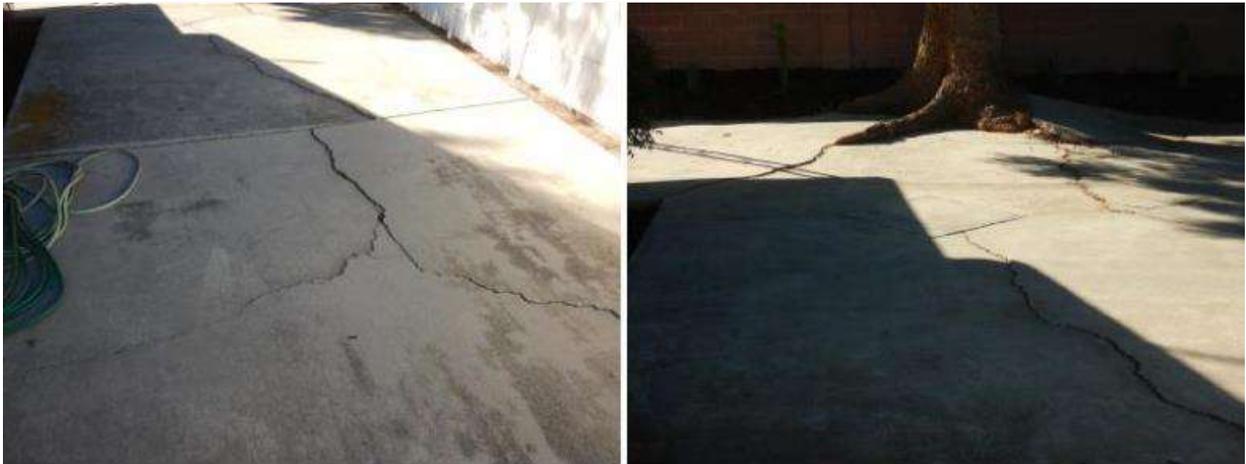
3.6 WALKWAYS:

Attention Needed - The walkways need action. Repair or replacement is indicated. Broken segments in walkways are unsightly and likely to continue movement.

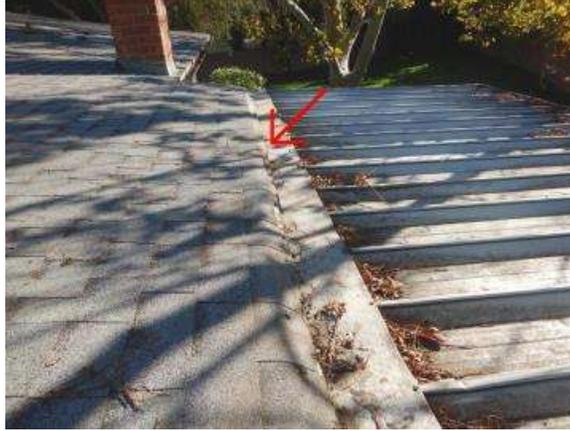
3.9 PATIO COVER CONDITION:

Attention Needed - The method of attachment of the patio cover to the house is incorrect. Without proper flashing, there is a potential for water entry into the wall and framing. Repairs are needed. Consultation with a qualified roofer as to the best method of repair may be indicated. Patio cover is in need of maintenance, debris noted in areas.

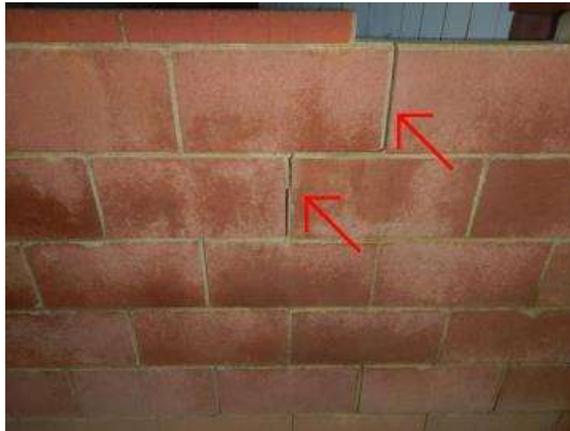
3.11 CONDITION:

Attention Needed - The fencing needs to be repaired, cracking/separation noted at the left side and rear, right side.

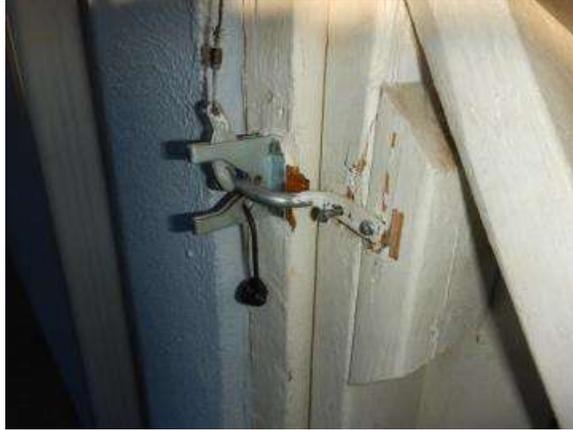
3.12 GATES:

Attention Needed - The gate or latch hardware needs repair to function as intended. The gate is not functional or is deteriorated to the degree that repairs is indicated.

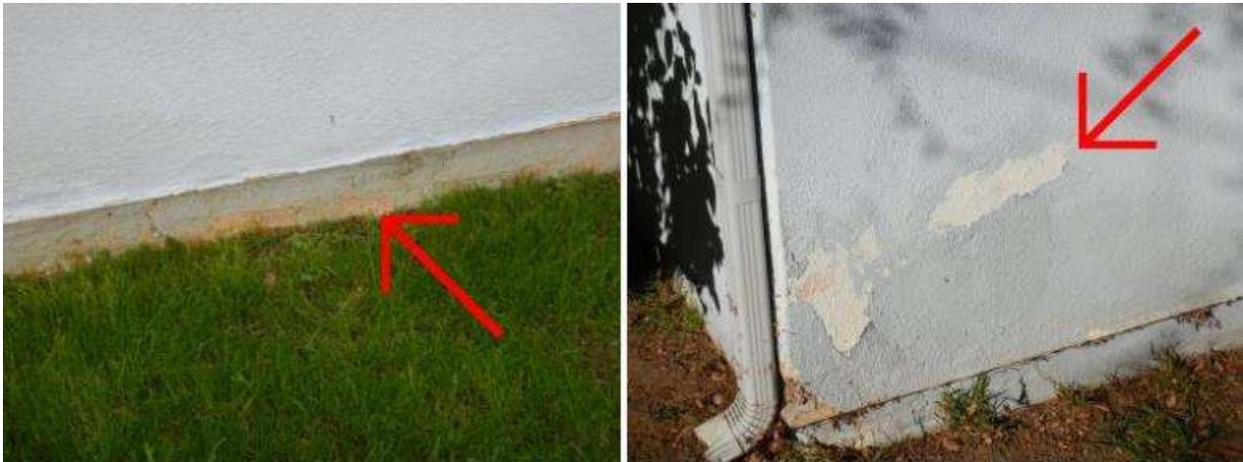
5.2 OBSERVATIONS:

Attention Needed - General areas of peeling stucco noted at and/or near the bottom of the exterior siding.

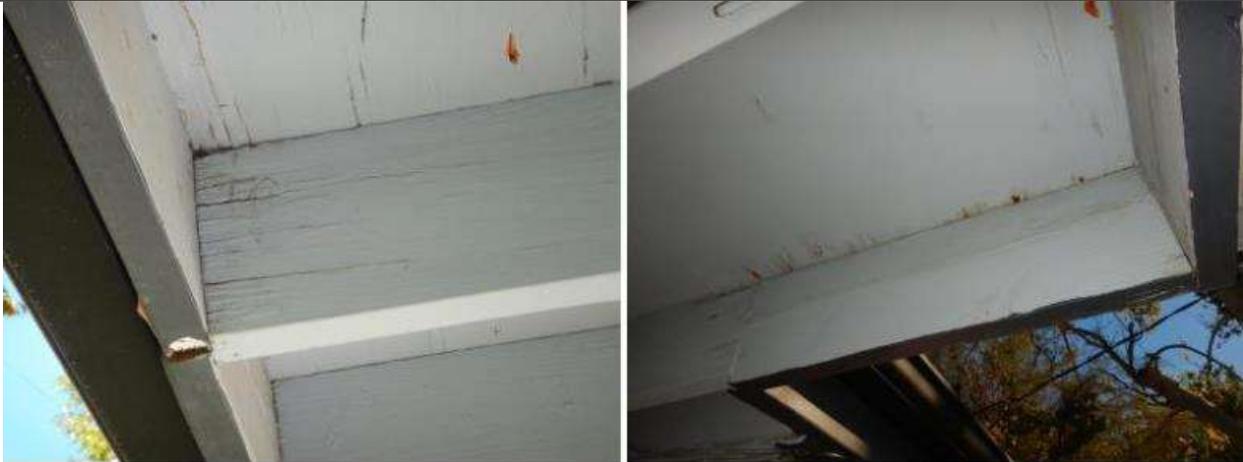
5.4 SOFIT & EAVES:

Attention Needed - Areas of apparent water damage noted. Further investigation is needed.

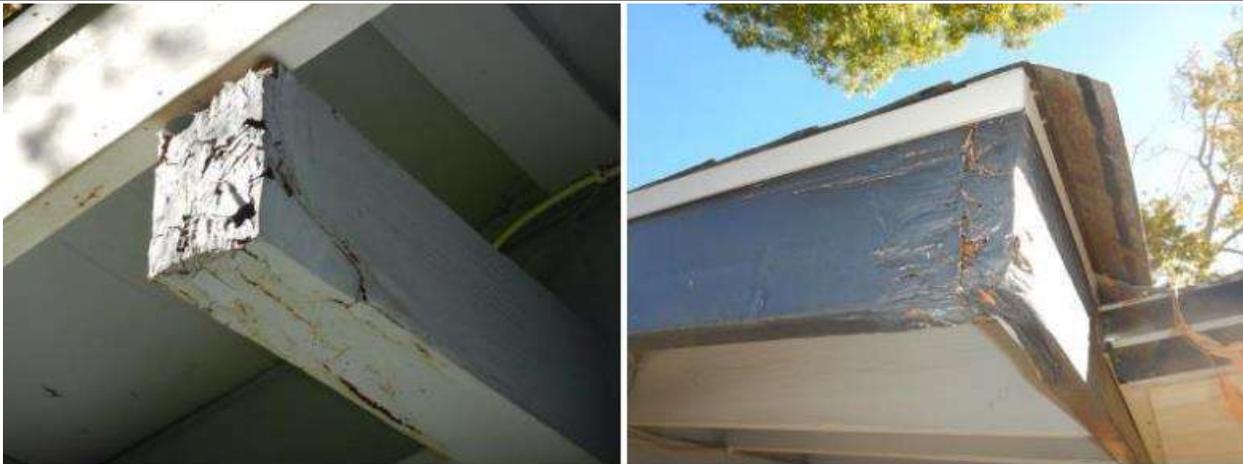
5.5 FASCIA & RAKE BOARDS:

Attention Needed - There is/are adverse condition(s) noted, such as; rake boards show some areas of water damage. Consult a licensed termite agency for additional inspection or refer to recent termite inspection report.

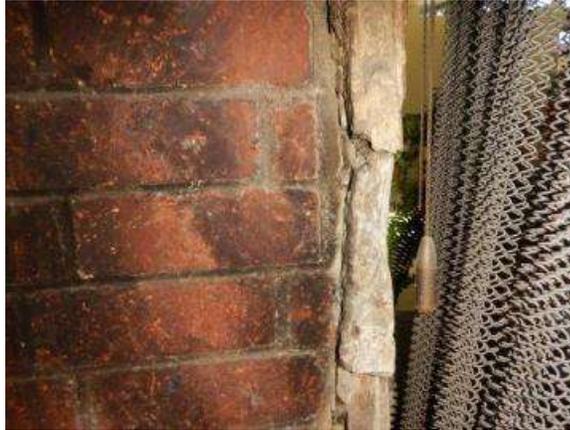
5.17 FIREBOX CONDITION:

Attention Needed - The firebox has a condition that needs attention. The services of a mason specializing in fireplace construction and repair may be needed. Cracks noted to masonry. Further evaluation is recommended. Loose material seen. Repairs needed to ensure functional use.

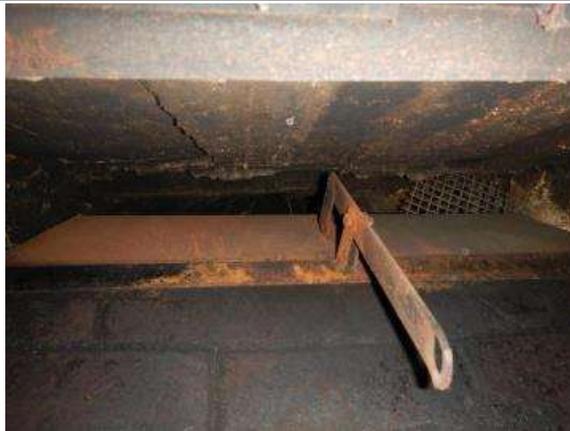
5.18 DAMPER CONDITION:

Action Necessary - The flue damper needs repair so that it will function as intended. The damper needs to be cleaned. Services of a professional chimney sweep are needed.

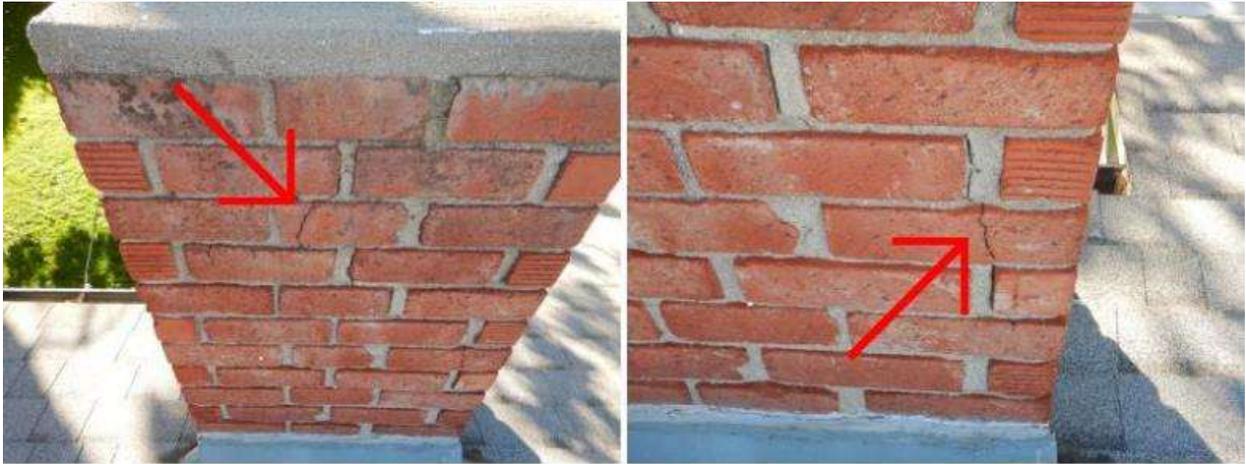
5.21 CONDITION:

Action Necessary - The exterior stack has a condition that calls for repair. Cracks noted in the exterior indicate some movement or possible overheated situation. Services of a professional chimney sweep are needed to make a final determination by performing a chimney scan.

Be aware that this is an older unreinforced masonry chimney and may not perform well during seismic activity. Consult a qualified chimney specialist for further evaluation.

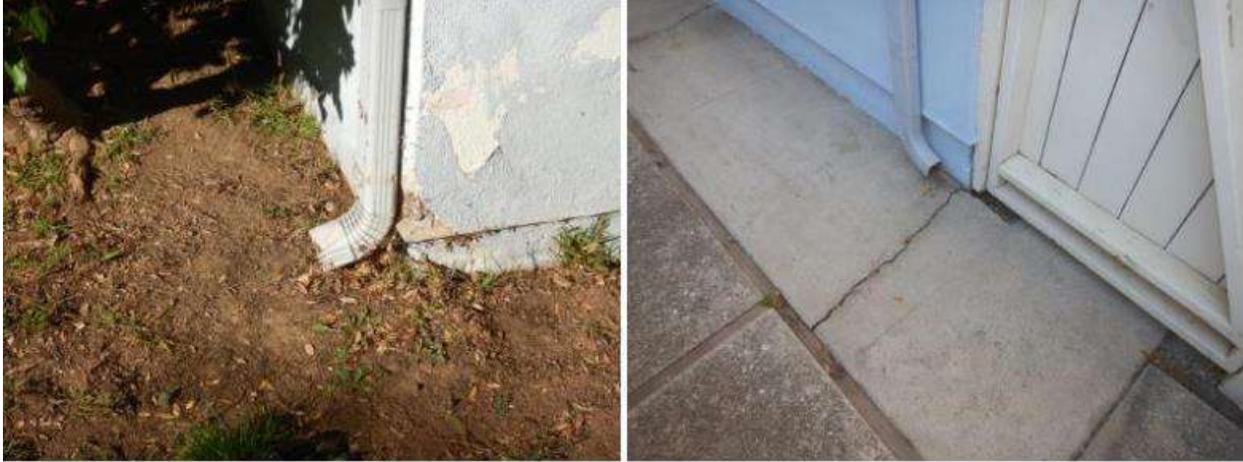
6.9 GUTTERS & DOWNSPOUTS:

Attention Needed- Extend down spouts further away from the foundation to reduce potential settlement of the structure.

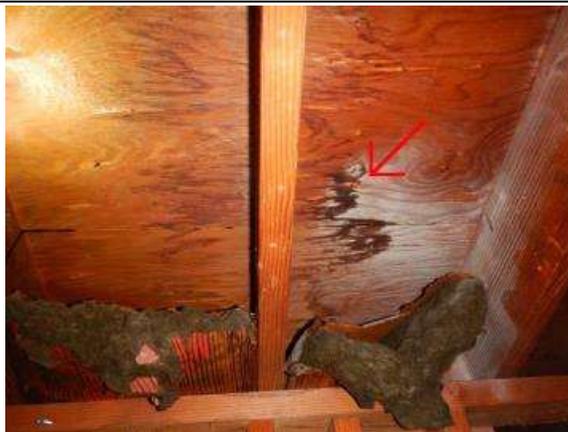
6.12 FRAMING:

Attention Needed- Water Stains are seen in areas. Inspector can not make any determination on whether or not these stains are from active leaks.

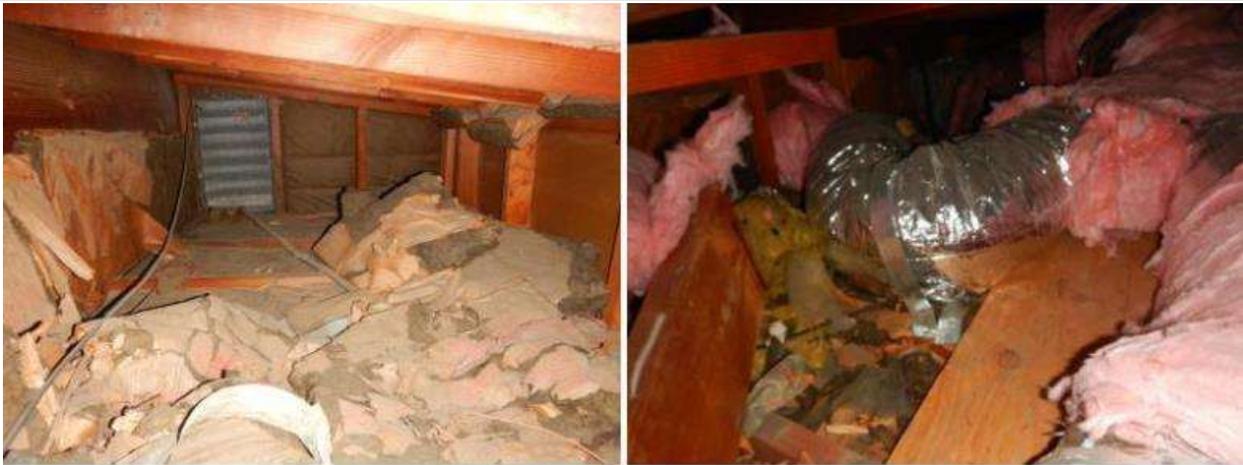
6.15 INSULATION:

The following type of insulation was noted in the attic: Rockwool poured in place.

Attention Needed - The attic insulation appears to be insufficient to properly insulate the living spaces below.

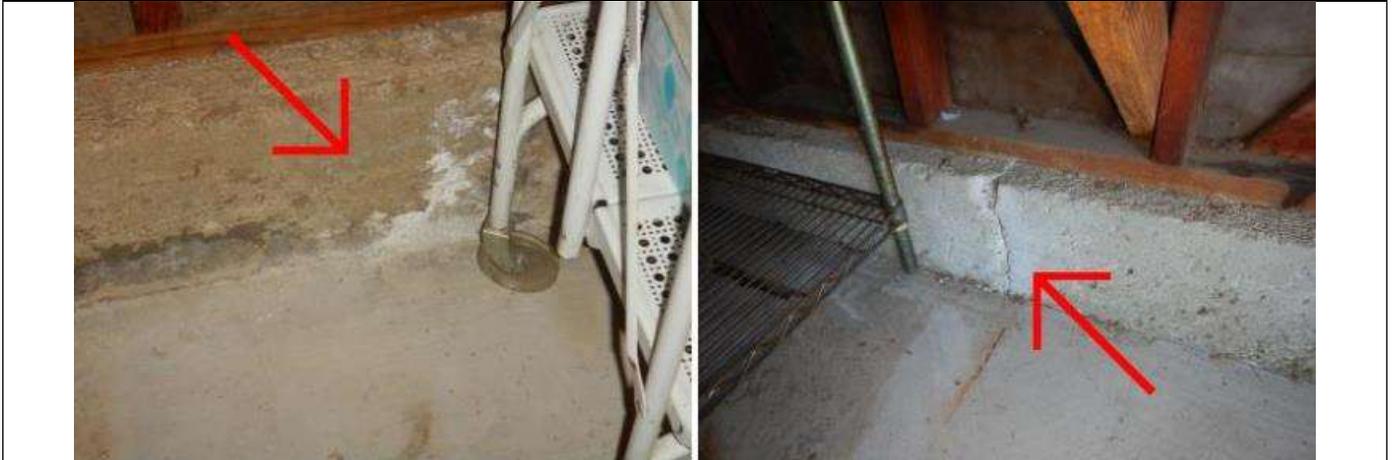
7.8 WALLS:

Satisfactory. Efflorescence (This is the white chalk like substance) is seen on areas of concrete indicating past water infiltration. Corrections are needed to adjacent grade as this can promote decay. There is at least one crack on the ceiling. It does not appear to be a structural concern at this time.

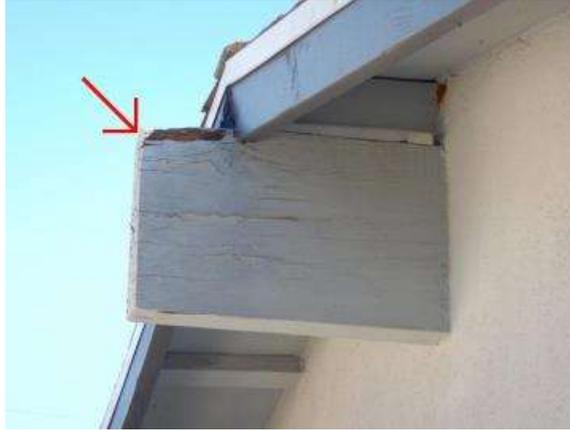
7.13 FASCIA & RAKE BOARDS:

Attention Needed - There is/are adverse condition(s) noted, such as; ridge boards show some areas of water damage. Consult a licensed termite agency for additional inspection.

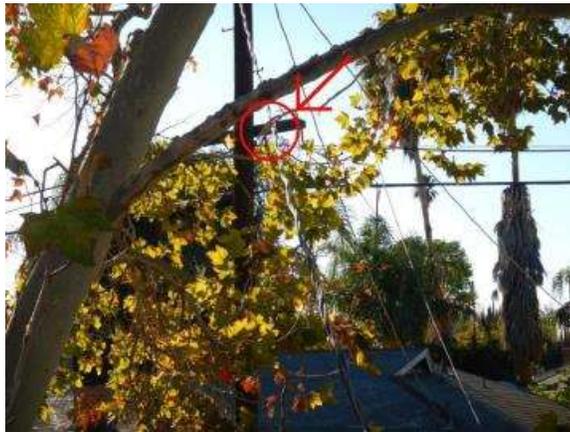
9.2 SERVICE TYPE & CONDITION:

An overhead service entrance cable used. It comes from local utility pole and attaches to a mast head which is attached to the structure

Attention Needed- The service entrance lines appear to be under undue stress from tree branches.

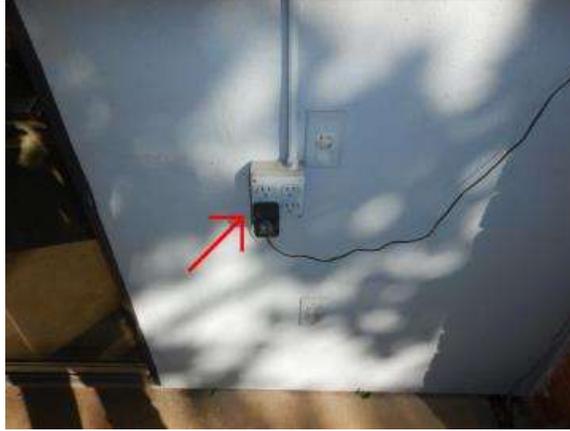
9.17 EXTERIOR ELECTRICAL:

Attention Needed- There are exterior outlet receptacles used to provide permanent power without appropriate full dome type covers. Corrections are needed.

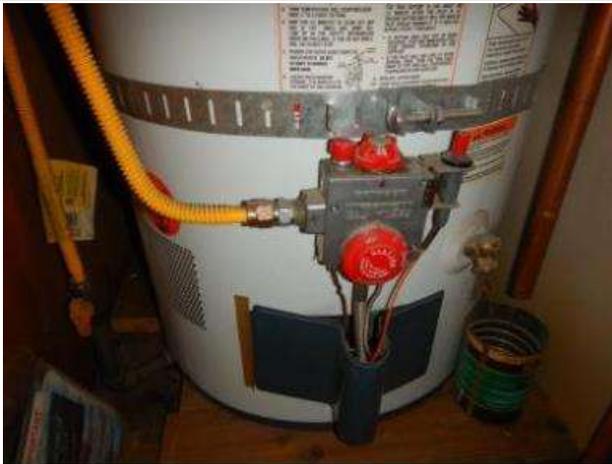
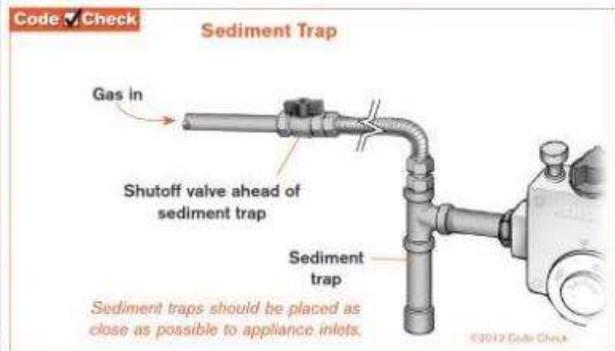
10.20 DRIP LEG?:

No - There is no drip leg or sediment trap installed on the incoming gas line to the water heater. Installation of a drip leg is recommended to prevent debris from getting into the gas valve.

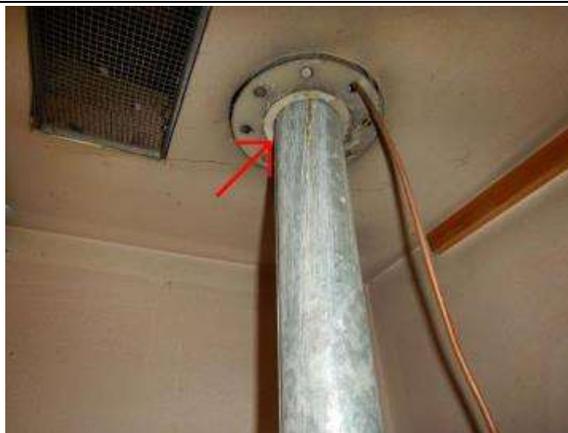
10.22 VENT PIPE CONDITION:

Attention Needed - There is evidence of poor drafting. This means that the gases are spilling

back down rather than expelling to the exteriors. Consult licensed plumber for further evaluation.

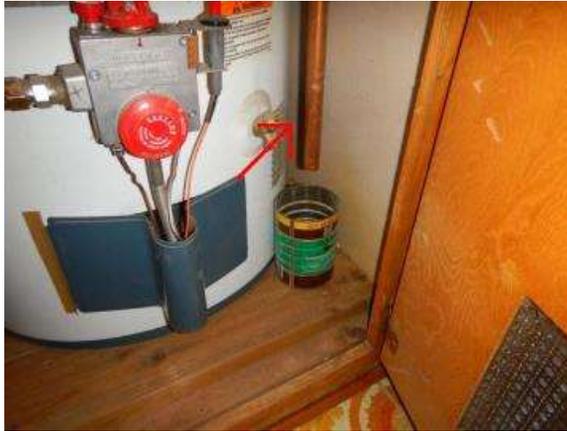
10.25 TPRV:

Attention Needed- There is an overflow pipe installed, but it does not extend to within 6" of the floor or outside the structure. The existing pipe should be replaced, not extended.

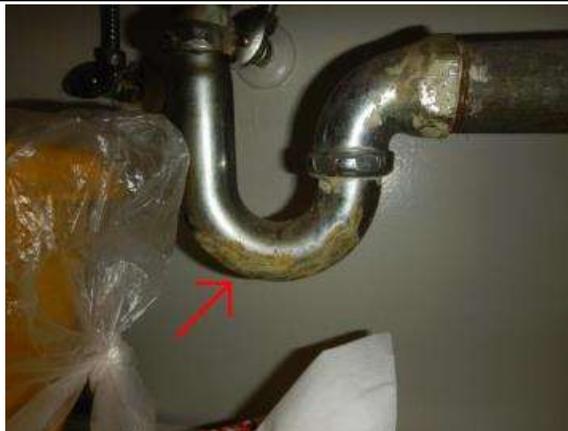
11.3 BASIN & DRAIN:

Attention Needed- The basin or drainage fixture needs attention. There is corrosion on the trap or drain line. This is an early warning of future failure. It may not be currently leaking, but it will need to be replaced in the near future.

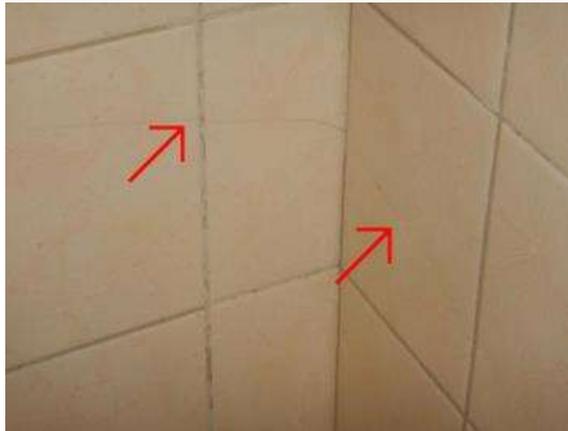
11.7 TUB & SHOWER WALLS:

Attention Needed - Tile is cracked in areas, repairs are recommended to prevent potential damages.

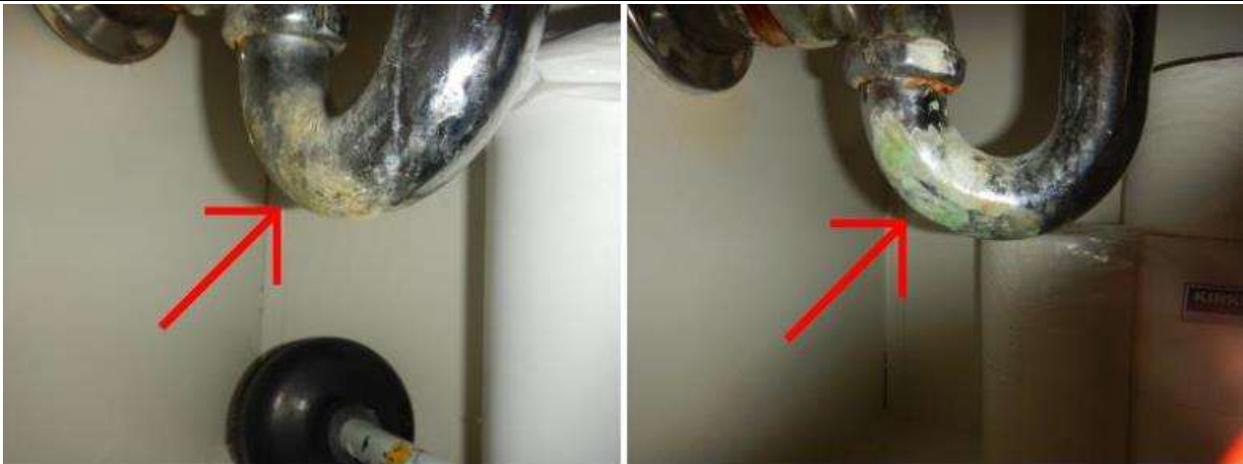
11.14 BASIN & DRAIN:

Attention Needed- The basin or drainage fixture needs attention. There is corrosion on the trap or drain line. This is an early warning of future failure. It may not be currently leaking, but it will need to be replaced in the near future. Sink basin is chipped. Plan on upgrades as this condition does worsen in time.

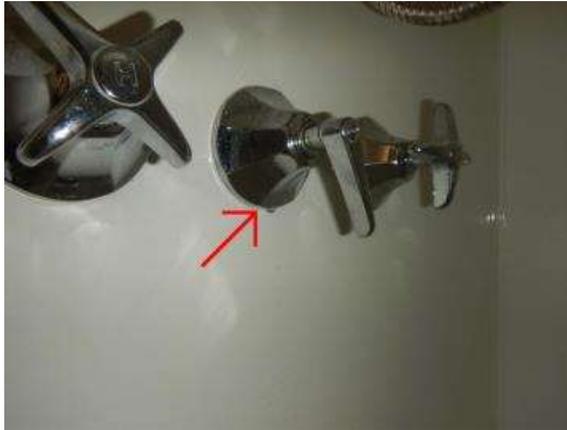
11.18 SHOWER FIXTURES:

Attention Needed - Shower diverter leaks when fixtures are operated.

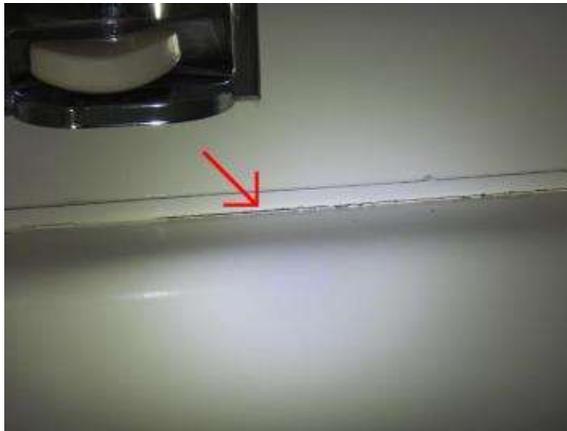
11.19 TUB & SHOWER WALLS:

Attention Needed - Seal along where tub meets wall tile is in need of some repair. Improvements are needed at this time.

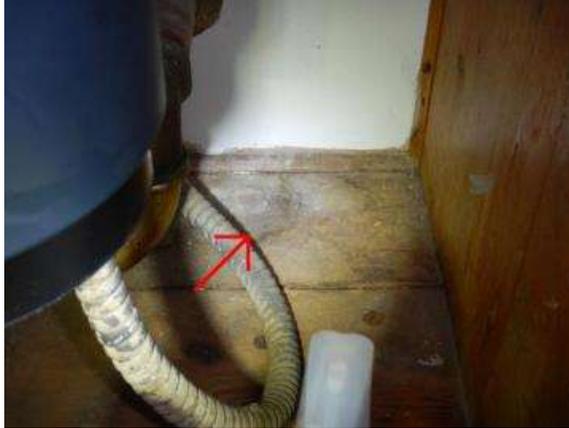
12.7 CABINETRY:

Attention Needed- Water damage is noted within cabinet under sink. Expect repairs.

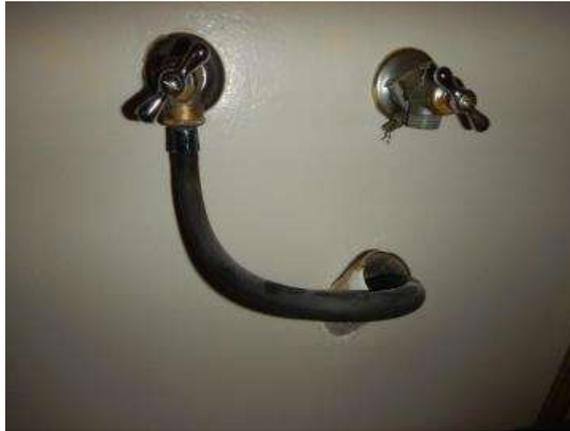
13.2 WASHER HOOK UPS:

Washer hook ups provided. These valves are not tested. Inspector simply notes the presence of fill valves and drainage. Hooks ups are currently not installed properly.

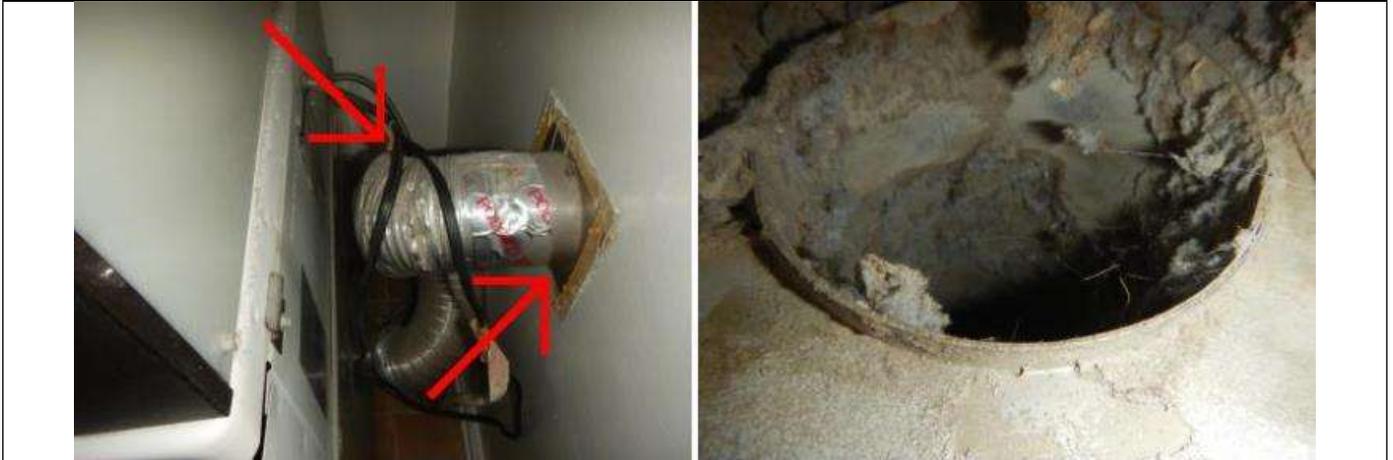
13.4 DRYER EXHAUST:

Attention Needed - Duct is in need of cleaning at this time. Excessive lint buildup noted at the flapper on the exterior vent hood. Dryer exhaust is not properly secured, recommend repairs. The clothes dryer exhaust system is an upflow installation. This does require continual maintenance from a duct cleaning company to prevent lint build up. We recommend cleaning duct out at least once a year.

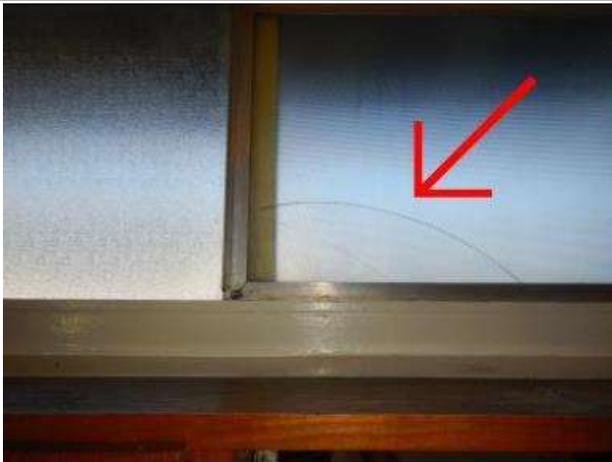
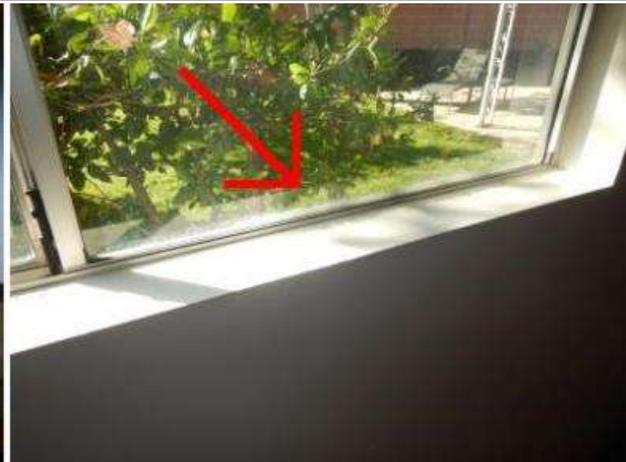
14.3 TYPE & CONDITION:

Windows are: Aluminum, Sliders, Single pane.

Attention Needed- Cracked window panes noted, such as, Entry hall bathroom. Some of the windows have sustained water damage, such as, bedroom windows.
