Professional Commercial & Residential Inspections
8209 Foothill Boulevard, Suite A124, Sunland, CA. 91040

Confidential Inspection Report

**123 Anyplace Drive
Los Angeles, CA. 90000**

**Prepared for: Jane & John Smith
Prepared By: Robert Gaudreault**

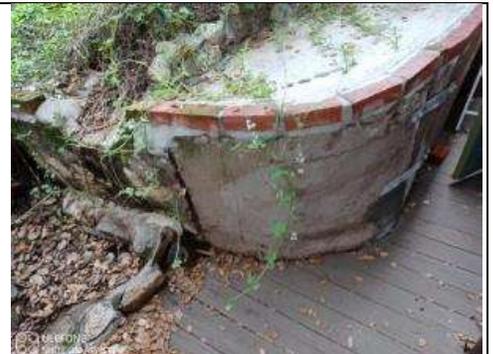
2.2 GENERAL PLANTING:

Fracture noted at planter box that appears to have been filled with cement at left upper deck. Possibly due to adjacent tree roots.

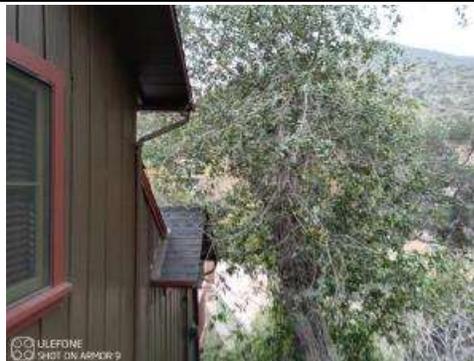
2.3 TREES:

Trees overhanging the structure need to be trimmed so that limbs, leaves, and rain will not drop off the tree onto the roof covering and clog the gutters, damage the roof, or promote moss growth. Trees that rub against the roof can cause severe damage and can drastically reduce the

life of the roofing material.

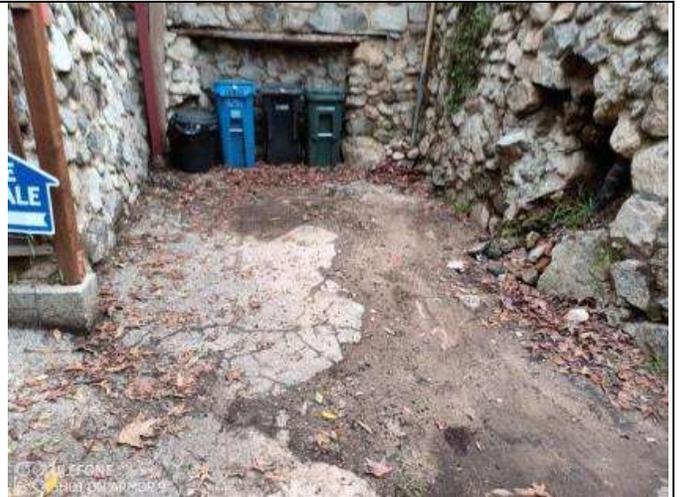
2.6 DRIVEWAY CONDITION:

Paving at parking area for this dwelling is in poor repair and needs replacing.

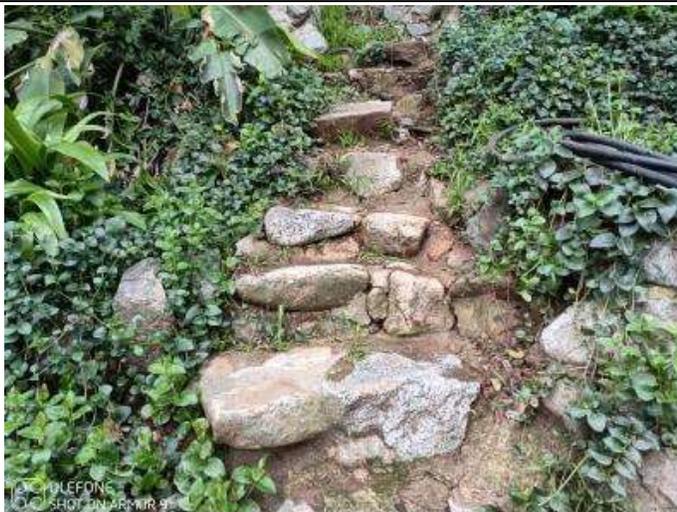
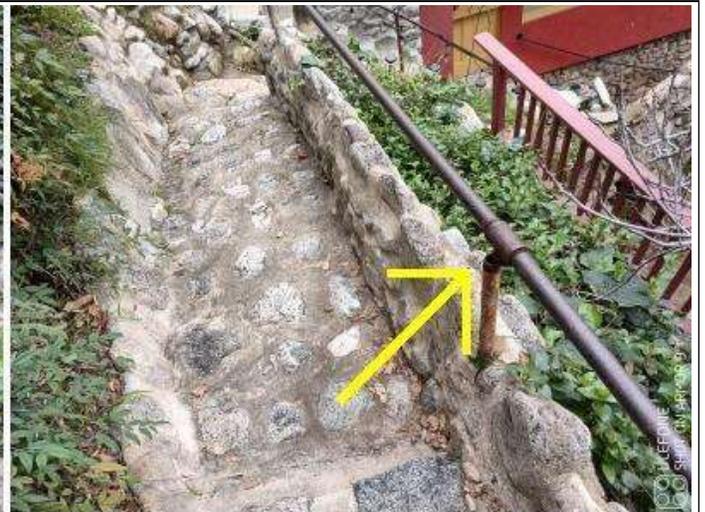
2.7 LOCATION:

Site stairs. Stairs are of stone and were acceptable in the day however be aware that they are not constructed per current industry standards and can pose a trip hazard. Railings are also lower than standard and one section has come apart. Correct as needed Use caution when ascending and descending.

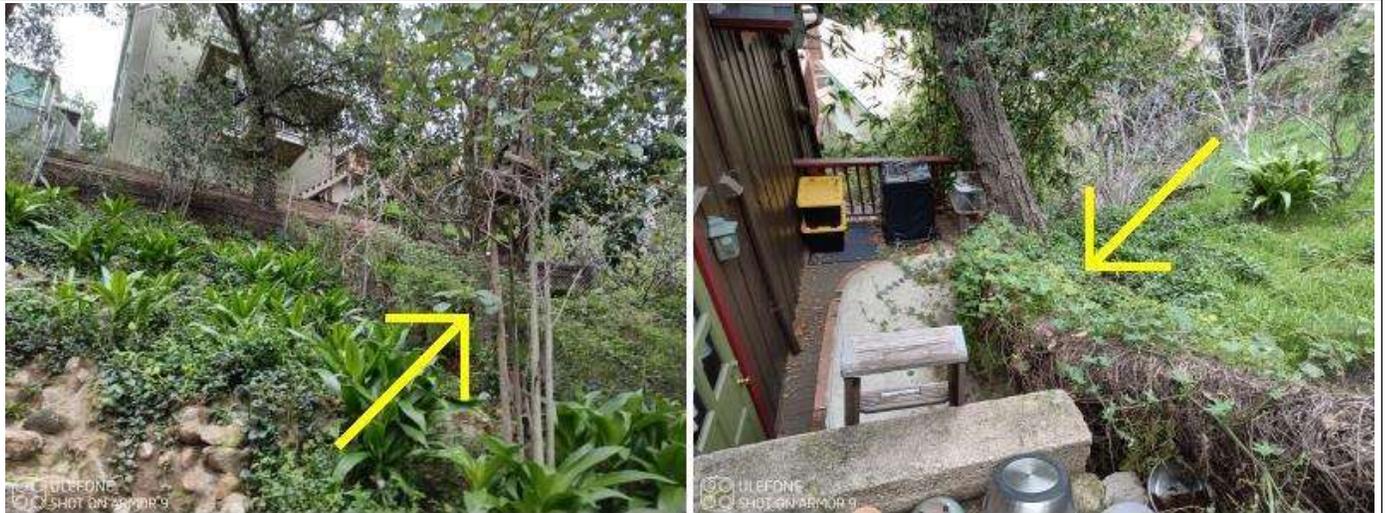
2.8 MATERIALS:

Chain link, chicken wire. Damaged sections noted throughout various locations of yard perimeter. Fencing is generally shared with neighboring property. Neighbors would need to be consulted prior to repairs. Any comment made related to fencing is done out of courtesy. Inspector is not conducting a survey to determine where property line actually is located. This can only be done by qualified surveyor.

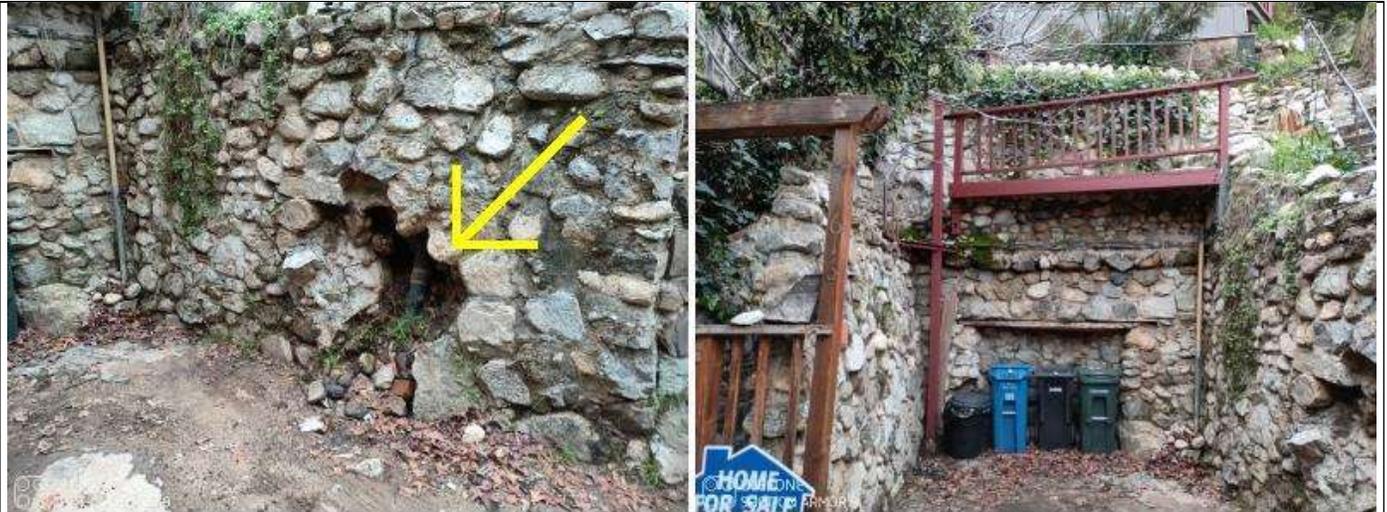
2.11 CONDITION:

Attention Needed-Damage sections noted. One section of main retaining wall at front right of parking space has been excavated out to perform repairs to a section of waste line. This may have compromised integrity and performance and could have weakened the wall to an extent. Though these retaining walls appear to have been constructed for some time they are prone to failure. Stone if installed with the best craftsmanship can perform well in most other areas of the country or world for years. However unreinforced retaining walls such as of stone are more likely to fail in other situations, such as areas of more frequent seismic events and land movement. For this reason I strongly recommend that further analysis be performed by a qualified Geo Technician (Geologist or soil engineer).

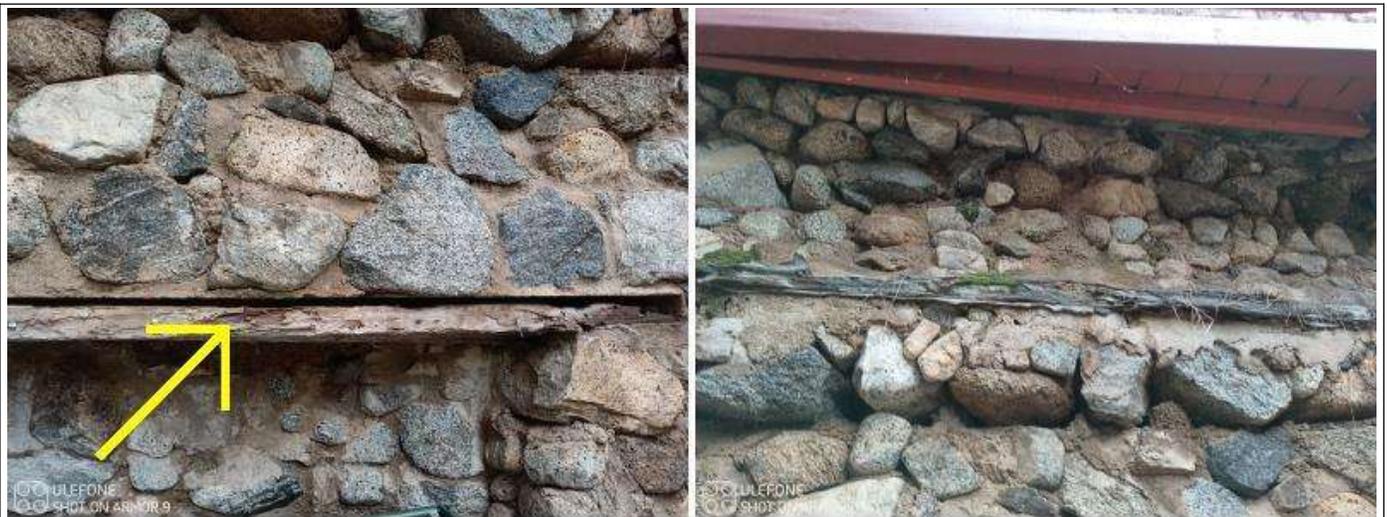
Deteriorated wood shelving.

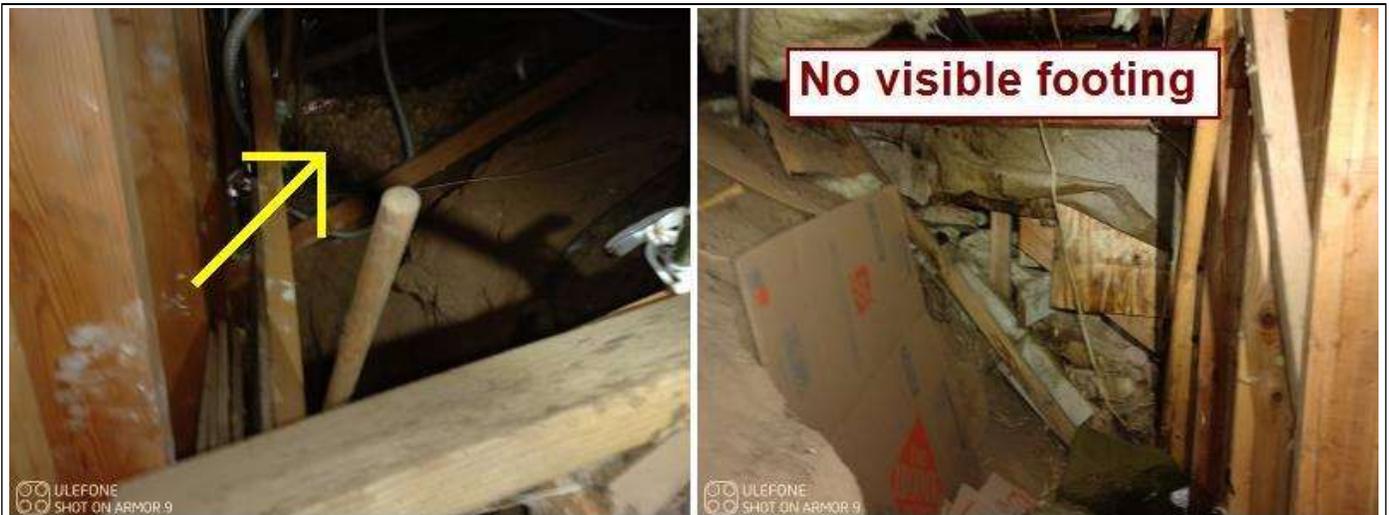
3.2 CONDITION:

Attention Needed-Foundation is of unconventional construction and has a high probability of not performing as intended. There is evidence of prior movement of the structure to the downhill direction. Further evaluation needed by licensed foundation specialist.

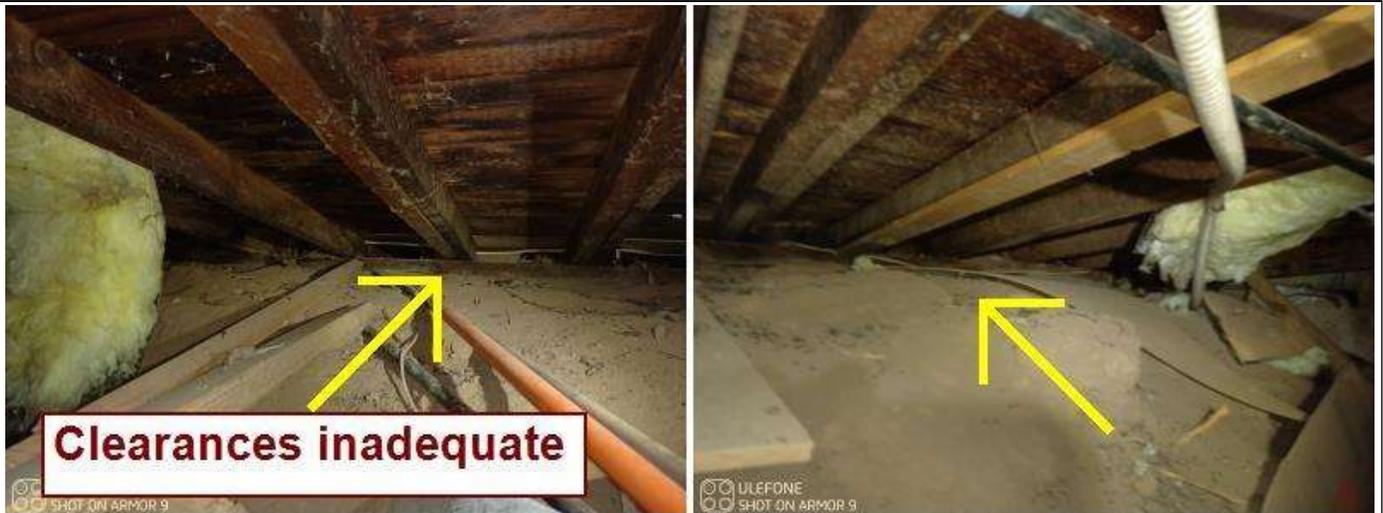
3.4 ENTRANCE:

Not accessible. Crawl area can only be viewed from storage door. Clearance is inadequate. Earth to wood contact.

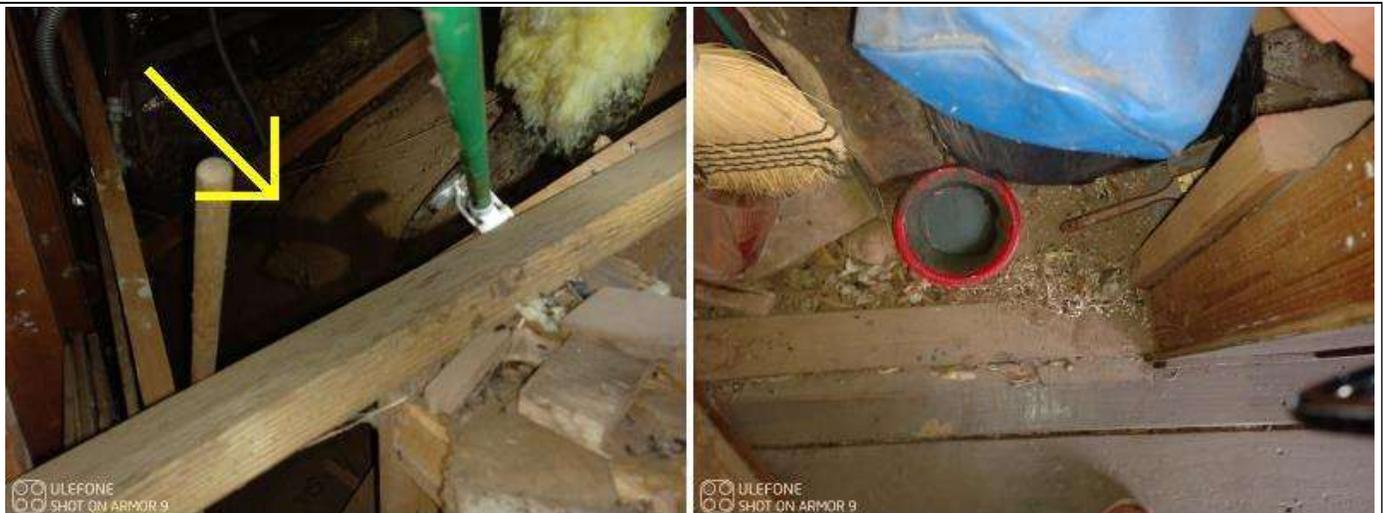
3.6 CONDITION:

Visible soil erosion noted. Soil has eroded onto framing which can pose wood decay and is conducive to wood destroying organism.

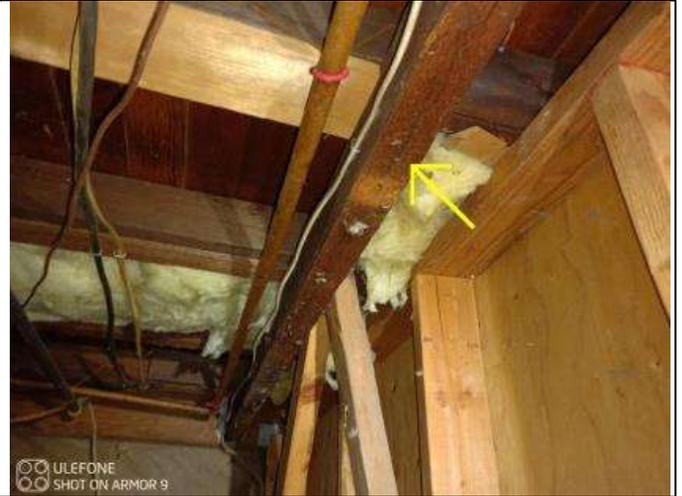
3.9 BEAMS:

No real support beam along front section of structure other than added framing. No ties or anchors.

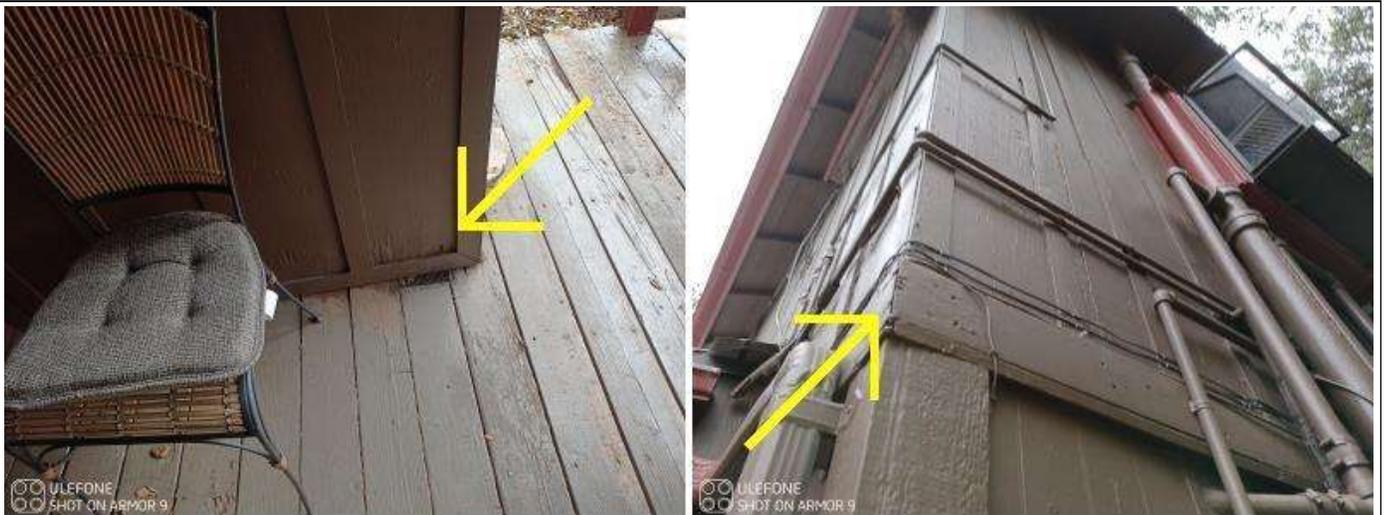
4.2 OBSERVATIONS:

Water related damage apparent. Further inspection needed by licensed termite inspection agency.

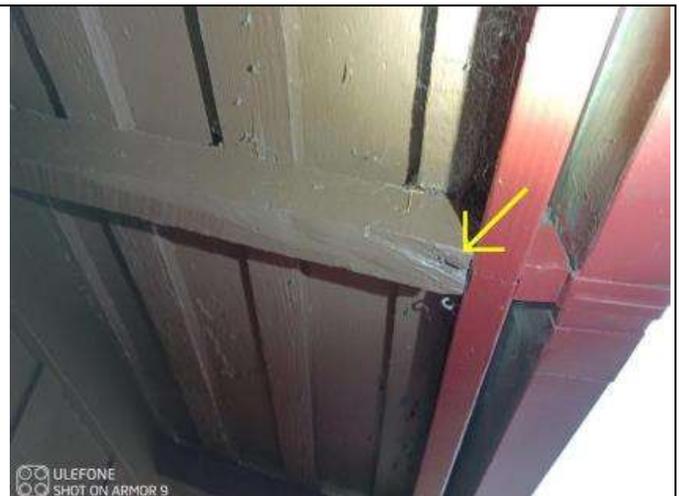
4.3 SOFIT & EAVES:

The soffit/eaves appear to be in satisfactory condition and show only signs of normal wear with at least one or two damaged rake boards.

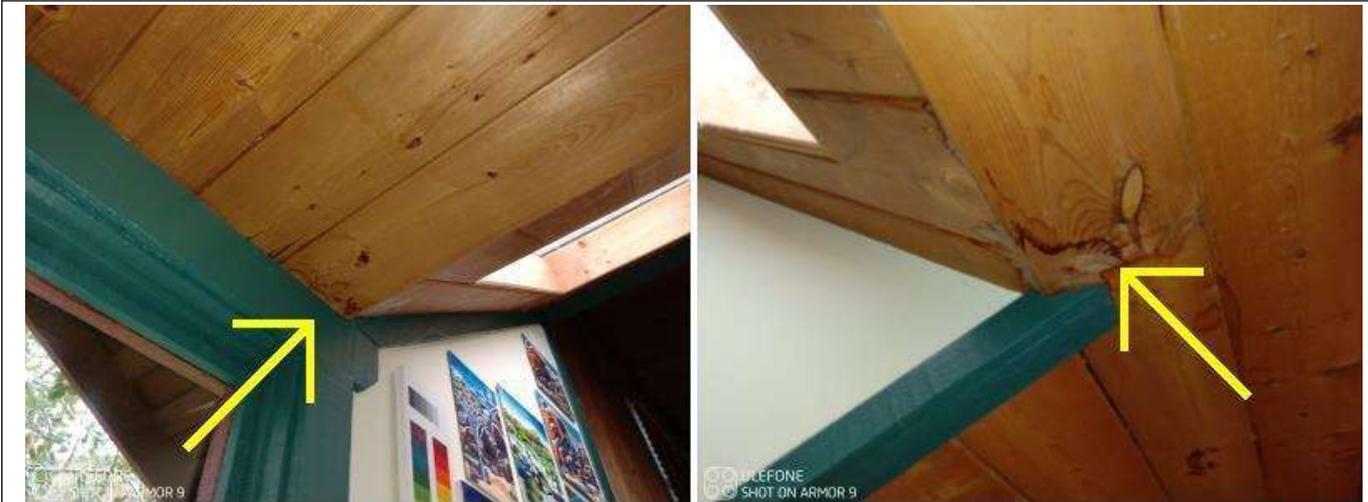
4.9 COMMENTS:

Water stains noted at ceiling around the vicinity of skylight.

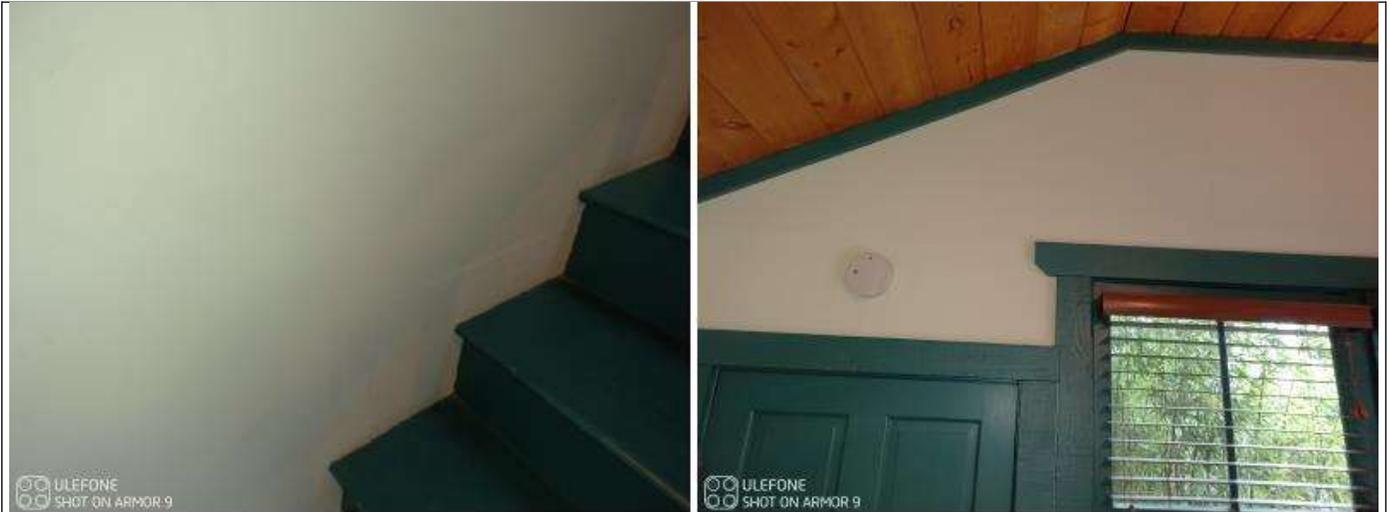
Settlement or plaster cracks noted at various locations that are indicative of structure movement.

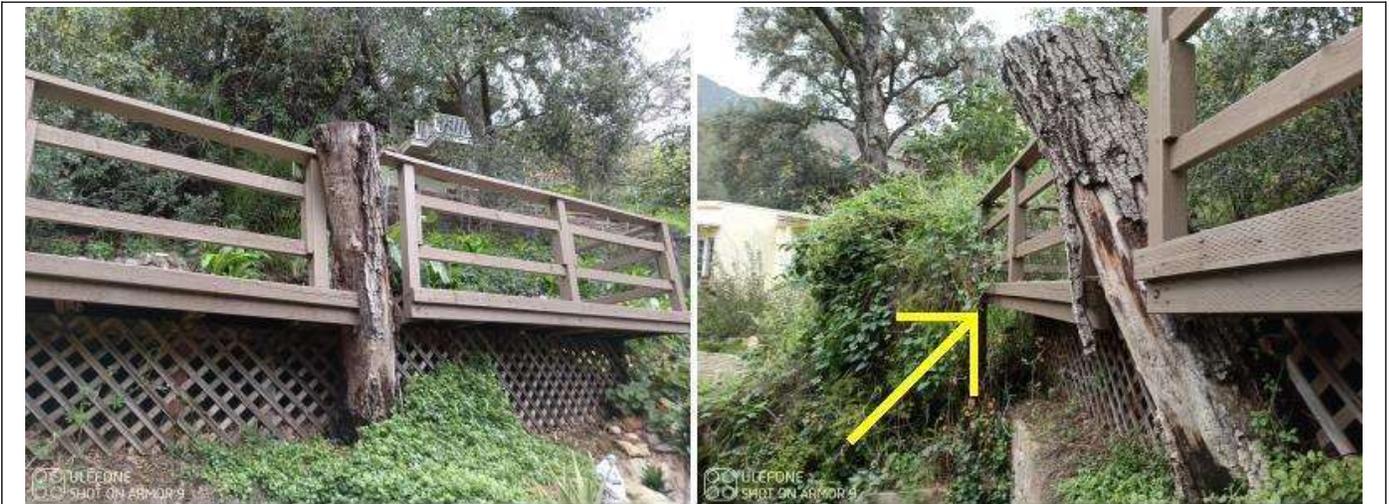
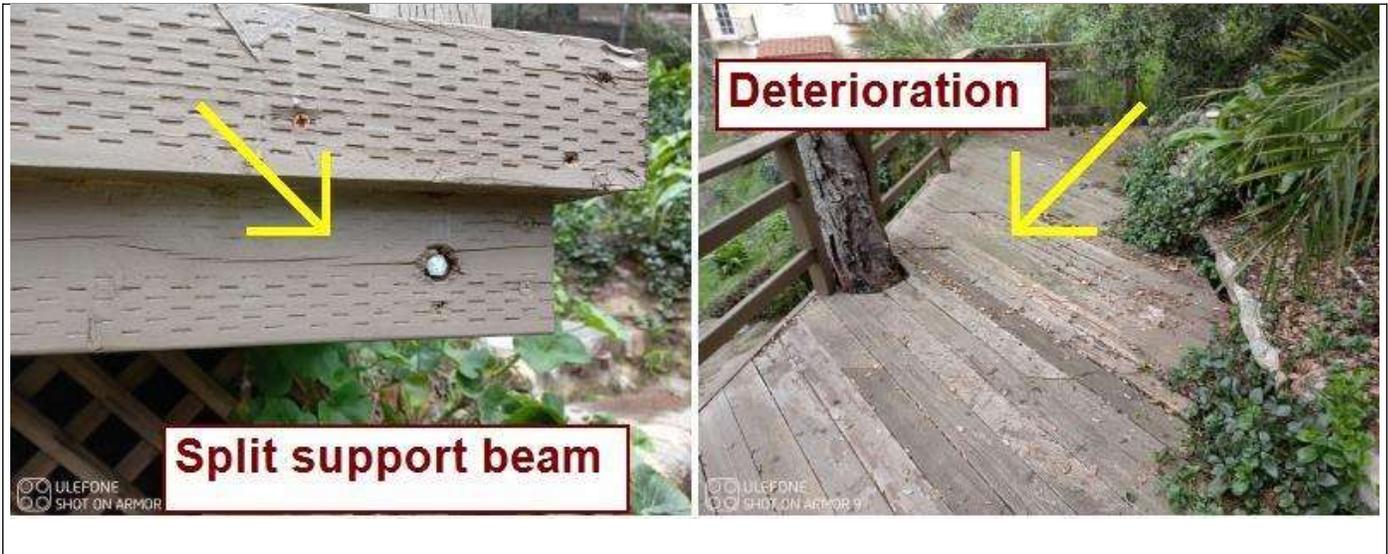
4.10 CONDITION:

General damage and deflection of uppermost decking.

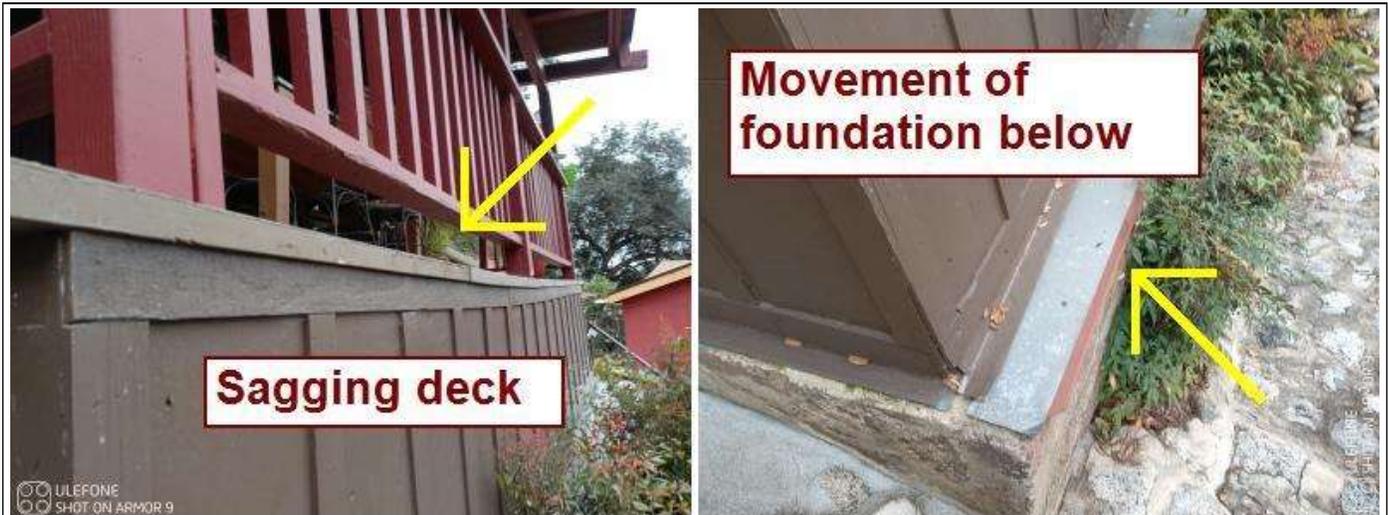
4.11 DECKS:

There are existing adverse conditions that pose safety concerns related to decking and balconies. Implications of deck deficiencies can pose safety concerns such as failures during seismic events of when in use by personnel. Immediate evaluation is needed by a qualified licensed specialist or general contractor.

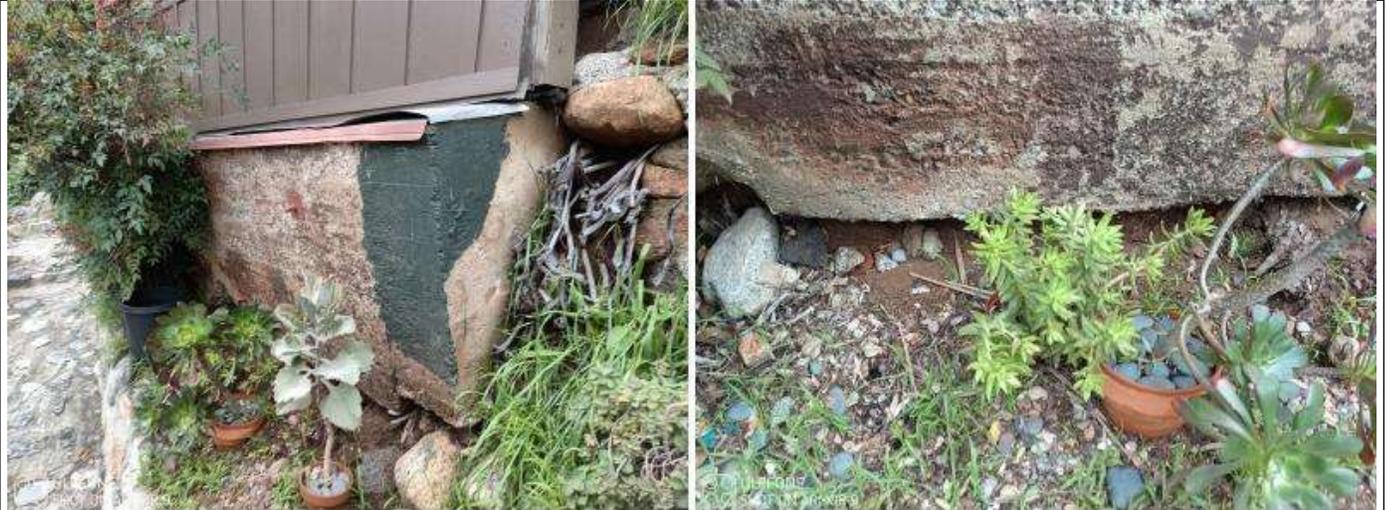
4.13 FOUNDATION FOR DECKS:

Mostly not visible however clearly some deflection can be seen that can affect stability and safe use. Fracture and lean noted at lower deck foundation.

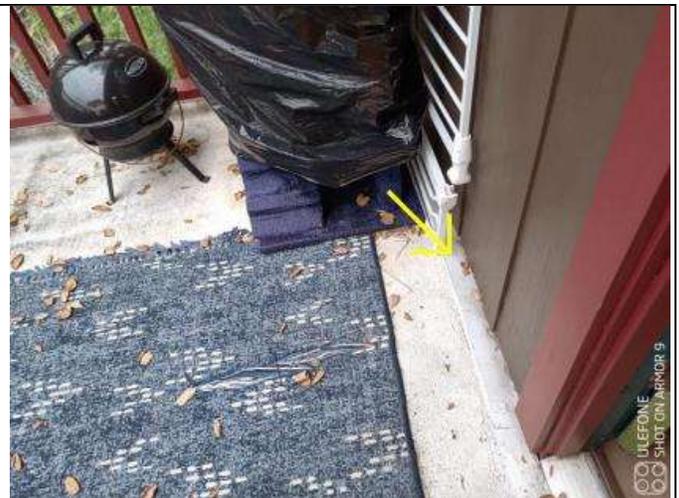
4.15 CONDITION:

Flashing where balcony deck meets house structure slopes to the home rather than away. Implications are potential for water entry into substrate.

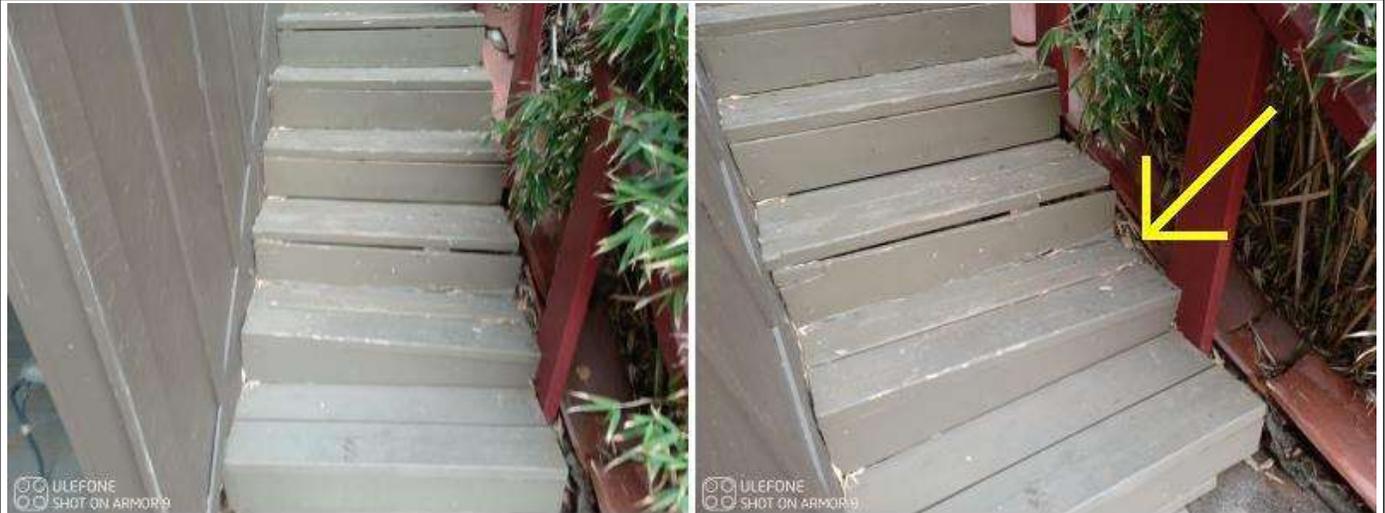
4.17 LOCATION:

Attention Needed - Damage apparent at right side main entry stairs. Some water related damage. Step risers are not of even increments and a potential trip hazard. Steps should not vary more than 3/8 of an inch from step to step.

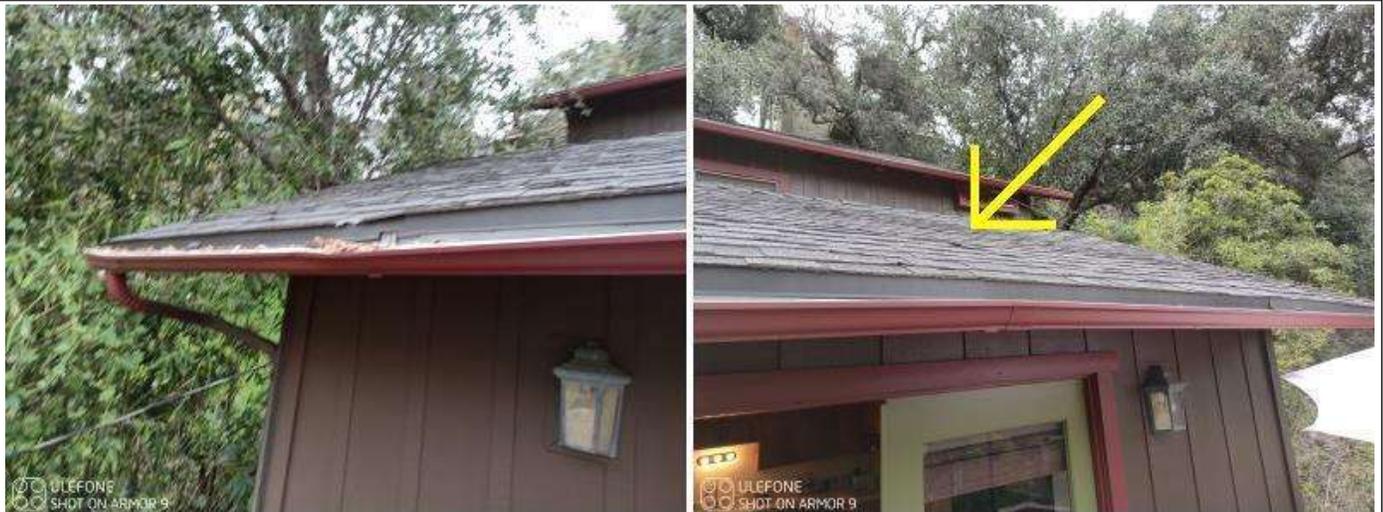
5.3 SLOPE ROOF CONDITION:

Some shingle lift in a few locations that need repair.

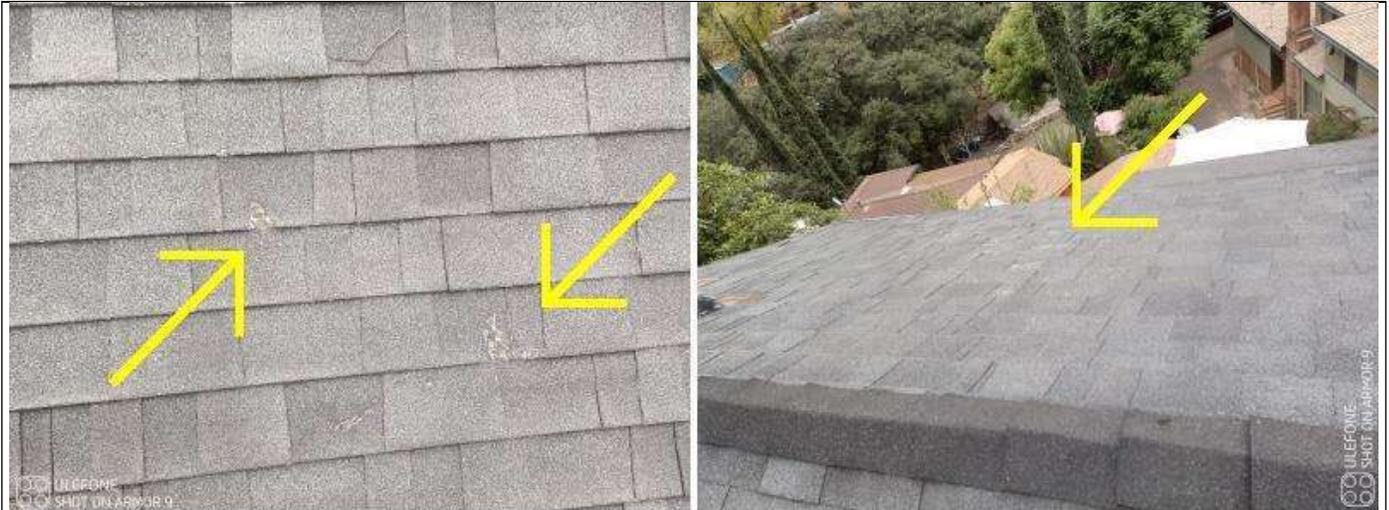
Few cracked and damaged shingles noted and granule loss at one section along front side to the degree that fiberglass substrate is exposed and no longer protected.

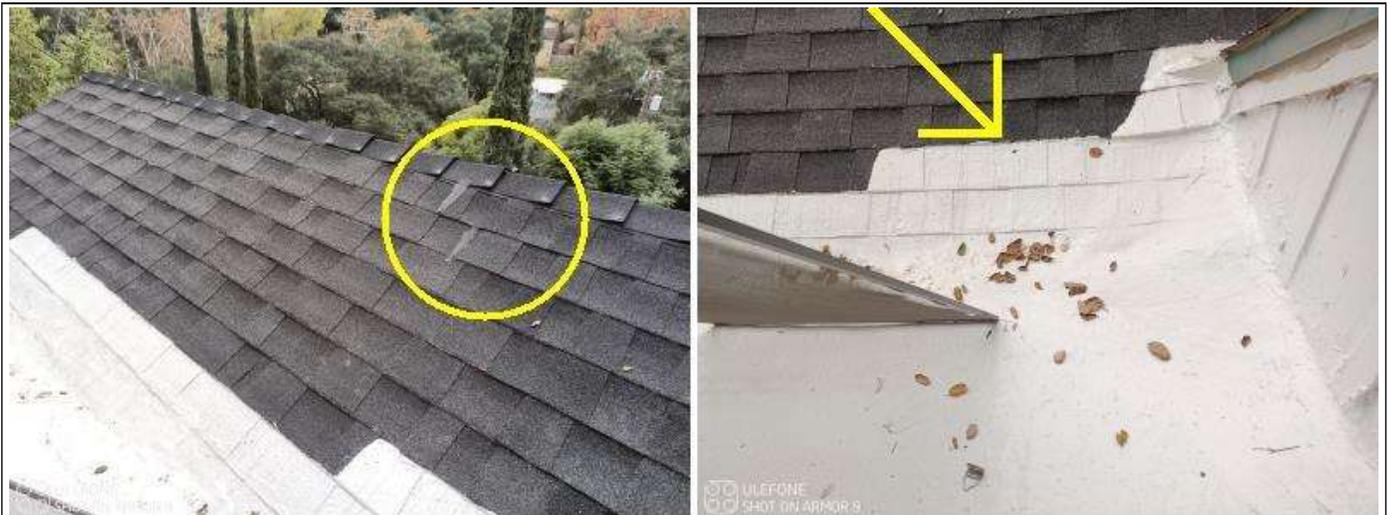
Patches were seen in general areas. Patching is evidence that there had been a problem in the past.

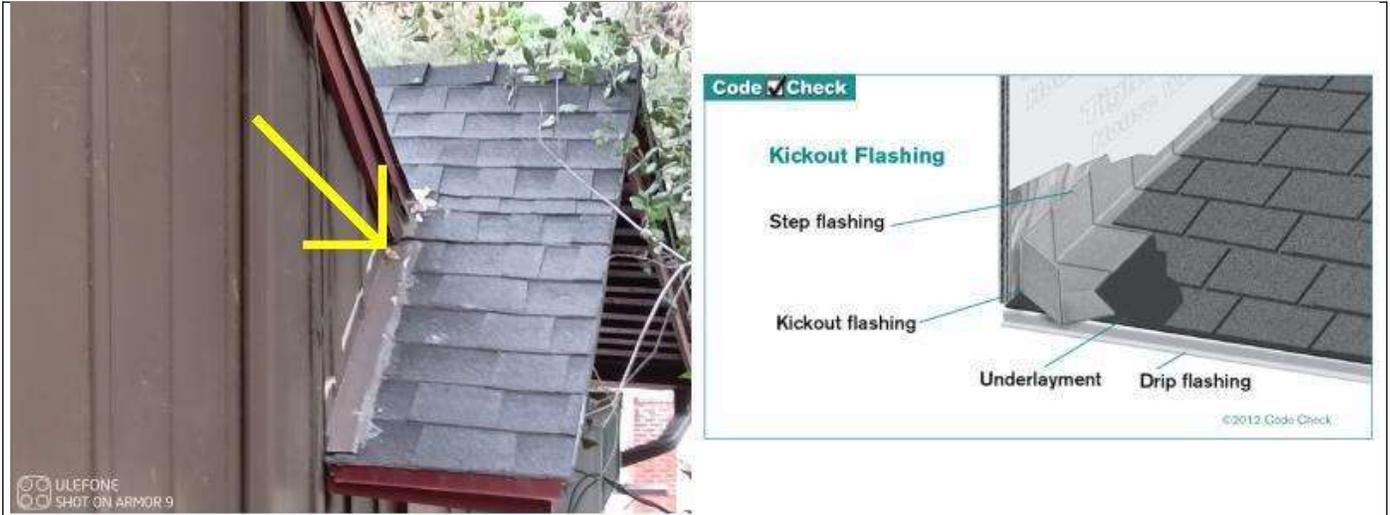
5.4 FLASHING:

Roof to wall section lacks proper step flashing and is more prone to leak as a result.

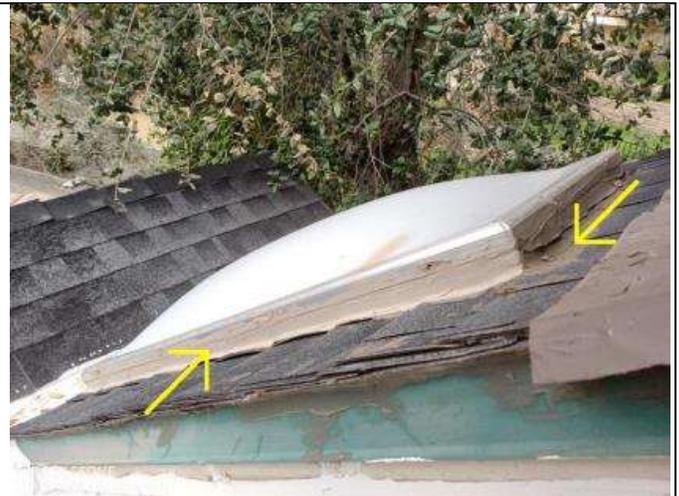
5.5 SKYLIGHTS:

Improper flashing installation. No proper step flashing installed. This will result in future leak issues unless repaired. Skylight does appear to leak.

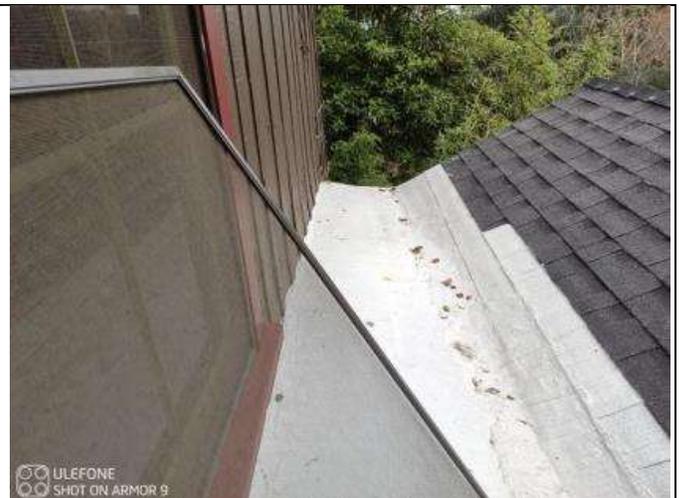
5.6 VALLEYS:

Dip at valley section can result in decay and may leak in the future. Further evaluation and repair needed.

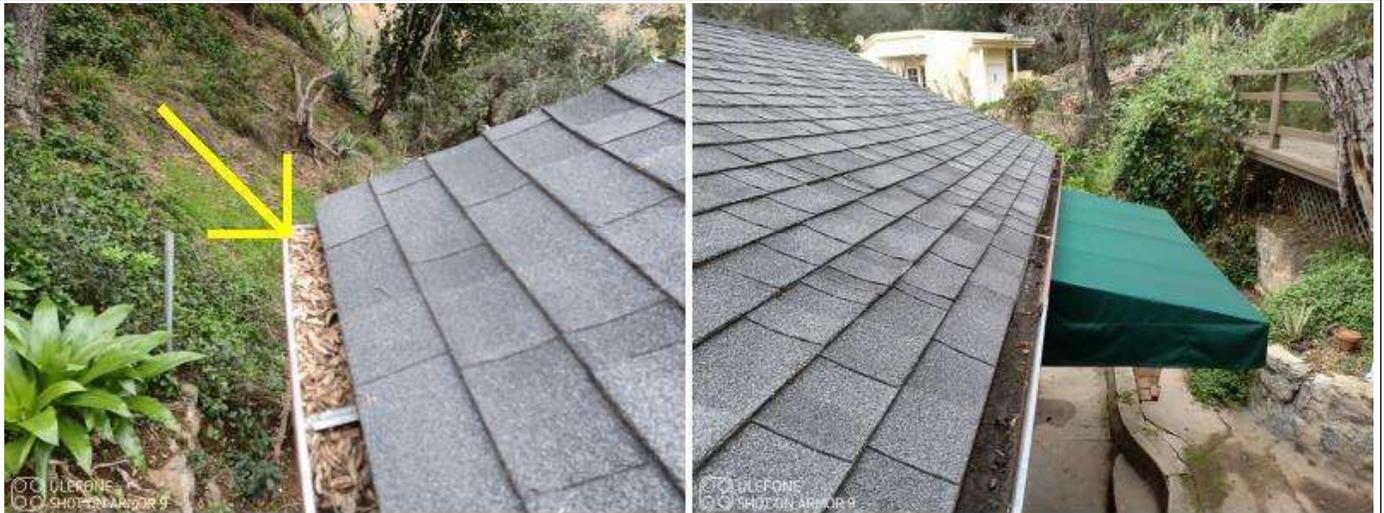
5.7 GUTTERS & DOWNSPOUTS:

Gutters are poorly sloped resulting in sections that will hold water rather than drain efficiently. Repairs needed. Contact a gutter installation agency for further evaluation and cost to replace or repair. Gutters are full of debris and in need of maintenance at this time.

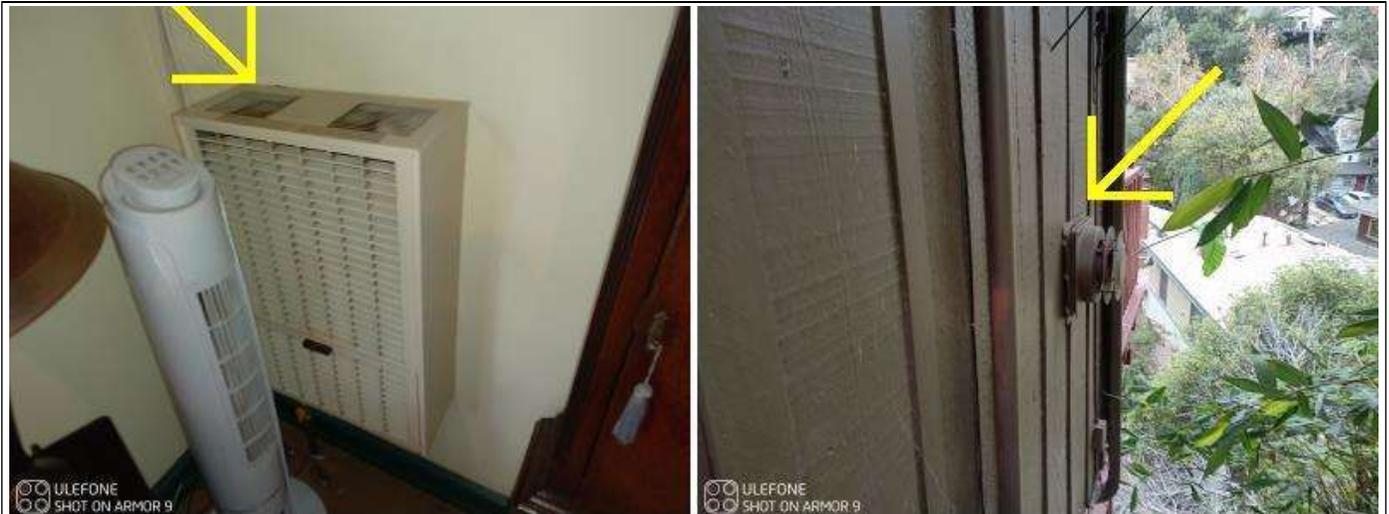
6.6 Flues, Vents, Plenum:

Attention Needed-There is evidence that gases from the wall furnace are spilling back into dwelling rather than exteriors and direct vent component not adequately sealed at exteriors to prevent water entry into unit and substrate.

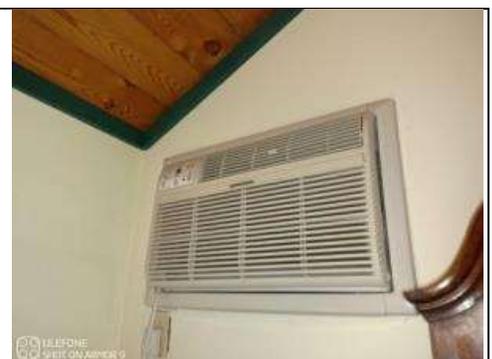
6.9 AIR CONDITIONING:

Operational however controls are out of reach. Systems are being turned off and on via Ground Fault Circuit Interrupter switches.

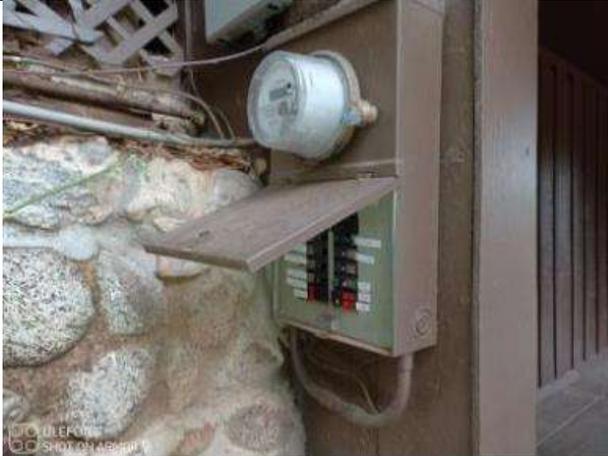
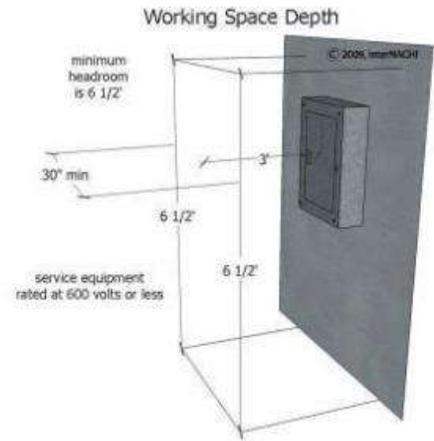
7.5 PANEL ACCESSIBLE?

The electrical panel is not in a location that makes it readily accessible as required by industry standards.

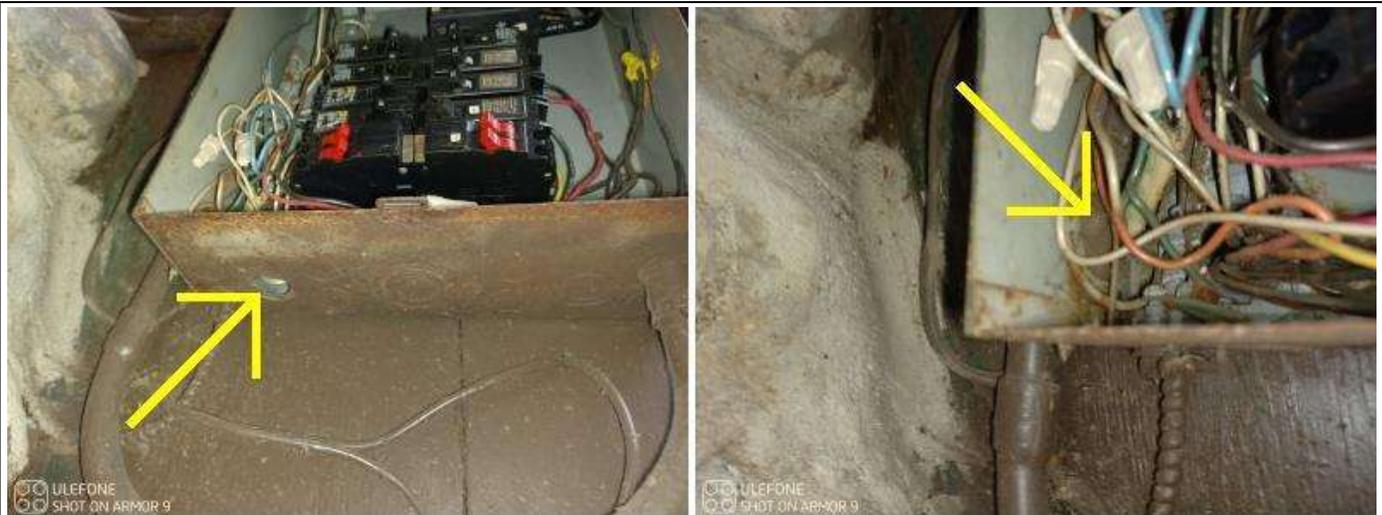
7.6 PANEL TYPE & CONDITION:

Knock out holes viewed within the main panel. All panel boxes should be sealed tight to prevent any potential for animal entry which could result in a potential fire hazard.

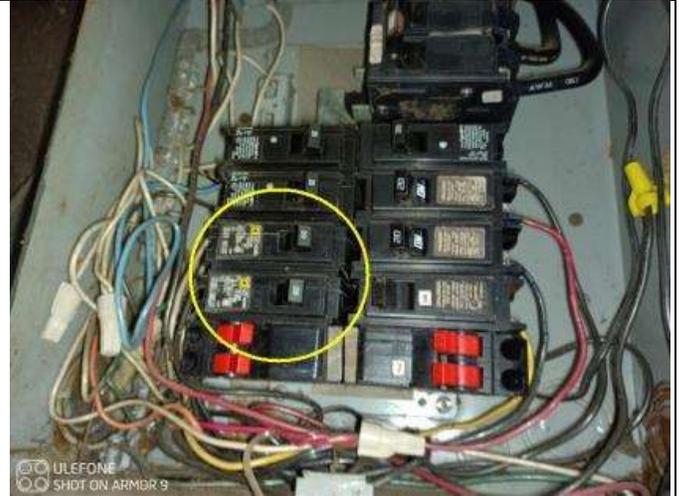
7.7 BREAKER/FUSE:

In the electrical distribution panel of at two circuit breakers were of a brand different from that of the panel. Because circuit breakers made by different manufacturers vary in design, panel manufacturers typically require that breakers manufactured by their company be used in their panels. Breakers from one manufacturer used in the panel of another manufacturer may result in poor connections that can be a potential fire or shock/electrocution hazard.

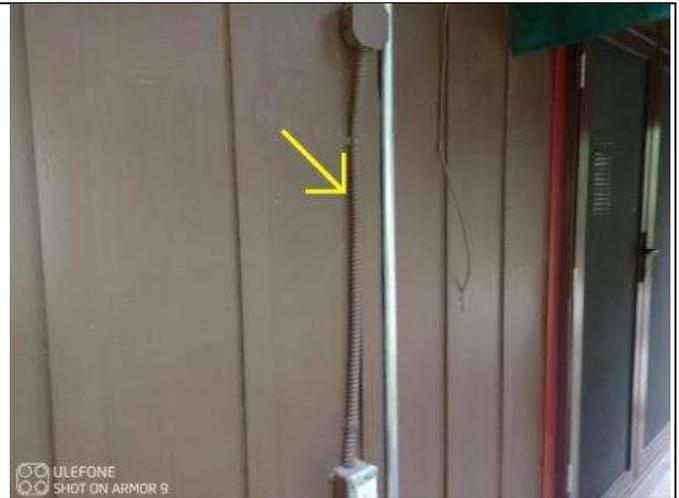
There are electrical conduits used at exteriors that are not intended for exterior use.

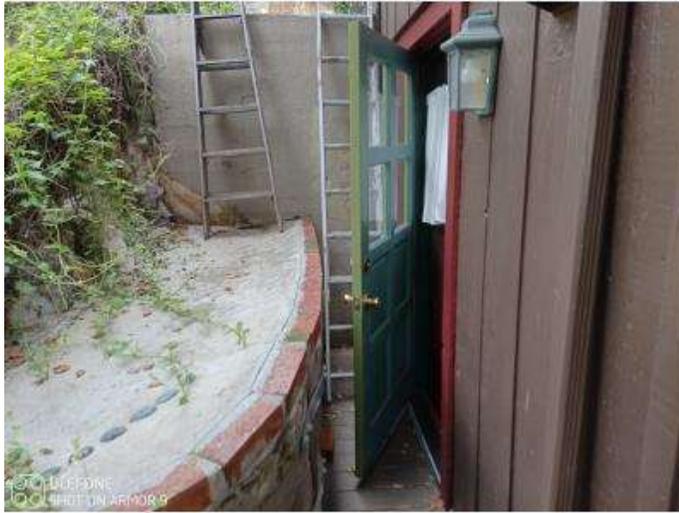
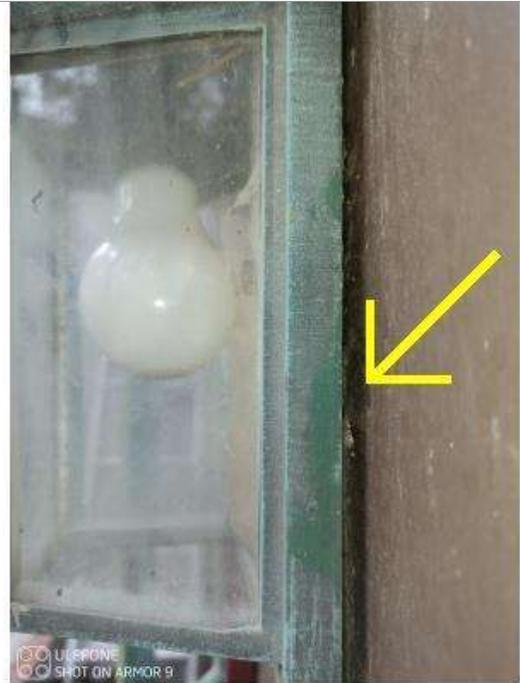
7.15 EXTERIOR ELECTRICAL:

Attention Needed- Ideally exterior light sconce covers would be sealed to prevent water entry.

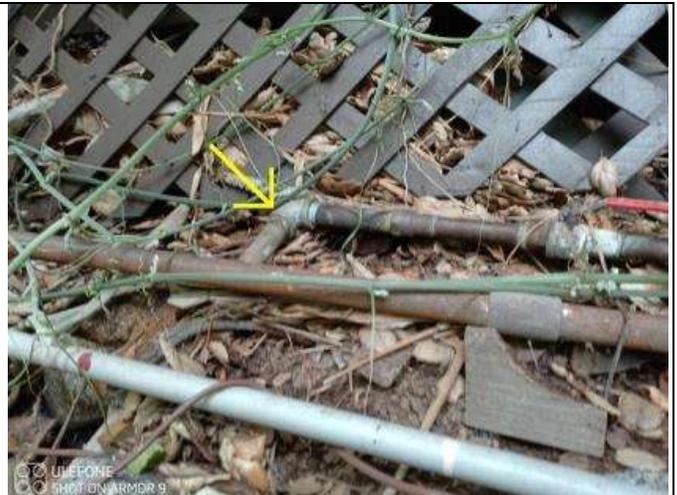
8.2 TYPE/CONDITION:

Water pipe seen is of galvanize material. Galvanize pipe has a general life expectancy of 35 to 40 years. Anticipate replacement in the hot to distant future.

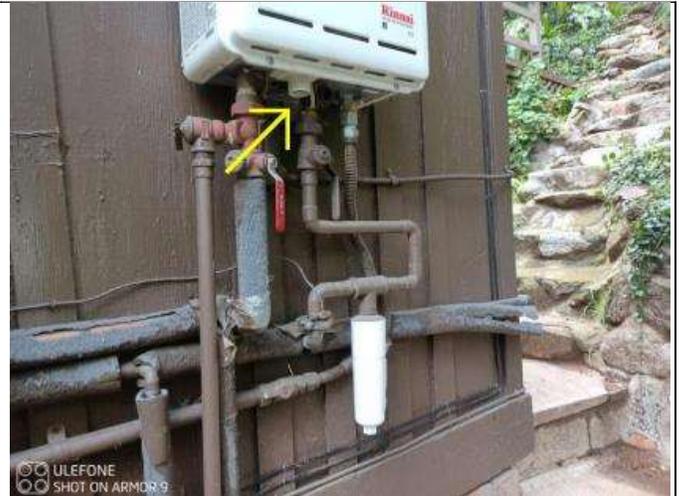
8.14 CONDITION:

Unit was working at time of inspection however condensation drain should have been installed.

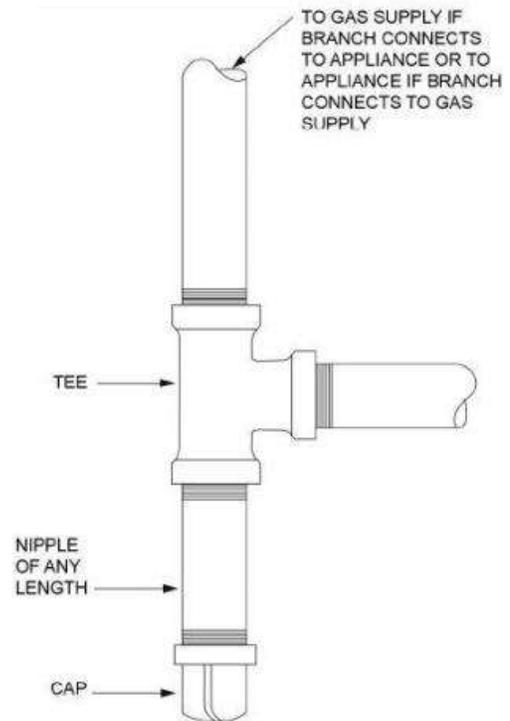
8.15 DRIP LEG?:

No drip leg or settlement trap installed per manufacturers specifications.
