Professional Commercial & Residential Inspections
8209 Foothill Boulevard, Suite A124, Sunland, CA. 91040

Confidential Inspection Report

**123 Anyplace Drive
Los Angeles, CA. 90000**

**Prepared for: Jane & John Smith
Prepared By: Robert Gaudreault**

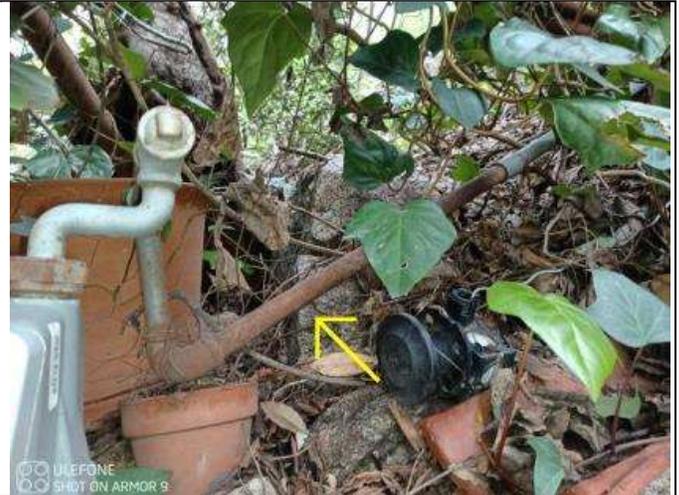
8.21 CONDITION:

Excessive rust and corrosion noted to portions of the gas line piping. Recommend that rust be cleaned off and gas pipe be painted. Gas lines should be protected from any form of damage or corrosion.

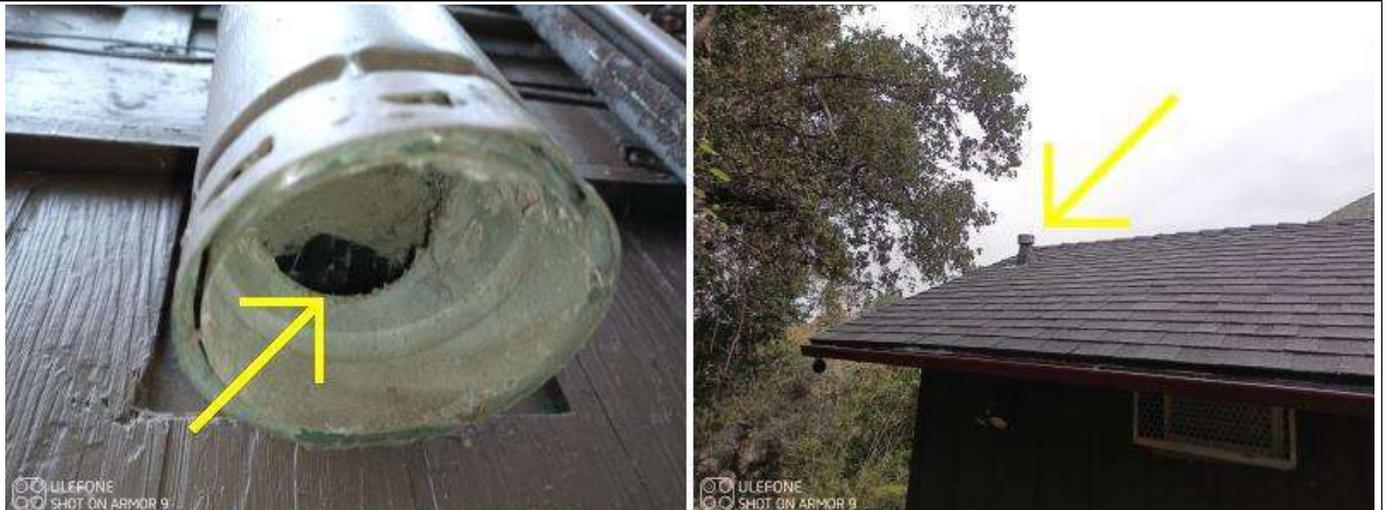
11.4 DRYER EXHAUST:

Improper termination. Vent is open at bottom end. Implications are lint back up or animal entry. Simple corrections needed.

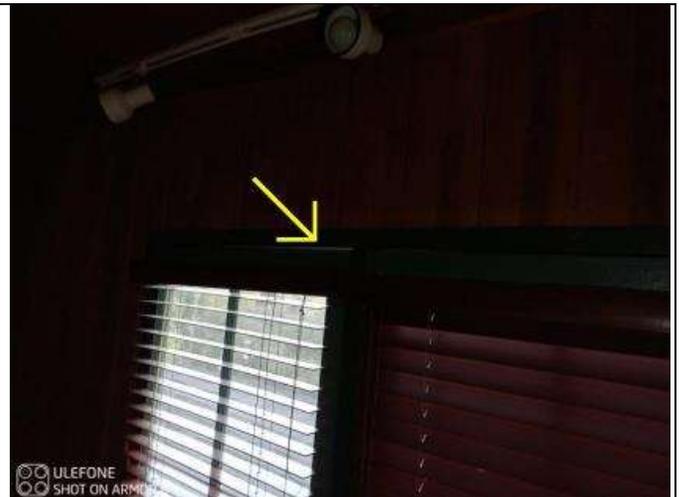
12.3 TYPE & CONDITION:

Windows are of wood casement type and operated as intended however these windows do not seal tight when closed which can affect heating and cooling efficiency.

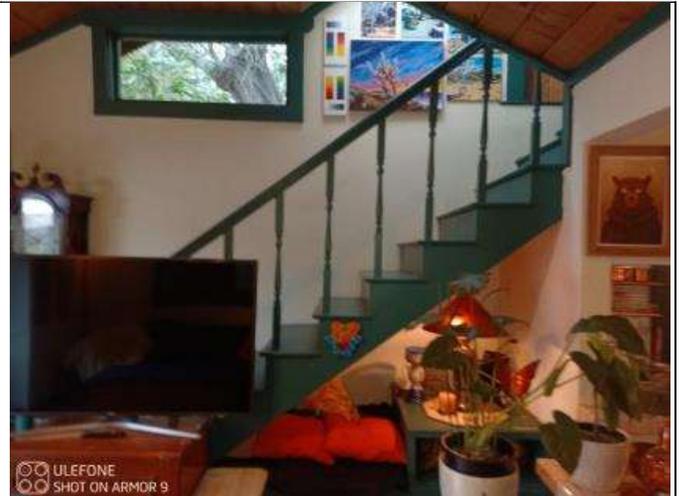
12.5 CONDITION:

Client should be aware that the spacing between rails is not to the child safety standards of 4 inches apart. Consider improvements.
