Professional Commercial & Residential Inspections

Confidential Inspection Report

4321 N. Anywhere St.
Los Angeles CA 90000
June 5, 2024

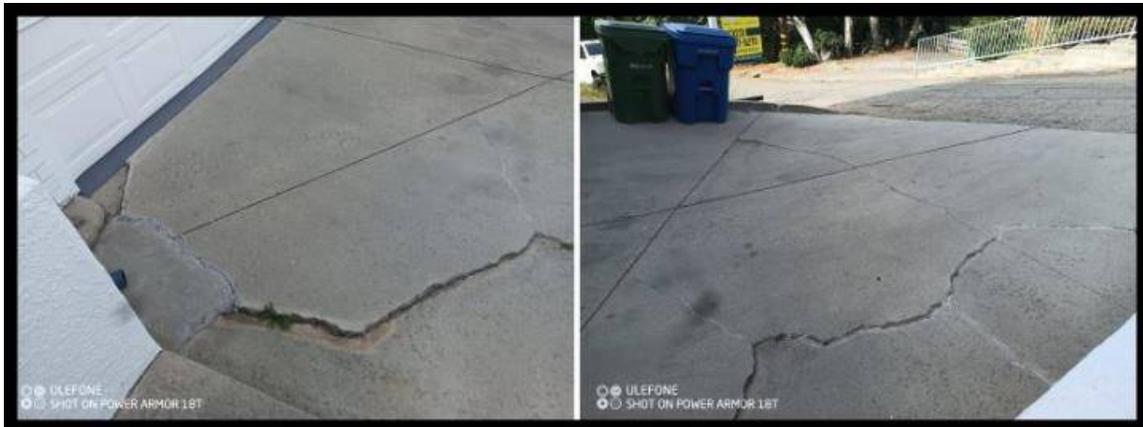
2.3 CONDITION OF PAVING:

Attention Needed - The paving area needs action. There is heaving noted in the driveway. It should be repaired to prevent further deterioration or a trip hazard.

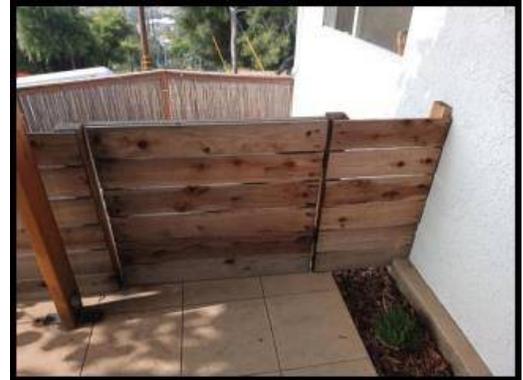
Patio gate needs some repairs. Gate does not operate well and needs adjusting.

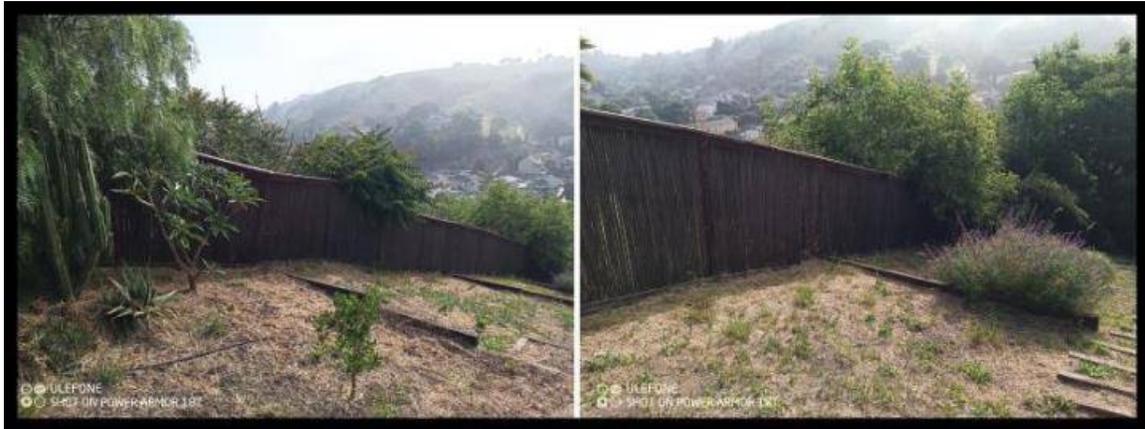
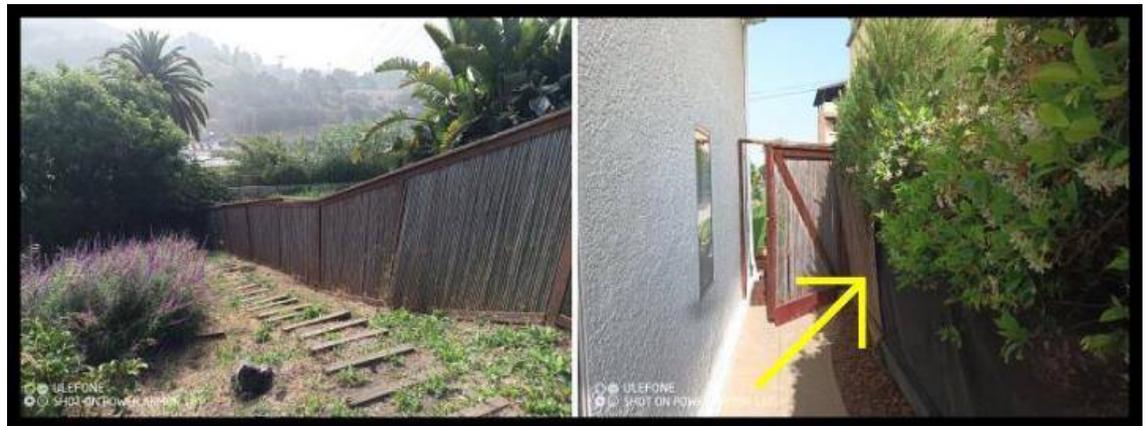
2.12 CONDITION:

2. **Attention Needed** - The fencing needs to be repaired. Some of the fencing is leaning at various locations.

Attention Needed - The fencing needs to be repaired. Some of the fencing is leaning at various locations.

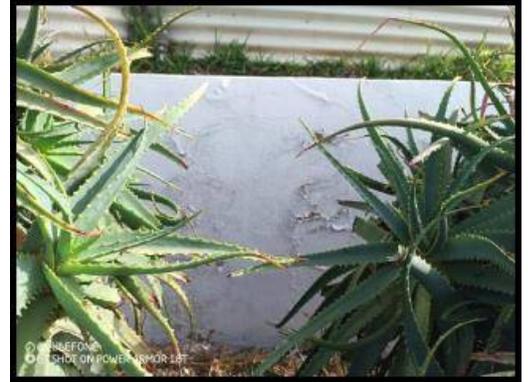
2.16 CONDITION:

Satisfactory - The retaining wall is in functional condition except paint finish is peeling at certain sections.

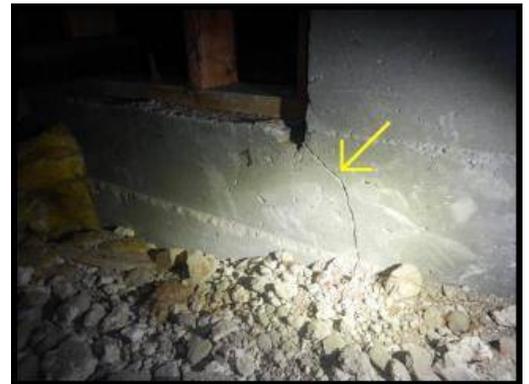
3.2 CONDITION:

The foundation is performing the job it was intended to do in supporting the structure. Crack of 1/4 inch or less were noted in the foundation walls in at least one section. This condition does not yet warrant further investigation provided the movement is not recent or does not show differential movement. If future movement is noted or the cracks grow, then further investigation by a professional structural engineer and/or a licensed qualified foundation contractor will be needed to determine the cause and course of action.

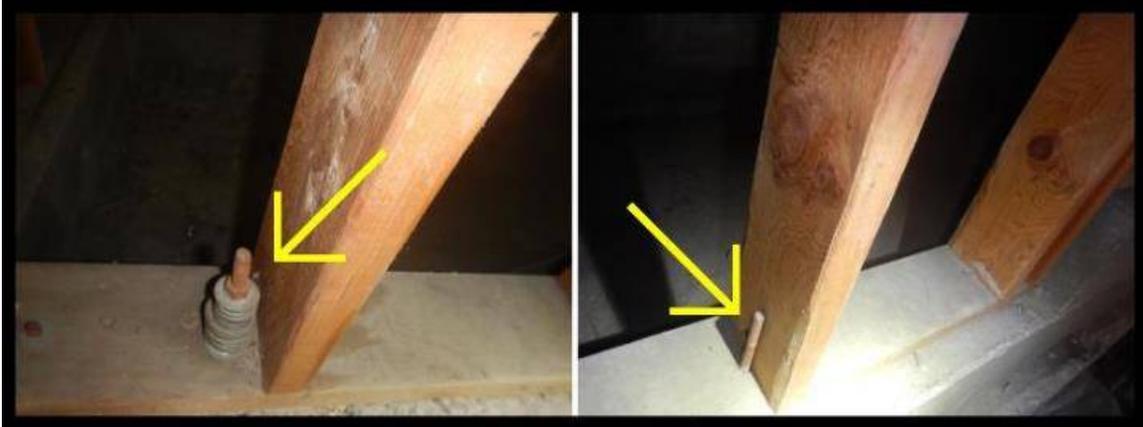
3.3 ANCHORED?

Yes - This inspection noted the presence of foundation bolts correctly used to secure the framing to the foundation. There was only a random look at these bolts or brackets, and no warranty as to their performance is given.

However some of the bolts were either too long or not embedded into the concrete enough. Some bolts also lack washer and nuts as noted in at least one section.

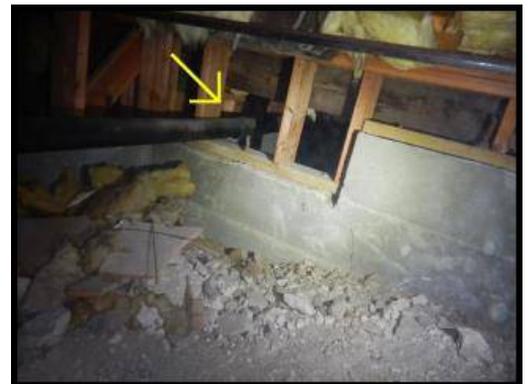
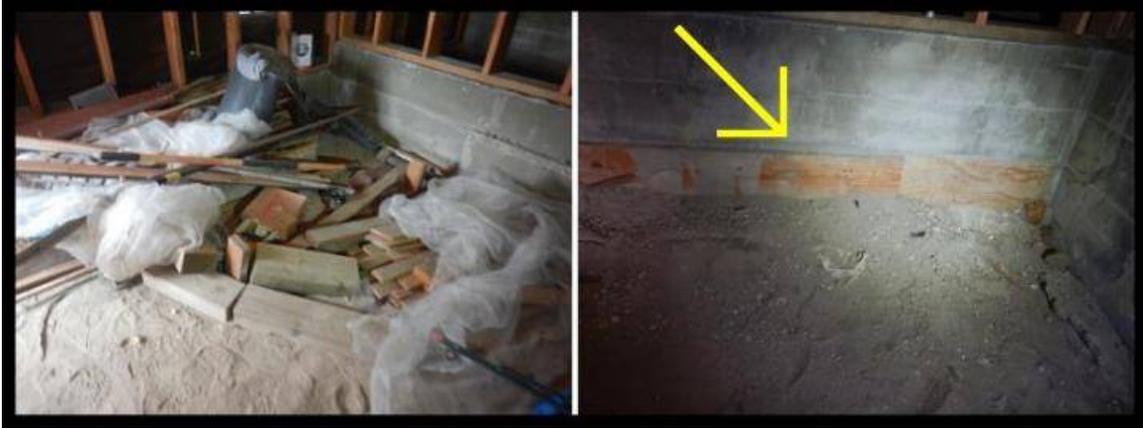
3.6 CONDITION:

1. **Attention Needed**-One section of crawl space is inaccessible due to inadequate opening or obstruction. Implications are limitations for inspections or repairs to that area. Recommend installing additional form of entrance.

Attention Needed-One section of crawl space is inaccessible due to inadequate opening or obstruction. Implications are limitations for inspections or repairs to that area. Recommend installing additional form of entrance.

Notable debris seen throughout areas of the crawl space as well as earth to wood contact. Refer to your termite inspection report for additional information.

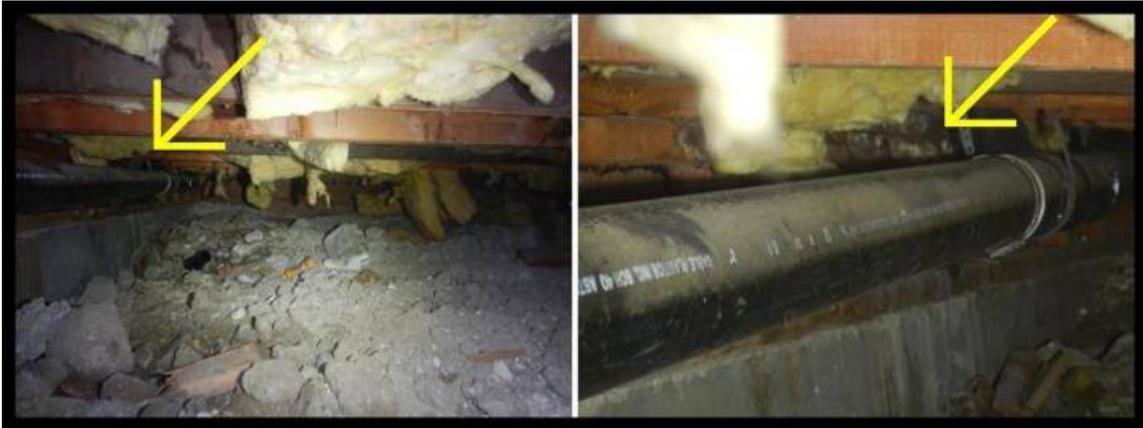
3.8 SUB FRAMING:

2. **Attention Needed**-Most of the visible framing seems satisfactory however water damage is apparent at center section of area that could not be accessed. Recommend further evaluation as there are what appears to be black stains or microbial growth which should be inspected by a qualified environmental agency.

Attention Needed-Most of the visible framing seems satisfactory however water damage is apparent at center section of area that could not be accessed. Recommend further evaluation as there are what appears to be black stains or microbial growth. It should be inspected by a qualified environmental agency.

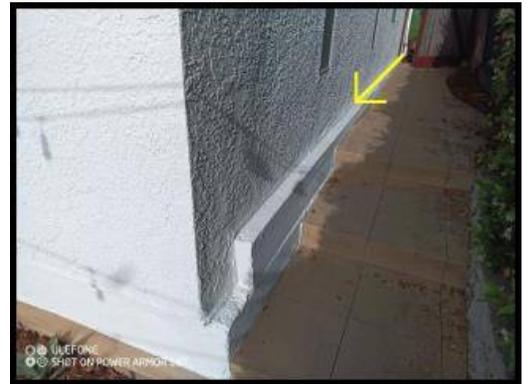
Satisfactory however there are some sections of added curb, such as along left side, that should have had counter flashing installed. Monitor and maintain as needed.

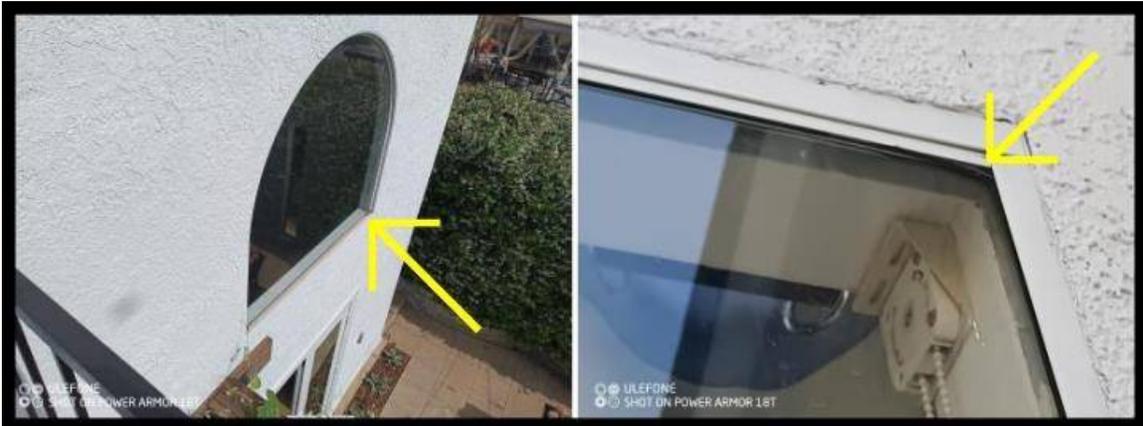
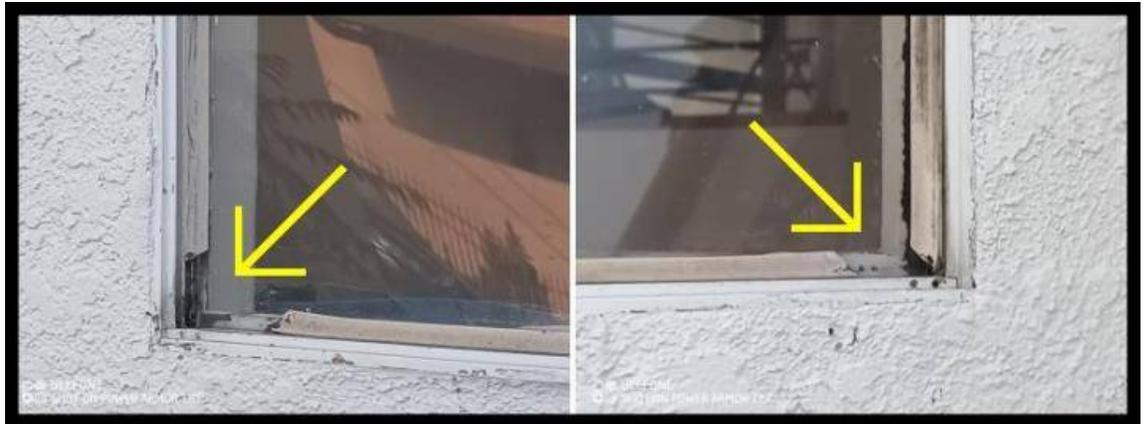
4.8 WINDOWS CONDITION:

3. **Attention Needed** - Window functional for the most part though aged. Gasket damaged and/or displacement to some windows. Anticipate future upgrades. In the mean time caulking is recommended to ensure weathertightness until such time that upgrades are achieved.

Attention Needed - Window functional for the most part though aged. Gasket damage and displacement noted to some. Anticipate future upgrades. In the mean time caulking is recommended to ensure weathertightness until such time that upgrades are achieved.

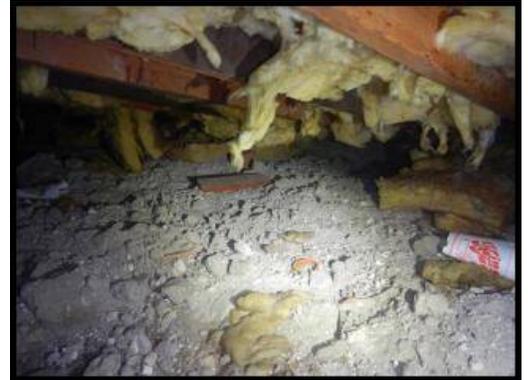
Repairs or corrections are needed, such as crawl space at inaccessible location, there are portions of the insulation that are falling away from the sub floor.

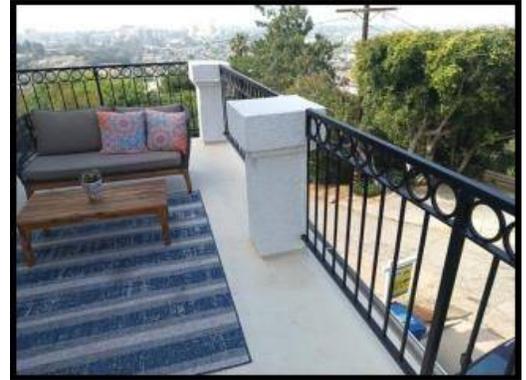
4. **Unsatisfactory**- Railings are loose and a potential hazard. Immediate evaluation and repairs are needed by a licensed contractor.

Unsatisfactory- Railings are loose and a potential hazard. Immediate evaluation and repairs are needed by a licensed contractor.

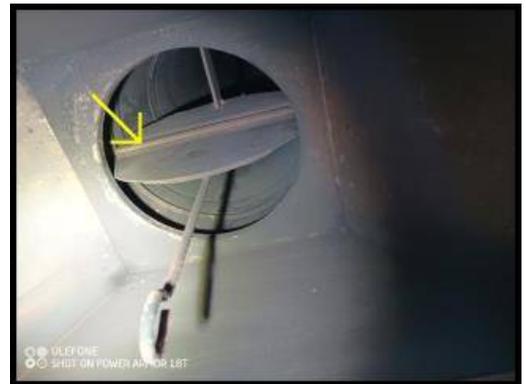
4.19 DAMPER CONDITION:

Attention Needed - There is no damper clip installed. All fireplaces with a gas connection should have a clip installed that will allow a small airflow up the chimney.

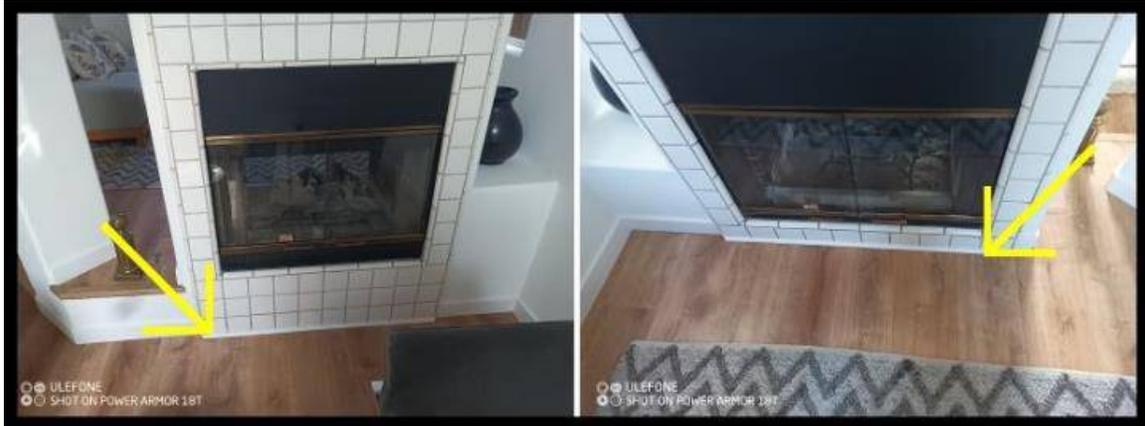
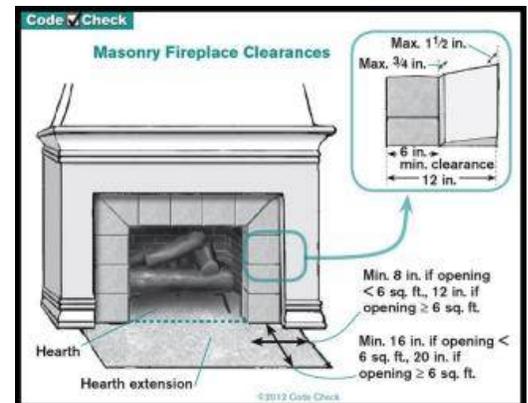
4.23 HEARTH CONDITION:

Attention Needed- There is no hearth extending in front of the firebox at either side.

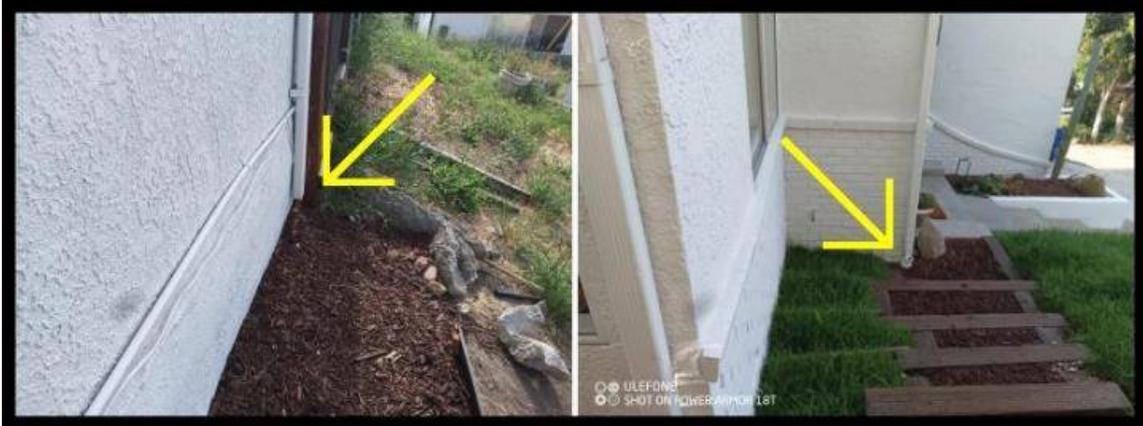
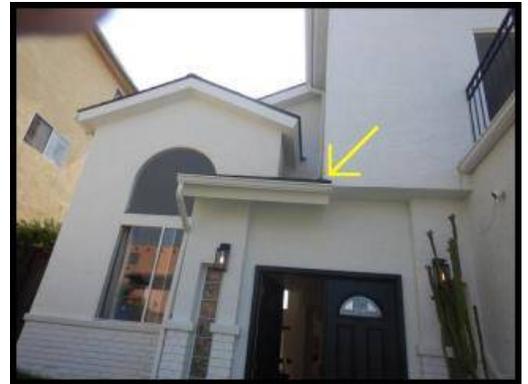
5.7 GUTTERS & DOWNSPOUTS:

Attention Needed- Extend down spouts further away from the foundation to reduce potential settlement of the structure. Inadequate slope noted at front gutter over entry. Corrections needed to ensure water sheds to drain.

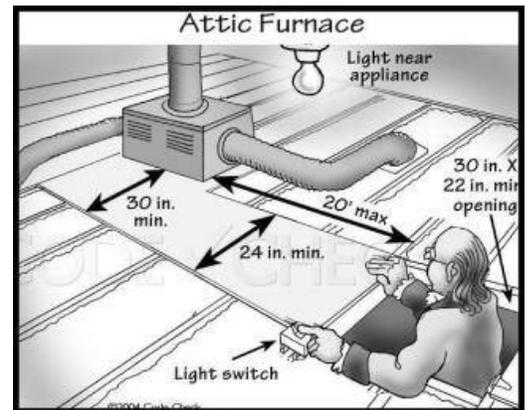
Attic. Unit lacks adequate working platform along the front to prevent any potential damage to ceiling when being serviced and source of illumination should be located near attic scuttle.

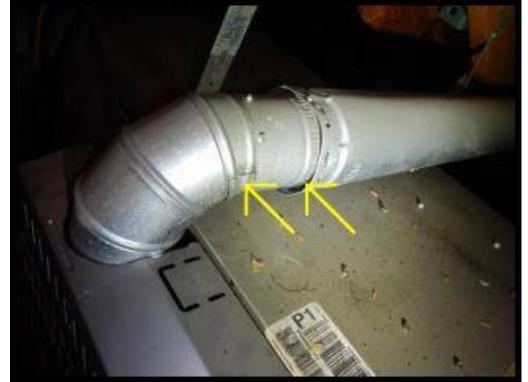
Attention Needed- Improvements needed at vent connectors from single wall vent pipe to double wall B vent pipe with the use of approved tape. Current installation could allow gases to emit into attic space and potentially dwelling.

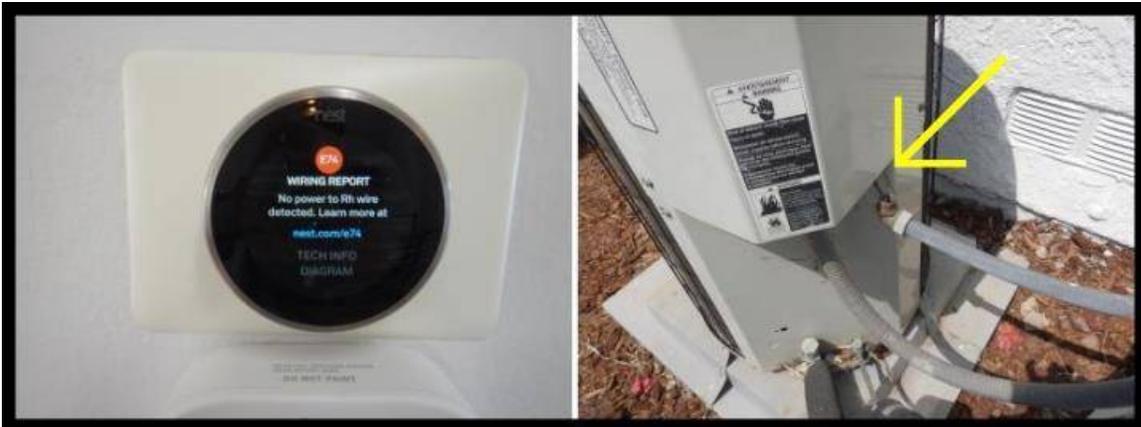
6.9 Thermostat condition:

1. **Attention Needed** - Thermostat controls need repair. Thermostat is indicating an error. Further evaluation and correction needed. Conduit near condenser has come apart from the unit.

Attention Needed - Thermostat controls need minor adjustment. Thermostat is indicating an error. Further evaluation and correction needed. Conduit near condenser has come apart from the unit.

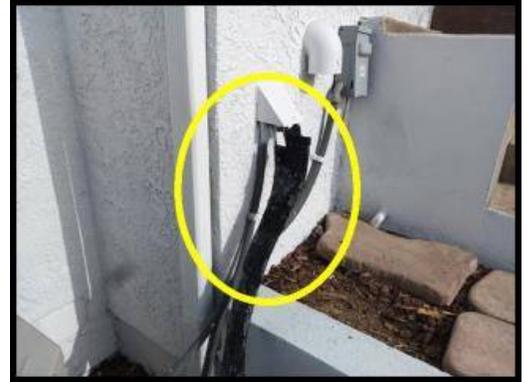
The insulation wrap for the suction line to the condenser/compressor is damaged and needs replacement. This condition affects the efficiency of the cooling system.

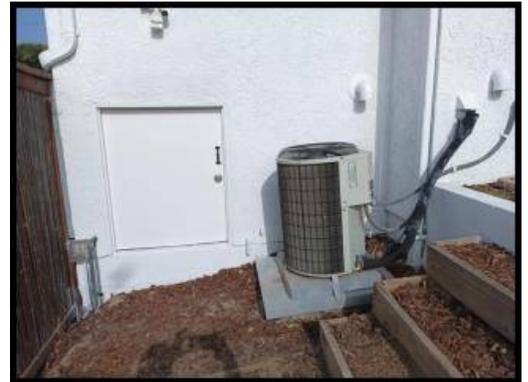
6.13 Placement of condenser:

Attention Needed- The condenser pad should be solid and within 5-10 degrees of level. The current condition does not allow stability and may prohibit adequate lubrication. Action is recommended before continued use.

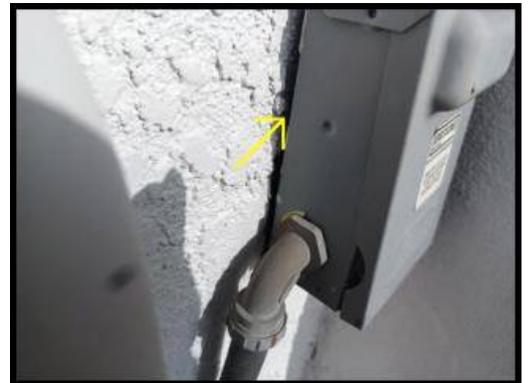
6.14 Service disconnect:

Attention Needed- Back of service disconnect where it meets the wall should be caulked to prevent water entry into substrate.

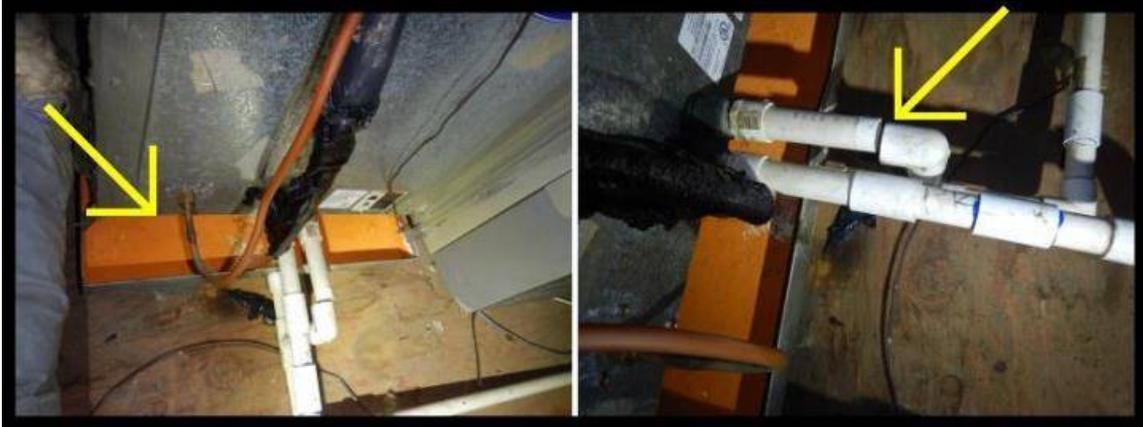
6.15 Condensation drain:

2. **Unsatisfactory**-Condensation drain has come apart. Sheet metal pan is also full of rust denoting prior back up causing condensation water to collect into pan. Location of secondary drain termination could not be located. Implications are potential for condensation to spill onto attic ceiling posing water damage.

Unsatisfactory-Condensation drain has come apart. Sheet metal pan is also full of rust denoting prior back up causing condensation water to collect into pan. Location of secondary drain termination could not be located. Implications are potential for condensation to spill onto attic ceiling posing water damage.

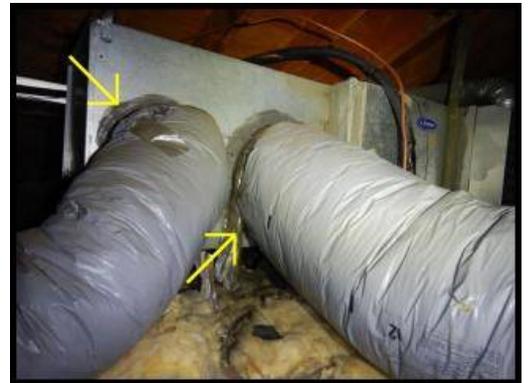
Attention Needed - Inadequate seal where ducts leave air plenum. Repairs needed to improve efficient use.

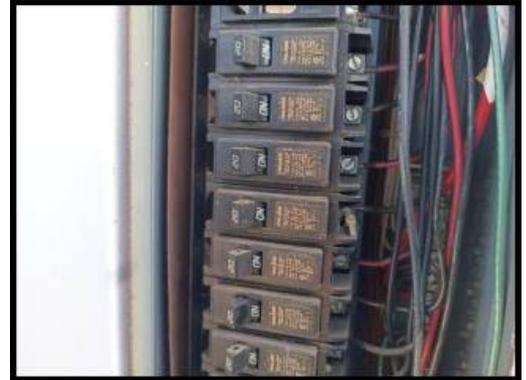
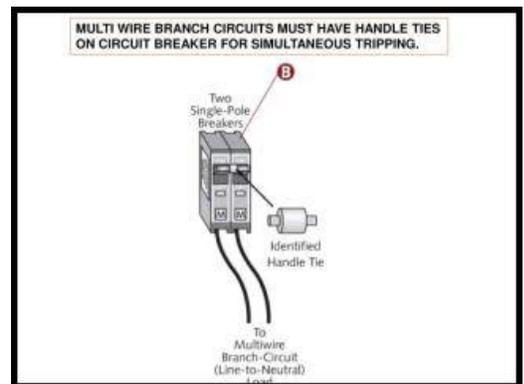
Attention Needed- Breakers for multi branch circuits seen that are without handle ties. Multi branch wiring is where there are two hot conductors that share the same neutral. Where two or more branch circuits supply devices or equipment on the same yoke or mounting strap, a means to simultaneously disconnect the ungrounded supply conductors shall be provided at the point at which the branch circuits originate.

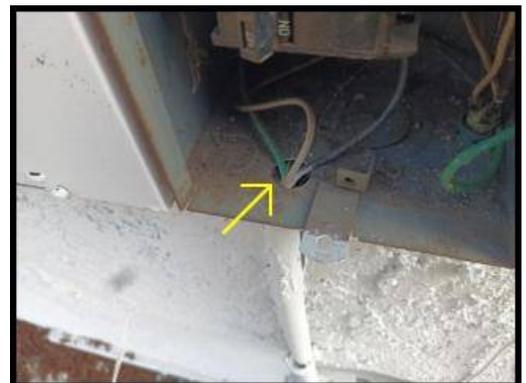
2. **Action Necessary** - Electrical circuitry wiring in the power panel shows a condition that calls for repair. Wiring enters base of enclosure without the use of a metal conduit clamp. Implications are potential for damage. Have electrician conduct repairs.

Action Necessary - Electrical circuitry wiring in the power panel shows some condition that calls for repairs. Wiring enters base of enclosure without the use of a metal conduit clamp. Implications are potential for damage. Have electrician conduct repairs.

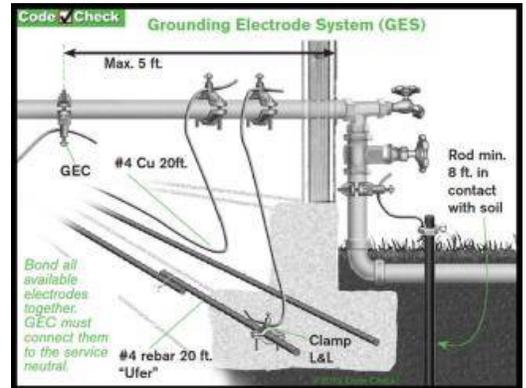
7.10 GROUNDING:

Attention Needed - The ground wire attached to the water pipe is on the house side of the meter. There is no jumper installed to allow the removal of the meter and yet allow the electrical ground to be intact. A jumper is needed.

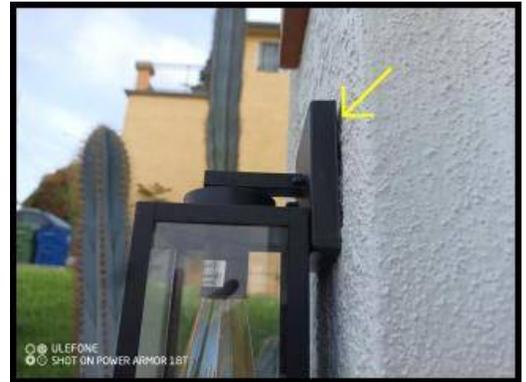
Ideally exterior light sconce covers would be sealed to prevent water entry.

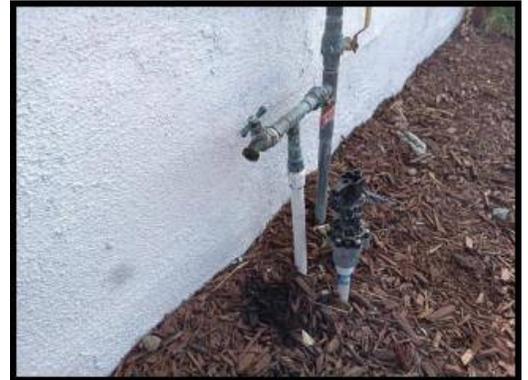
1. **Attention Needed** - Continuous drip is noted to one of the exterior hose bibs.

Attention Needed - Continuous drip is noted to one of the exterior hose bibs.

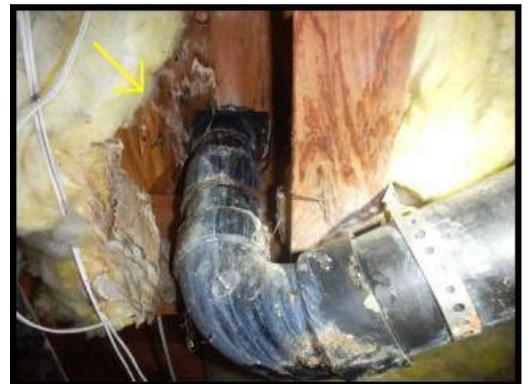
2. **Attention Needed**-There is evidence of prior leak from water closet bend of lower 1/2 bath toilet. There was no leak observed during inspection however fitting may be prone to failure. Have plumber examine to ensure integrity of flange and fittings are in good repair.

Attention Needed-There is evidence of prior leak from water closet bend of lower 1/2 bath toilet. There was no leak observed during inspection however fitting may be prone to failure. Have plumber examine to ensure integrity of flange and fittings are in good repair.

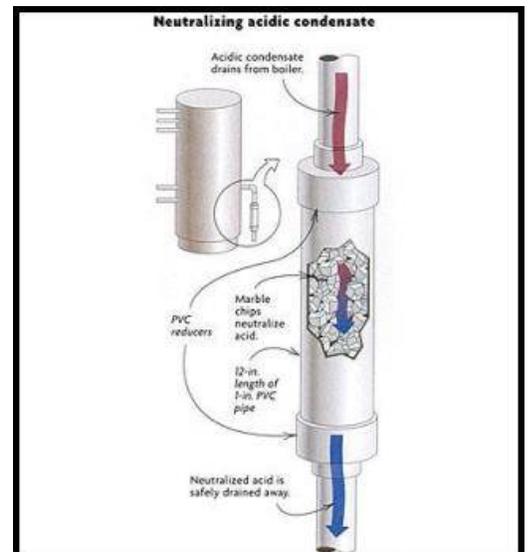
Unit was working at time of inspection. However filter missing from condensation discharge drain of this tankless water heater. Condensate neutralizers are crucial for treating acidic condensate from high-efficiency heating appliances. Without a neutralizer, condensate has the potential to corrode a building's foundation, floors, and drainage system. Properly installing a neutralizer is fundamental.

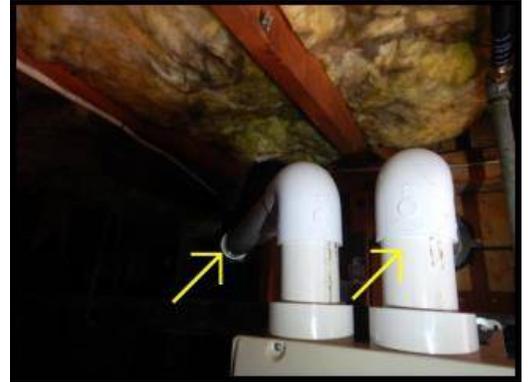
Attention Needed - PVC flue pipe fittings lack primer as part of the adhesive. Immediate repairs needed as this can affect bonding of joints. Implications are fittings which could come apart allowing gases to leak into living space. Per the manufacturers instructions all joints must be properly cleaned, primed, and cemented. Use only cement and primer

Attention Needed - PVC flue pipe fittings lack primer as part of the adhesive process. Immediate repairs needed as this can affect bonding of joints. Implications are fittings which could come apart allowing gases to leak into living space. Per the manufacturers instructions all joints must be properly cleaned, primed, and cemented. Use only cement and primer

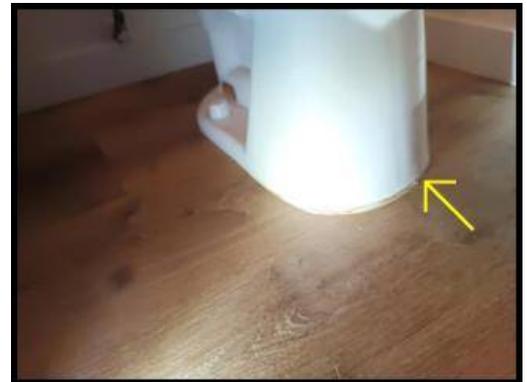
Base of the toilet should be caulked. The base of a toilet should be caulked, according to the International Plumbing Code and the International Residential Code. Caulking the toilet to the floor helps to create safety and provide sanitary protection. It's also generally recommended to caulk or seal the bottom of the toilet if there is a gap between the toilet and the floor. Refer to plumbing section as relates to water closet drain.

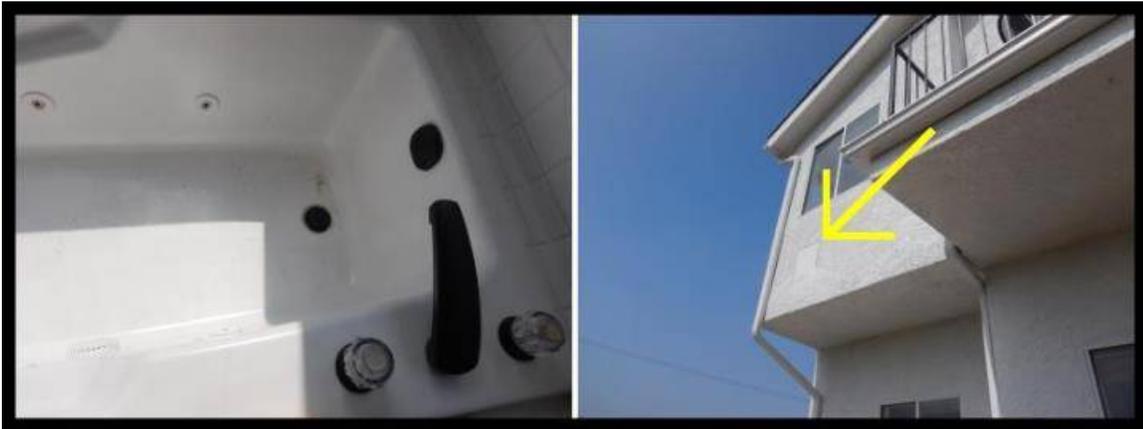
9.26 JET TUB:

3. **Attention Needed**- Contaminated water filled the tub when unit was put into operation. This dirty water more than likely comes from the jet tubs from previous baths. These tubes are not draining adequately resulting in an unsanitary condition. An online search can recommend methods of maintenance to solve this problem.

Attention Needed- Contaminated water filled the tub when unit was put into operation. This dirty water more than likely comes from the jet tubs from previous baths. These tubes are not draining adequately resulting in an unsanitary condition. An online search can recommend methods of maintenance to solve this problem.

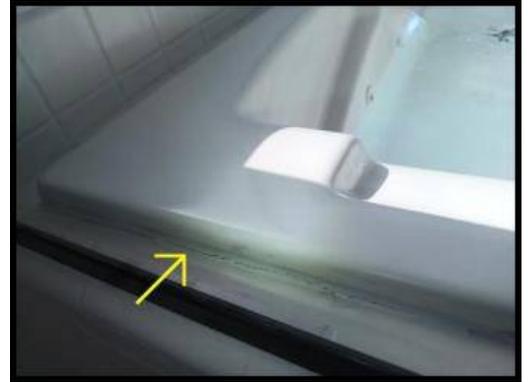
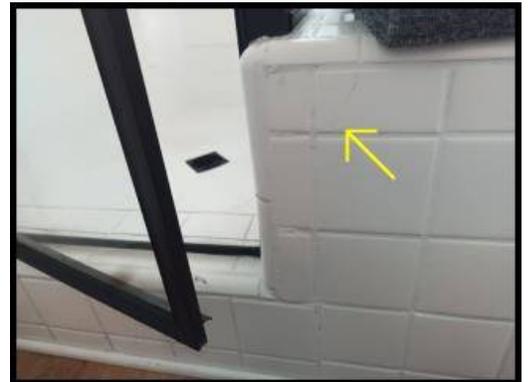
Attention Needed - Seal along where tub meets wall tile is in poor repair. Improvements are needed at this time. Some cracked tile also noted at wall between shower and tub.

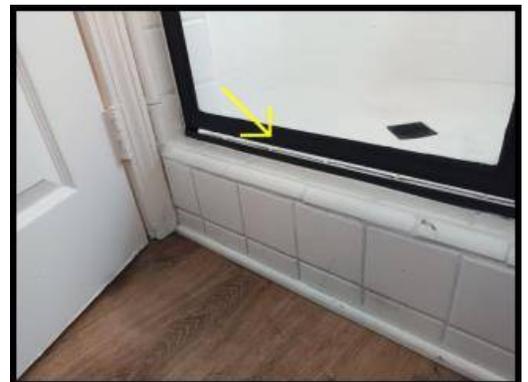
9.29 ENCLOSURE:

Attention Needed-Recommend weather stripping be installed at base of enclosure to prevent water from running off onto the adjacent wall and floor.

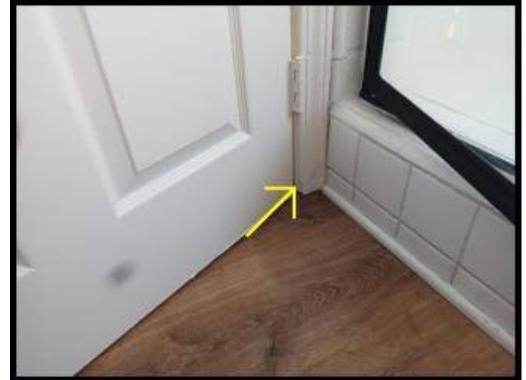
9.30 WALLS/CEILINGS:

Attention Needed -Signs of previous water related damage seen at wall adjacent to shower stall.

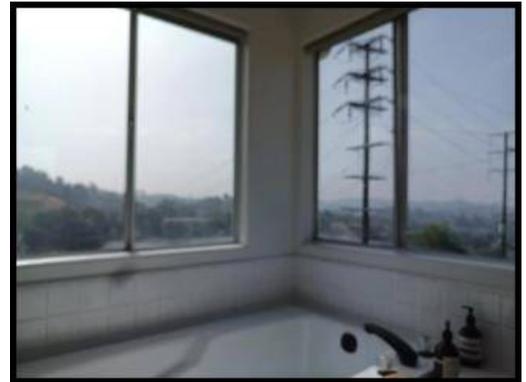
9.31 WINDOW(S):

Attention Needed - The window adjacent to tub area does not appear to be of tempered glass. Contact a glazing company for further evaluation and corrections. South facing window would not close all the way.

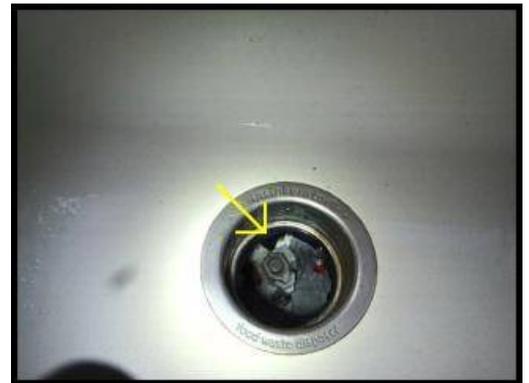
Attention Needed-Rubber strainer is missing from sink drain. These can be purchased as an after market component from a well stocked hardware store.

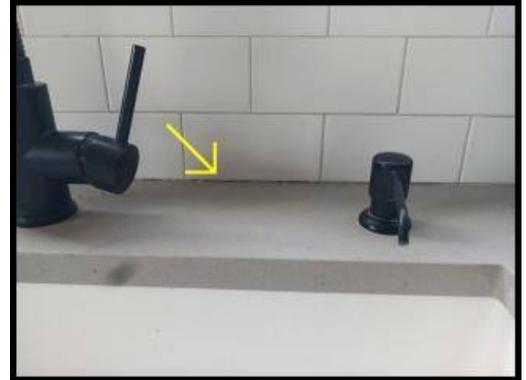
10.4 CAULKING:

Attention Needed- The caulking in water contact areas appears to need attention, such as along where countertop meets splash wall. If left unsealed, water can cause costly damage.

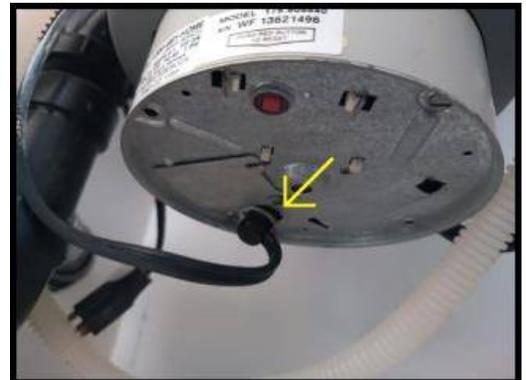
Unsatisfactory- Electrical wiring to power component is in an unsafe condition. Unit is noisy while in operation. Possible bad bearings.

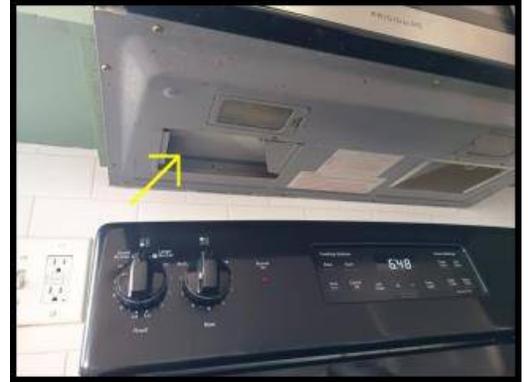
Screen missing from vent hood base. The exhaust hood is a filter and recirculation type.

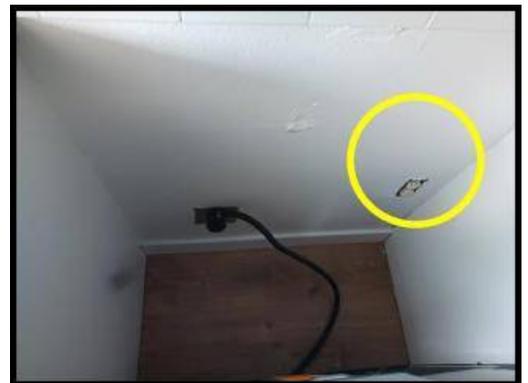
At least one or some of the outlets noted in the kitchen needs an outlet cover.

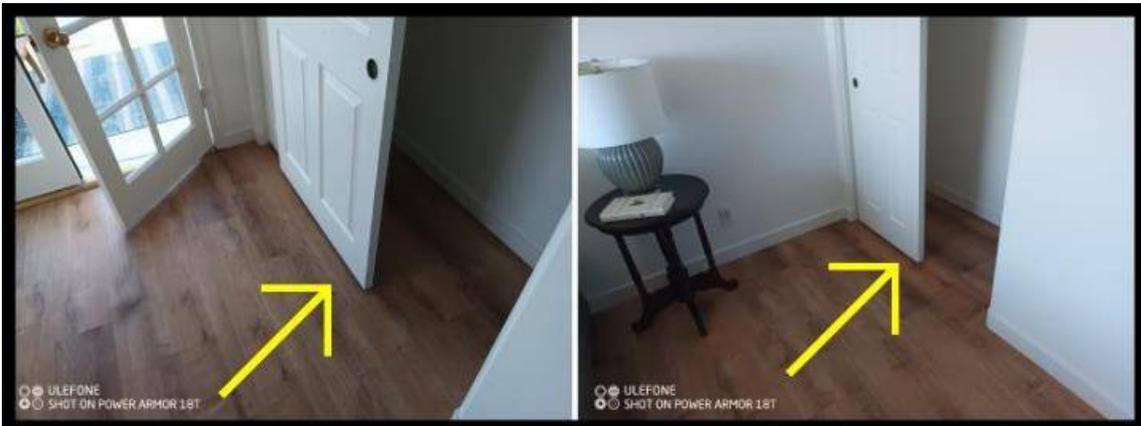
12.2 INTERIOR DOORS:

A representative sampling of doors was achieved. Those operated were in serviceable condition. However lower track guides of closet sliding doors are missing resulting in doors that excessively swing when operating.

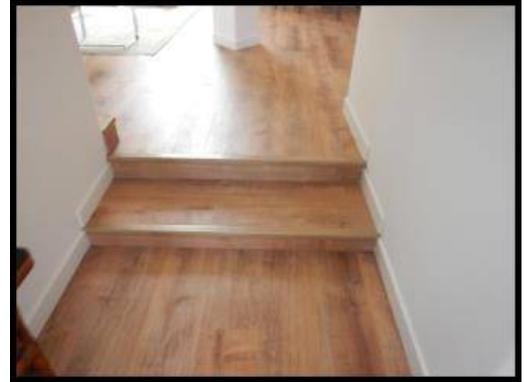
Satisfactory for main stairs however, riser heights of smaller stair are not of equal measurement. Step risers should not vary more than 3/8 of an inch from step to step as this can pose trip and fall issues.

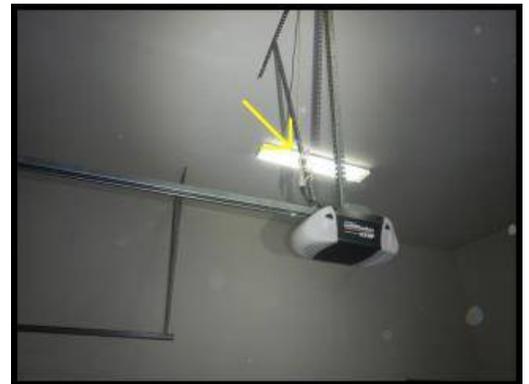
Attention Needed - Extension cord is being used to supply power to unit. Extension cords should not be used to supply permanent power to any component. There should be an outlet receptacle within cord reach of unit. Contact a licensed electrician for corrections. Could not operate. Controls not prevent during my inspection.

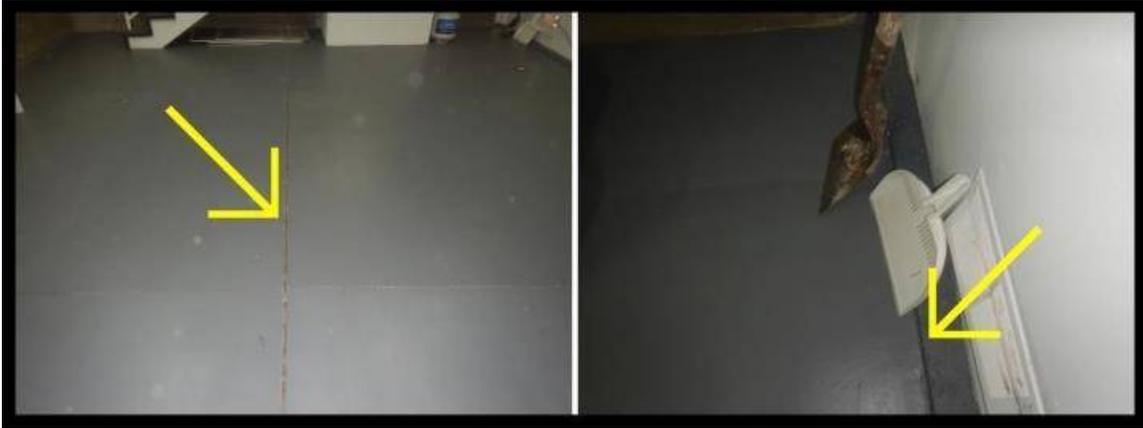
13.5 FLOOR SLAB:

7. **Attention Needed** - There is evidence of settlement noted to garage slab floor. Consult your foundation specialist for further information.

Attention Needed - There is evidence of prior settlement noted to garage slab floor. Consult your foundation specialist for further information.
