**Report:** Mr. Customer PCR **Address:** 1234 Commercial St.

# Confidential Property Condition Assessment Report

**1234 Commercial St.  
Los Angeles CA 90000**

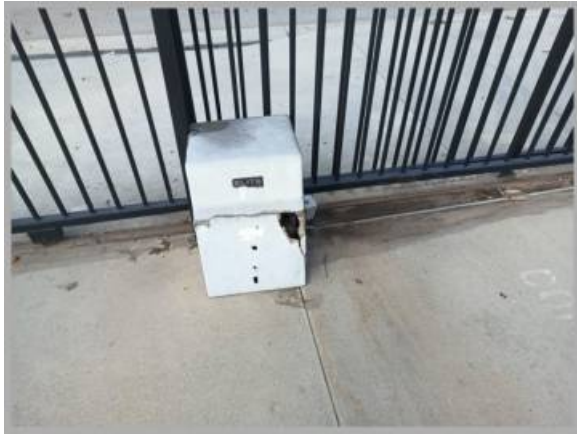
**2.14 ACTION:**

The automatic gate opener for building 1 is not functional or is deteriorated to the degree that replacement is indicated.

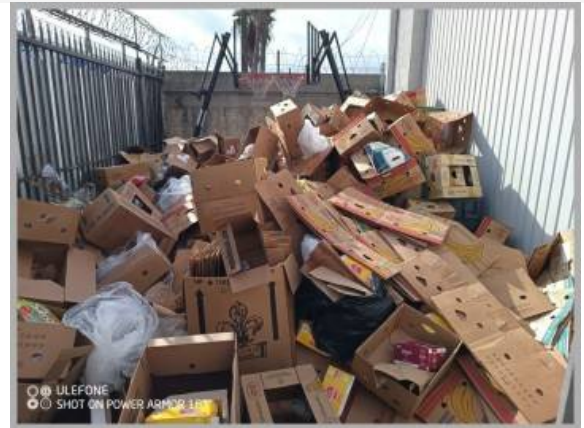
Site full of debris at some locations and in need of immediate maintenance. Excessive debris can promote vermin activity. Contact waste disposal company for clean up.

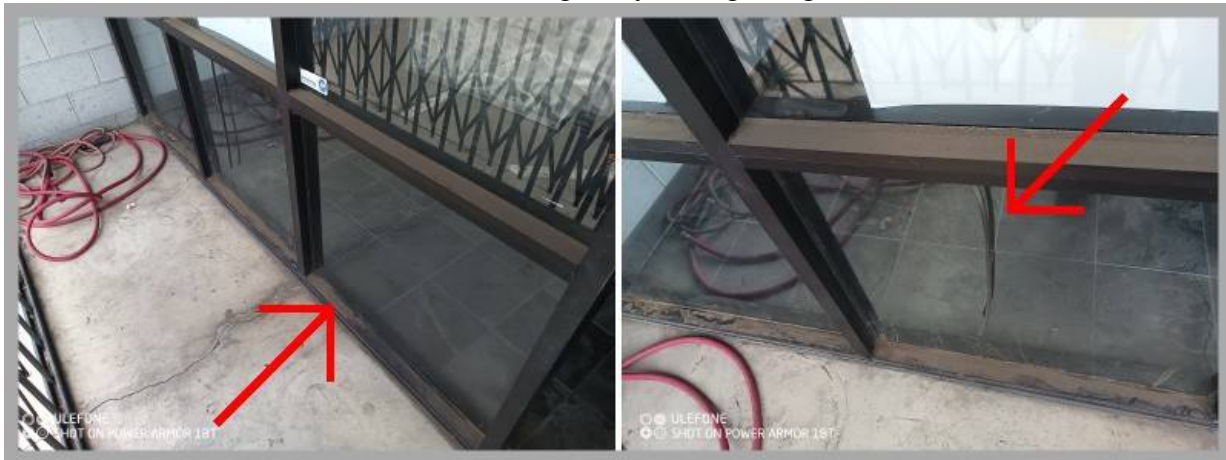
#### 3.6 TYPE & CONDITION:

Metal store front. Gasket seals are worn and coming away from glazing.

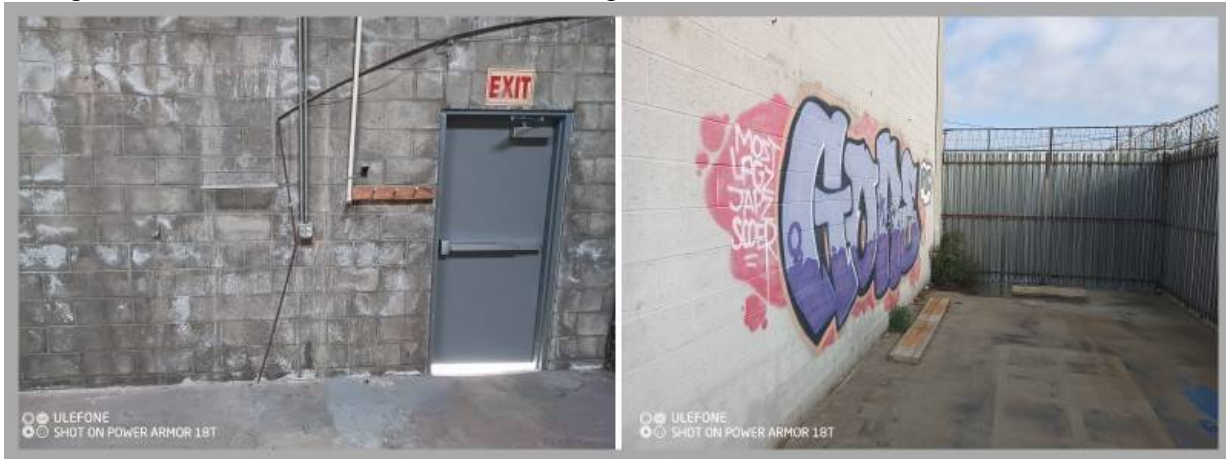
There are exit doors that empty out into a an area that is inadequate. A safety escape exit should lead directly to an open space outside, like a street, walkway, yard, or other public area that provides safe access to the outside, ensuring a clear path for people to evacuate quickly in an emergency.

No occupant load sign was posted at unit 1 which appeared to have some form of education or assembly. Any space or room that is an assembly occupancy should display a permanent, legible sign in a conspicuous place, near the exit or exit access doorway, showing the approved occupant load. Assembly Occupancy: 1. Used for a gathering of 50 or more persons for deliberation, worship, entertainment, eating, drinking, amusement, awaiting transportation, or similar uses; or 2. Used as a special amusement building, regardless of occupant load. Assembly occupancies might include the following: Armories, assembly halls, auditoriums, club rooms, dance halls, drinking establishments and exhibition halls among others.

Consult your local building department for advice on regulations of this municipality.

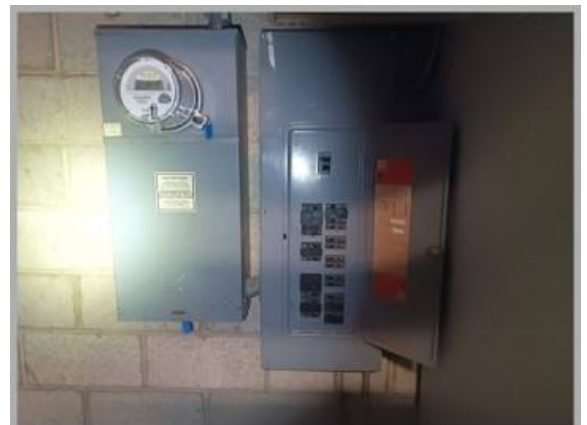
No - The electrical panel is not in a location that makes it readily accessible as required by industry standards.

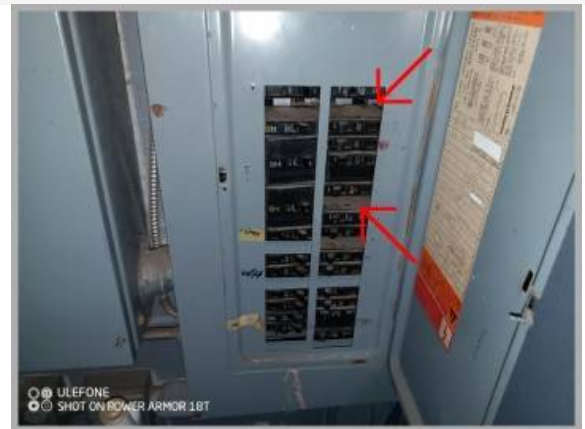
### 6.18 PANEL CONDITION:

Knock out covers are missing. Knock outs for future breakers should be sealed over with a cover to prevent potential for entry. All panel boxes need to be sealed tight. Sharp ended screws are used to fasten the dead front cover to this main panel. Sharp ended screws are not intended for this purpose as they could damage internal wiring and pose a shock or electrocution hazard. Dull ended screws should be used.

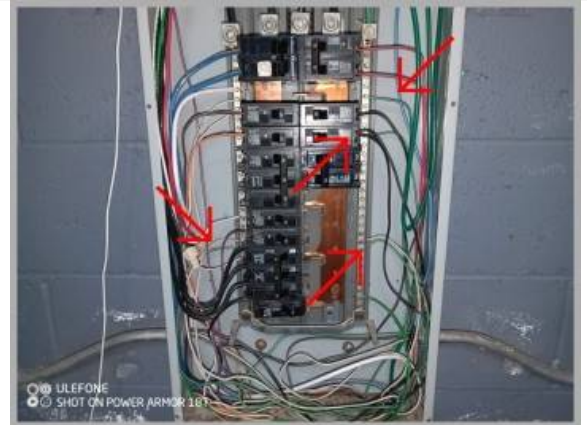
### 6.25 CONDITION:

Double lugging of neutral conductors noted. This is where there are two neutral conductors (The white coated wires) connected to one lug. This is not permissible in the electrical industry as it affects proper contact of the conductors. Double lugging noted. This is where there are two conductors connected to one breaker lug. This panel does not approve of this type of installation as it can affect proper contact of the conductors and affect proper function.

Wiring corrections needed to sub panel located in unit 1.

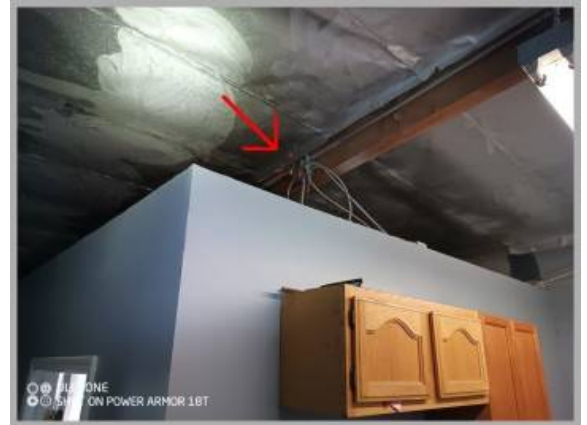
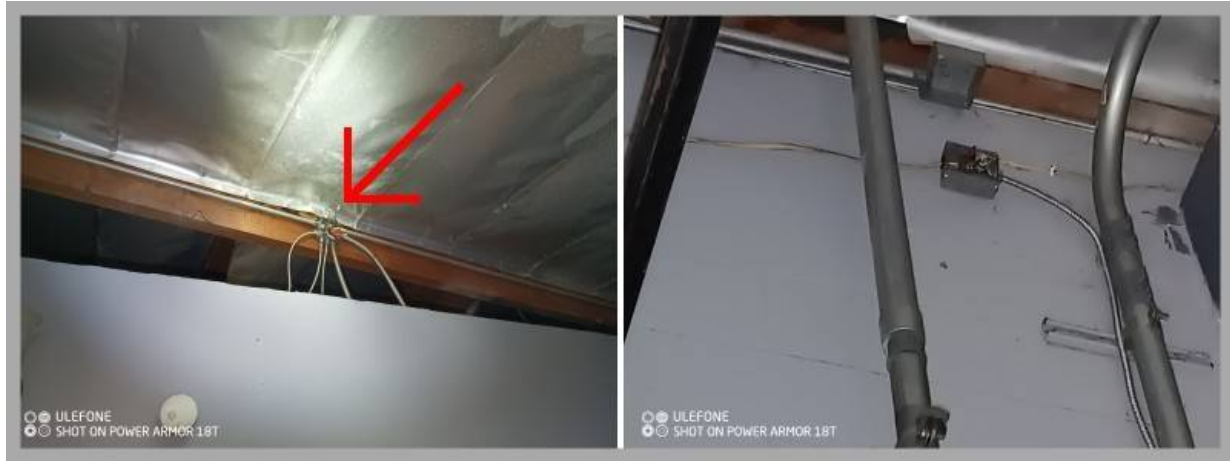
Open electrical boxes viewed in areas. Mostly within unit 1. Photos are not all inclusive and only a representative sampling. Electrical wires terminated outside of enclosure. Wires should terminate in an approved junction box with a proper cover installed. This condition is a potential safety hazard and should be corrected by qualified personnel.

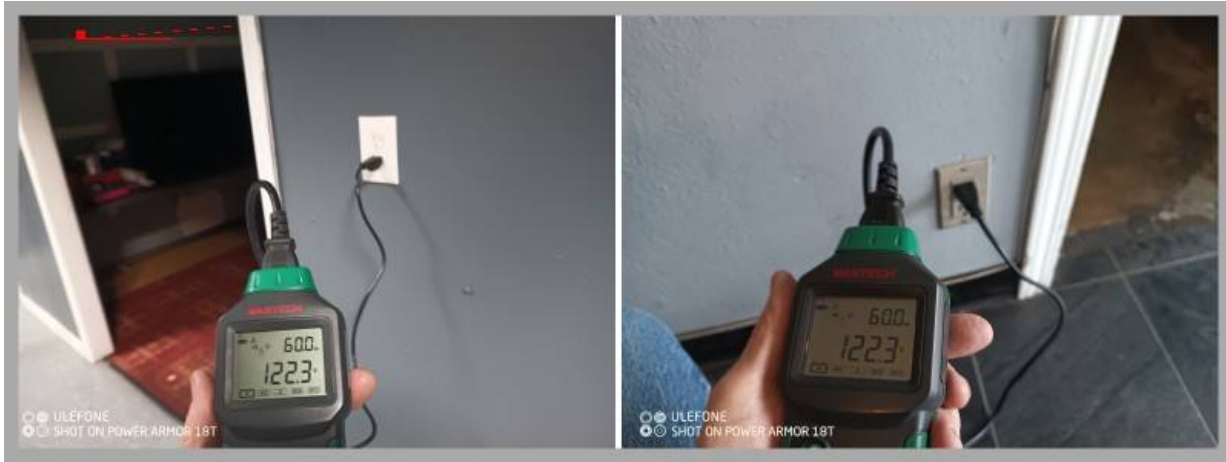
Some of the tested receptacles showed as having open/no ground. Location, Various locations of each unit. This is based off of a representative sampling. There may be other receptacles in this condition. Recommend having a licensed electrician go through all of the outlet receptacles and make the needed corrections to ensure a safe and operational source of electricity supply for future appliances and fixtures. Photos are not all inclusive and only a representative sampling.

Repair receptacles that have improper wiring, such as open or no grounding as indicated in report. Based on roughly 10%.

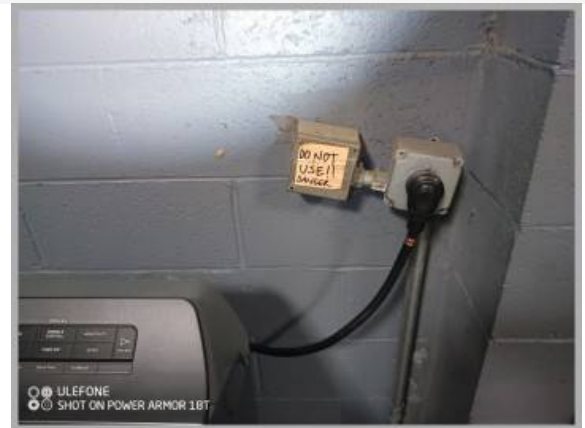
### 6.32 220 RECEPTACLES:

Added 220 outlet for clothes dryer of building 1 indicates a hazard and to not use. Consult a licensed electrician for further evaluation.

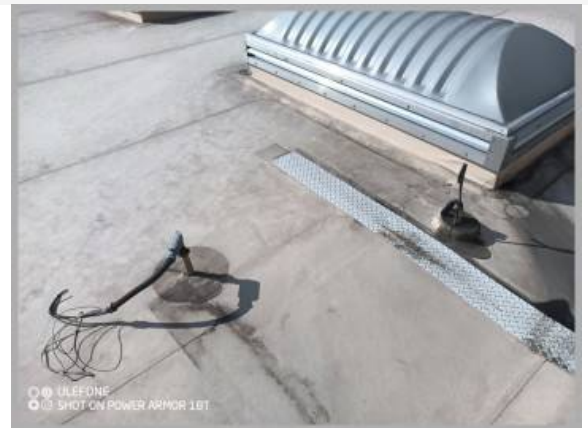
#### 7.1 Location:

Only one through wall unit located in unit 2. System is beyond its serviceable life and may not perform as intended. There did appear to be a package unit located at roof top of unit 1 though it seems to have been removed.

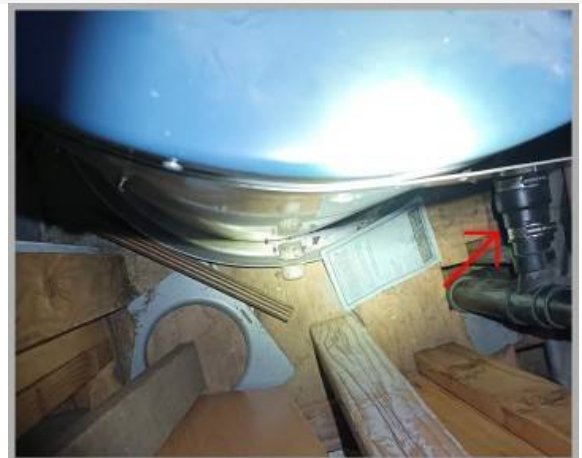
### 8.10 CONDITION:

Modifications noted at building 1 by adding clothes washer and additional bathroom. Inquire with seller, operator or tenant as to permit records. There should be no reduction in diameter of waste drains, such as seen from added laundry feature drain at building 1 as this can result in back ups posing water damage to building as well as interior content.

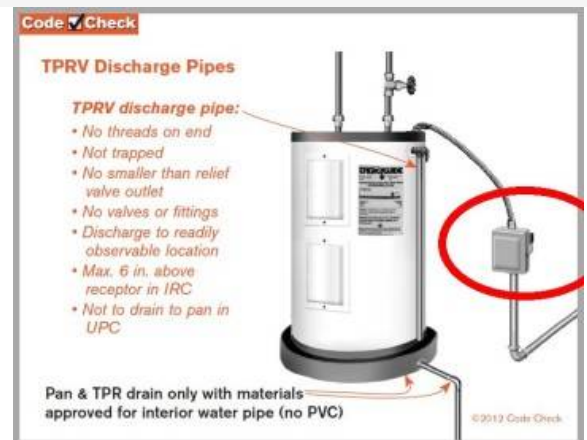
### 8.15 ELECTRIC SERVICE:

This electric water heater does not have a service disconnect situated within line of sight of component. Corrections are needed to ensure safety for workman during servicing.

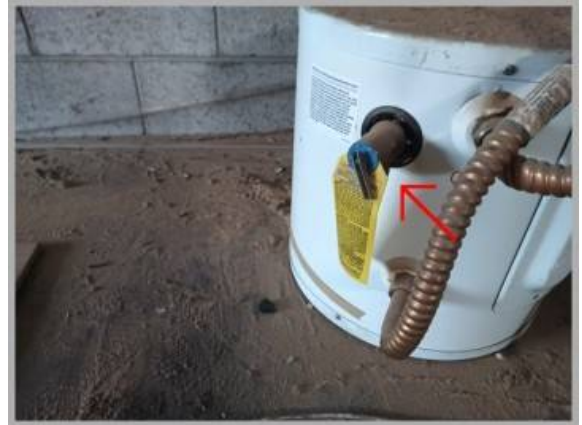
### 8.18 TPRV:

There is no overflow pipe installed. For safety reasons, immediate installation is needed to help minimize the possibility of serious injury. It should extend outside the building to the exteriors.

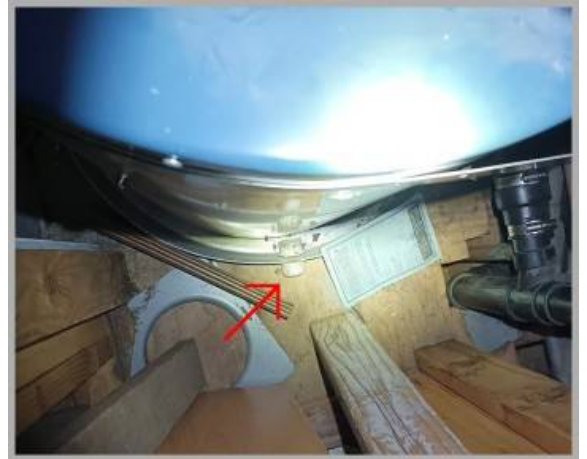
#### 8.26 CONDITION:

Tank lacks a drain that extends from sheet metal pan to approved location. Ideally a sheet metal pan would have been installed under this tank with a drain to prevent potential water damage to structure in the event of leak.

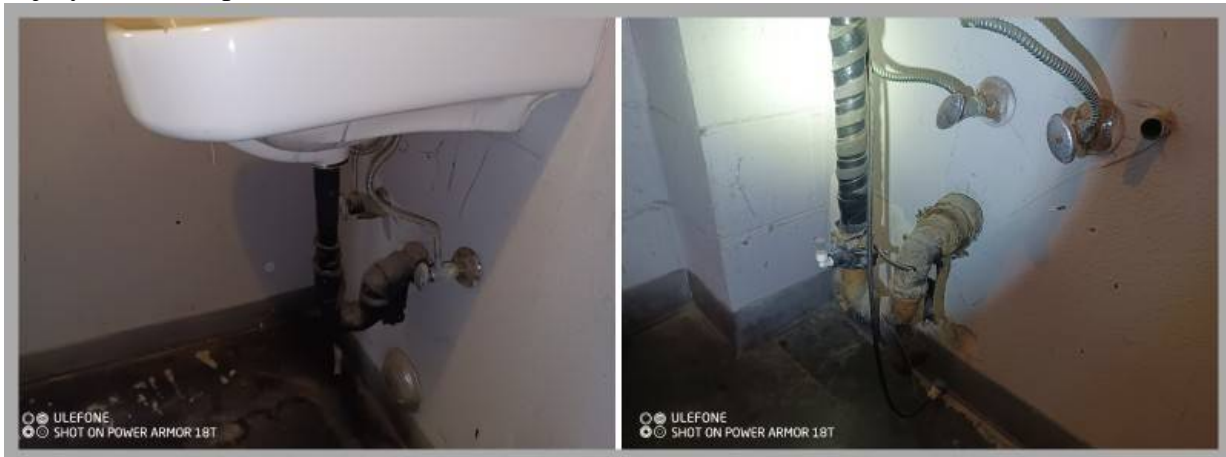
#### 9.2 BASIN & DRAIN:

Slightly loose from the wall. ADA pads missing from sink drains and angle stop valves. Corrections needed to prevent injury to disable personnel.

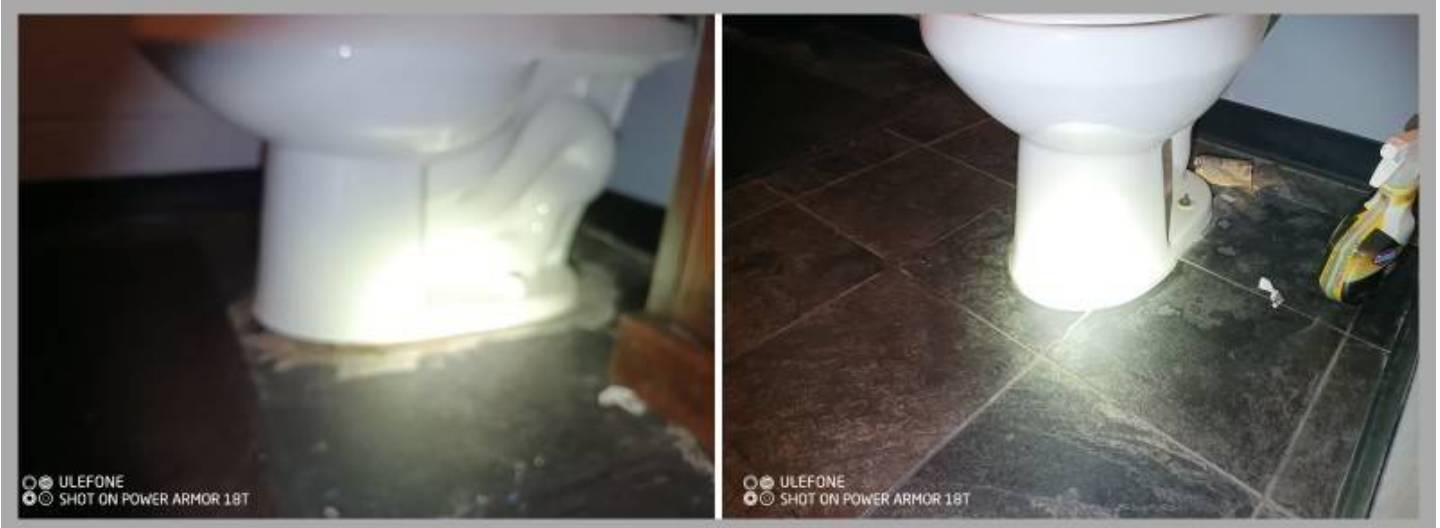
### 9.15 TOILET(S):

Base of the toilet should be caulked. The base of a toilet should be caulked, according to the International Plumbing Code and the International Residential Code. Caulking the toilet to the floor helps to create safety and provide sanitary protection. It's also generally recommended to caulk or seal the bottom of the toilet if there is a gap between the toilet and the floor. Toilet operated however fastener should be covered to prevent rust and corrosion which could result in a poorly secure base.

The toilet in this bathroom needs repair. The toilet at back or east bathroom is not secure to the floor, allowing it to wobble and possibly leak. Action should be taken to re-secure it to the floor. The toilet in east bathroom

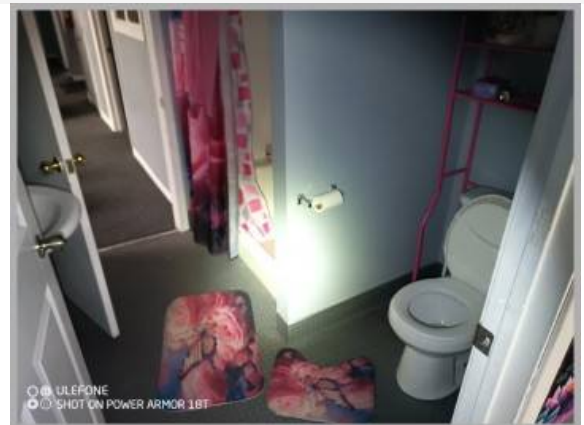
Upper level added mezzanine. Seems to be an added bath. Enquire with seller, owner or operator as to permit records.

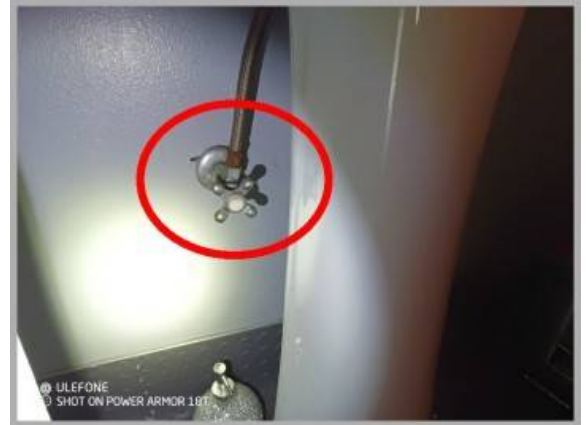
Angle stop shut off valve(s) located within cabinet under sink are corroded.

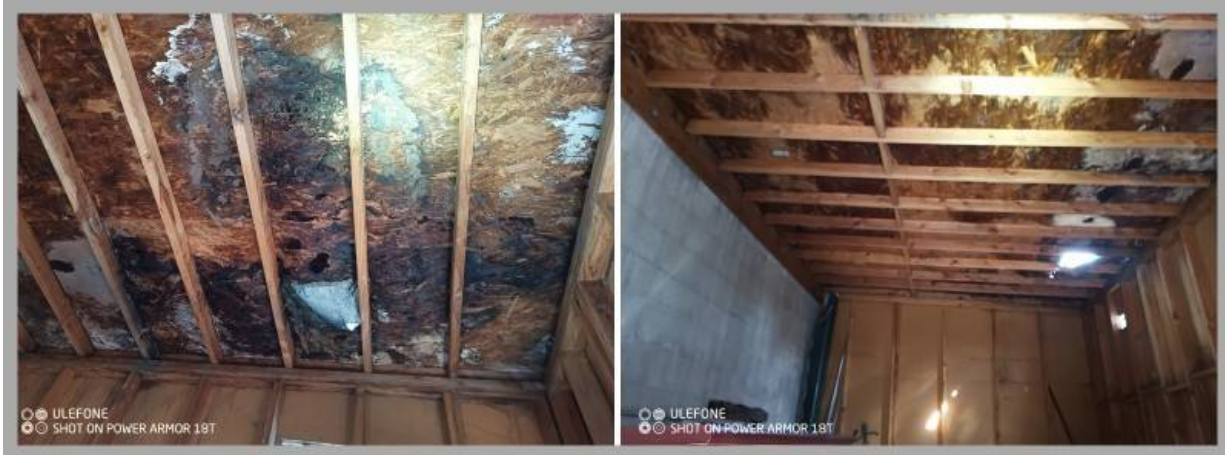
The shed at back of property is in poor repair and exhibits excessive water damage and apparent microbial growth. Removal needed. Testing of microbial growth should be achieved by an environmental agency which may affect the cost for any added remediation methods.

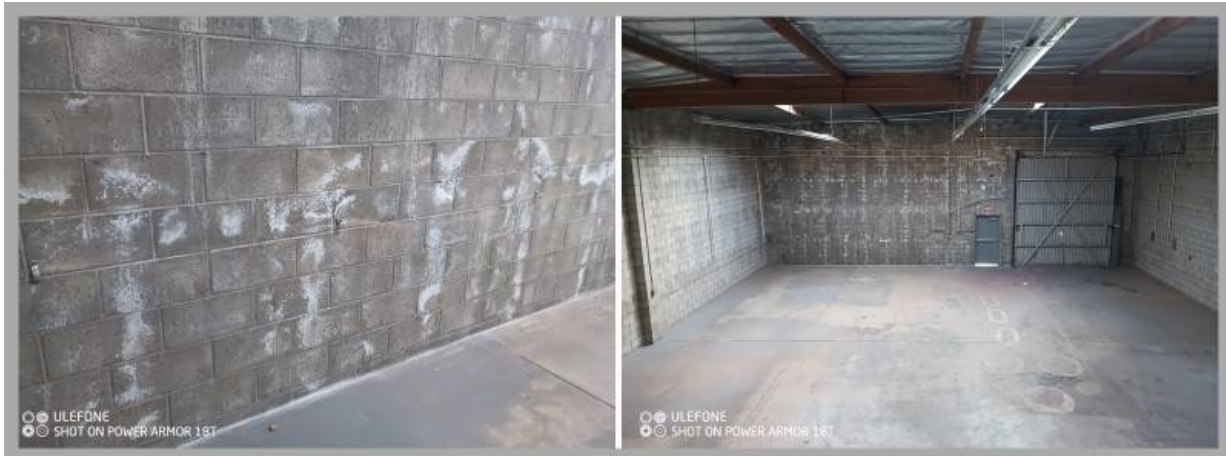
Excessive efflorescence (white chalky substances) at various locations of warehouse masonry walls from previous leak issues.

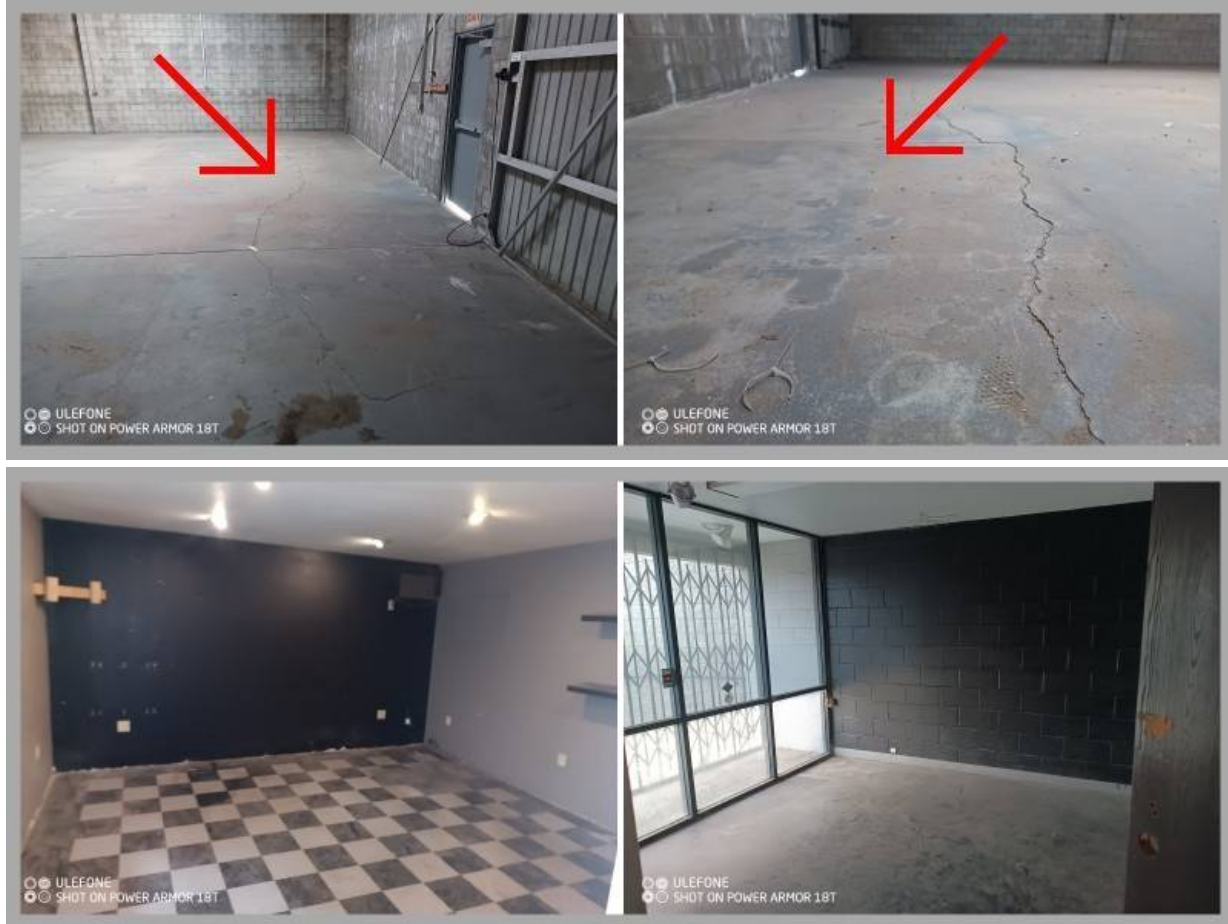
#### 11.5 Floor Condition:

Cracking along back side of warehouse from apparent settlement or heaving. Settlement did not appear to affect building walls and may not be a structural defect. However consult engineer of building contractor for further

evaluation and advice. Office flooring worn, aged and some sections are without any finish flooring. Ready for build out or simple tenant improvements.

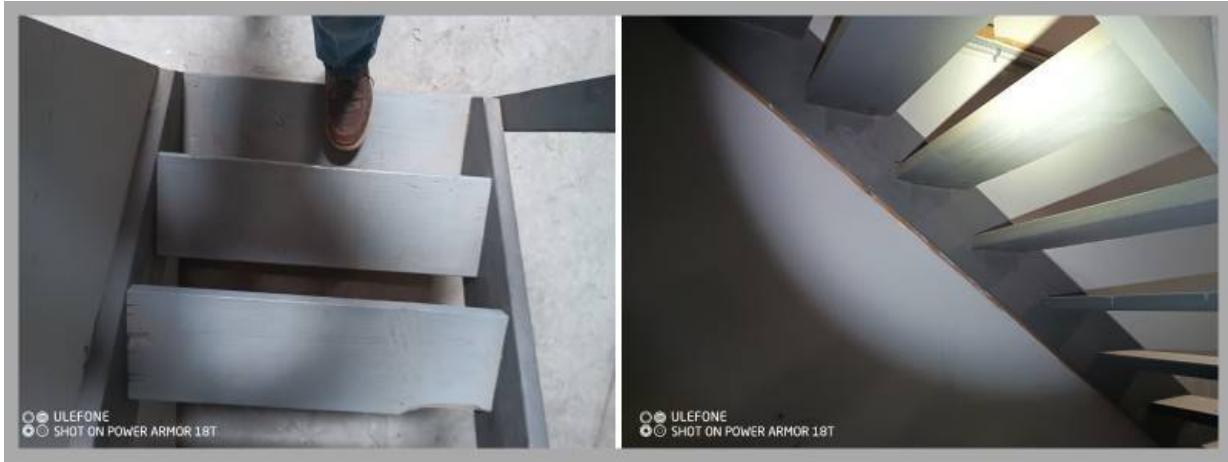
### 11.6 Stairs/Condition:

Treads at stairs of unit 2 are uneven and could pose a trip hazard. Method of anchoring step risers to stringer is unconventional and does not follow any acceptable prescriptive standards in stair construction. Railing is also loose and does not have graspable railing. Corrections needed by a licensed contractor familiar with stair construction to ensure safe use.

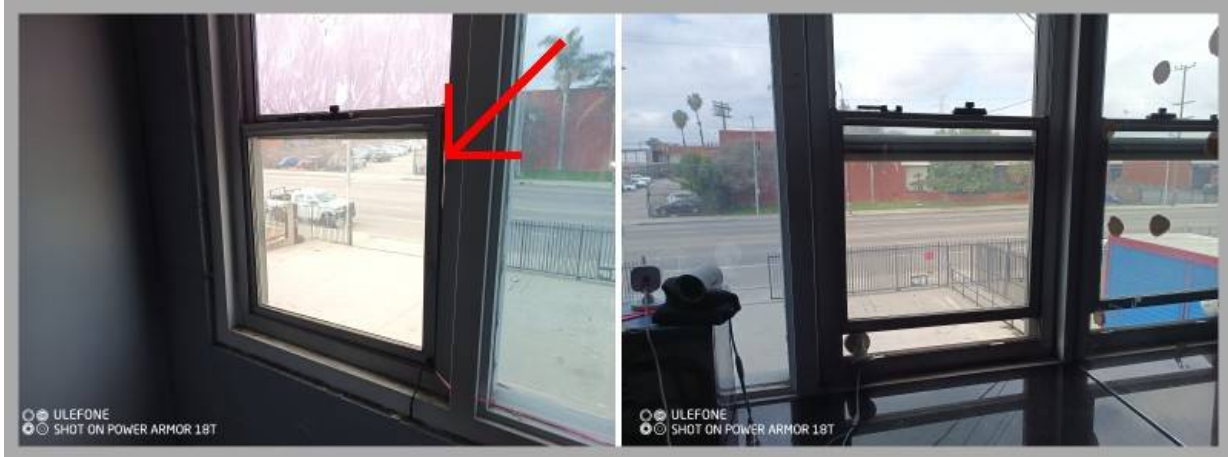
Upper level sash windows are misaligned and do not function as intended. Repairs needed.

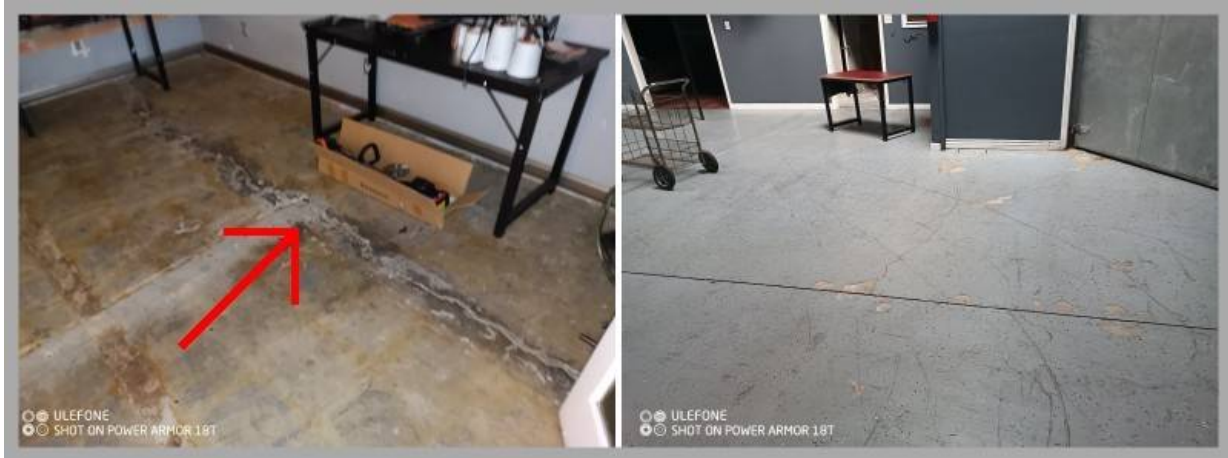
General wear and cracking noted to expose sections of slab flooring. Cracks had been filled and do not seem to pose a structural concern. Some peeling surface coating at warehouse. Anticipate improvements.

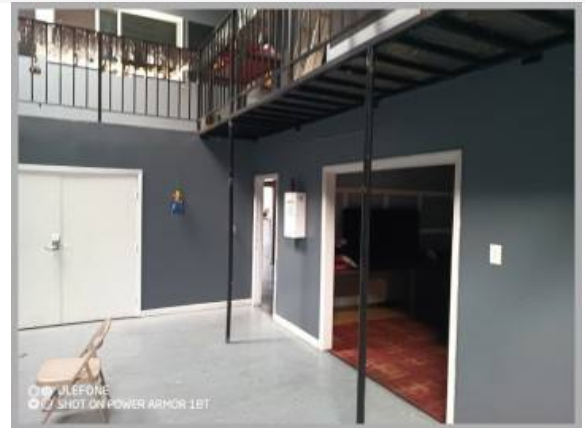
### 11.11 Stairs:

Stairs were functional however there is an extended section of elevated walk at mezzanine that draws concern. No load analysis is performed though from a simple visual assessment there appears to be some inadequacies in support. I suggest consulting a structural engineer for further evaluation and advice.
