ALLIANCE  
REAL ESTATE  
INSPECTIONS

# Confidential Property Condition Assessment Report

**Prepared for: Sample Client  
Prepared By: Robert Gaudreault**

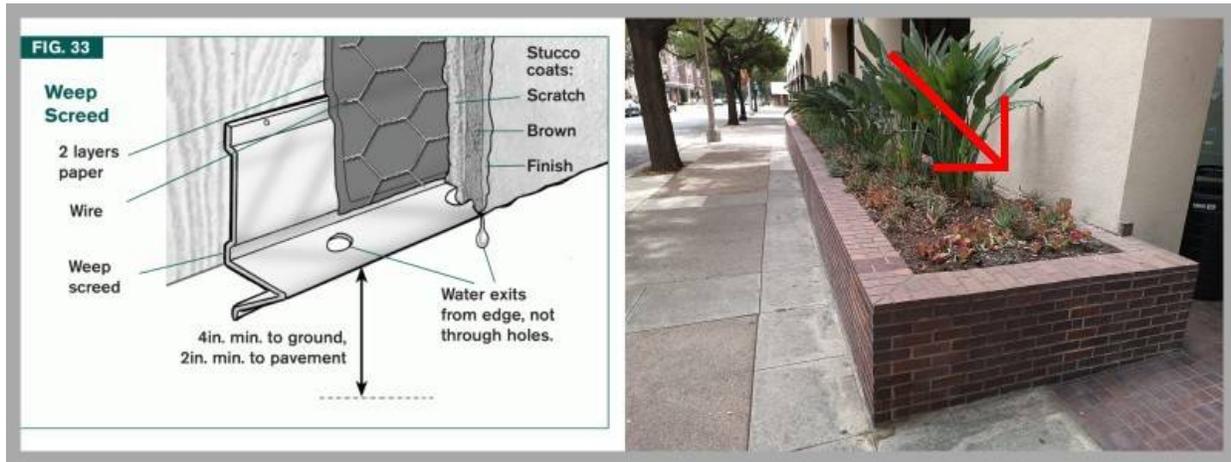
Planter box adjacent to structure is not properly flashed which can be a source of water entry into substrate. Wee screed lacks adequate clearance.

Further evaluation needed. Repair weep screed clearance along east planter.

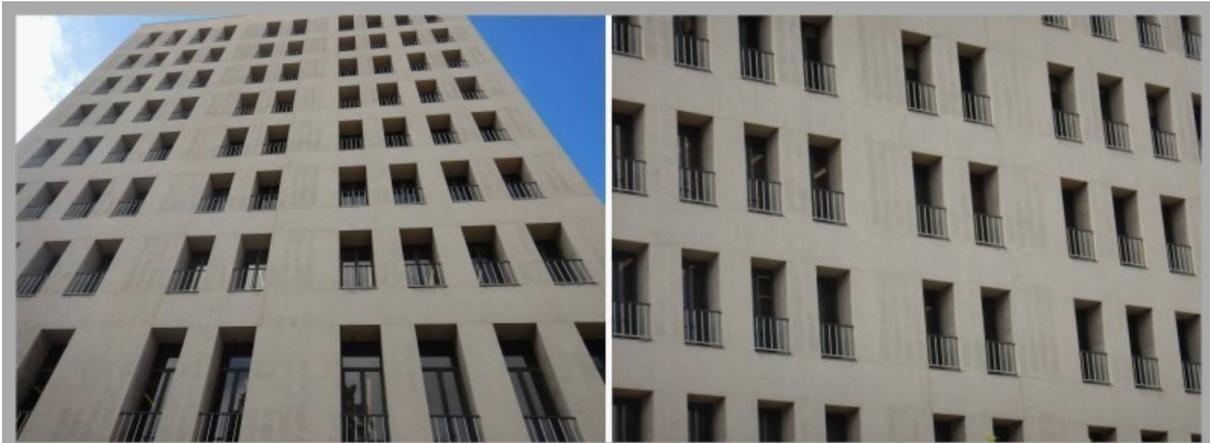
**Ghosting**

"Ghosting" in the context of stucco refers to the visible outlines of the underlying wall framing, often appearing as a darker or different shade of color on the stucco surface. This can occur due to various factors, primarily related to moisture, heat, and the accumulation of airborne particles. Painting alone generally won't fully correct ghosting effects on stucco. While painting can help blend the areas, it might not eliminate the visual difference entirely, especially if the stucco itself is different. Another alternative is to fog coat with like color. Fog coating is a cement-based coating used to refresh and recolor exterior stucco walls. It's a spray-applied cementitious product that blends discolored areas and changes the color of the stucco, offering a more durable and breathable alternative to traditional paint. Fog coating is made from the same materials as stucco and natural earth pigments

Further evaluation needed. Consult commercial stucco contractor. It would behoove you to have a qualified specialist determine what the underlying cause of the discoloration, referred to as shadowing or ghosting, is and remedy.

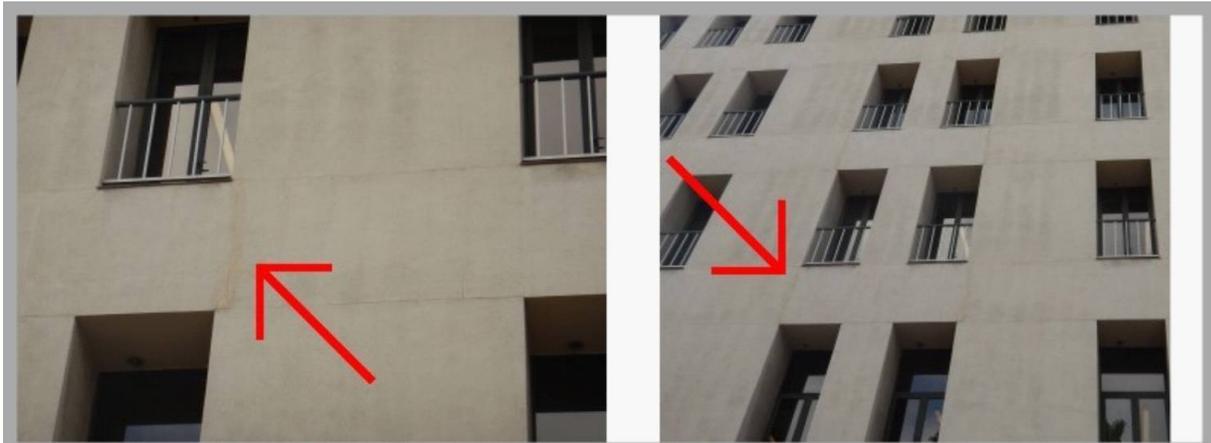
**Stucco cracks**

Some slight stucco cracking at north side center section. These cracks seem to be cosmetic in nature.

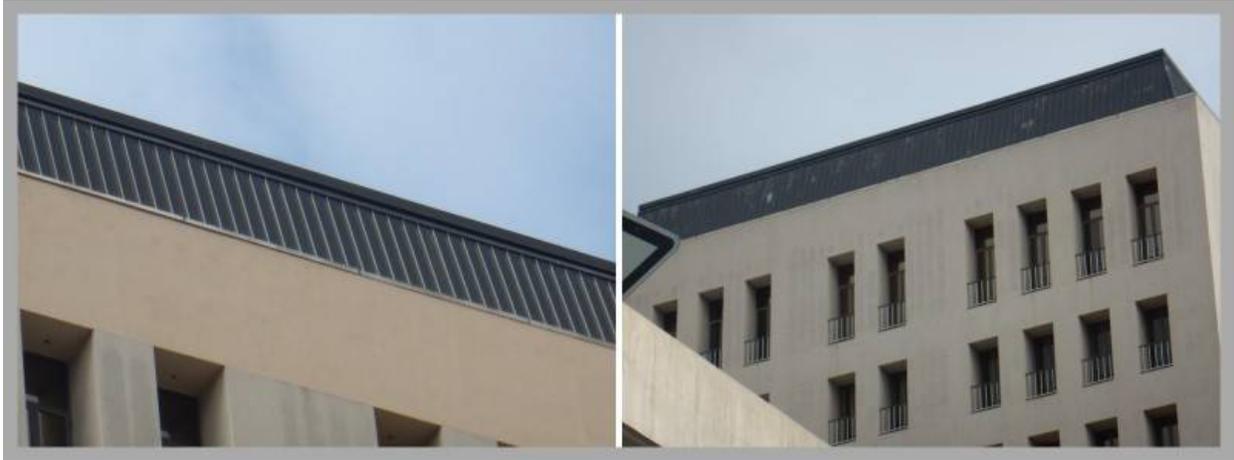
Discoloration seen commensurate with age and wear. Refinishing needed.

Refinish roughly 5000sf of metal stand and seem material along roof top.

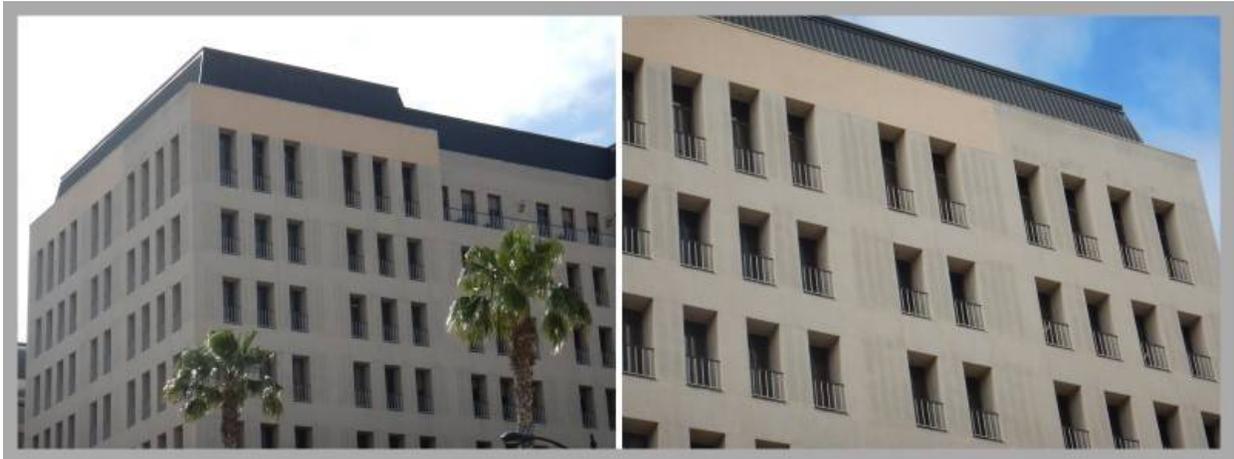
Exterior finish or painted surfaces are in a condition that calls for refinishing. Mismatched sections and general wear due to age. Roof top wind barrier exhibits paint wear. The lifespan of paint on a building depends on whether it's interior or exterior, the type of paint, the surface it's applied to, and the climate. Generally, interior paint can last 5-10 years, while exterior paint may last 5-7 years. Further evaluation needed. Consult licensed painting contractor specializing in painting of multi story buildings.

Painting to roughly 85000 sf of exterior stucco. Painting is based on using an engineered suspended scaffold. Not an entire scaffold from grade to roof.

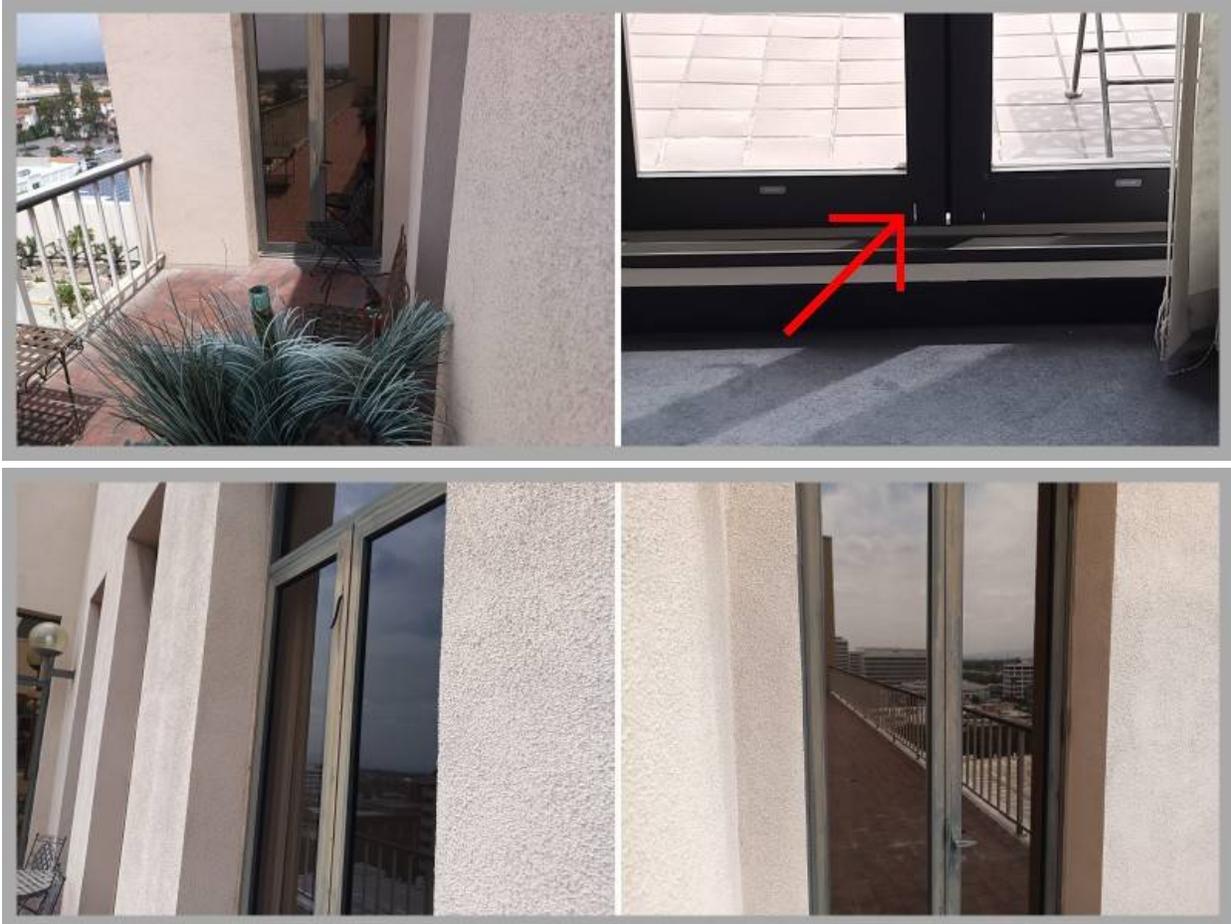
9th floor West and east balcony access doors exhibit fading and metal seam separation.

Restoration to 16 exterior balcony access doors and transoms needed. Services of a commercial door installer should be consulted.

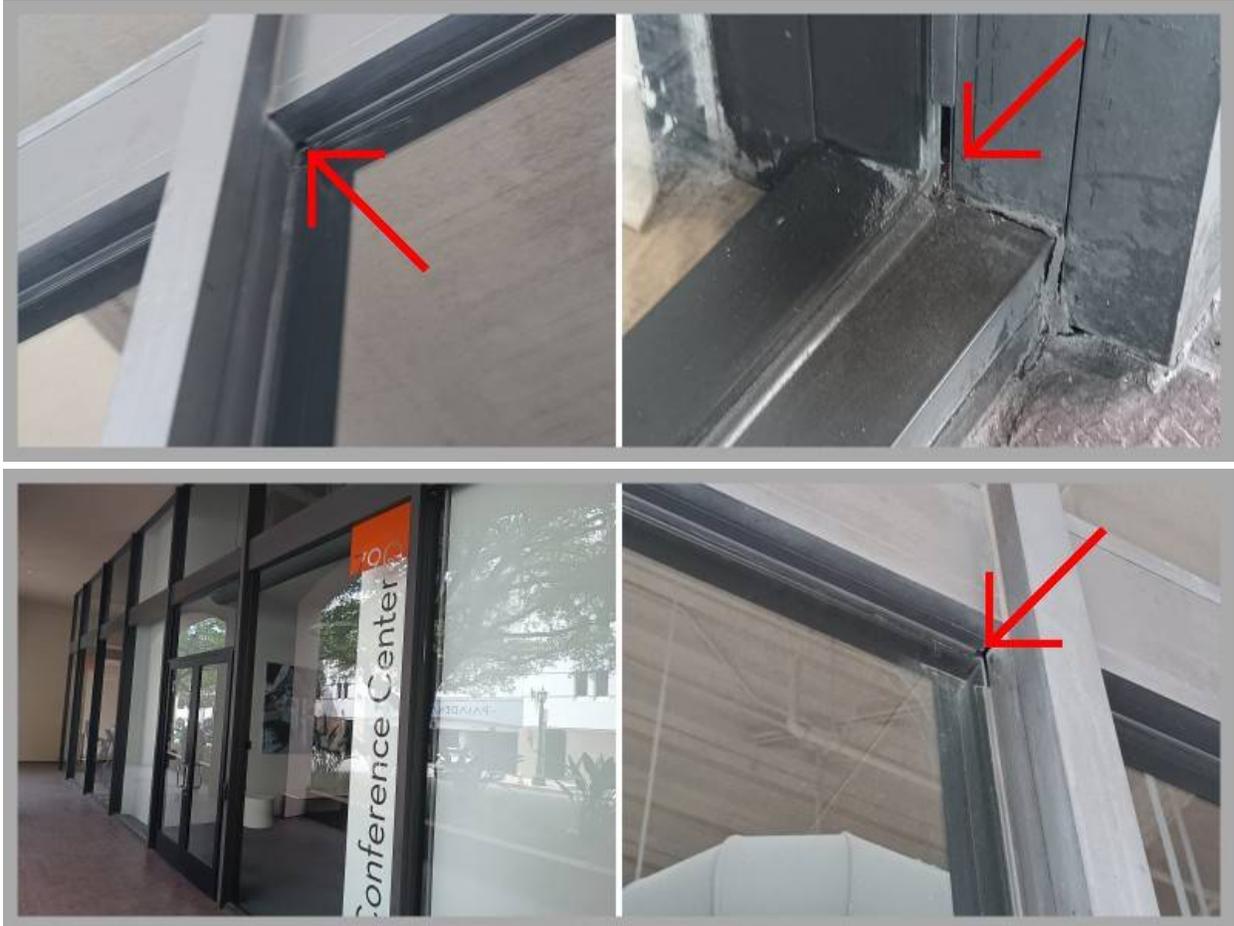
East and some at north side ground level store front windows have worn and damaged gasket seals. When gasket seals are compromised the entire gasket needs to be removed and glazing would be recaulked with approved glazing caulking.

Replace weather seal to roughly 50 percent of ground level store front windows lower. Contact window installer for further assessment and estimates.

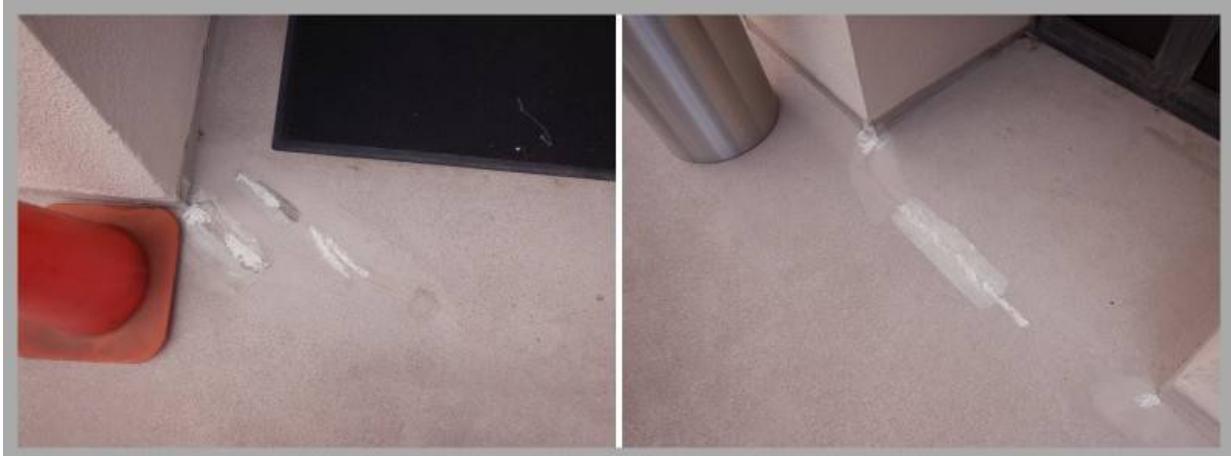
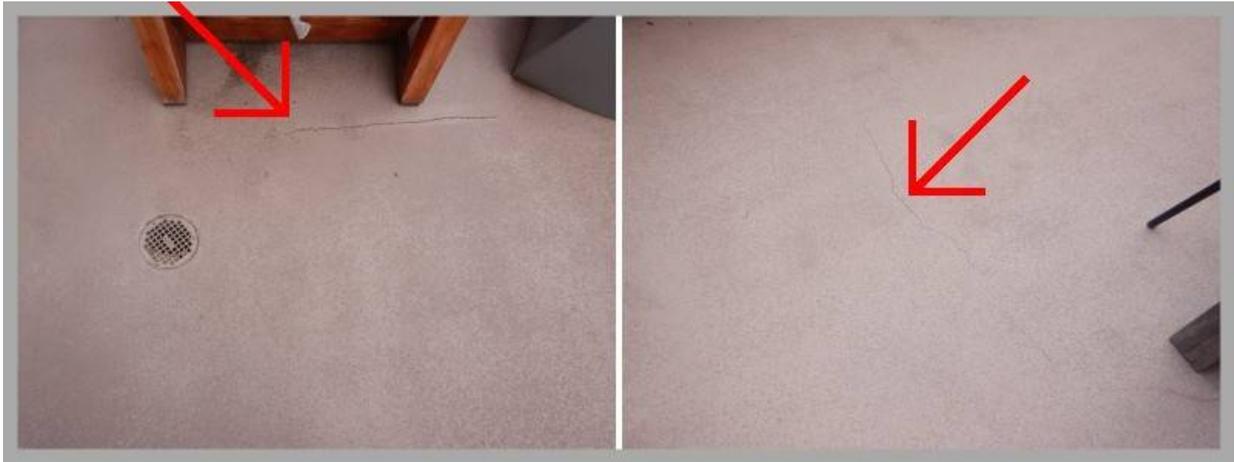
There is concrete material used. Cracking and evidence of leak as seen from ceiling of loading dock.

9. Seal cracks and resurface 18000 sf of lower west concrete decking.

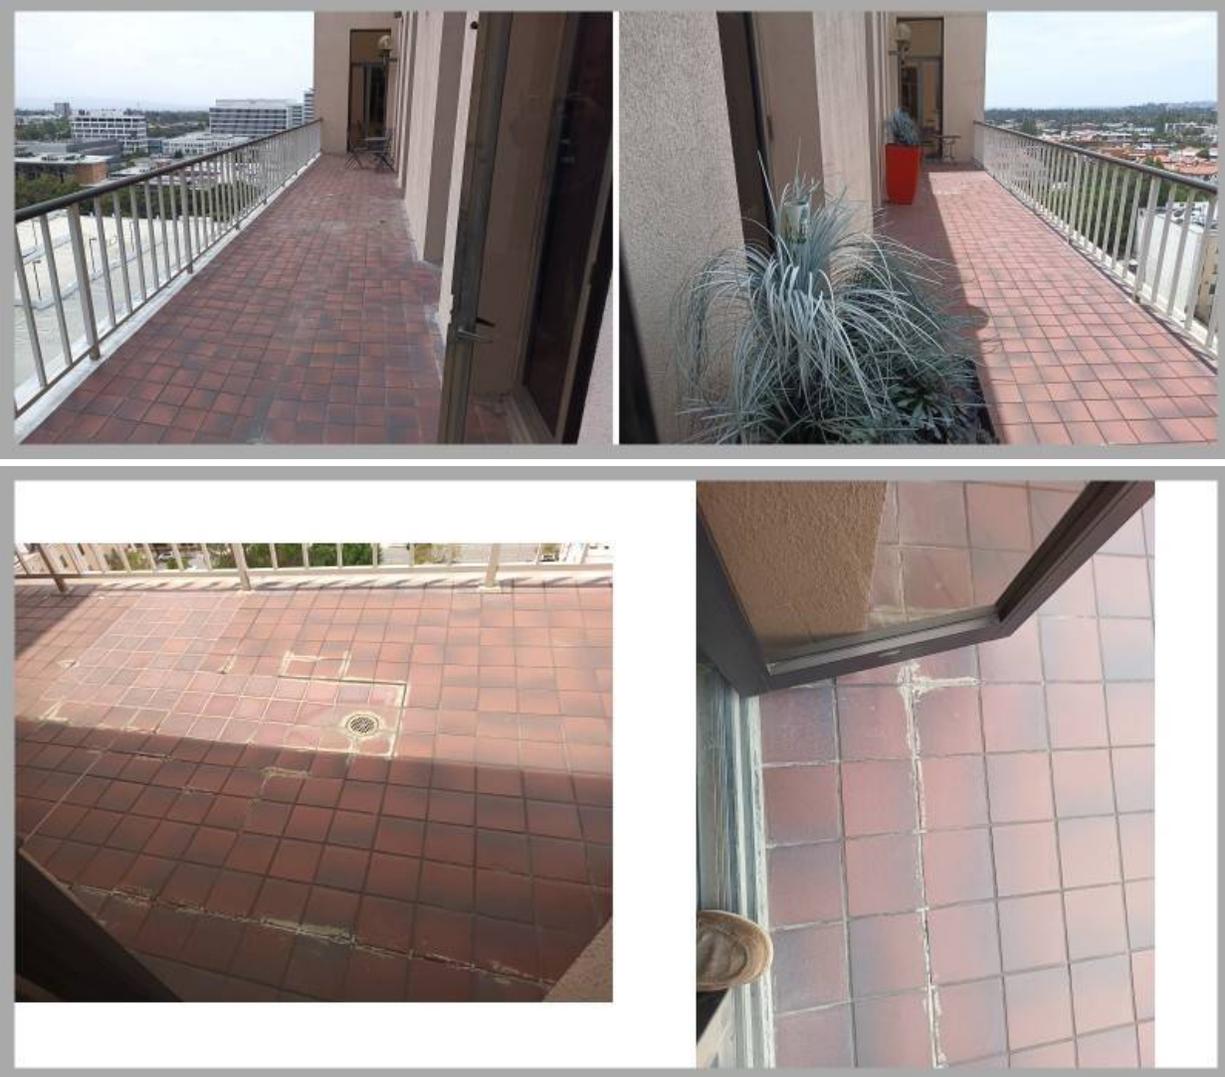
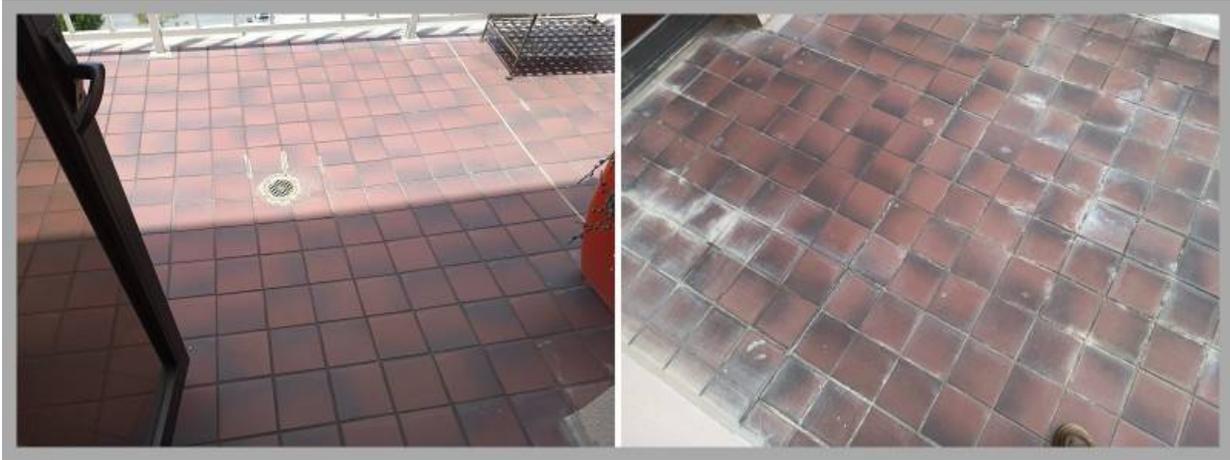
Ceramic tile is used at 9th floor balconies. Patching noted due to prior apparent leak issues. Tile is aged and starting to exhibit displacement or grout cracks.

12. Conditions noted that could affect use. Consult qualified licensed contractor for further evaluation and advice. Removal and replacement of roughly 1100 sf of tile decking indicated. Sub deck waterproof membrane may be failing.

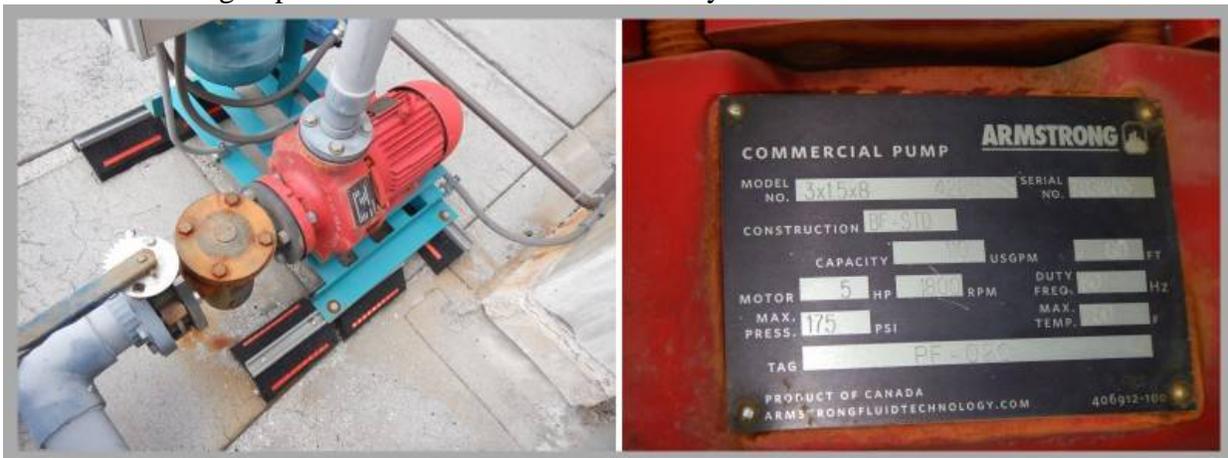
At least one 5 HP although operational near the end of its life cycle.

Monitor and maintain two of the pumps at cooling tower. Anticipate and budget for replacement in the not to distant future.

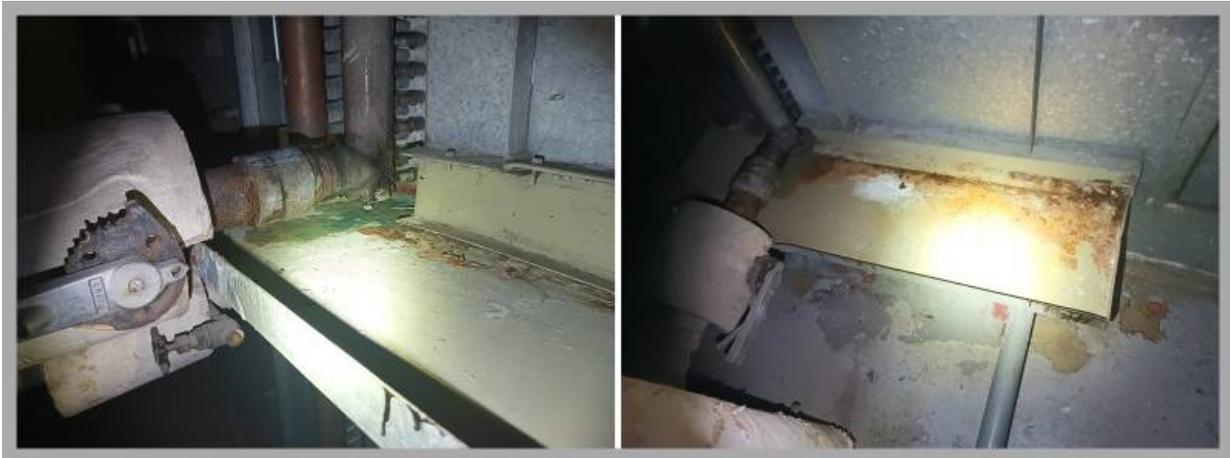
Visible rust and corrosion seen at base of interior coils. System otherwise maintained. Monitoring and cleaning should be routine.

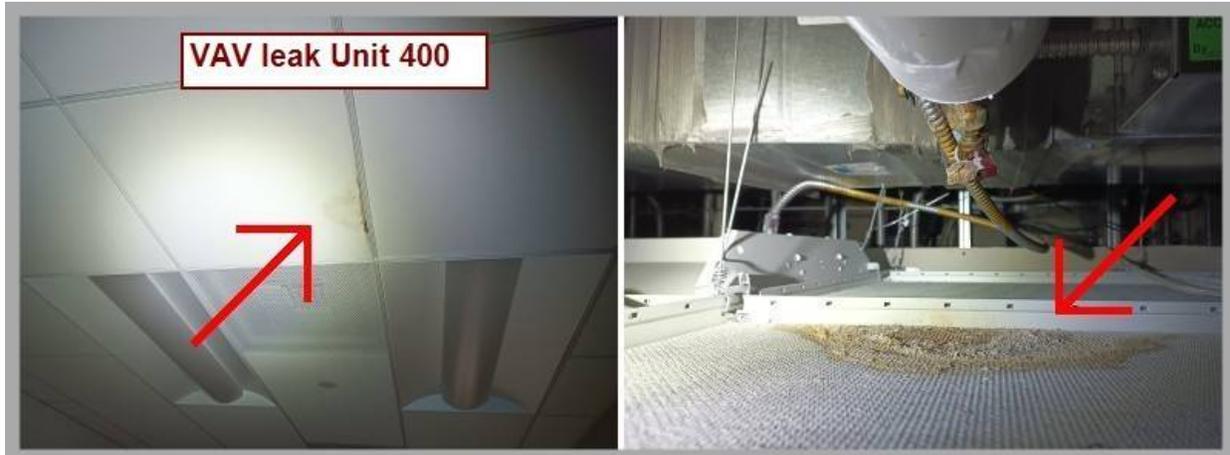
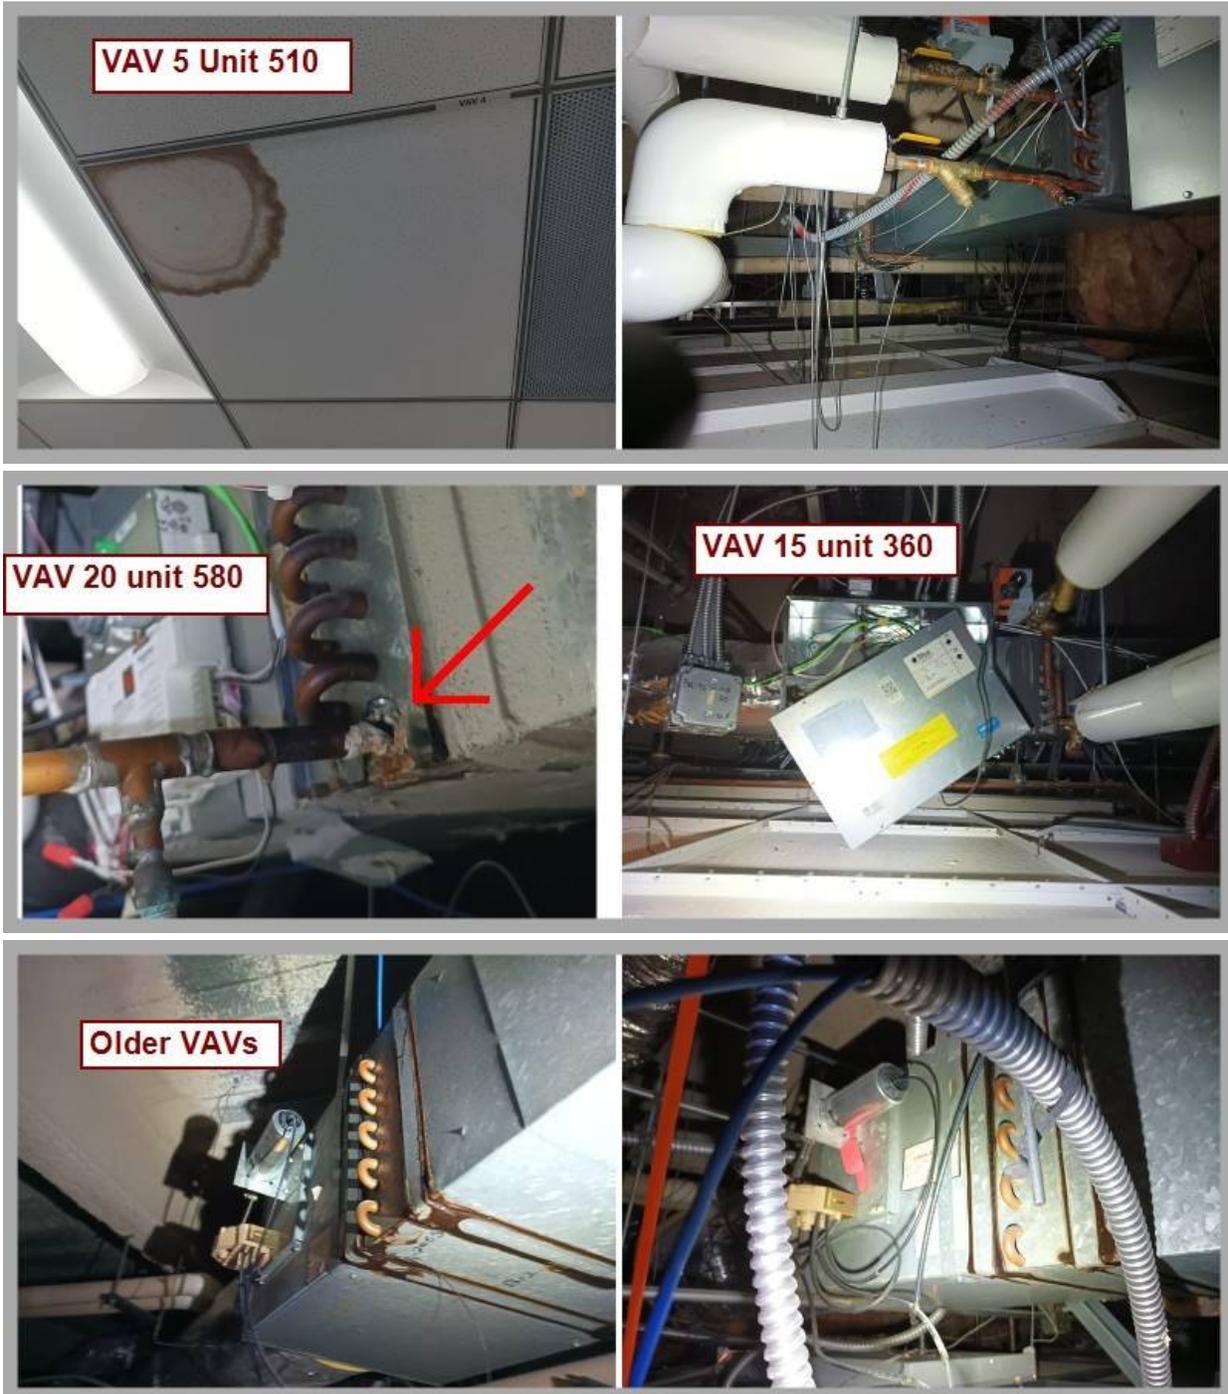
VAV Boxes: These terminal units, which control airflow to different zones, last 15-20 years with regular maintenance. Actuators and dampers may need repairs or replacement sooner, around 10-15 years. Therefore based on the existing age anticipate upgrades in the next few years. Such as VAV replacement, reconditioning cooling tower, replacing at least one chiller etc.

VAV 15 in unit 360 has a displaced cover and one VAV in unit 400 seems to have leaked onto ceiling panel. VAV5 in unit 510 did appear to have a leak though looks as though it was recently repaired. Corrosion was also noted to section of water line at VAV 20 in suite 580. Most of the VAVs at 7th, 8th and 9th floor appear to be from original installation and are more than likely near or at the end of their serviceable lives.

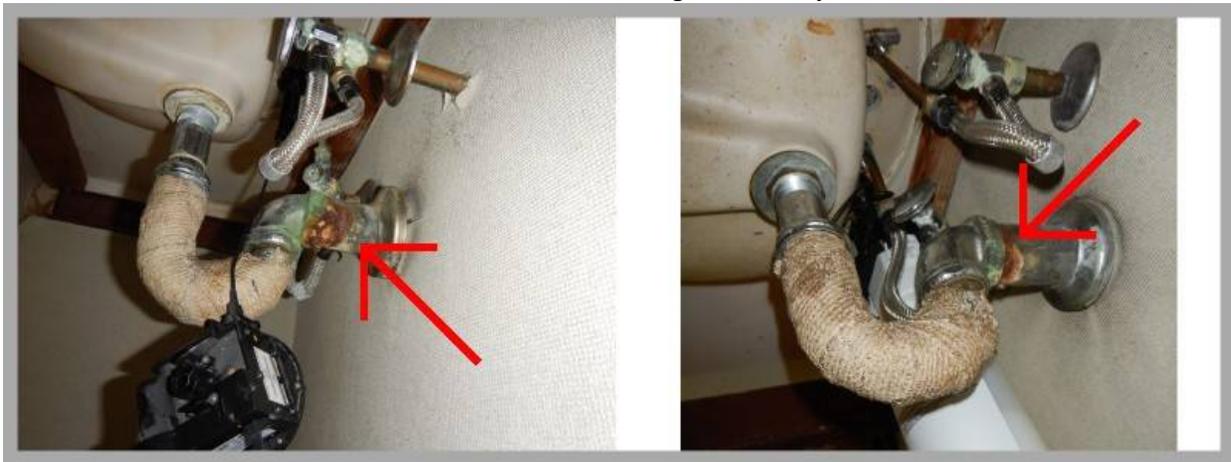
Waste disposal installation and waste vent installation is not visible for the most part. Consultant is solely judging adequacy of drainage by one person operating and viewing one fixture at a time. There may be hidden deficiencies that can go unnoted. There is however corrosion which can be seen at some of the interior fixtures as indicated in bathrooms and kitchens interiors section of report. Mostly at 9th floor.

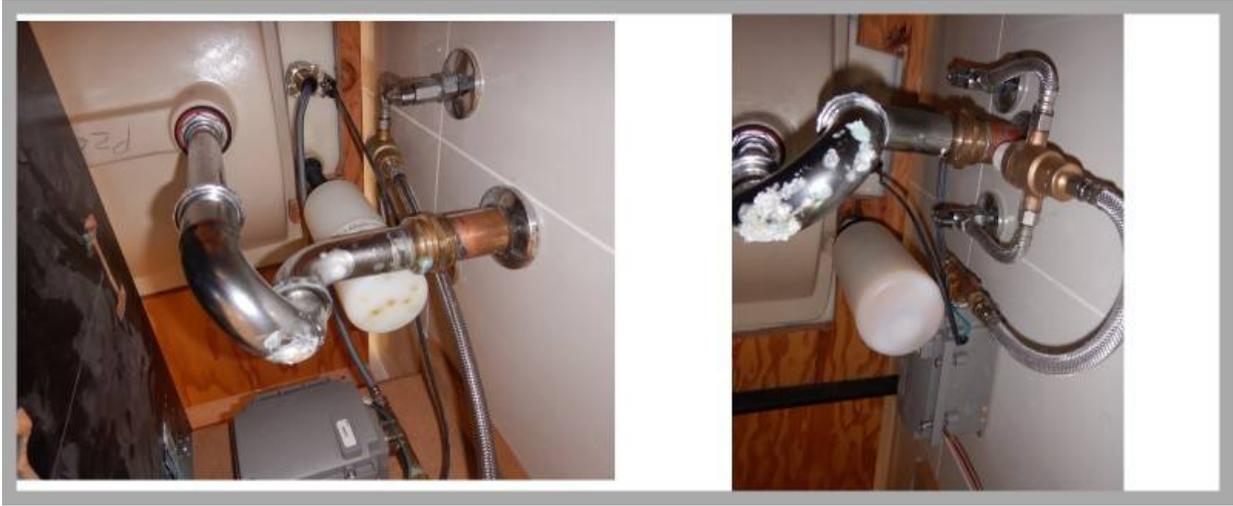
Deteriorated Lines - There is deterioration of the drain pipes under the basins of both restrooms. Replacement needed, faucets not operational likely due to leaks.

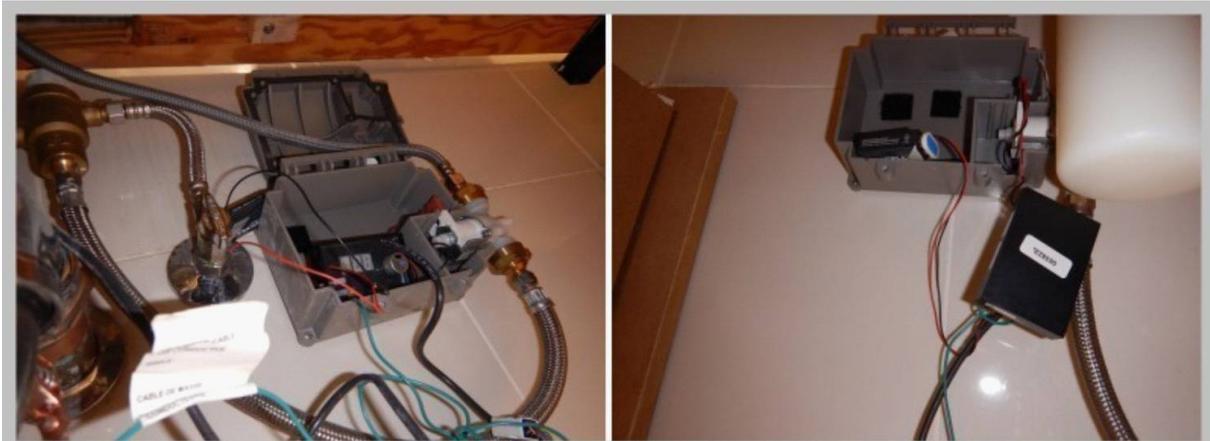
**1st floor Men's**

Deficient installation of the auto faucet mechanism noted in Men's restroom.

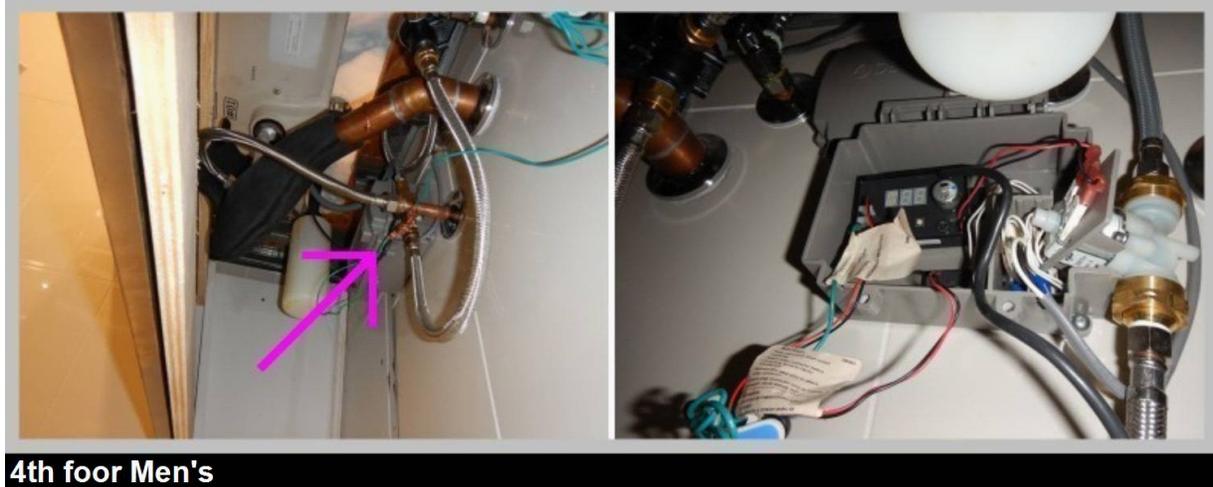
Under men's sink: Sub-standard wiring of auto faucet.

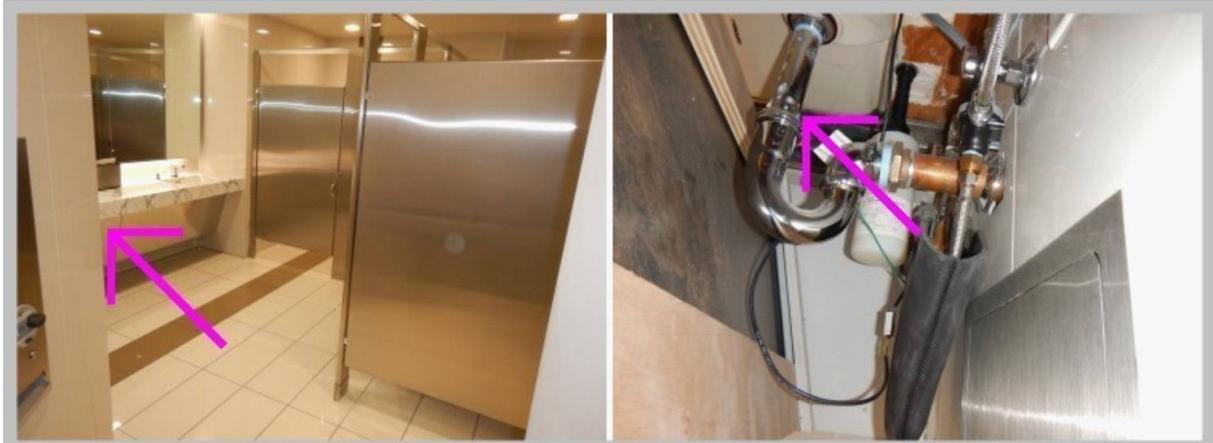
**Women's 4th floor**

There is deterioration of the drain pipes under the basin in women's restroom. Although there is currently no leak, expect replacement in the future.

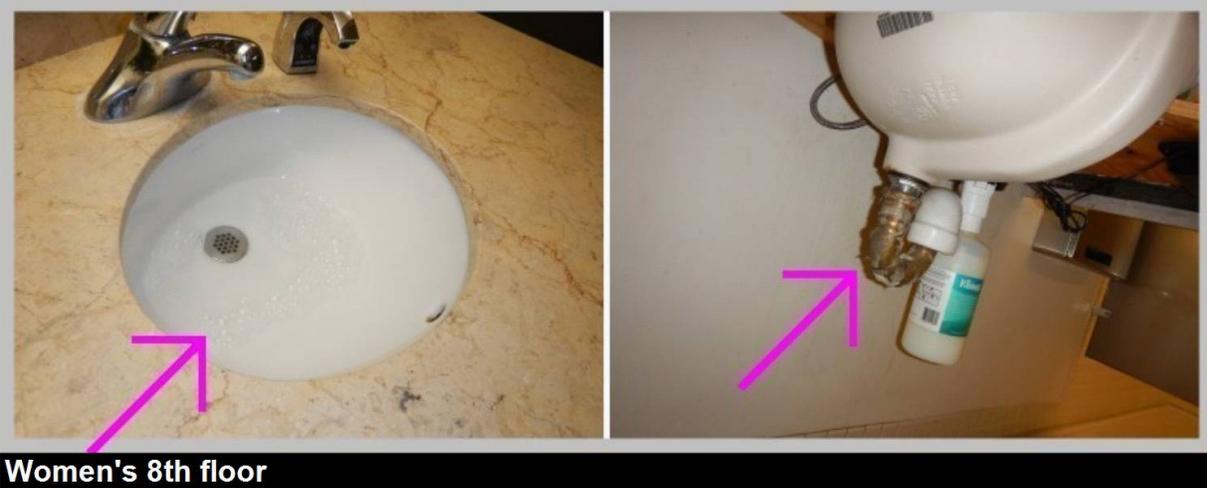
Deteriorated Line - There is deterioration of the drain pipes under the basins and slow drainage noted in women's restroom.

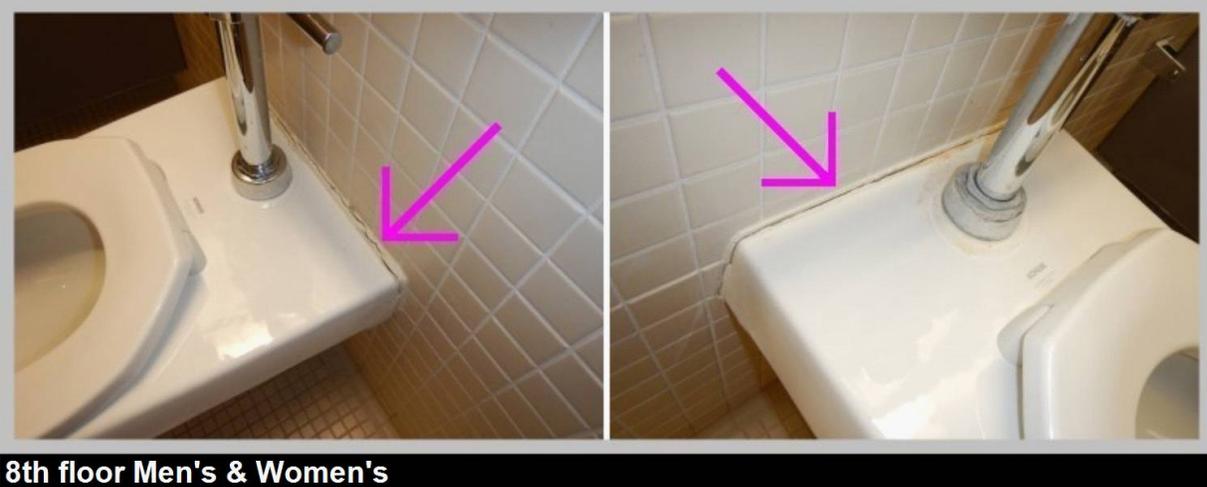
Caulking separation noted at toilet to wall connection. Possibly due to fixture movement.

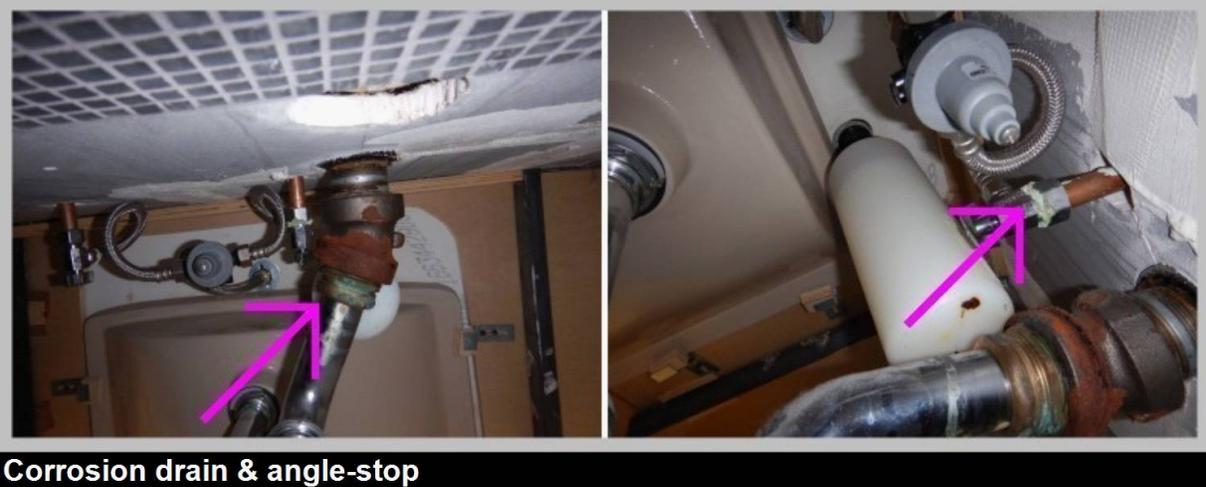
**Corrosion drain & angle-stop**

There is corrosion on the trap or drain line in Men's bathroom. This is an early warning of future failure. It may not be currently leaking, but it will need to be replaced in the near future.

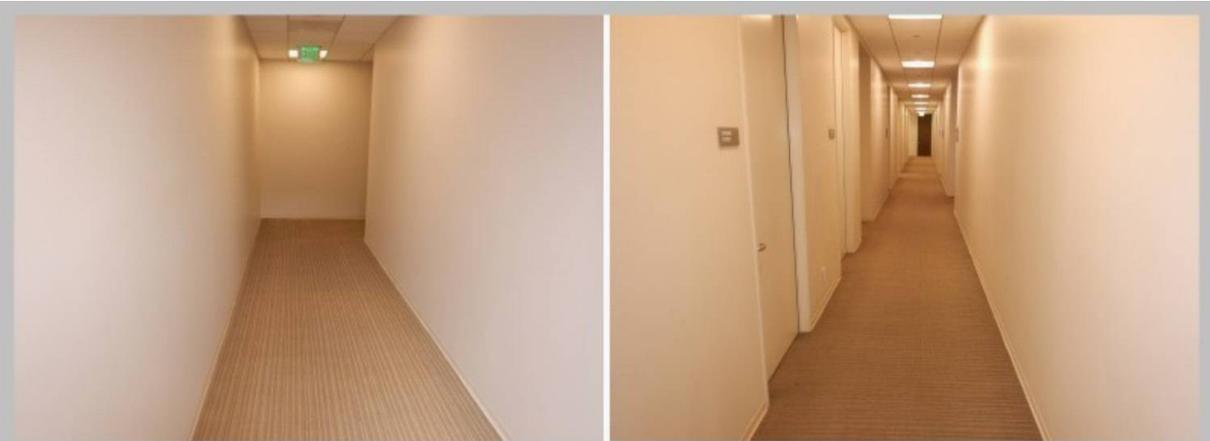
**2nd floor**

Overall satisfactory. Some staining noted on carpet by patio door and some paint damage in 2nd floor hall noted.

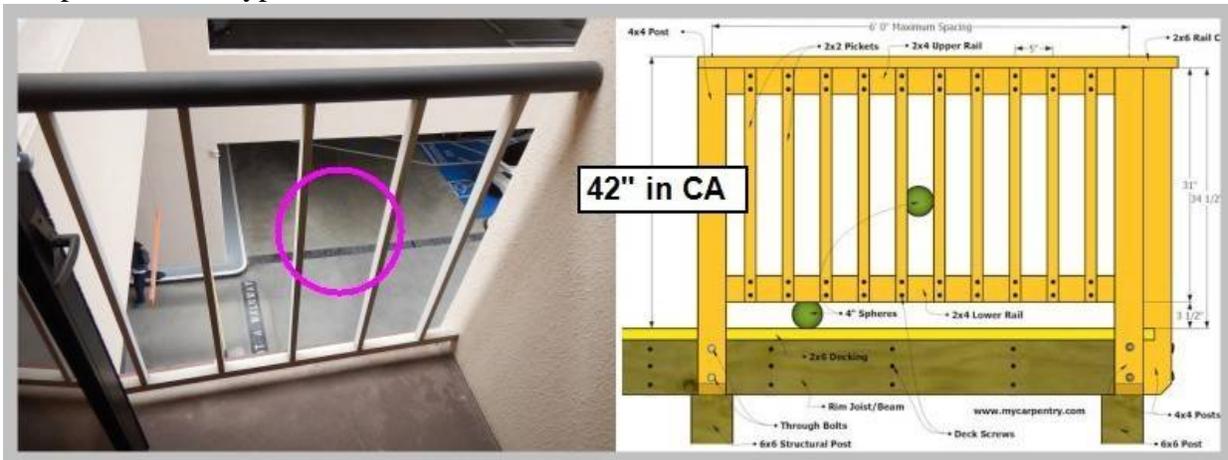
Client should be aware that the spacing between rails is not to the child safety standards of 4 inches apart. Consider improvements. Typical of all office balconies observed.

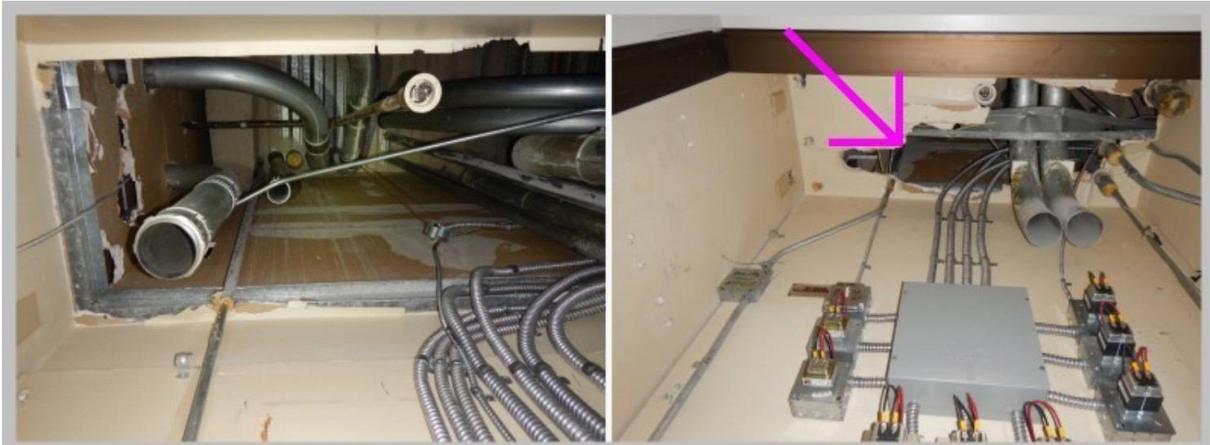
**2nd & 3rd Floor Men's restrooms**

There is a communication conduit closet in the Men's restroom. Repairs needed to ceiling to maintain fire separation. 2nd & 3rd floor restroom communications closet.

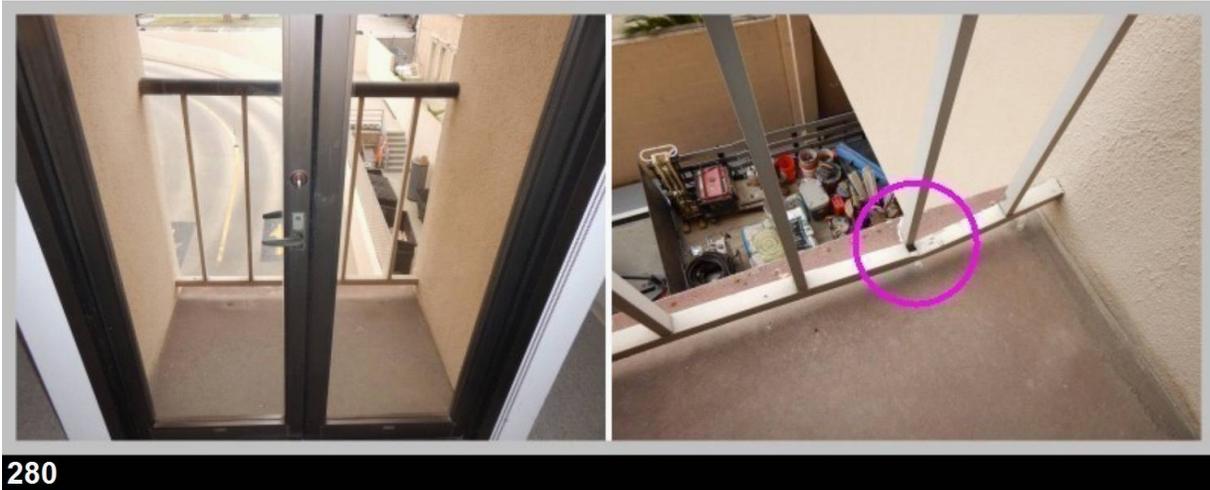
280

Many of the balcony doors would not open; stuck lock/latches, missing hardware (typical of all offices on all floors) inspected. It is possible that this can affect emergency egress, repairs should be made. Damage noted to balcony railings; safety hazard, repairs needed.

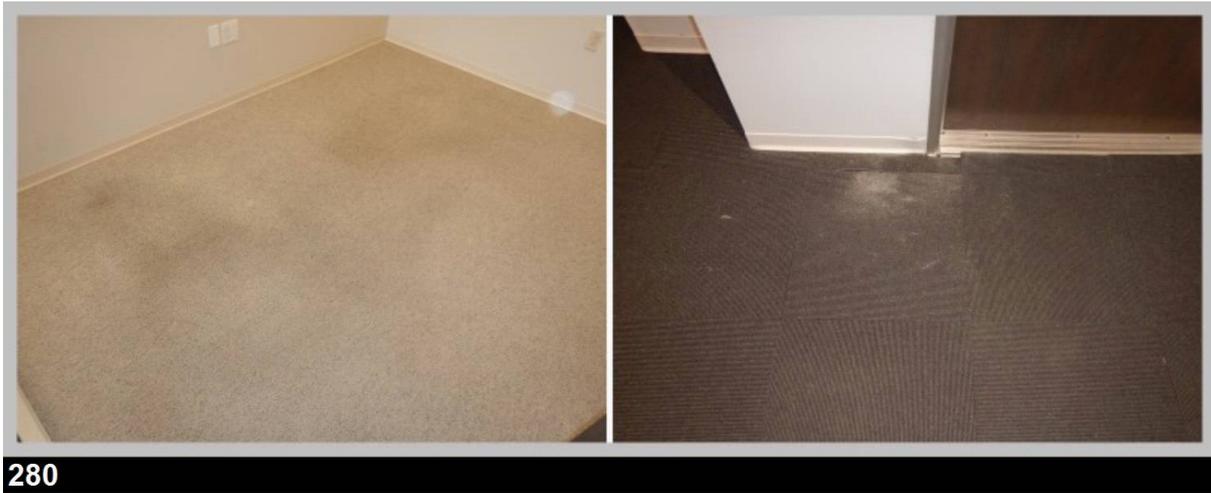
Stains area seen throughout. Inspector does not make any determination on whether or not these stains can be removed. Some damage to carpet also noted.

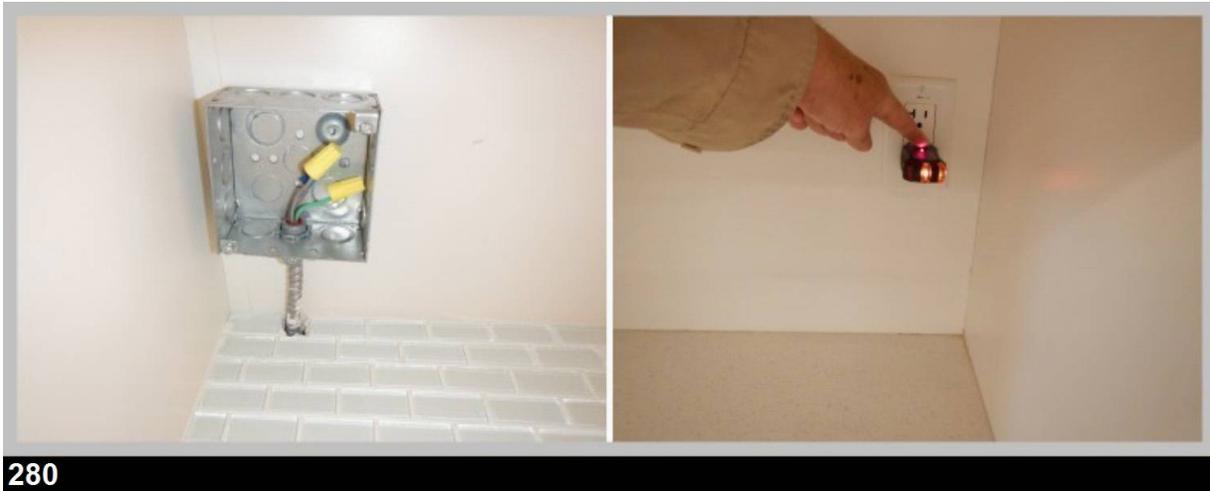
280

Exposed wiring; no j-box cover; shock hazard; repairs needed. This kitchen does not have Ground Fault Circuit Interrupt outlets installed at all locations; the age of the structure may predate the required installation; however, for safety considerations, it is strongly suggested that one be installed at any location within 6 feet of a water source.

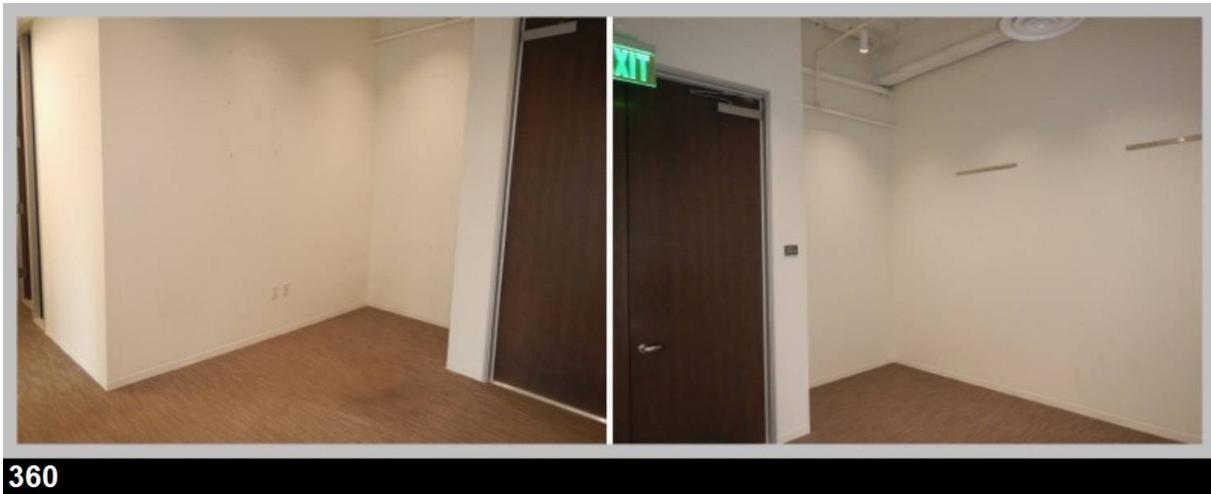
5.19 360

300: Satisfactory with general wear from previous tenant. 360: Unit interiors due for tenant improvement upgrades; damaged walls noted.

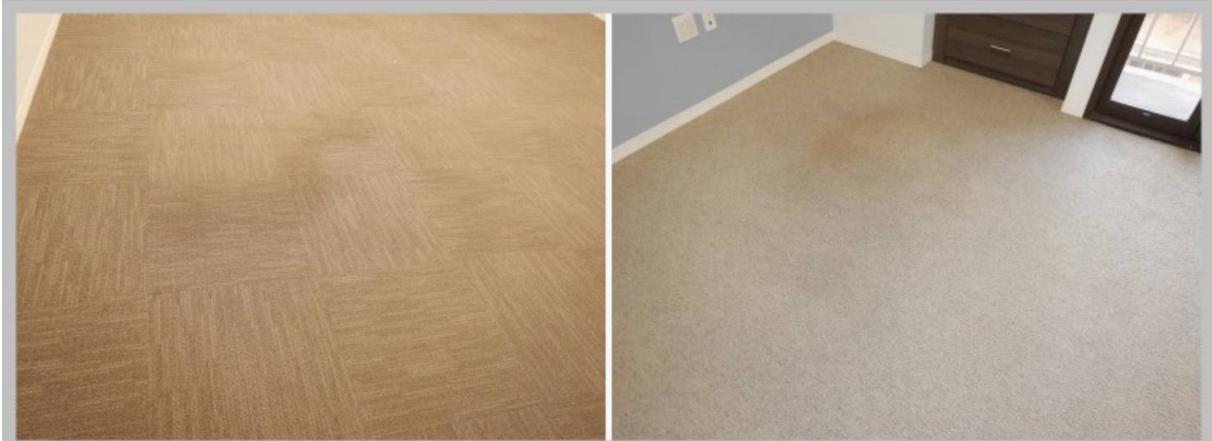
**300**

Stains area seen throughout. Inspector does not make any determination on whether or not these stains can be removed.
