ALLIANCE  
REAL ESTATE  
INSPECTIONS

# Confidential Property Condition Assessment Report

**Prepared for: Sample Client  
Prepared By: Robert Gaudreault**

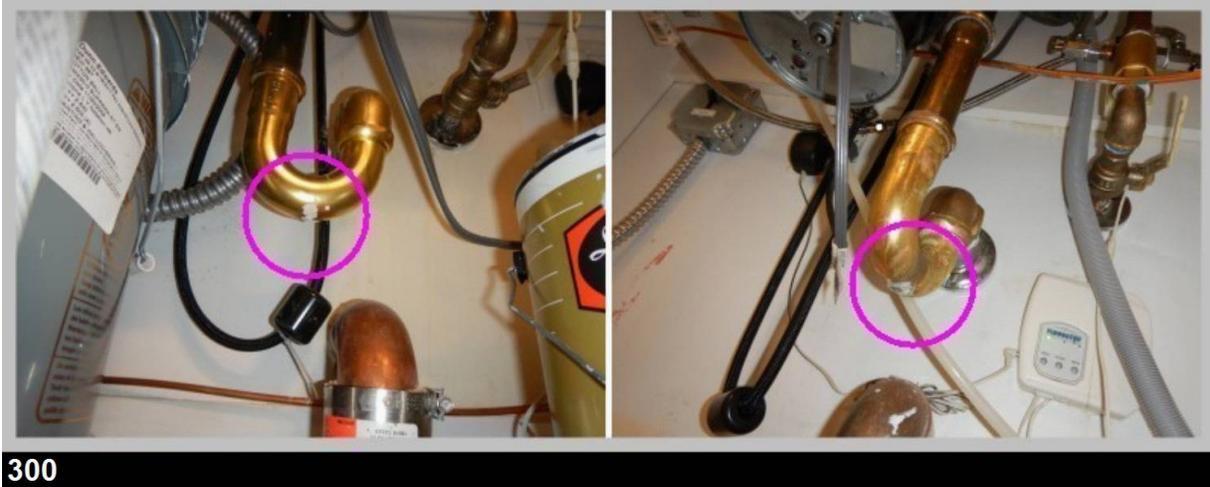
There is deterioration of the drain pipes under both sinks. Although there is currently no leak, there may be one in the future. When replacing the pipes, I recommend replacing with plastic piping which is not as affected by age and deterioration.

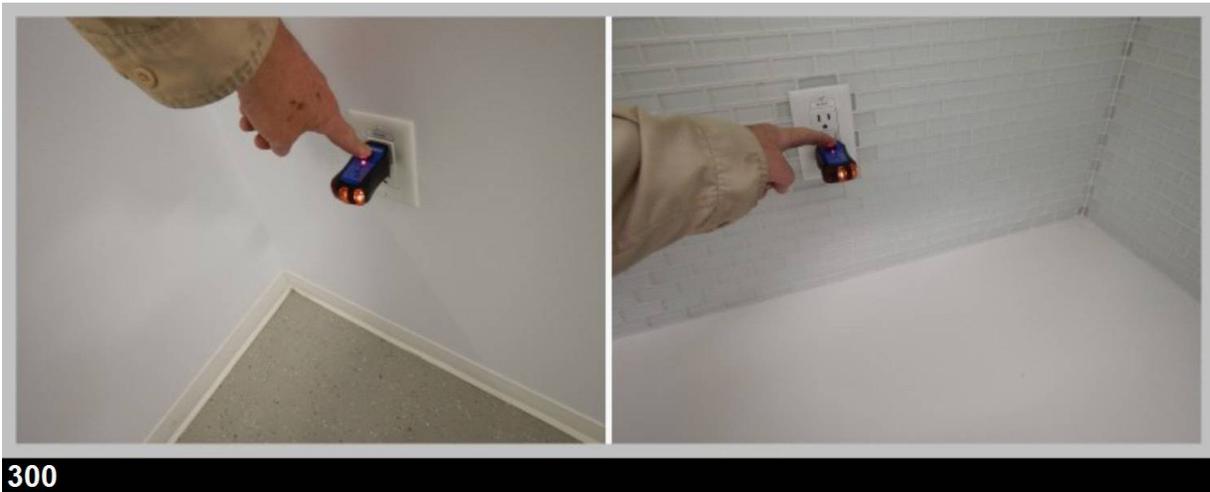
This kitchen does not have Ground Fault Circuit Interrupt outlets installed. The age of the structure may predate the required installation; however, for safety considerations, it is strongly suggested that one be installed at any location within 6 feet of a water source.

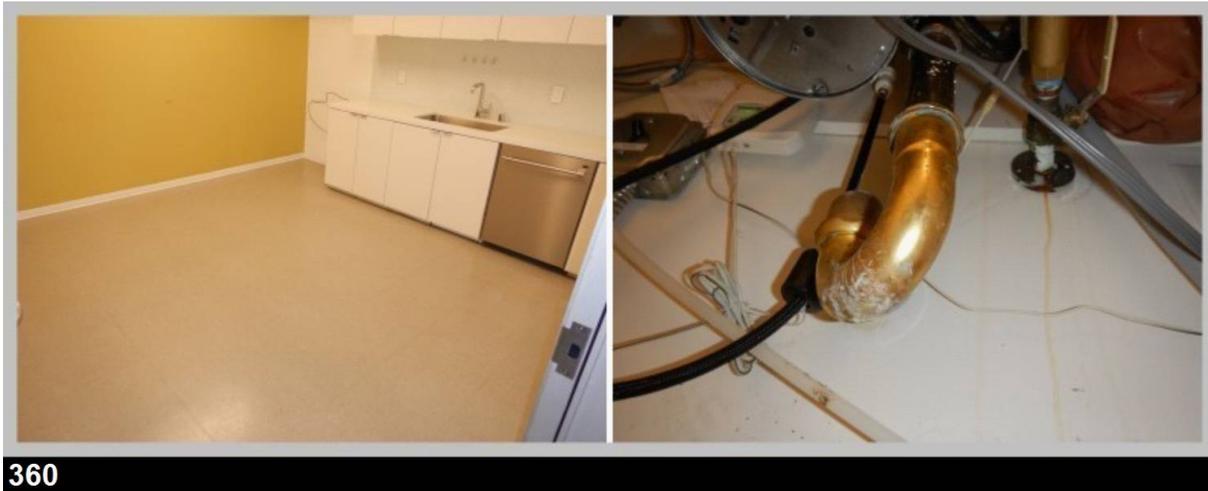
360

No hot water to faucet. Deteriorated drain, expect replacement/repairs.

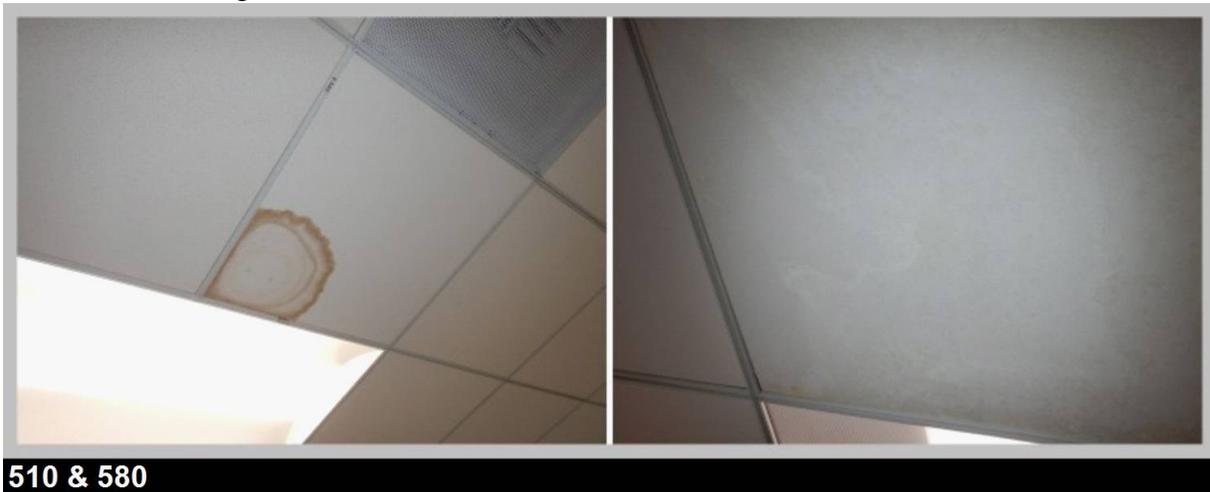
510 & 580

Water stains seen in ceiling of both 510 & 580.

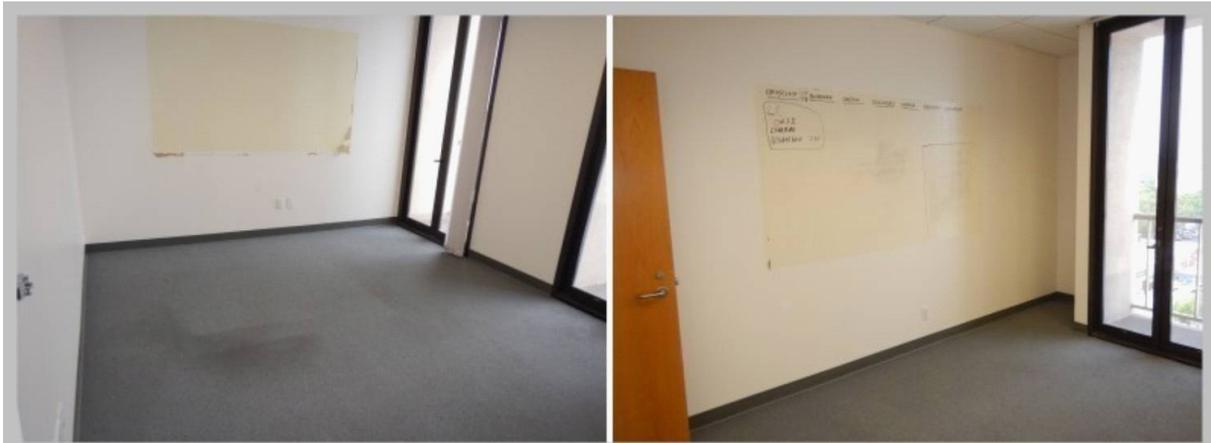
**797 Walls**

Unit interiors due for improvement and upgrades, such as paint and ceiling tiles (water stains and missing tiles).

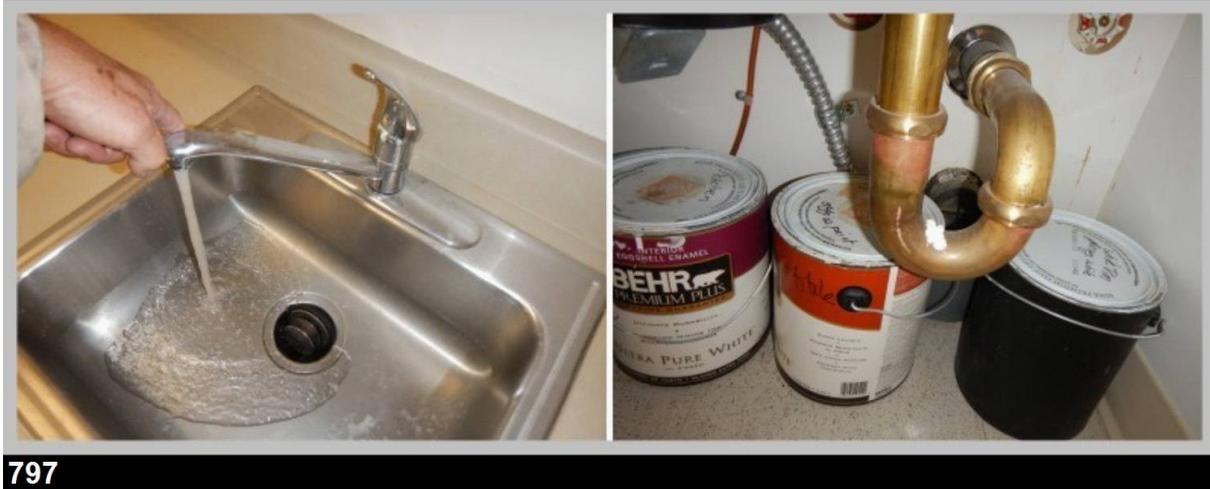
797

No hot water at faucet. Light corrosion views at P-trap or drain.

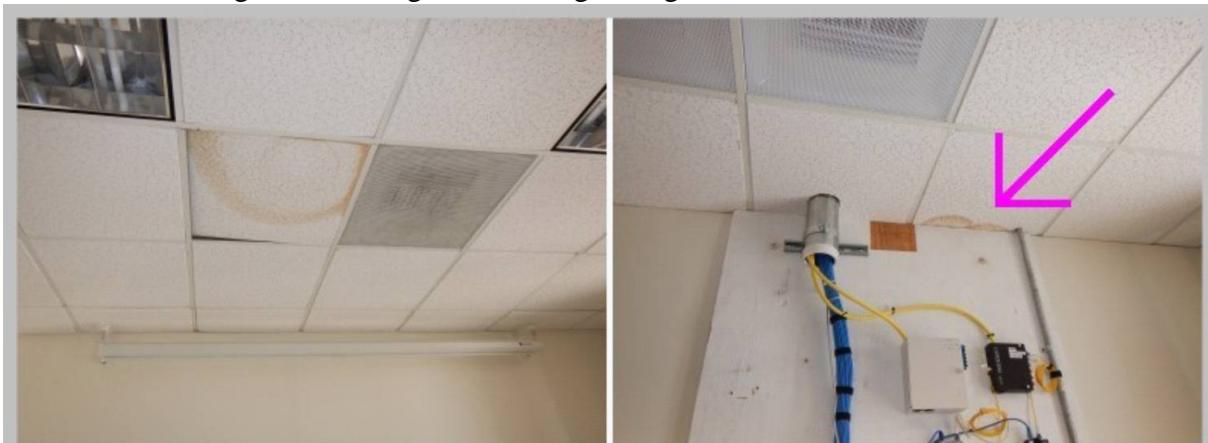
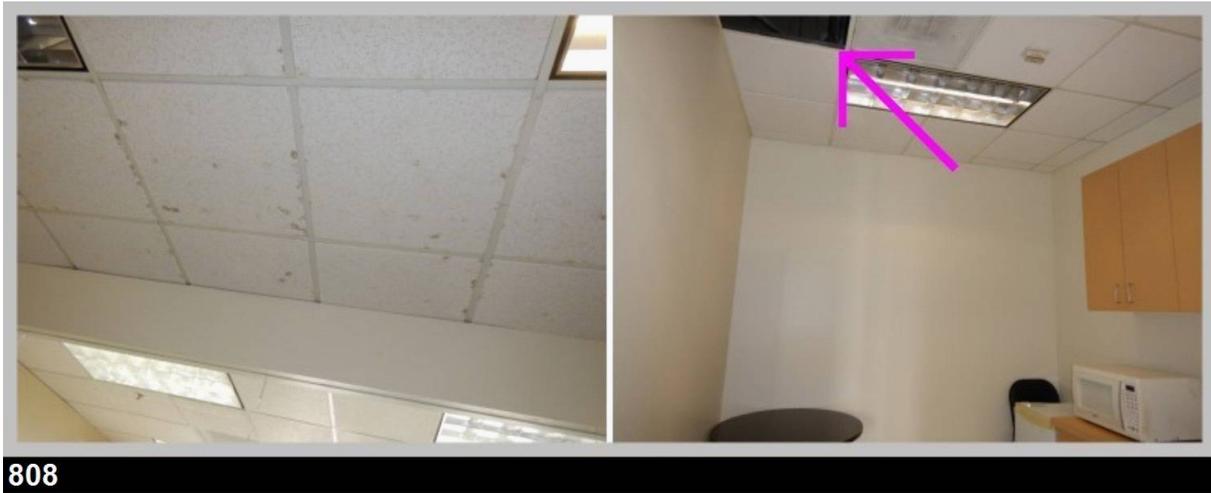
808 Water stains

Water stains seen in ceiling tiles. Damaged & missing ceiling tiles also noted.

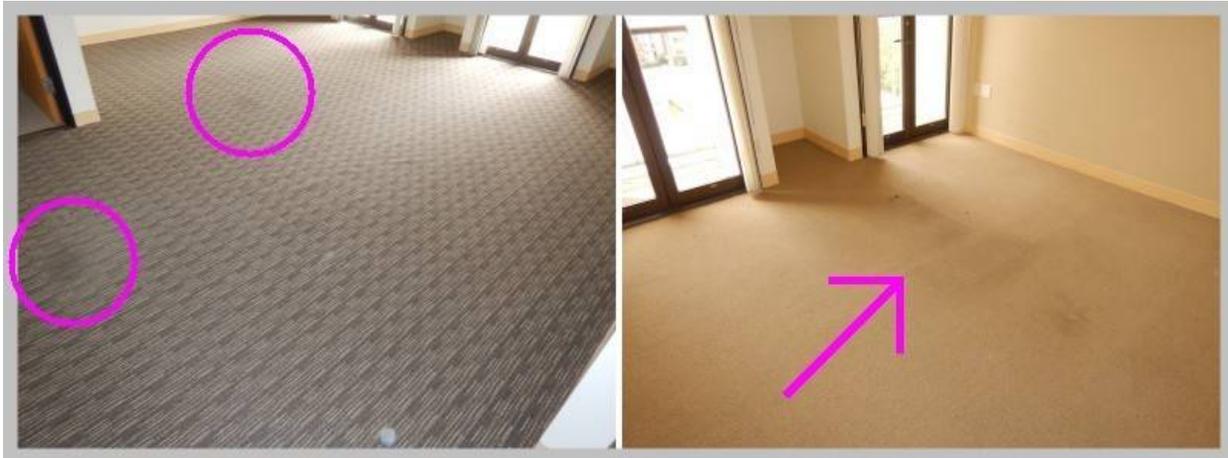
Stains area seen throughout. Consultant does not make any determination on whether or not these stains can be removed.

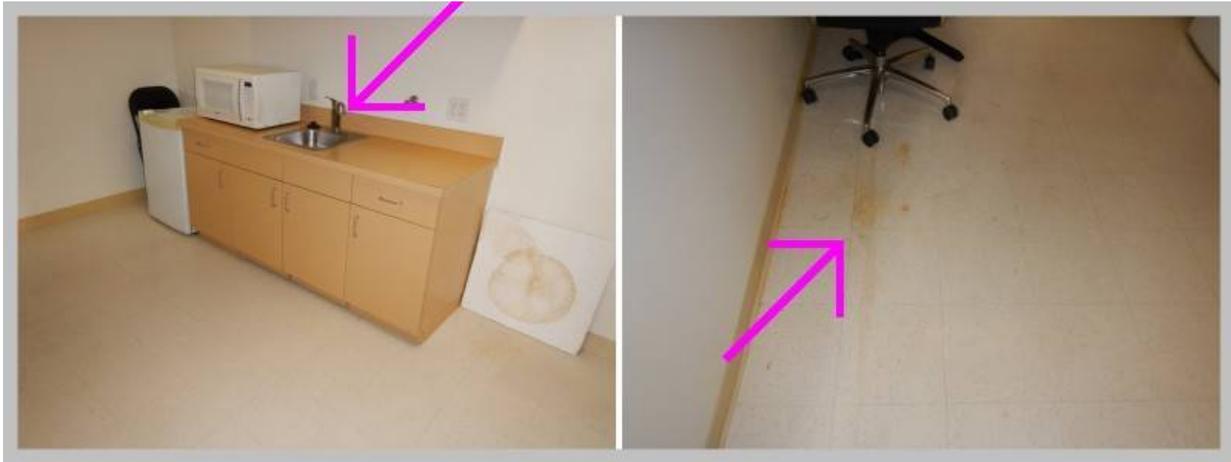
No hot water to faucet. Stains noted on flooring. Repairs needed.

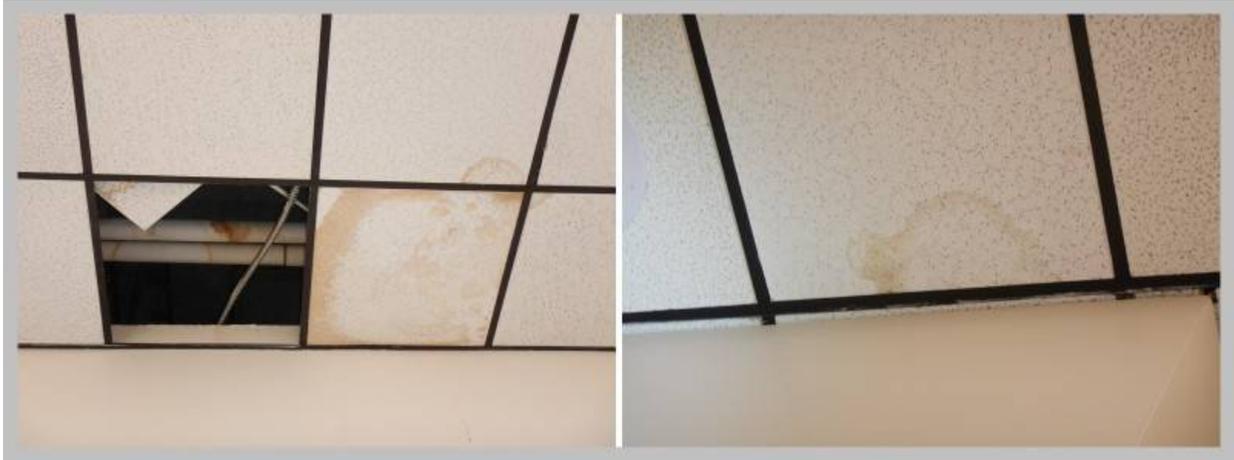
Water stains noted on ceiling tiles; expect repairs.

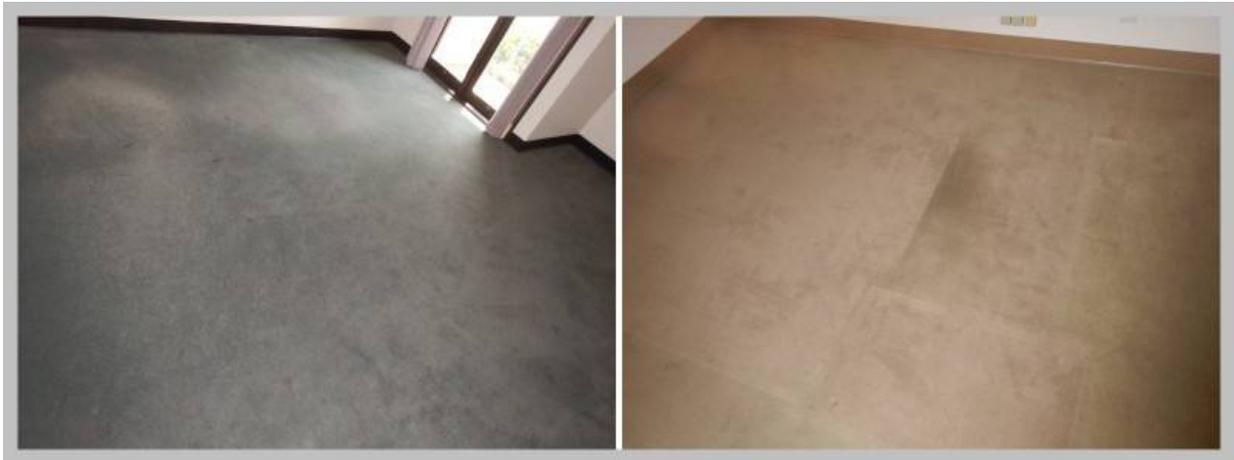
The general condition of most of the flooring is fair with some wear due to age and use. Stains area seen on carpets.

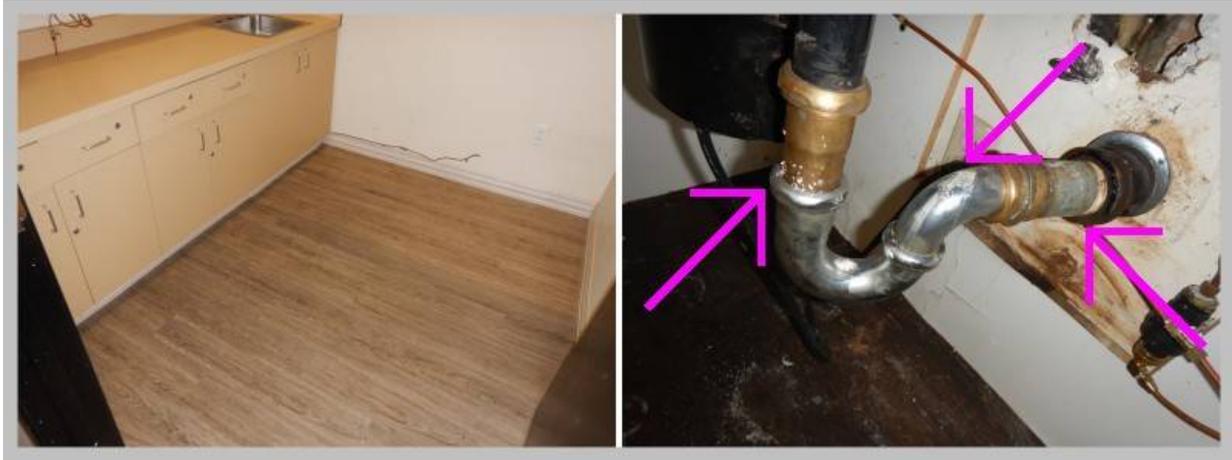
Corrosion noted to drain located under sink. Consider replacement to reduce risk of leak.

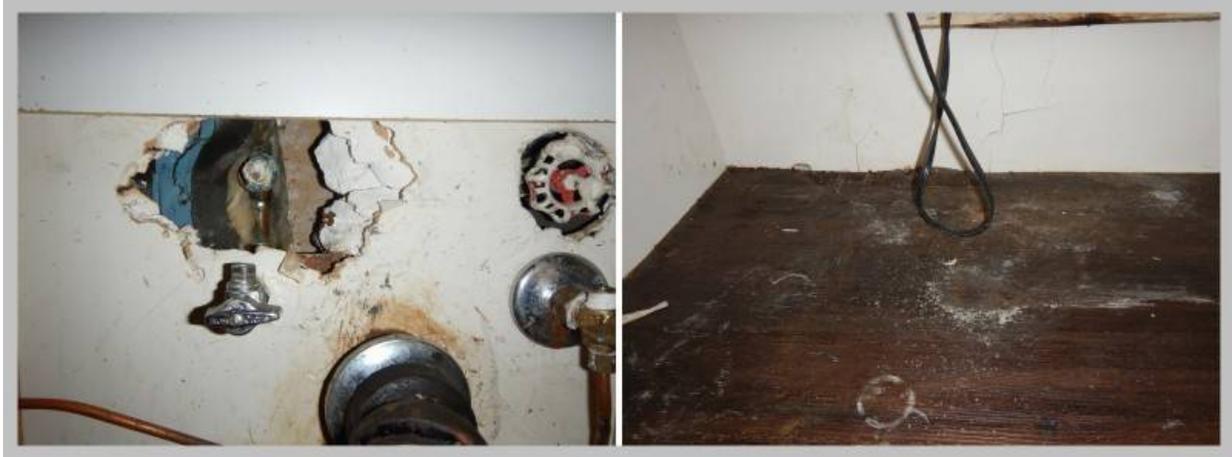
Water damage noted to cabinet bottom and there is a hole in the wall that was never patched; repairs needed.

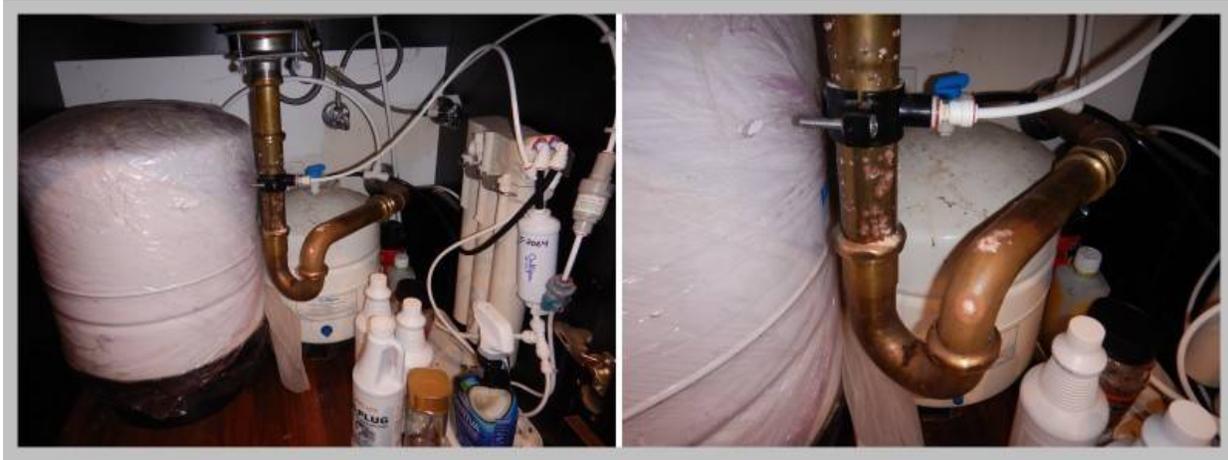
There is deterioration of the drain pipes under the sink. Recommend replacement before leaks occur.
