ALLIANCE
REAL ESTATE
INSPECTIONS

Confidential Property Condition Assessment Report

**1234 Your Drive
Simi Valley CA 93063**

**Prepared for: John Smith
Prepared By: Robert Gaudreault**

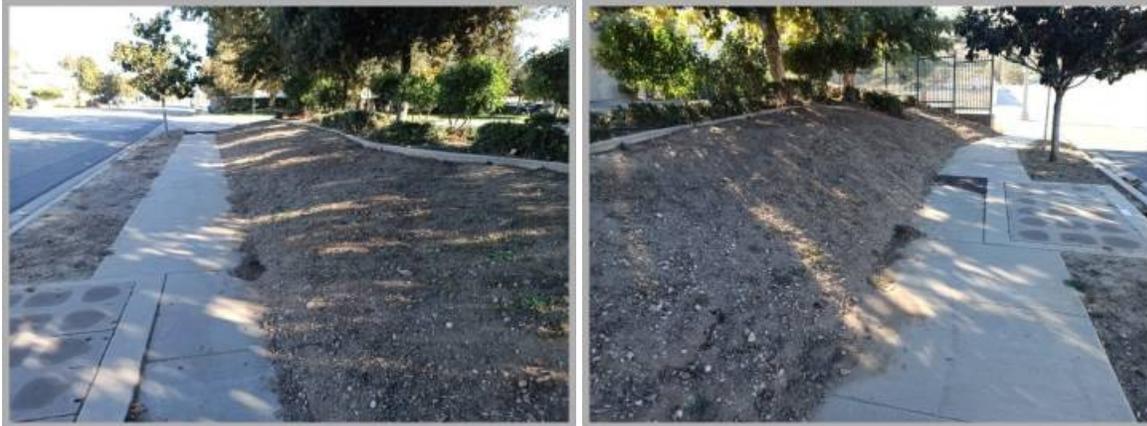
2.3 CONDITION:

West side berm lacks planting. Signs of some erosion onto public walk seems apparent.

Possibly an HOA issue. Enquire with owner.

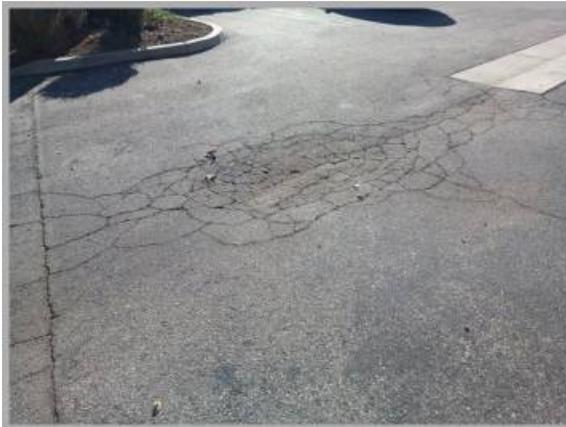
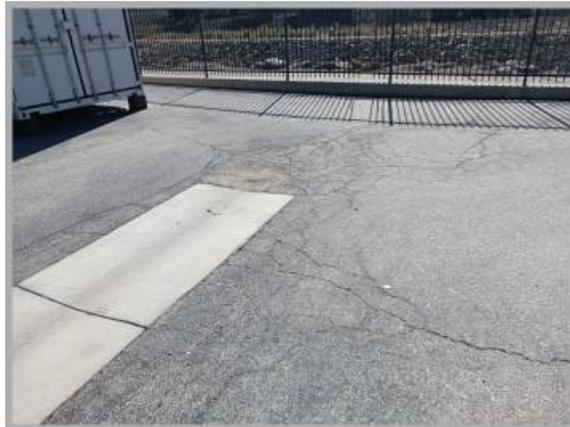
2.7 CONDITION:

The parking paving area needs action. Alligating of moderate severity at east parking. More than likely due to structural base failure. Seal coat over all areas of parking has worn off.

Patching 331 sf of segmented sections and seal coat overall 8200 sf pf paving.

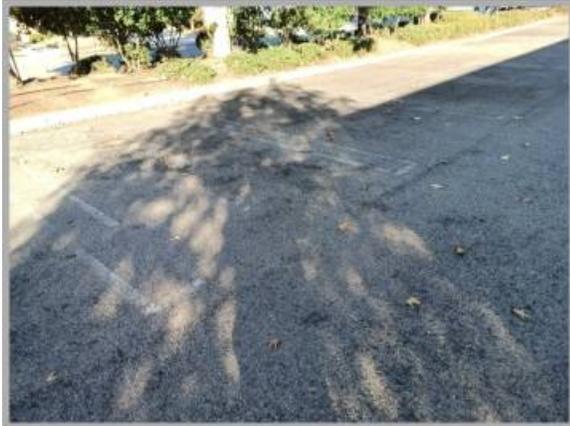
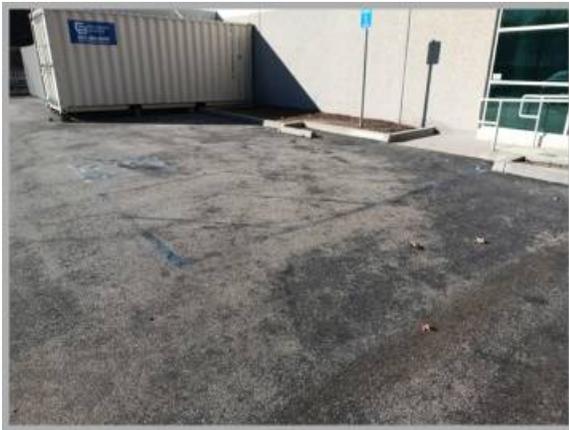
2.9 CONDITION:

Parking lot striping was generally severely worn, faded and illegible in areas. Parking lot should be re-striped. The parking lot capacity was approximately 27 parking stalls.

Restripe parking stalls and two ADA parking stalls.

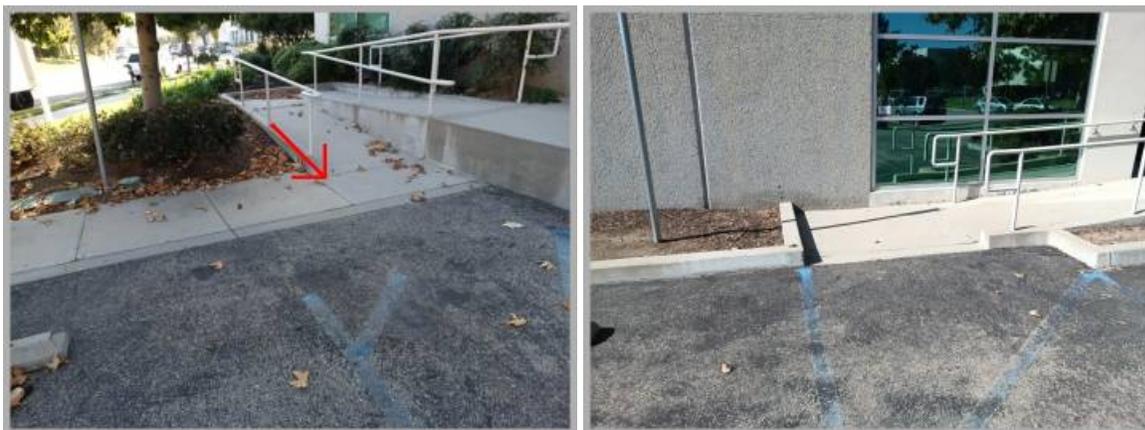
2.12 CONDITION:

Truncated domes are lacking at the ends of each ADA ramps. AI Overview The purpose of truncated domes is to provide a tactile warning to visually impaired individuals that they are approaching a hazardous area,

Recommend corrections to ADA ramps by adding truncated domes.

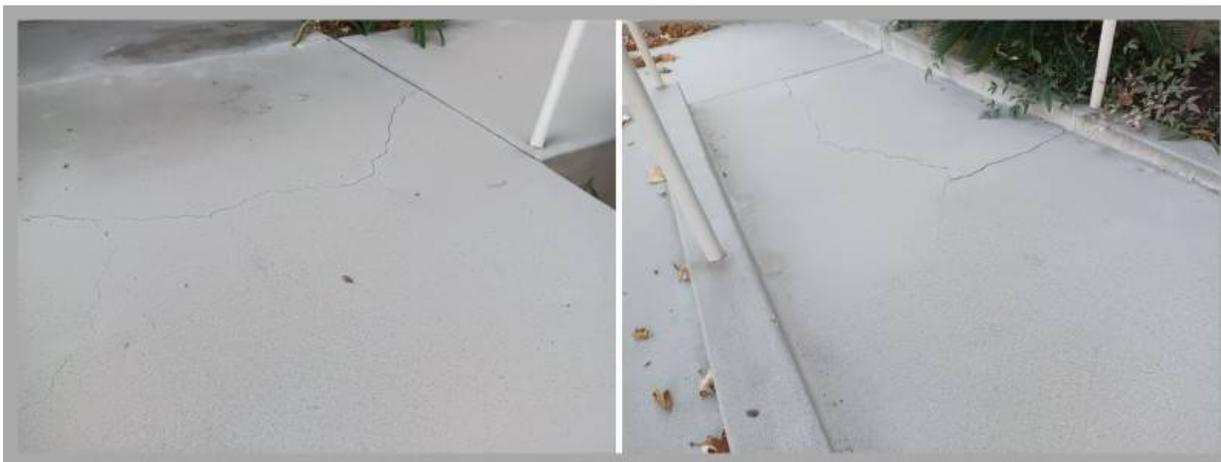
West side entrance ramp exhibited some slight settlement cracking. Maintain as needed by grinding out and slight raised section.

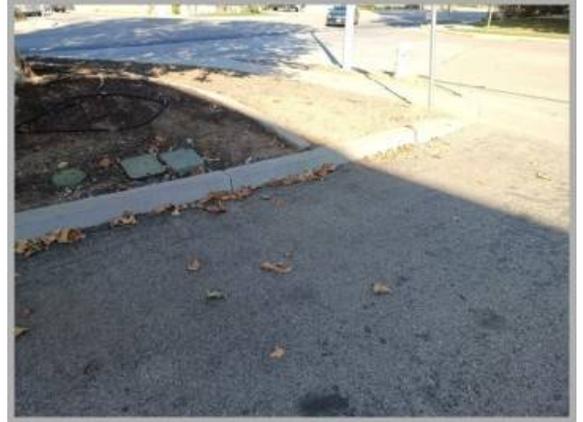
2.14 CONDITION:

Some heaving observed at north west section of curbing.

Repair 8 feet of concrete curb.

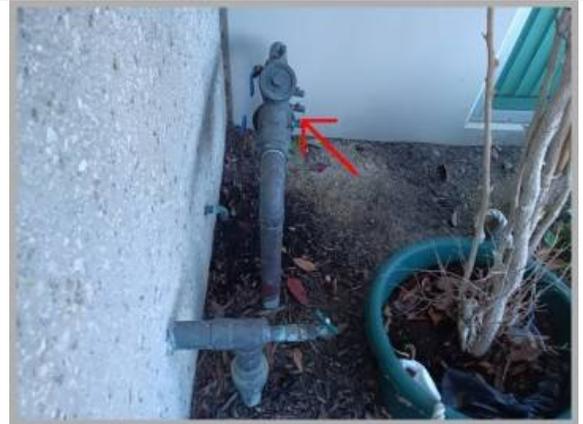
3.3 Visible Supply Lines:

Main water supply is copper. No evidence of back flow test. Backflow testing on a commercial irrigation supply should be done annually to ensure the proper functioning of the backflow prevention device and protect the potable water supply from contamination; most local regulations require annual testing.

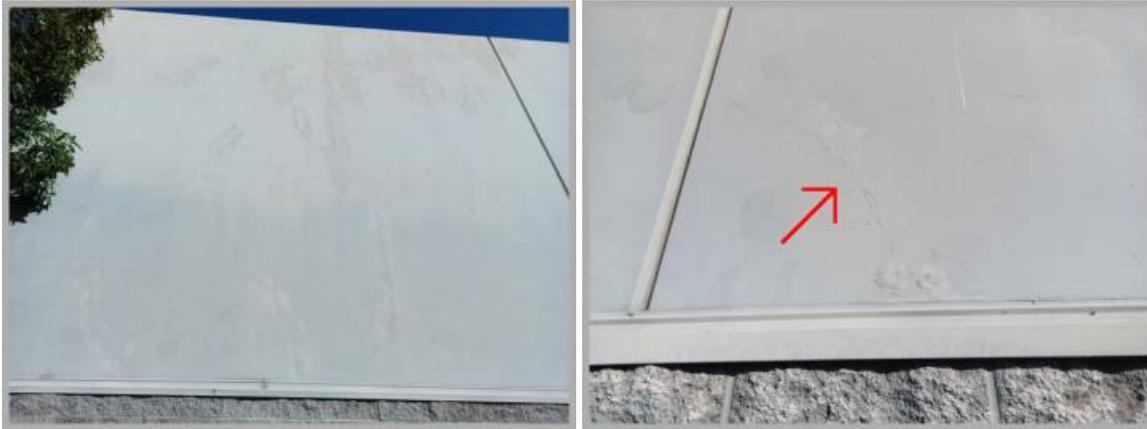
5.2 CONDITION:

Satisfactory with only hairline cracking indicative of hydration referred to as drying shrinkage cracking. Painting and sealing cracks can help reduce any water infiltration.

Monitor and maintain.

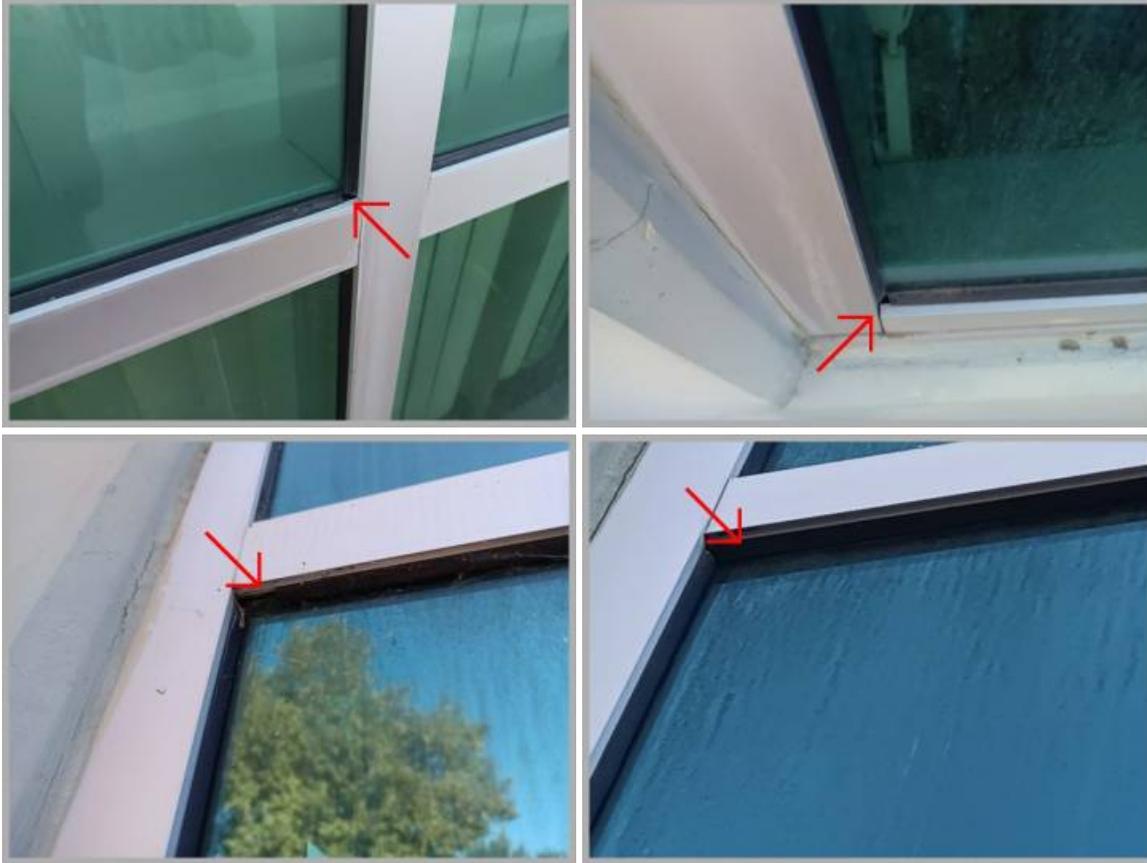
5.7 CONDITION:

Windows are in need of maintenance. Some gasket seals are starting to show damage. The standard for repair is to remove all gaskets from that damaged window and reseal the entire window with approved caulking.

Further evaluation needed. Consult window installer, glazing contractor. Repair gaskets to at least 5 to 6 window panes.

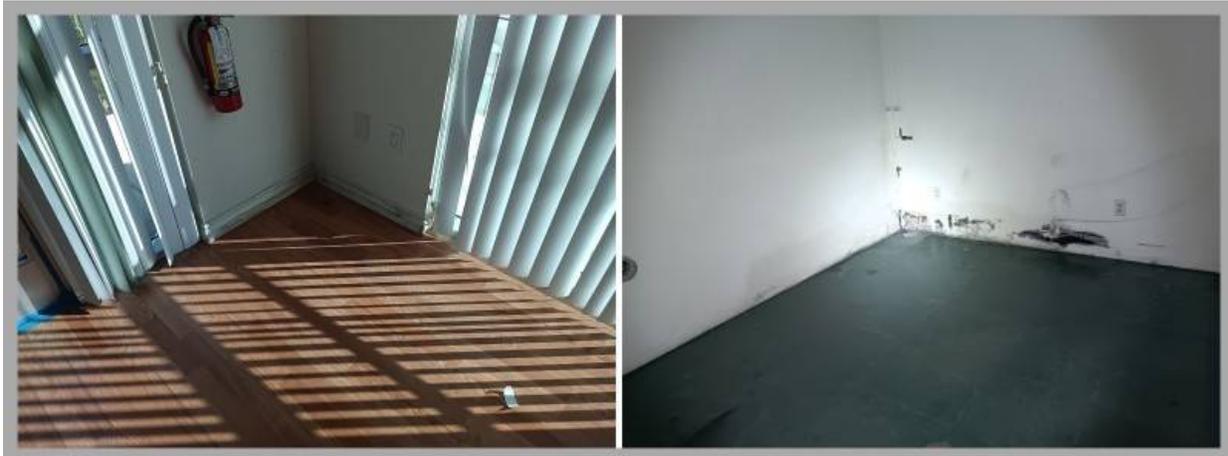
5.16 INTERIOR OBSERVATIONS:

Water stains seen in various areas that are more than likely due to previous roof leak issues, such as one room adjacent to warehouse and north east office space. Some of the darker stains should be evaluated and tested by an environmental agency. This would determine on whether or not any special remediation procedures would need to be followed.

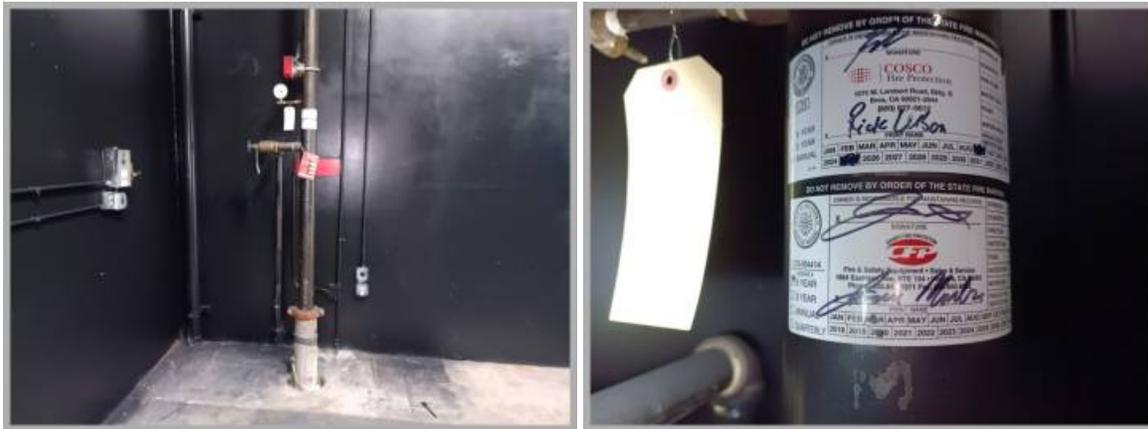
There is a fire sprinkler system installed. It is recommended that it be checked by a certified professional with appropriate experience. The type of system installed is referred to as a Wet Pipe System. 1 year and 5 year indicated past due.

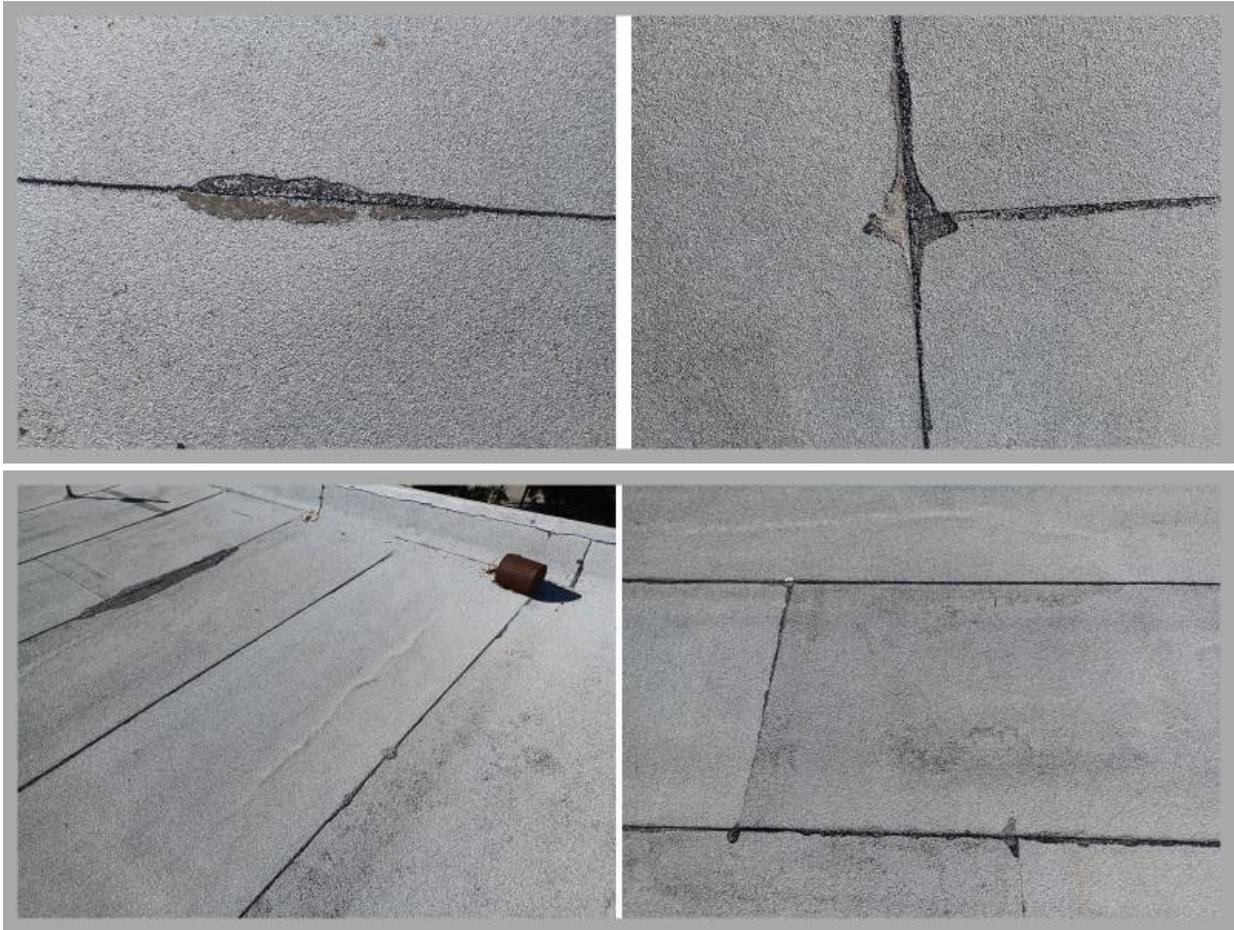
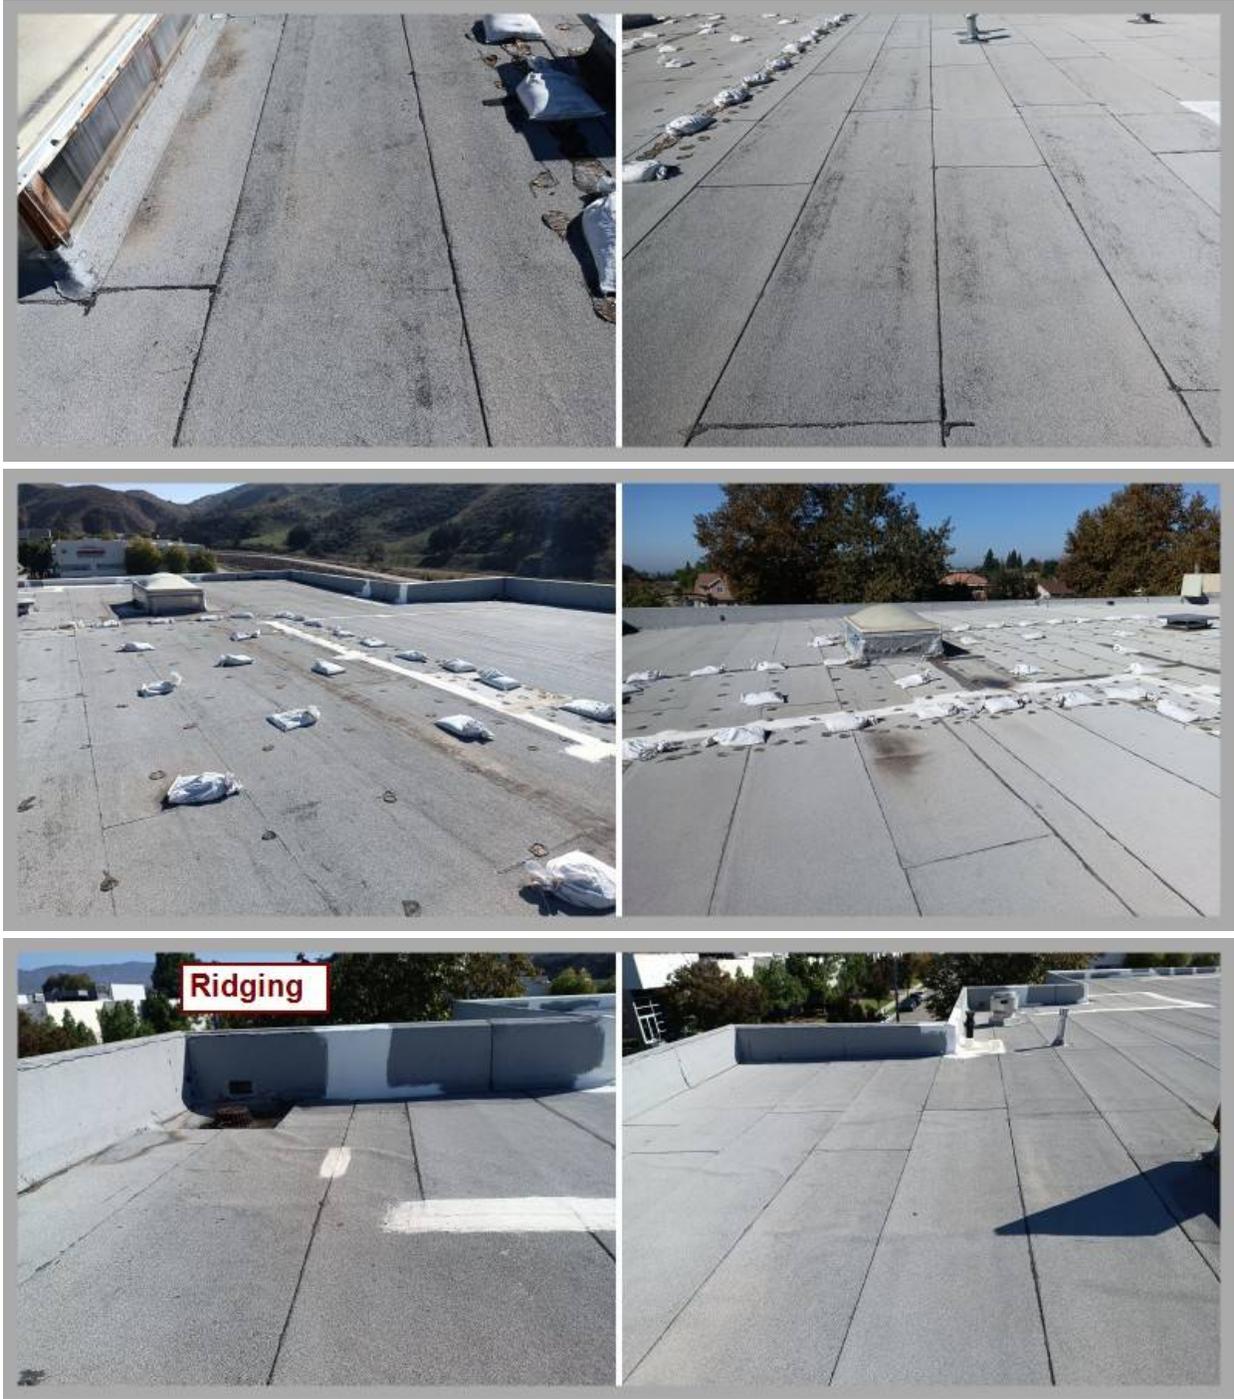
6.5 CONDITION:

Sand bags are seen on the roof system as well as odd patching. Uncertain as to what occurred. Enquire with seller as to any known history.

Rehabilitate roughly 7900 sf of roofing. Flat roof rehabilitation is a process of cleaning, repairing, and applying protective fluid type coatings or membranes to an existing flat roof to extend its lifespan, rather than replacing it entirely.

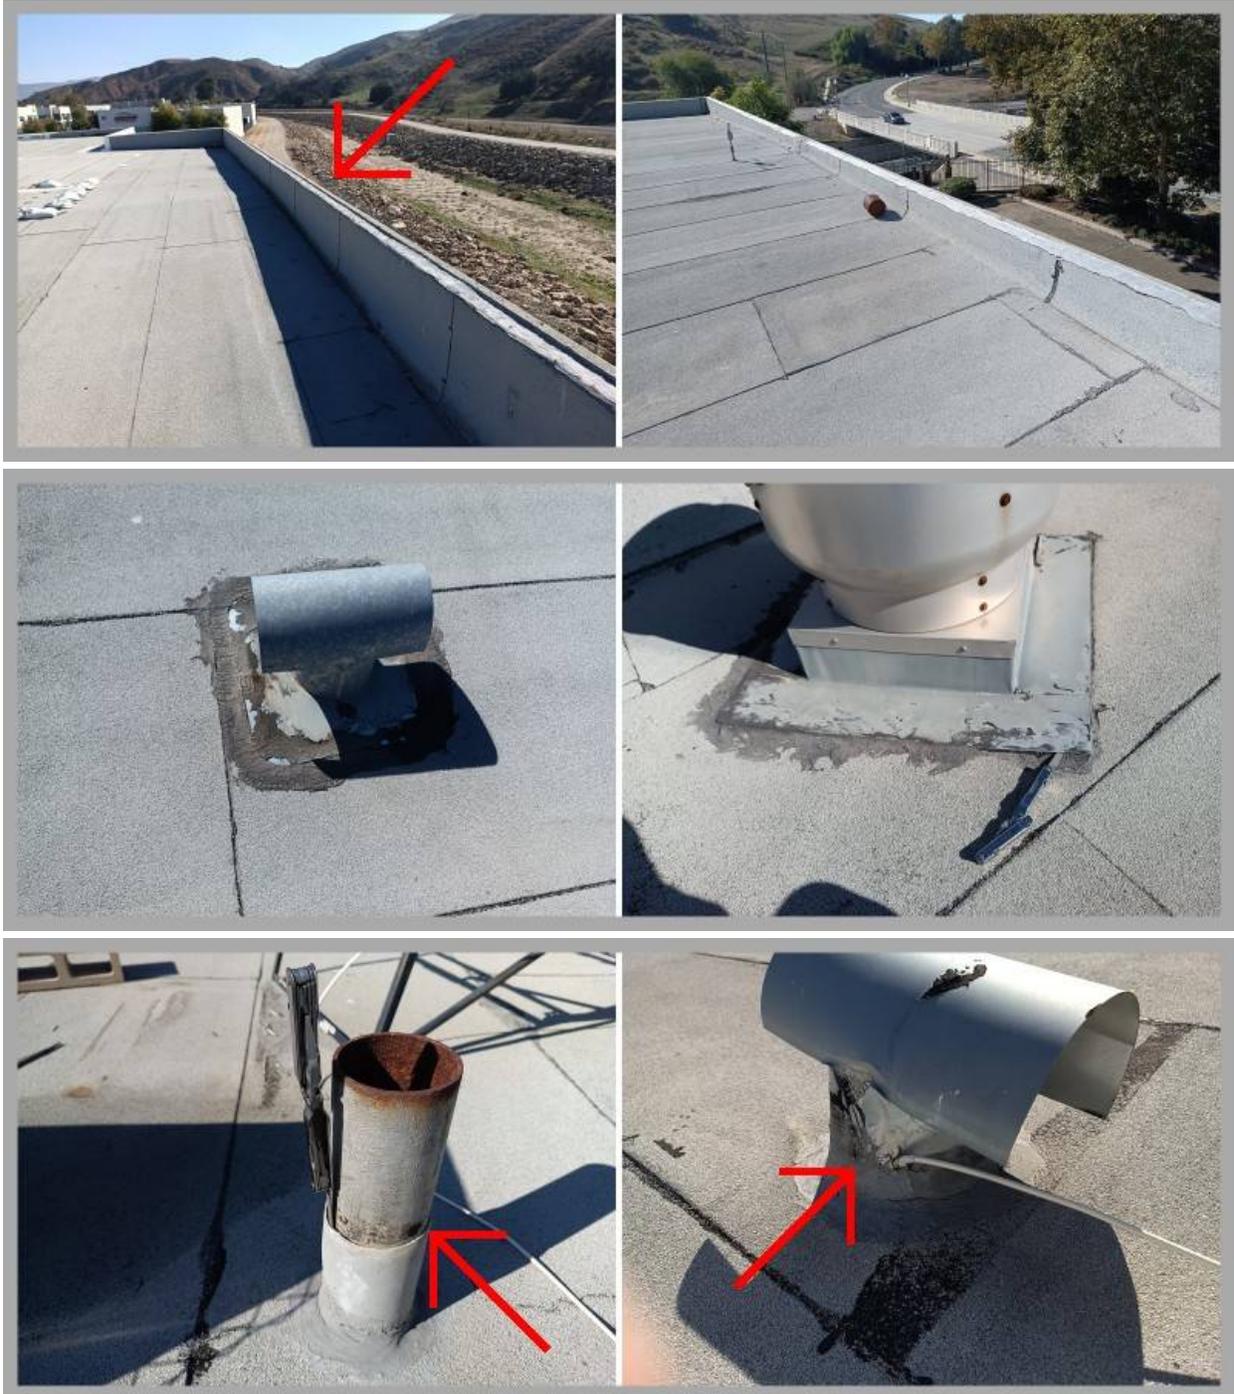
6.6 FLASHINGS:

Parapet wall lacks coping flashing, mastic applied to some of the roof penetrations is worn and cracked and prone to leak.

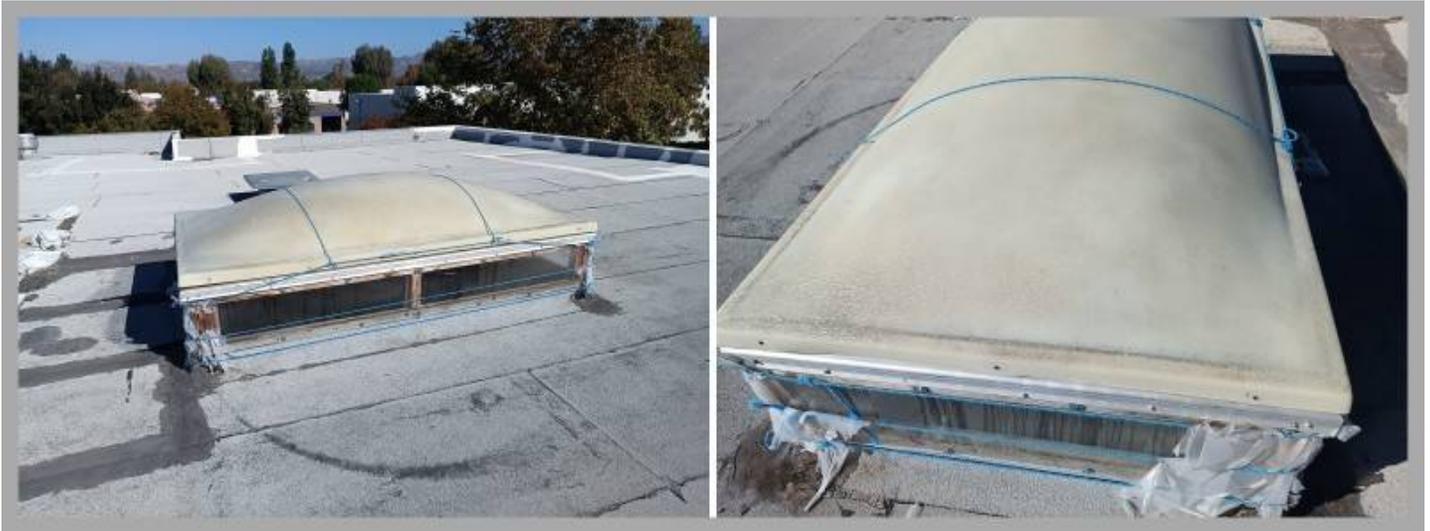
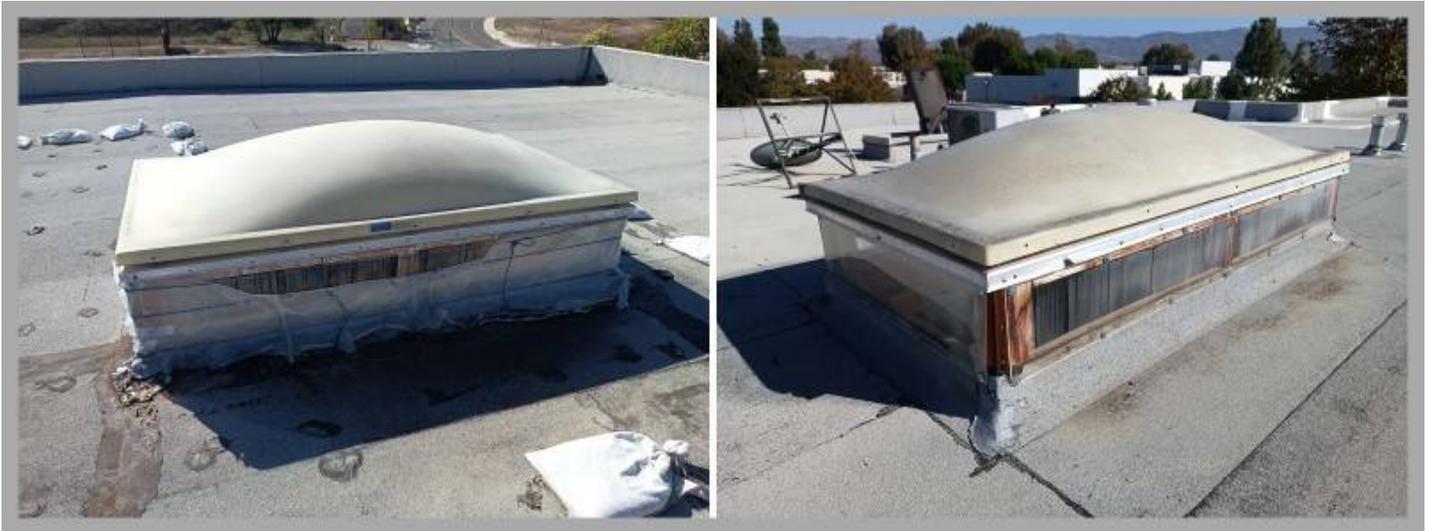
6.7 SKYLIGHTS:

Skylights have been modified from their original configuration which can void any warranty or coverage. Dome lenses are deteriorated and need replacing.

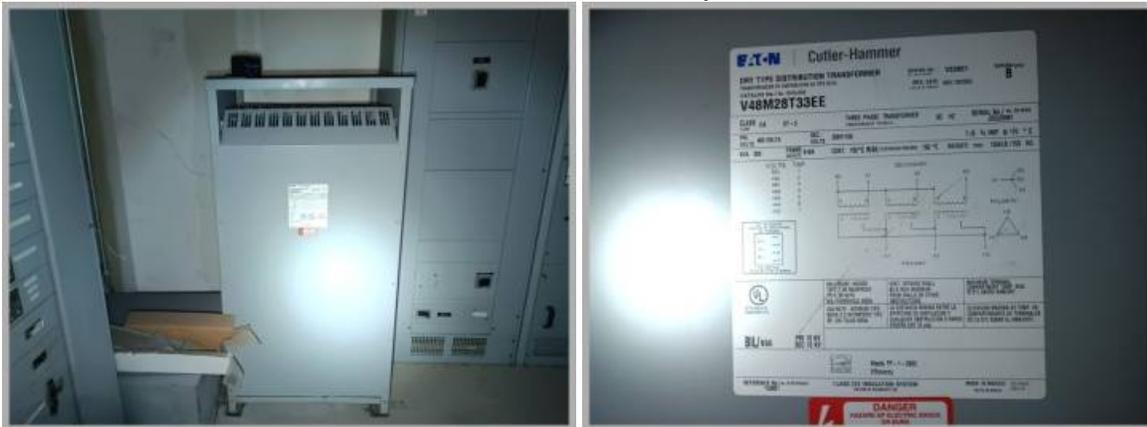
7.33 LOCATION & TYPE:

Dry type, Size: 300 KVA. Located in main electrical room. 22 year old.

Some humming. Maybe normal. Transformers produce audible hum due to: Magnetostriction core laminations vibrating at 120 Hz (from 60 Hz AC). or loose mounting bolts or panels rattling. Although this humming may not be of significance is should be reviewed further.

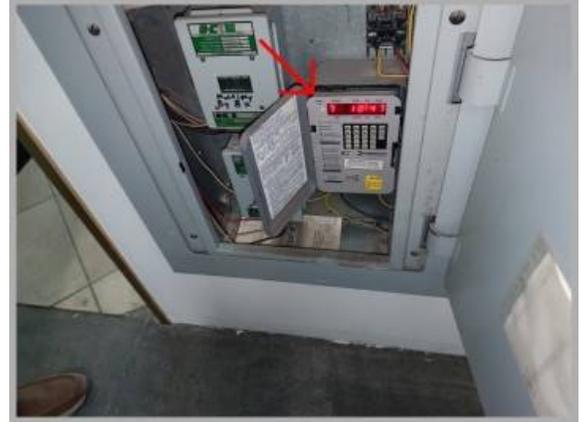
A representative sampling of switches was achieved. These tested appeared to be operating properly. However timer controls of office lighting is loose from within its box.

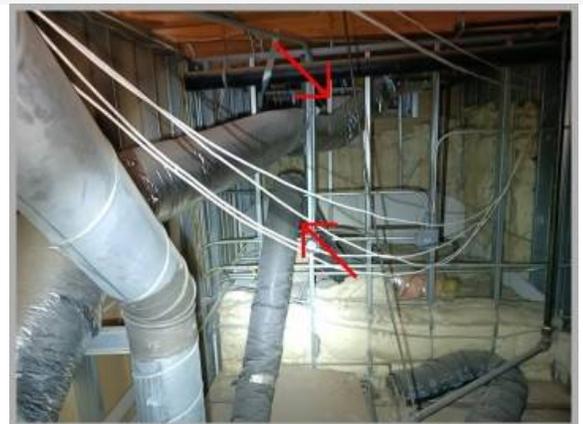
Poor. Inadequate support and sections of duct seem to sag more than one inch in 4 feet. Sagging ducts should be prevented as it can affect efficient air flow.

Replacement of 5 ton package unit.

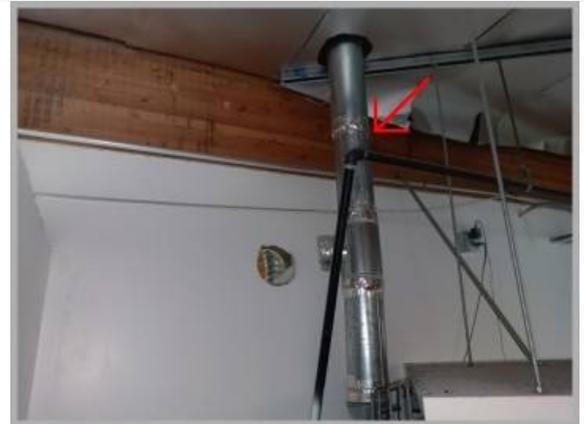
Evidence of leak seen along vent at west side unit.

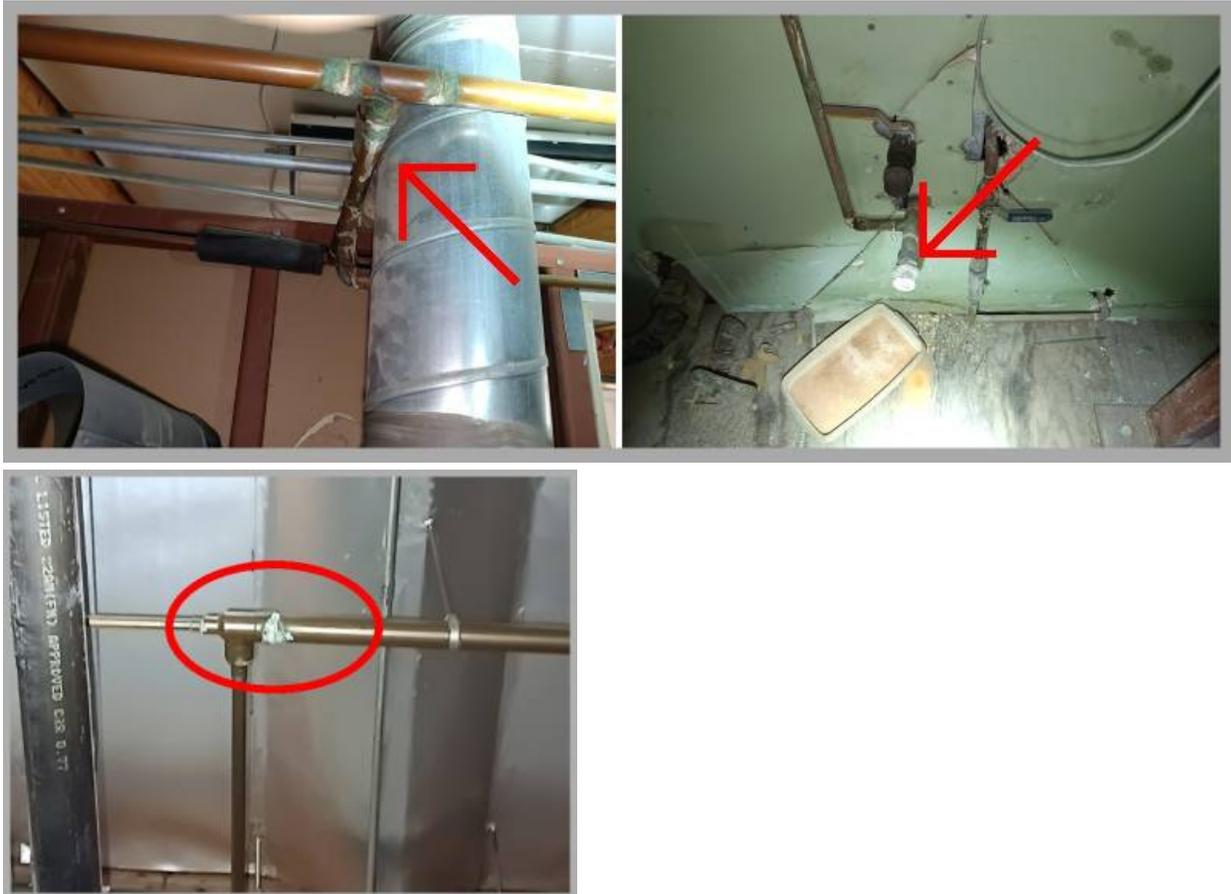
Copper to galvanized contact noted in areas. This does result in eventual corrosion as the more pure metal (copper) will eat away at the less pure (Galvanized). This is referred to as electrolysis. Ideally a coupler or brass would have been used between the two metals and heavy oxidation observed in at least one location. Implications are greater potential for leaks posing water damage to structure as well as interior content. This condition is noted at ceiling above office area.

Further evaluation needed by a licensed plumber.

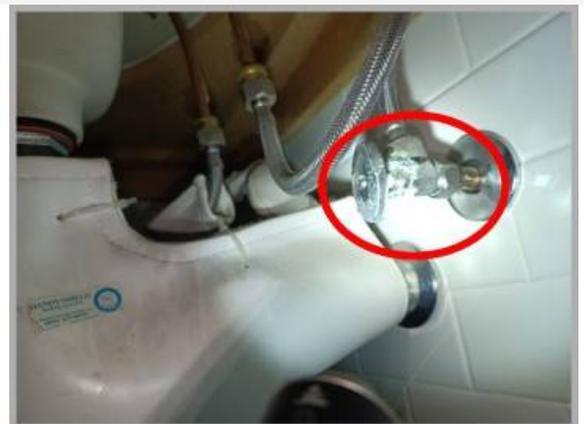
11.2 FAUCET:

ADA pads are missing from angle stops. These exposed valves exhibited oxidation. No leak at this time however maintenance should be achieved.

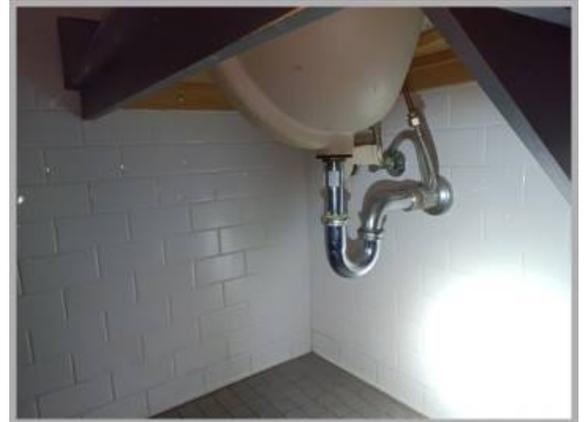
11.12 VANITY CABINETS:
ADA protection pads missing.

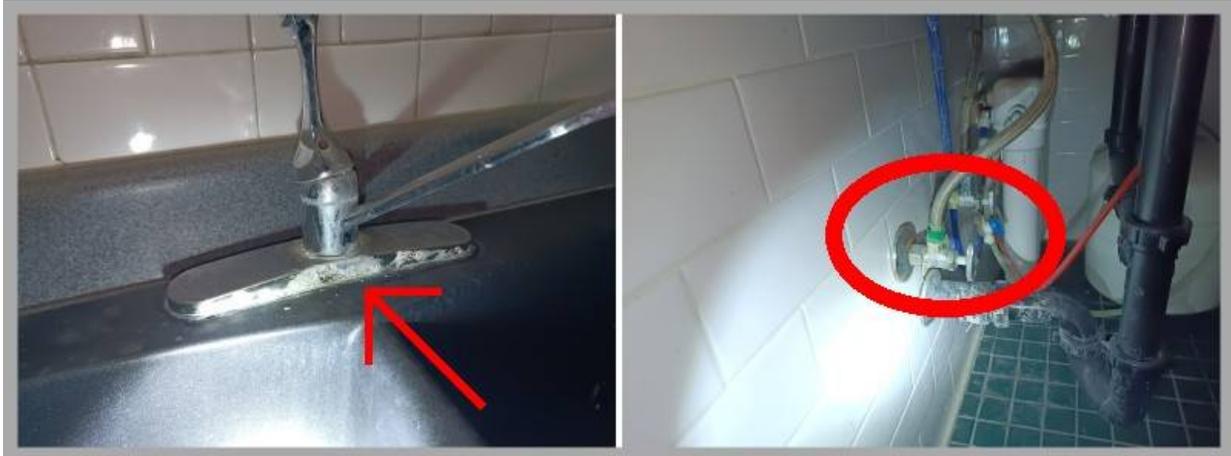
11.19 FAUCET:

Heavy oxidation at angle stop valves and faucet is excessively corroded and needs replacing.

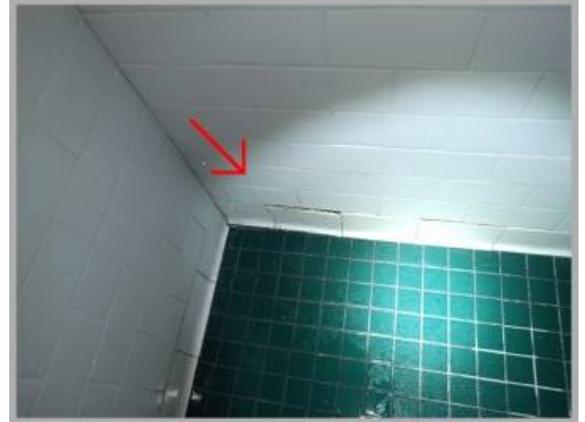
Damaged wall tile. Implications are potential for leak into substrate.

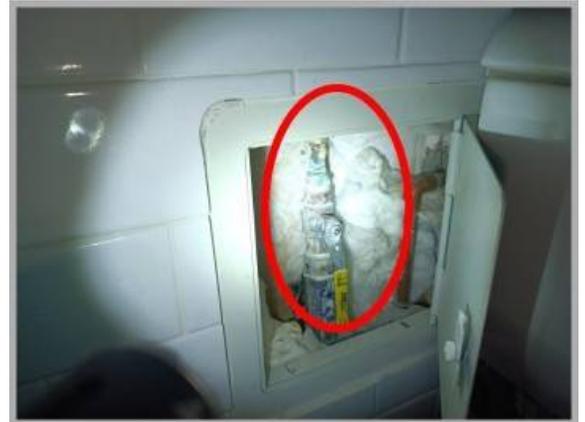
Corrosion is noted to fill valve located behind toilet. Further evaluation needed. Consult plumber.

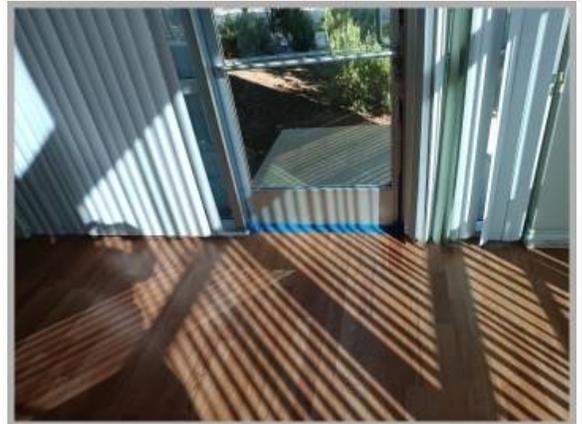
12.5 Doors:

A representative sampling of interior doors was achieved. Those operated were in serviceable condition. However entry door of north east office is tapped over apparently to prevent water or dirt entry.

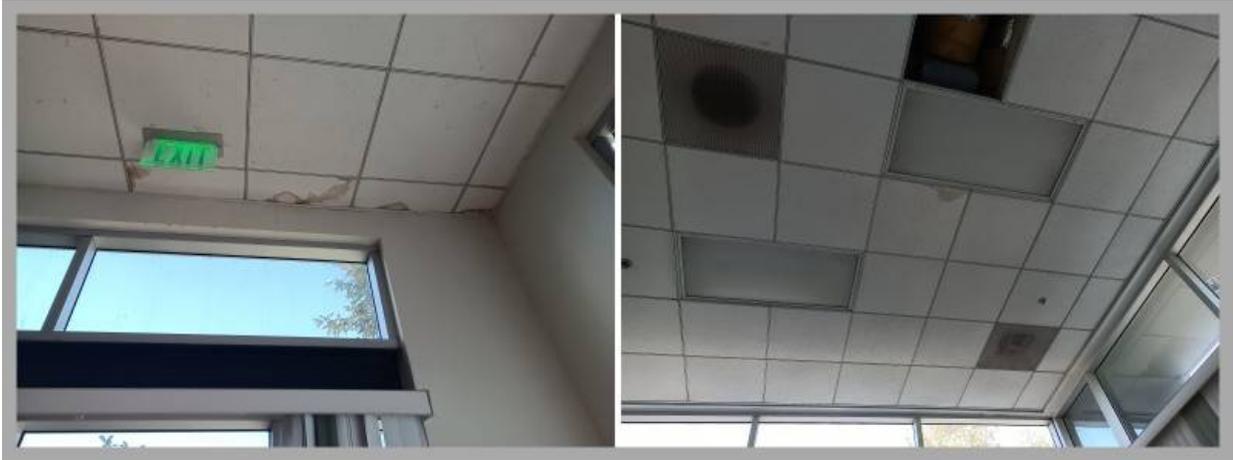
12.6 Condition of interiors:

Water stains seen at various locations.

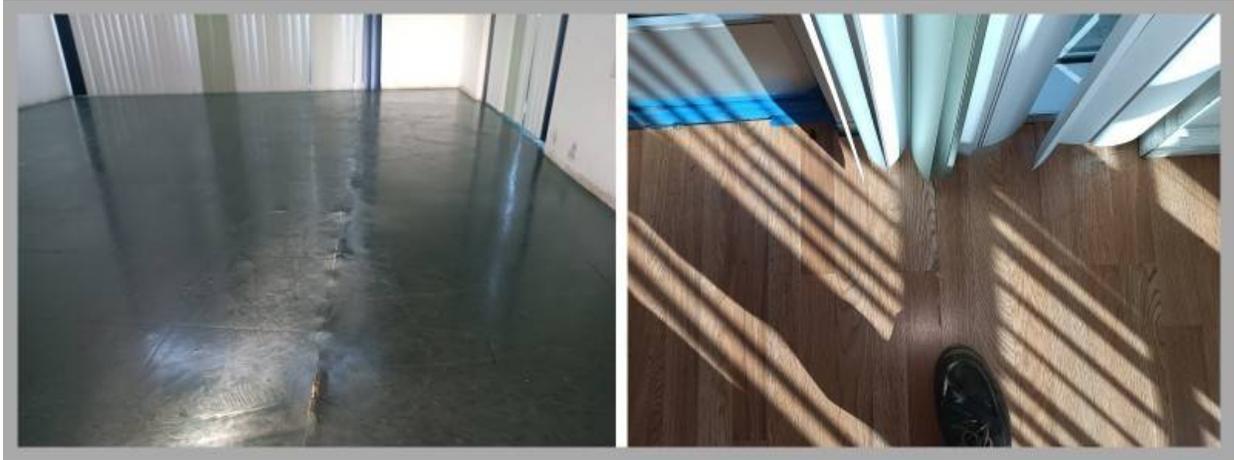
12.8 Floor Condition:

Resilient flooring exhibited damage, such as curling which is indicative of water related damage, water damage also apparent at wood flooring of north east office.
