ALLIANCE
REAL ESTATE
INSPECTIONS

Confidential Property Condition Assessment Report

**Prepared for: Sample Client
Prepared By: Robert Gaudreault**

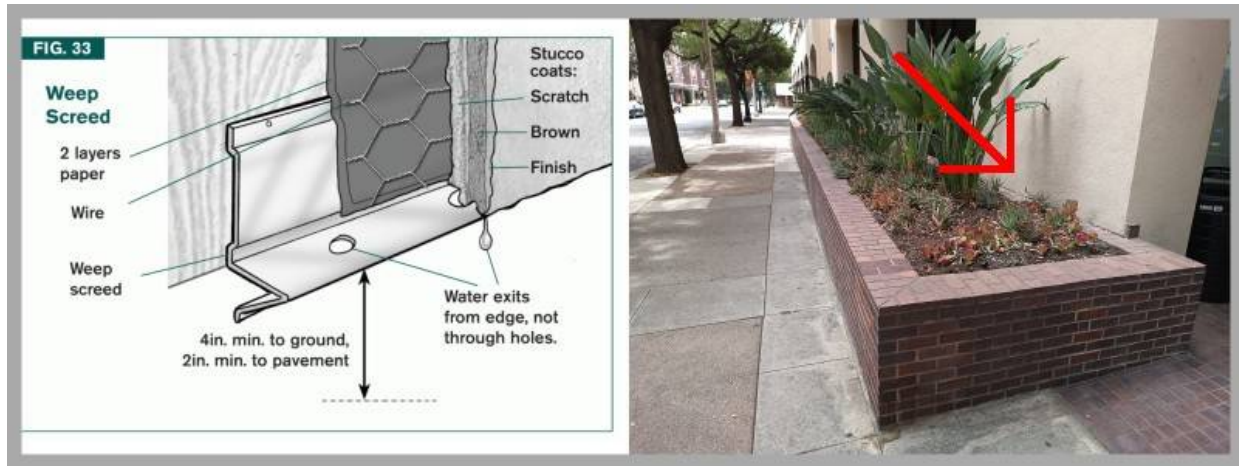
Planter box adjacent to structure is not properly flashed which can be a source of water entry into substrate. Wee screed lacks adequate clearance.

Further evaluation needed. Repair weep screed clearance along east planter.

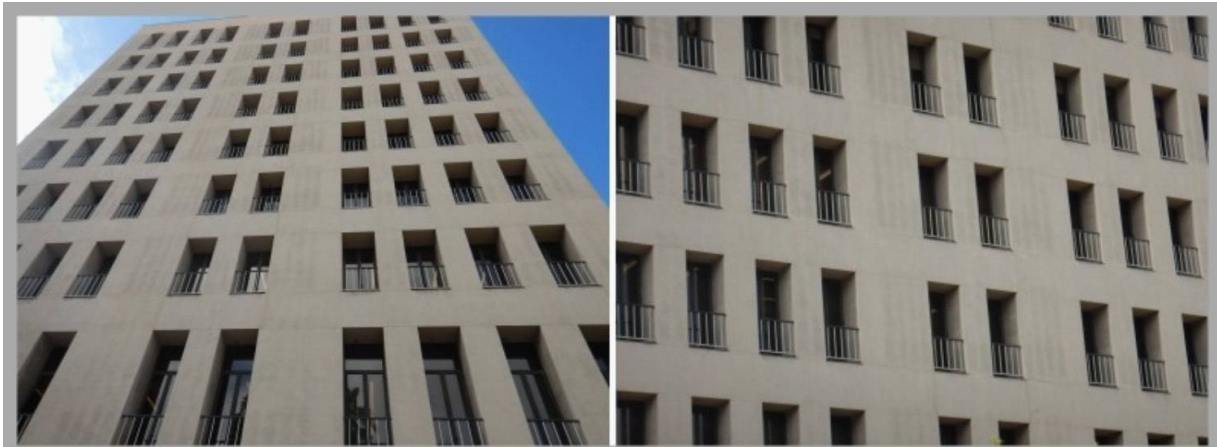
"Ghosting" in the context of stucco refers to the visible outlines of the underlying wall framing, often appearing as a darker or different shade of color on the stucco surface. This can occur due to various factors, primarily related to moisture, heat, and the accumulation of airborne particles. Painting alone generally won't fully correct ghosting effects on stucco. While painting can help blend the areas, it might not eliminate the visual difference entirely, especially if the stucco itself is different. Another alternative is to fog coat with like color. Fog coating is a cement-based coating used to refresh and recolor exterior stucco walls. It's a spray-applied cementitious product that blends discolored areas and changes the color of the stucco, offering a more durable and breathable alternative to traditional paint. Fog coating is made from the same materials as stucco and natural earth pigments

Further evaluation needed. Consult commercial stucco contractor. It would behoove you to have a qualified specialist determine what the underlying cause of the discoloration, referred to as shadowing or ghosting, is and remedy.

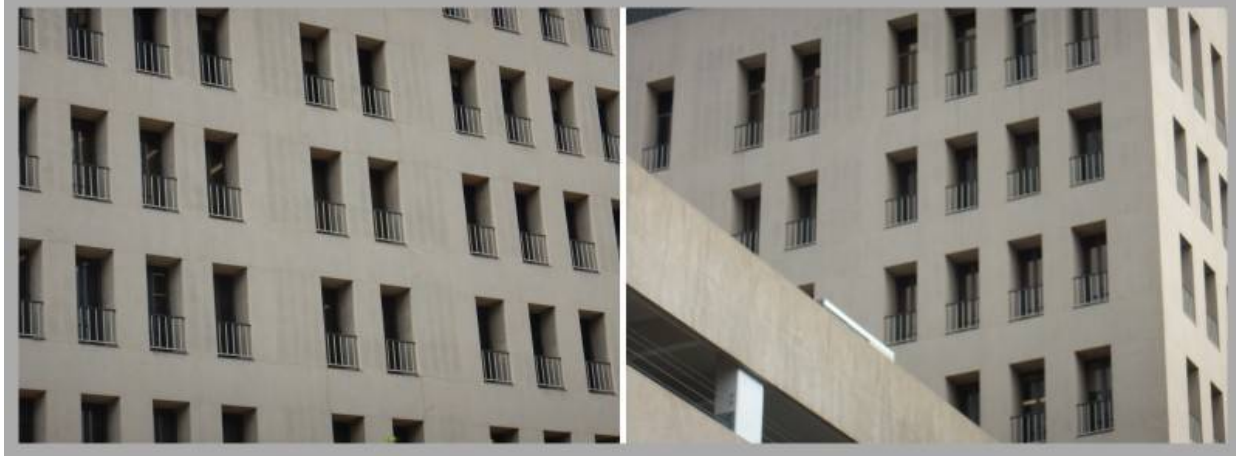
Stucco cracks

Some slight stucco cracking at north side center section. These cracks seem to be cosmetic in nature.

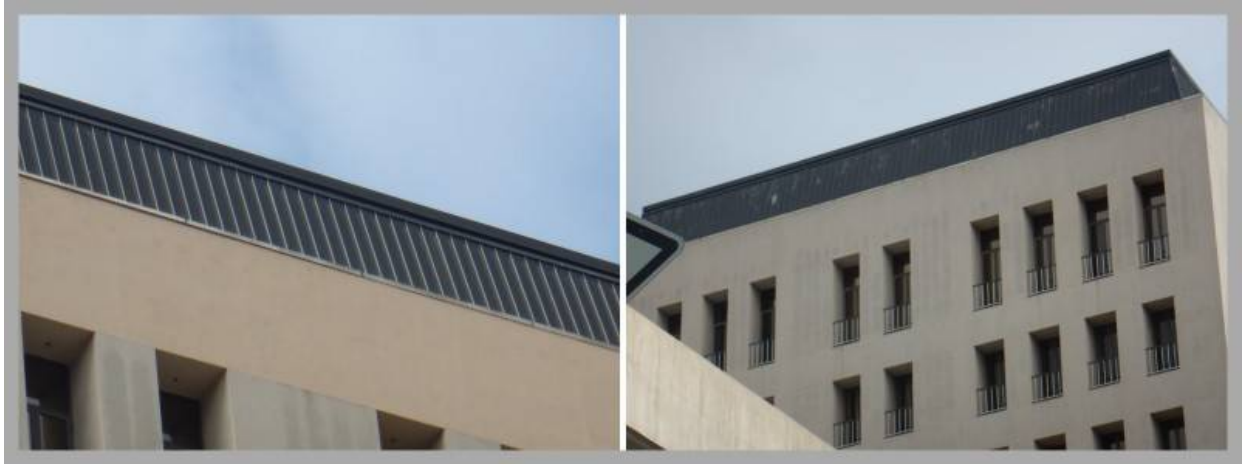
Discoloration seen commensurate with age and wear. Refinishing needed.

Refinish roughly 5000sf of metal stand and seem material along roof top.

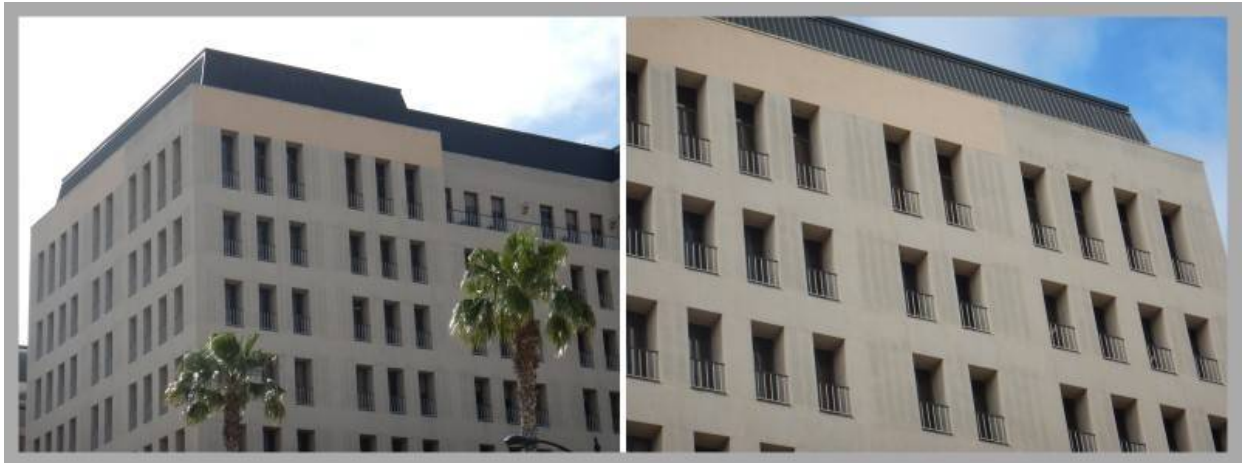
Exterior finish or painted surfaces are in a condition that calls for refinishing. Mismatched sections and general wear due to age. Roof top wind barrier exhibits paint wear. The lifespan of paint on a building depends on whether it's interior or exterior, the type of paint, the surface it's applied to, and the climate. Generally, interior paint can last 5-10 years, while exterior paint may last 5-7 years. Further evaluation needed. Consult licensed painting contractor specializing in painting of multi story buildings.

Painting to roughly 85000 sf of exterior stucco. Painting is based on using an engineered suspended scaffold. Not an entire scaffold from grade to roof.

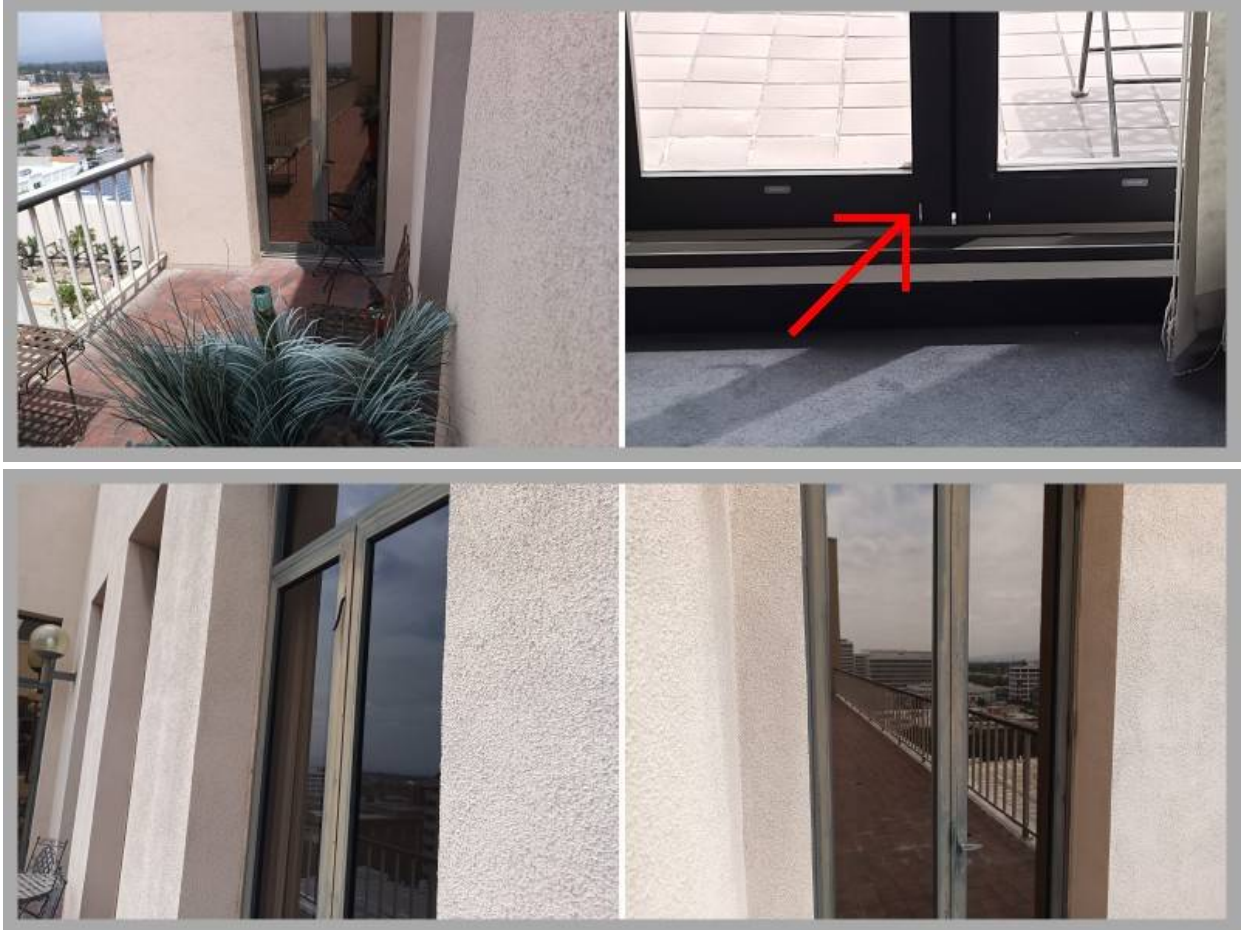
9th floor West and east balcony access doors exhibit fading and metal seam separation.

Restoration to 16 exterior balcony access doors and transoms needed. Services of a commercial door installer should be consulted.

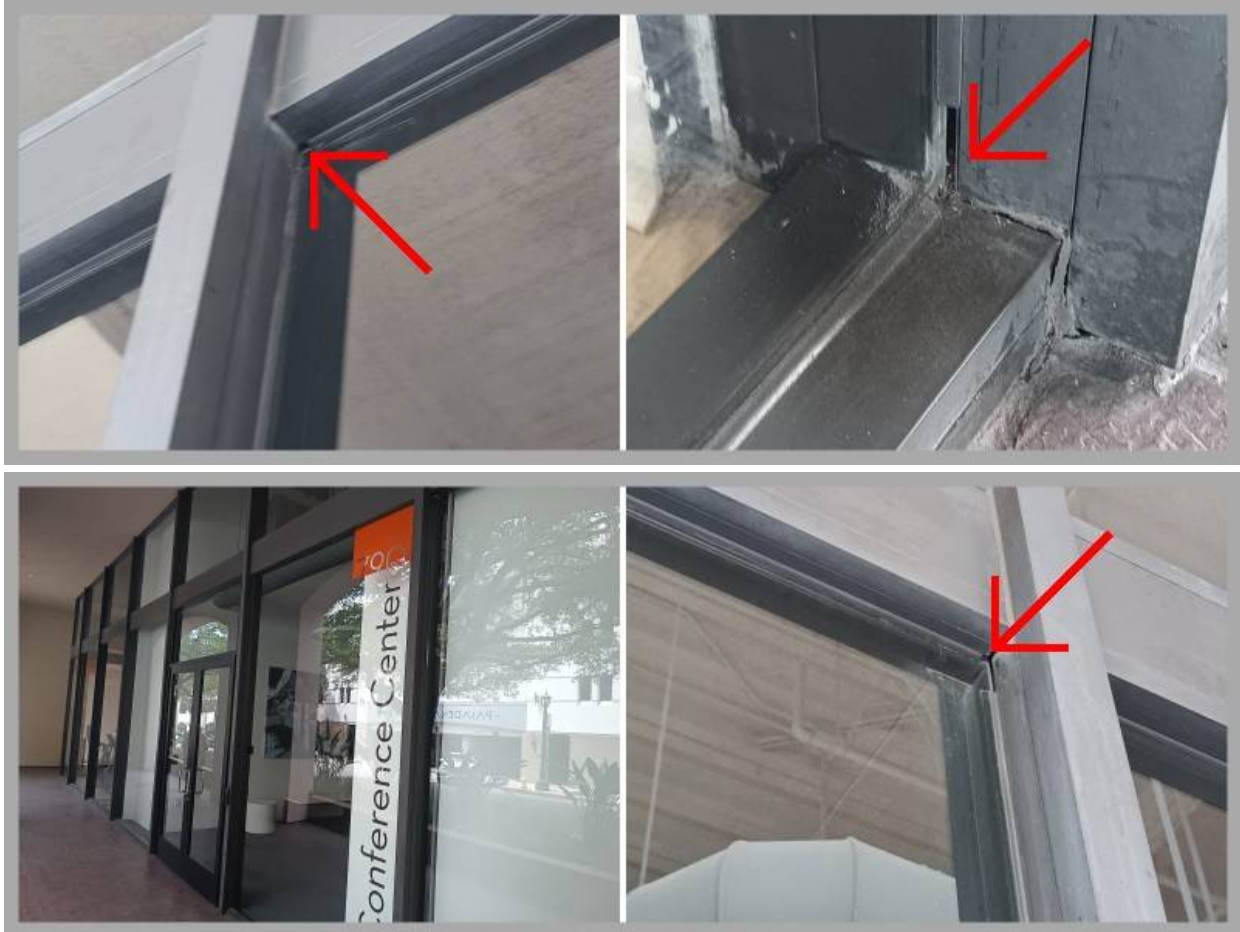
East and some at north side ground level store front windows have worn and damaged gasket seals. When gasket seals are compromised the entire gasket needs to be removed and glazing would be recaulked with approved glazing caulking.

Replace weather seal to roughly 50 percent of ground level store front windows lower. Contact window installer for further assessment and estimates.

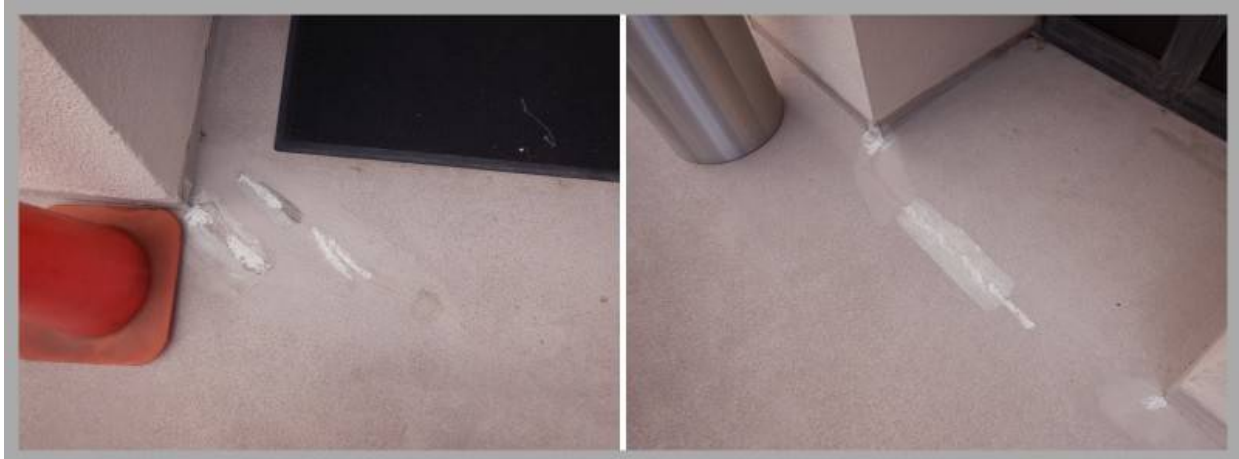
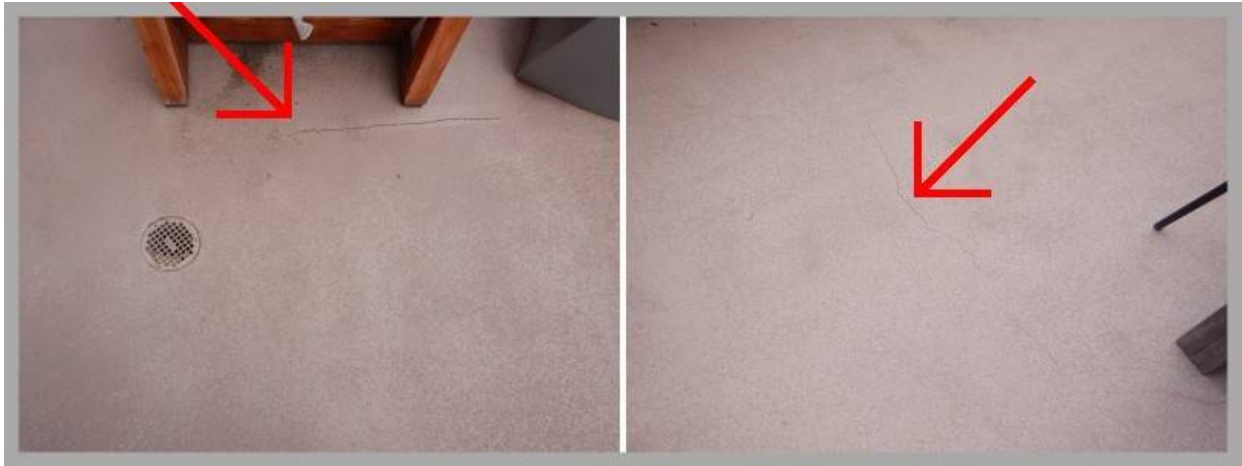
There is concrete material used. Cracking and evidence of leak as seen from ceiling of loading dock.

9. Seal cracks and resurface 18000 sf of lower west concrete decking.

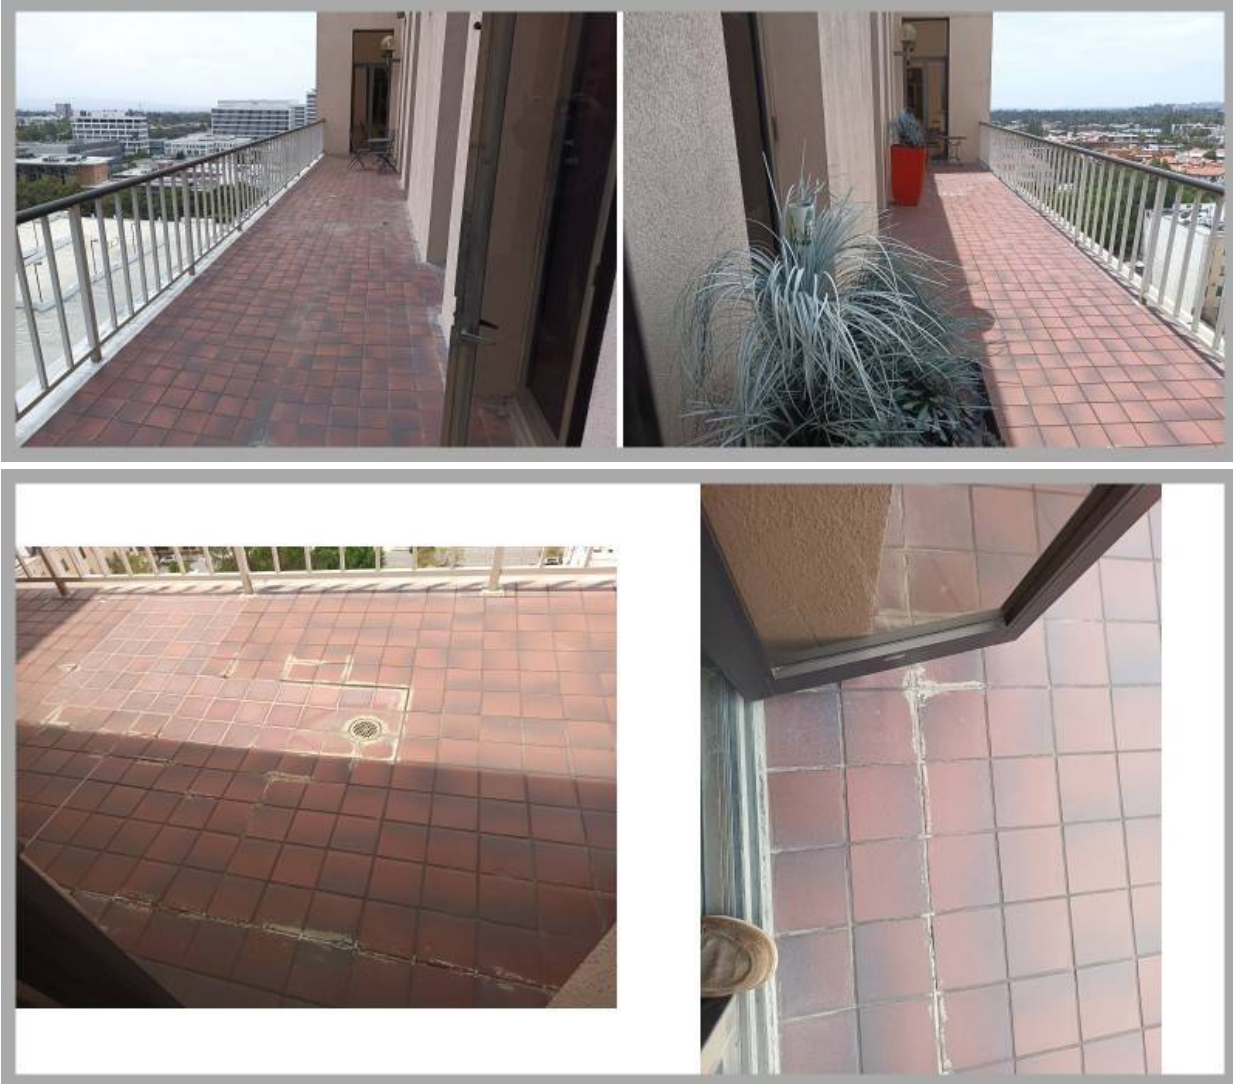
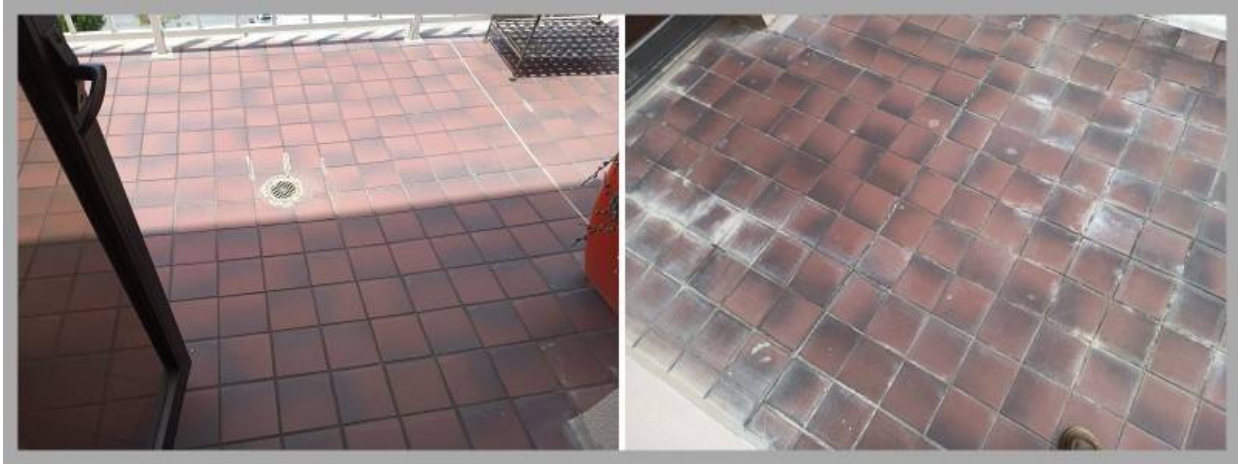
Ceramic tile is used at 9th floor balconies. Patching noted due to prior apparent leak issues. Tile is aged and starting to exhibit displacement or grout cracks.

12. Conditions noted that could affect use. Consult qualified licensed contractor for further evaluation and advice. Removal and replacement of roughly 1100 sf of tile decking indicated. Sub deck waterproof membrane may be failing.

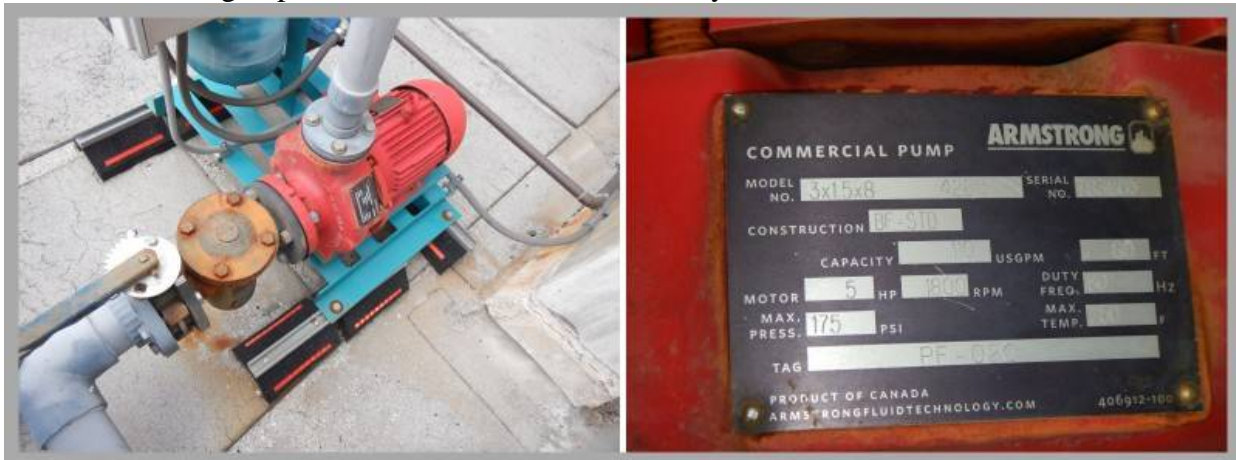
At least one 5 HP although operational near the end of its life cycle.

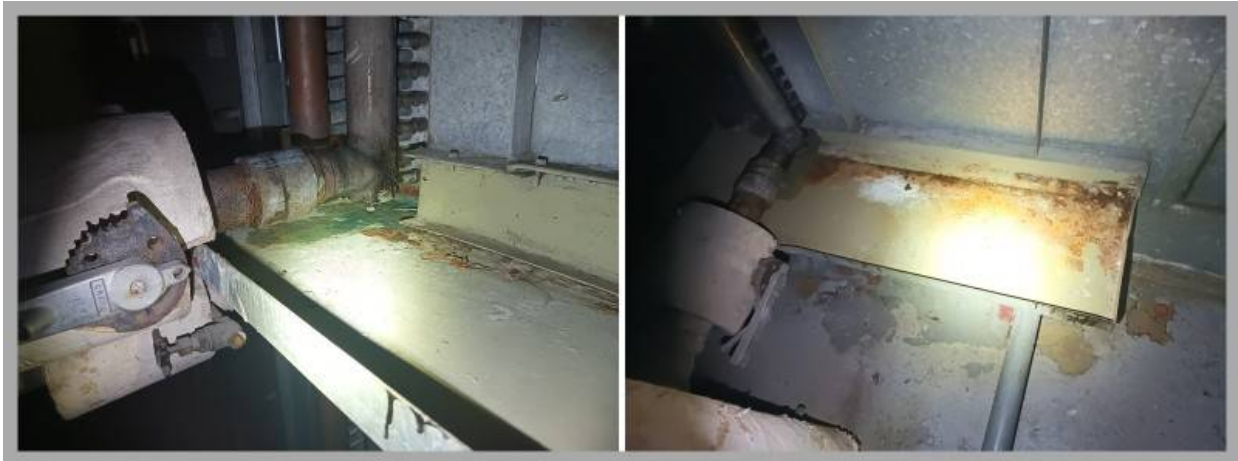
Visible rust and corrosion seen at base of interior coils. System otherwise maintained. Monitoring and cleaning should be routine.

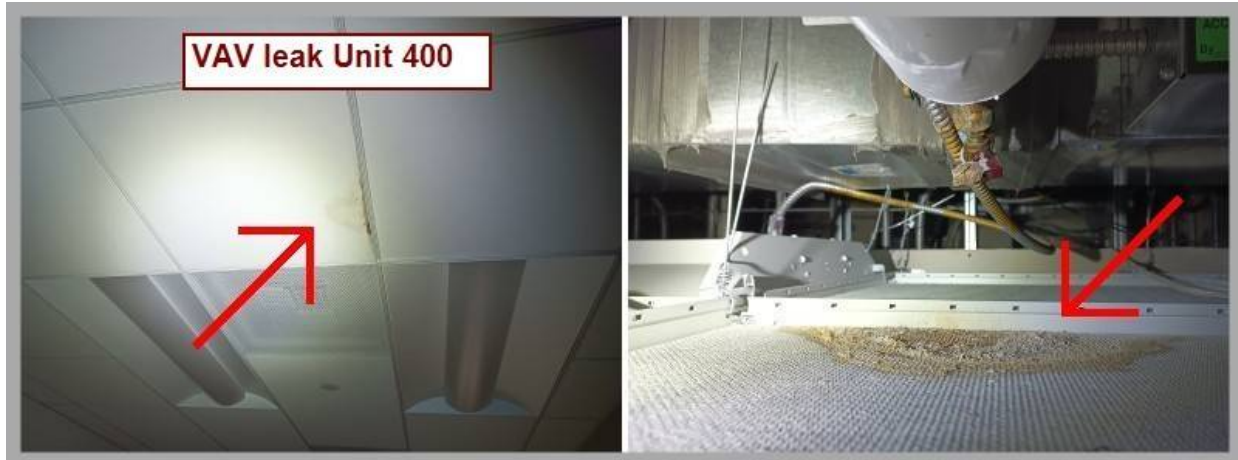
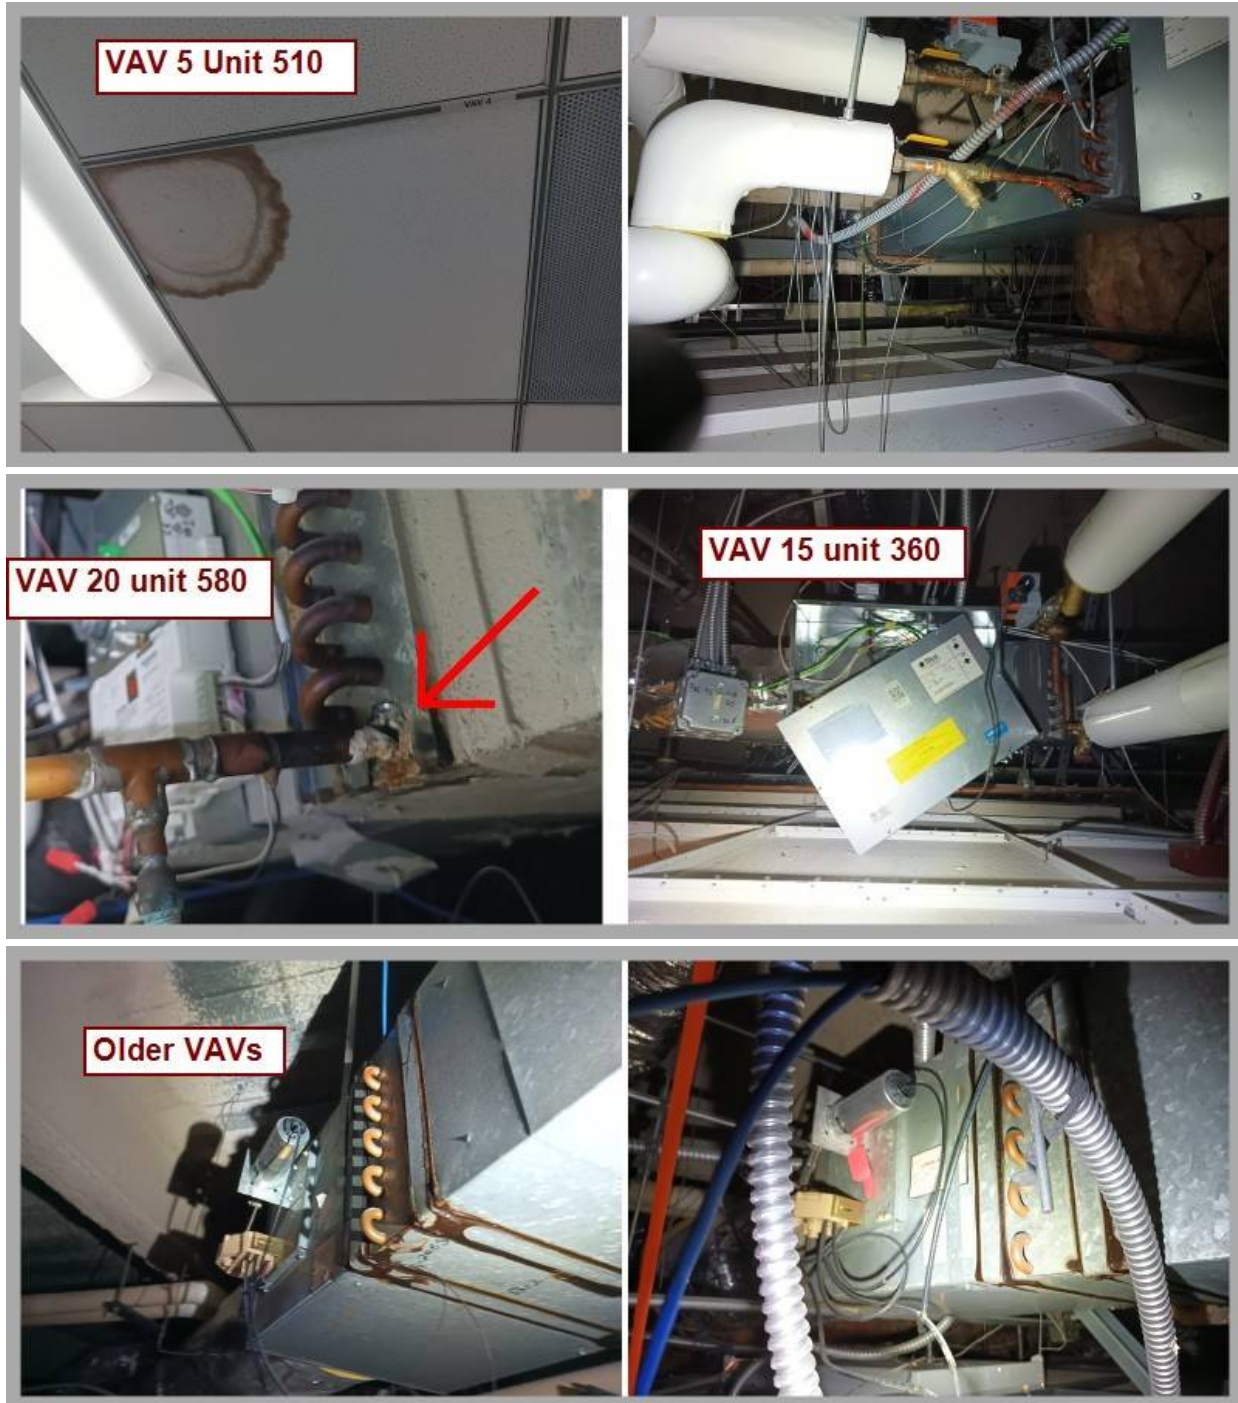
VAV 15 in unit 360 has a displaced cover and one VAV in unit 400 seems to have leaked onto ceiling panel. VAV5 in unit 510 did appear to have a leak though looks as though it was recently repaired. Corrosion was also noted to section of water line at VAV 20 in suite 580. Most of the VAVs at 7th, 8th and 9th floor appear to be from original installation and are more than likely near or at the end of their serviceable lives.

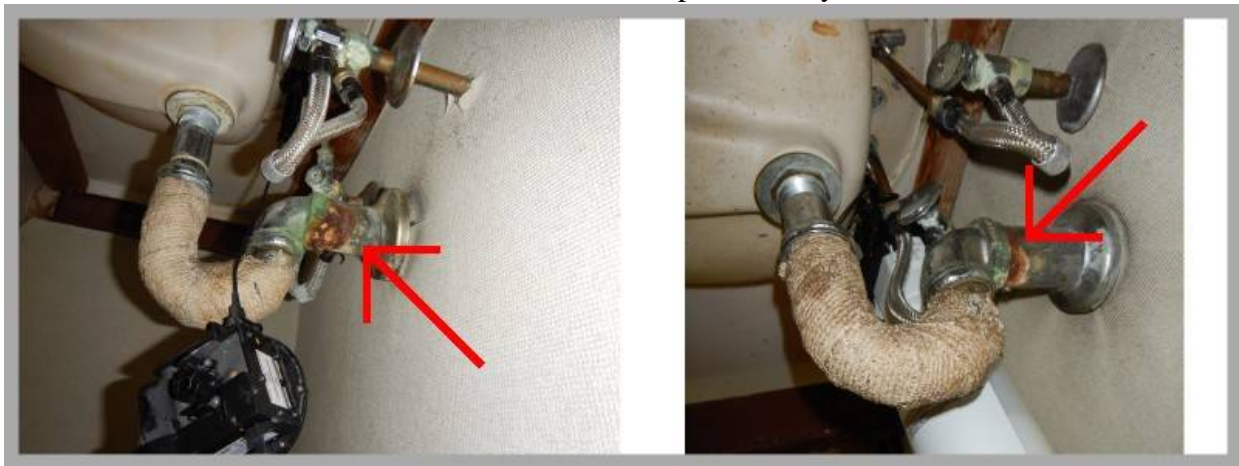
Waste disposal installation and waste vent installation is not visible for the most part. Consultant is solely judging adequacy of drainage by one person operating and viewing one fixture at a time. There may be hidden deficiencies that can go unnoted. There is however corrosion which can be seen at some of the interior fixtures as indicated in bathrooms and kitchens interiors section of report. Mostly at 9th floor.

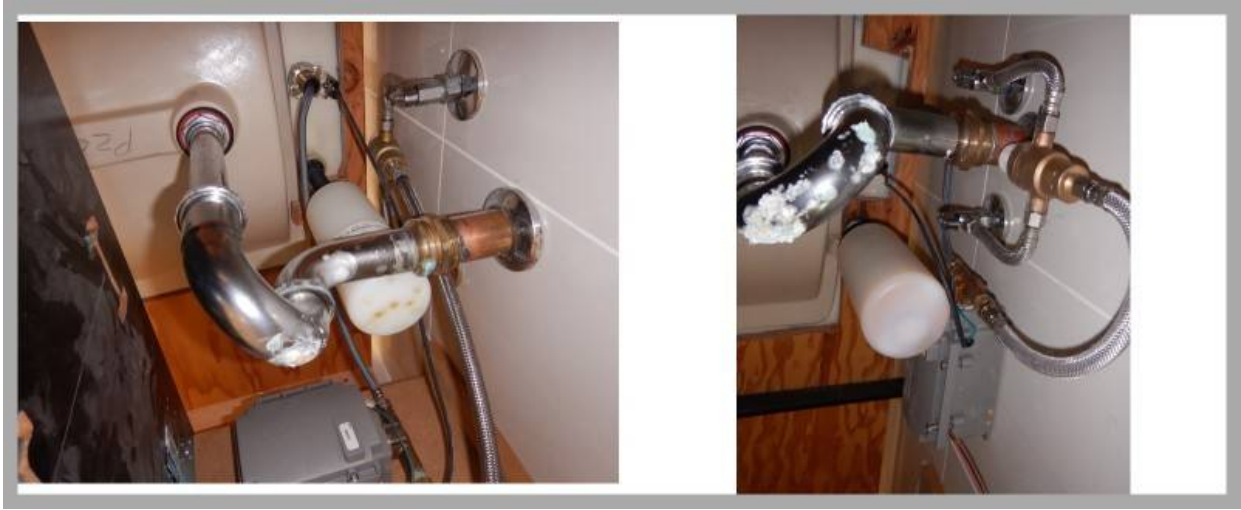
Deteriorated Lines - There is deterioration of the drain pipes under the basins of both restrooms. Replacement needed, faucets not operational likely due to leaks.

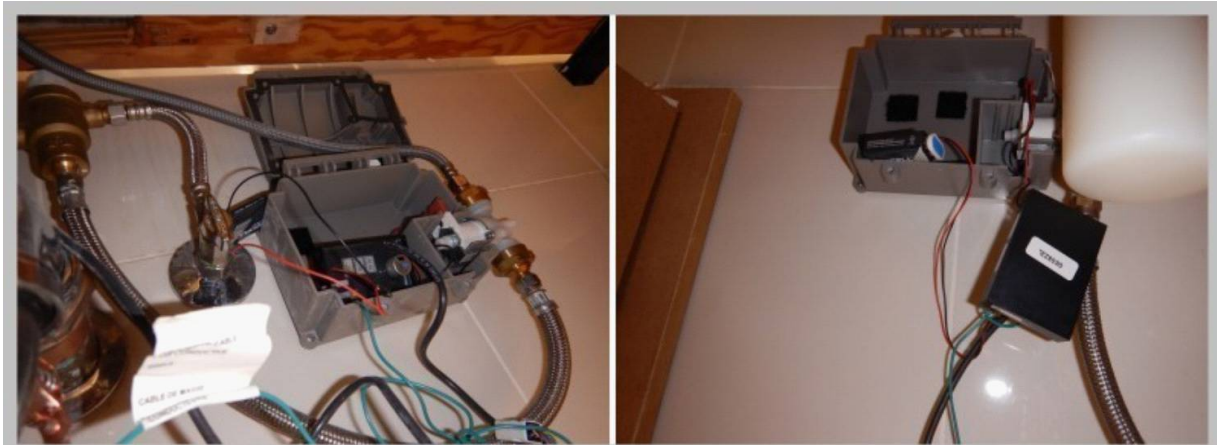
1st floor Men's

Deficient installation of the auto faucet mechanism noted in Men's restroom.

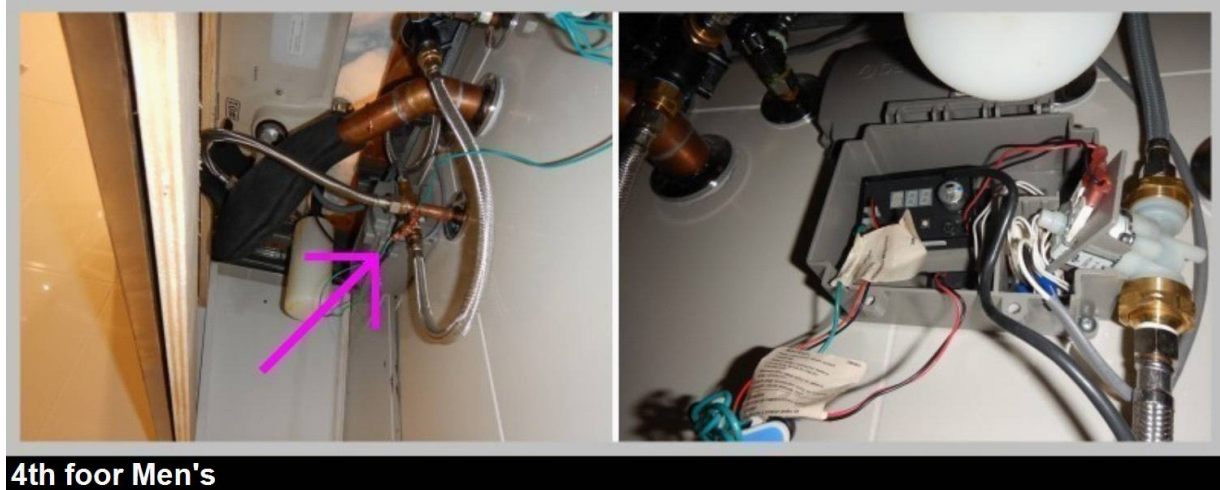
Under men's sink: Sub-standard wiring of auto faucet.

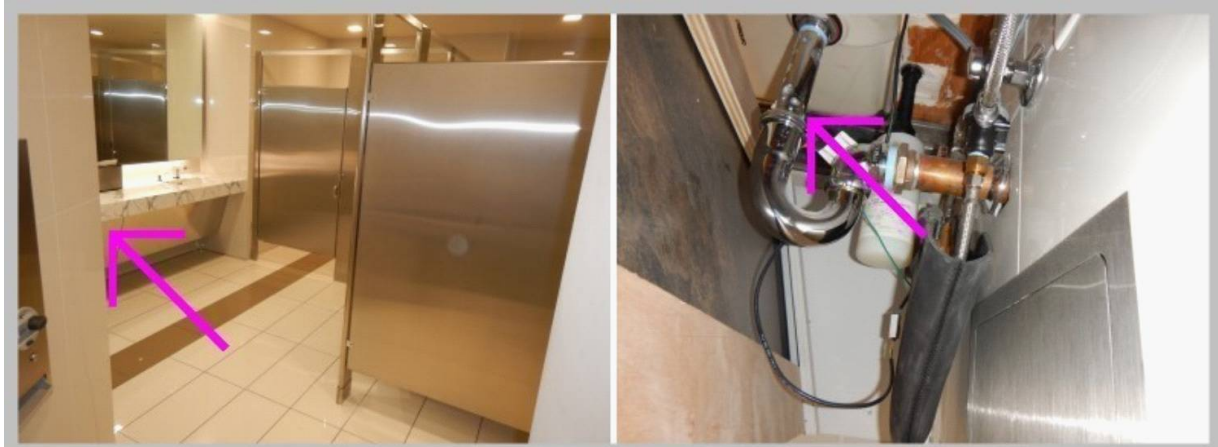
Women's 4th floor

There is deterioration of the drain pipes under the basin in women's restroom. Although there is currently no leak, expect replacement in the future.

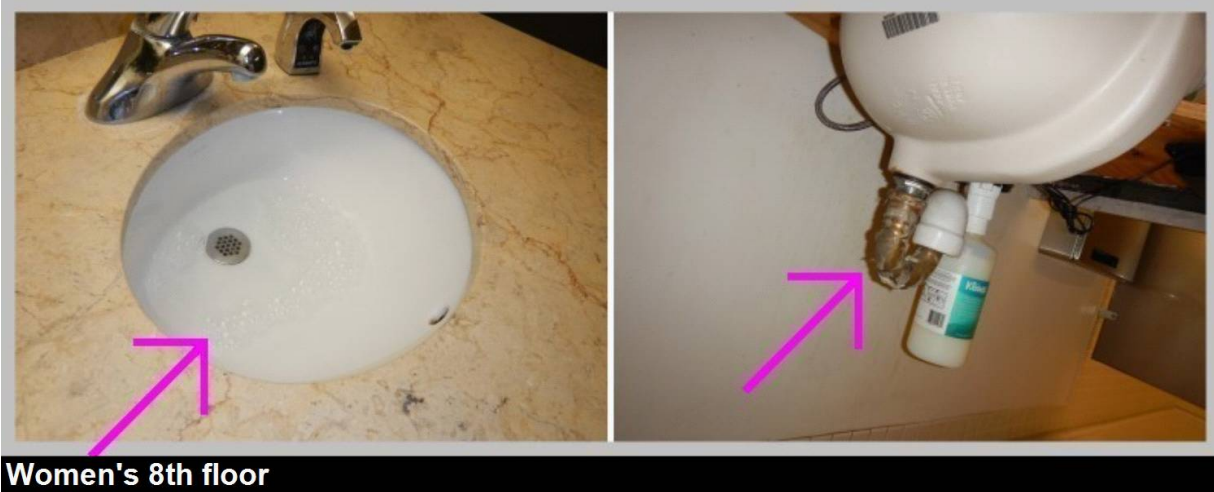
Deteriorated Line - There is deterioration of the drain pipes under the basins and slow drainage noted in women's restroom.

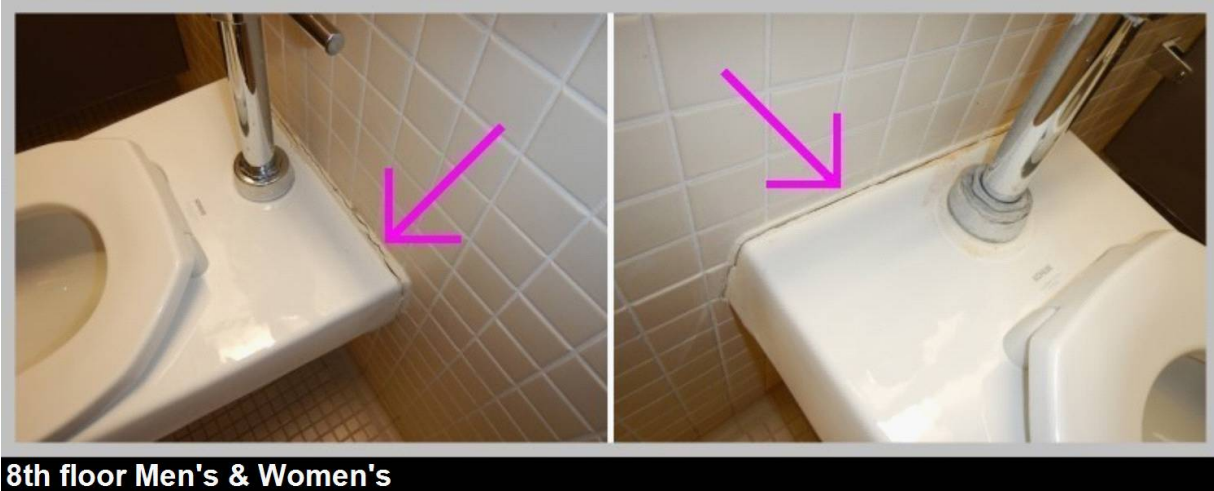
Caulking separation noted at toilet to wall connection. Possibly due to fixture movement.

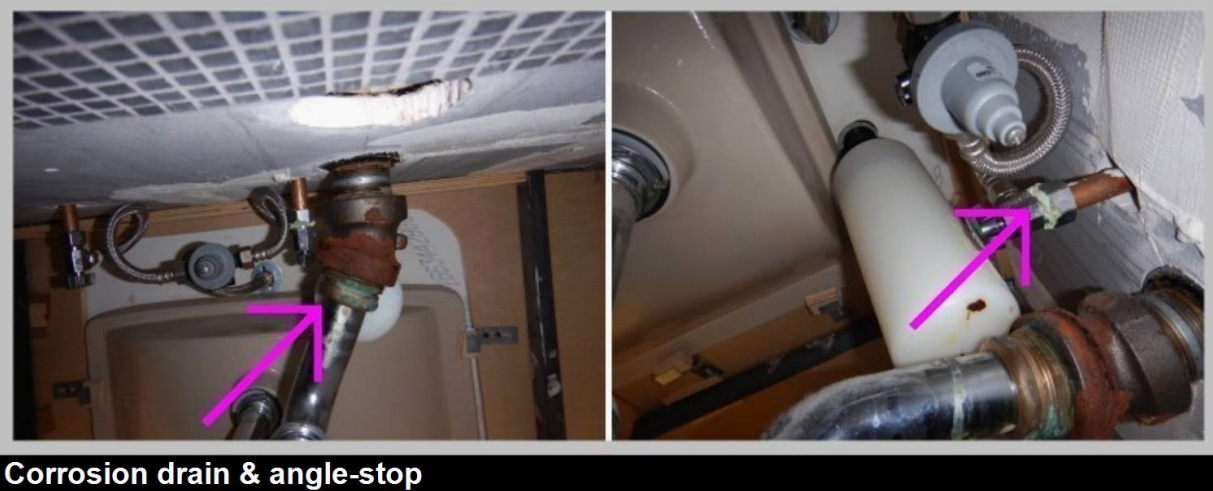
There is corrosion on the trap or drain line in Men's bathroom. This is an early warning of future failure. It may not be currently leaking, but it will need to be replaced in the near future.

Corrosion drain & angle-stop

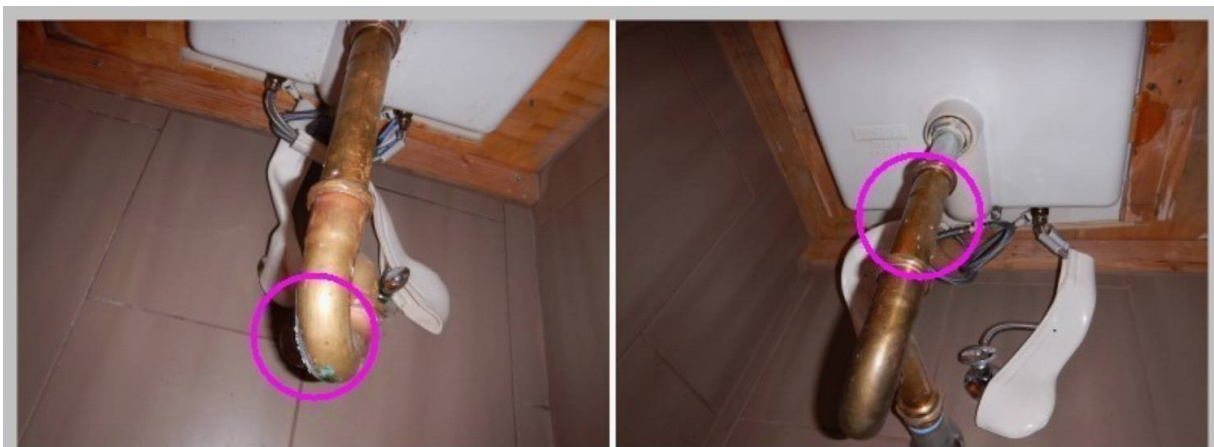
Regency Both

There is corrosion on the traps or drain line. They are not be currently leaking but will need to be replaced in the near future.

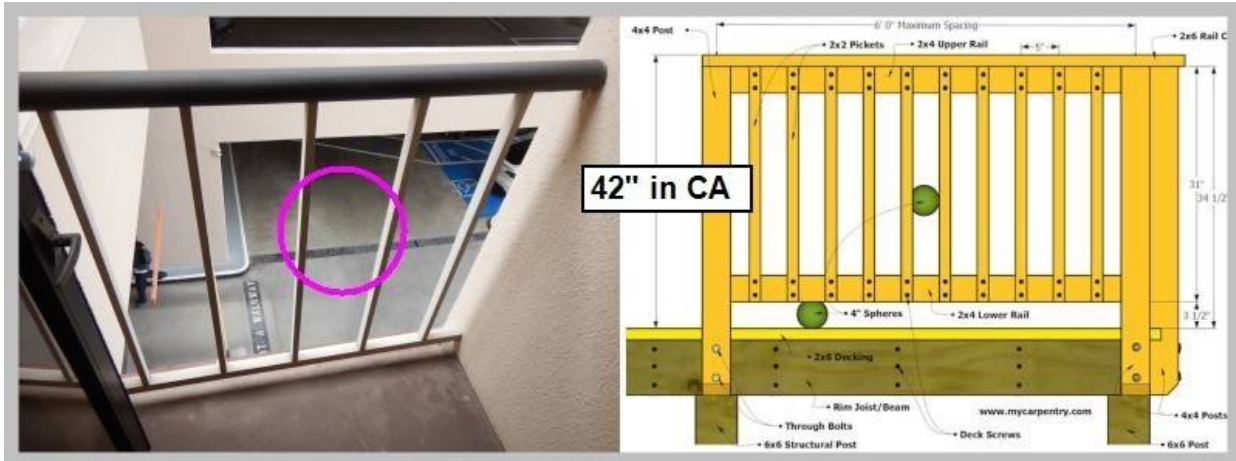
Client should be aware that the spacing between rails is not to the child safety standards of 4 inches apart. Consider improvements. Typical of all office balconies observed.

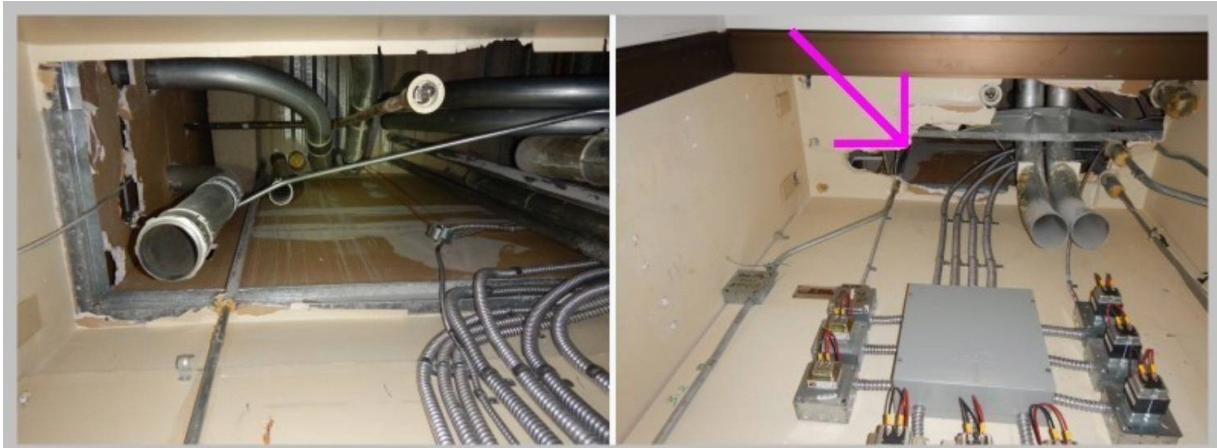
2nd & 3rd Floor Men's restrooms

There is a communication conduit closet in the Men's restroom. Repairs needed to ceiling to maintain fire separation. 2nd & 3rd floor restroom communications closet.

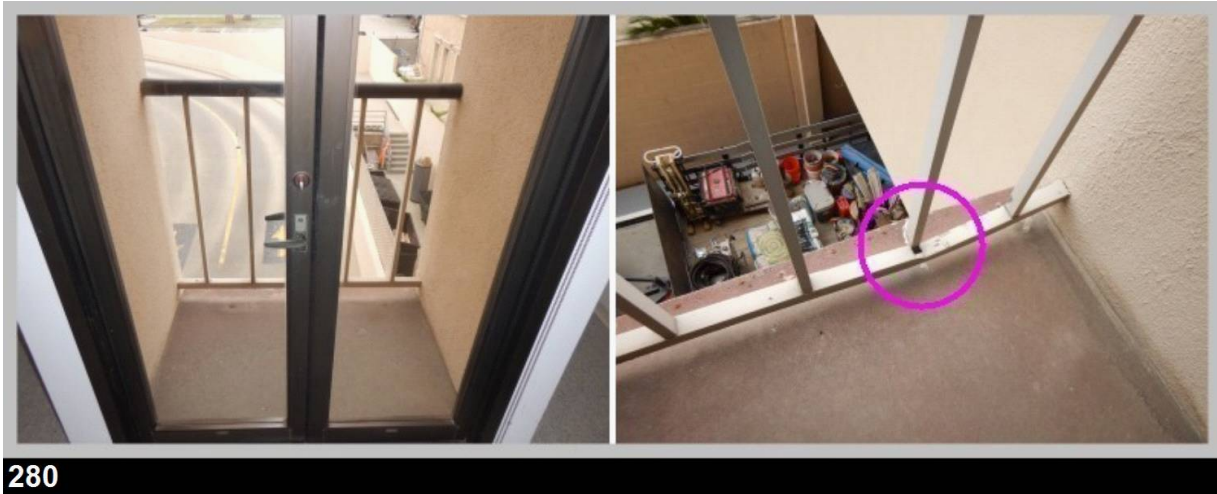
280

Many of the balcony doors would not open; stuck lock/latches, missing hardware (typical of all offices on all floors) inspected. It is possible that this can affect emergency egress, repairs should be made. Damage noted to balcony railings; safety hazard, repairs needed.

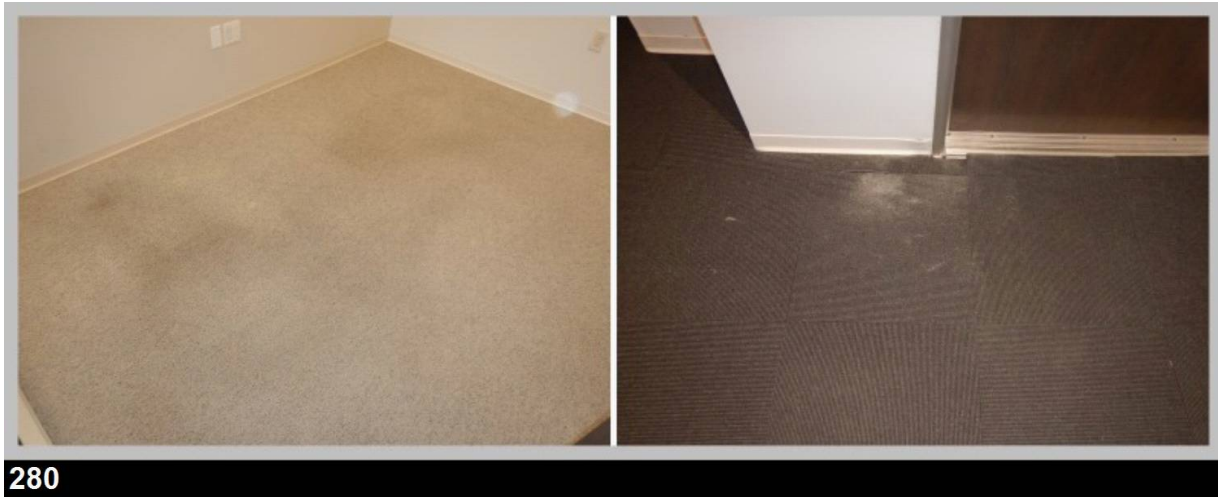
Stains area seen throughout. Inspector does not make any determination on whether or not these stains can be removed. Some damage to carpet also noted.

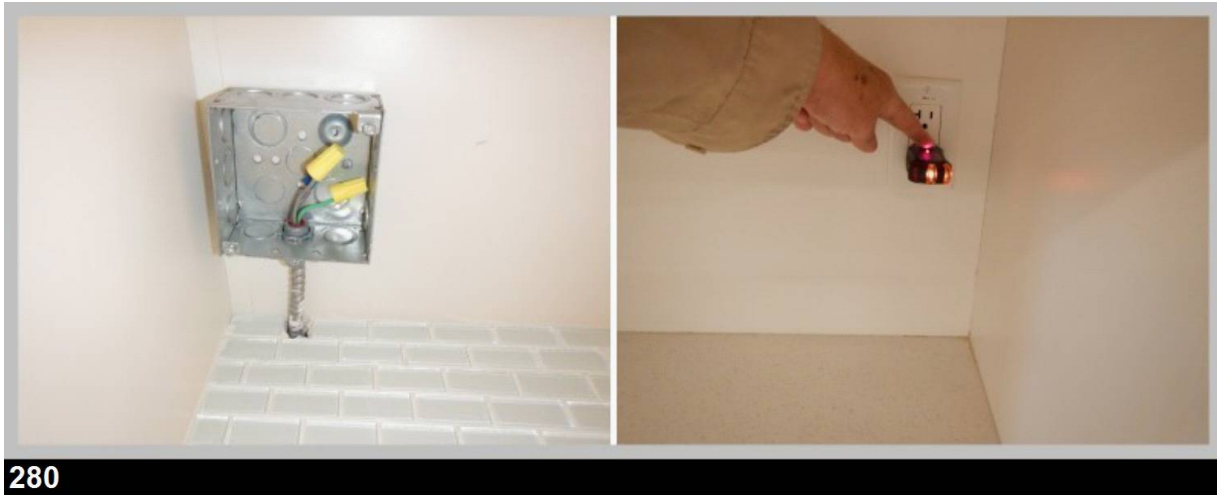
280

Exposed wiring; no j-box cover; shock hazard; repairs needed. This kitchen does not have Ground Fault Circuit Interrupt outlets installed at all locations; the age of the structure may predate the required installation; however, for safety considerations, it is strongly suggested that one be installed at any location within 6 feet of a water source.

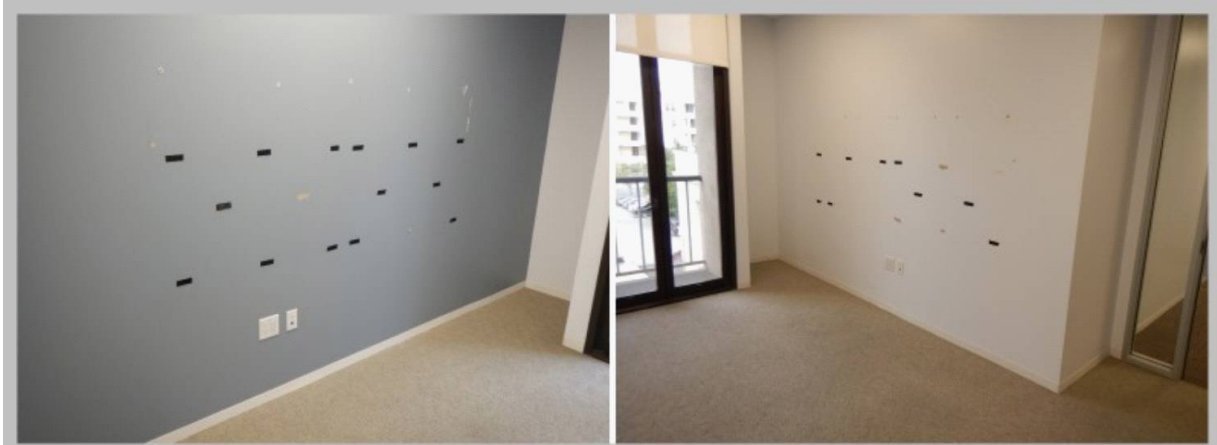
300

300: Satisfactory with general wear from previous tenant. 360: Unit interiors due for tenant improvement upgrades; damaged walls noted.

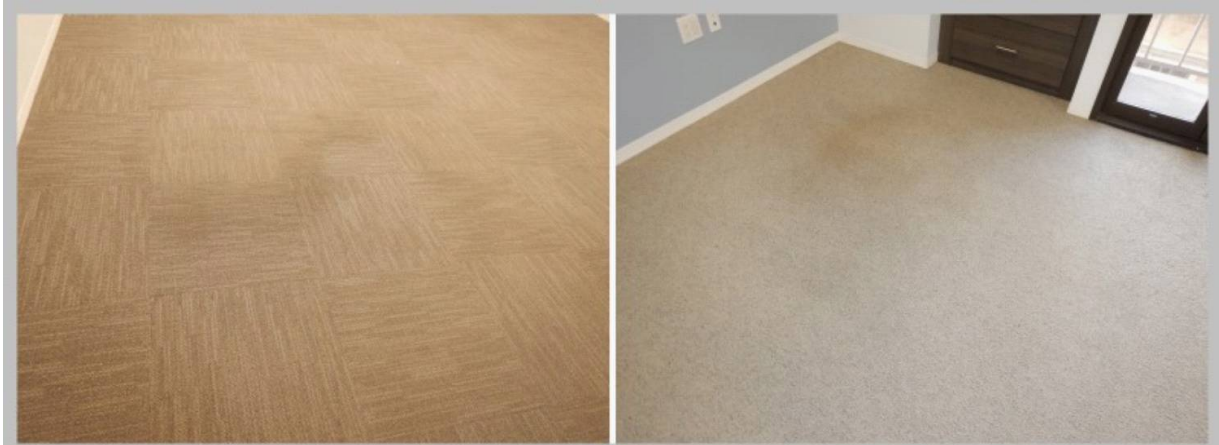
300

Stains area seen throughout. Inspector does not make any determination on whether or not these stains can be removed.
