ALLIANCE
REAL ESTATE
INSPECTIONS

Confidential Property Condition Assessment Report

**Prepared for: Sample Client
Prepared By: Robert Gaudreault**

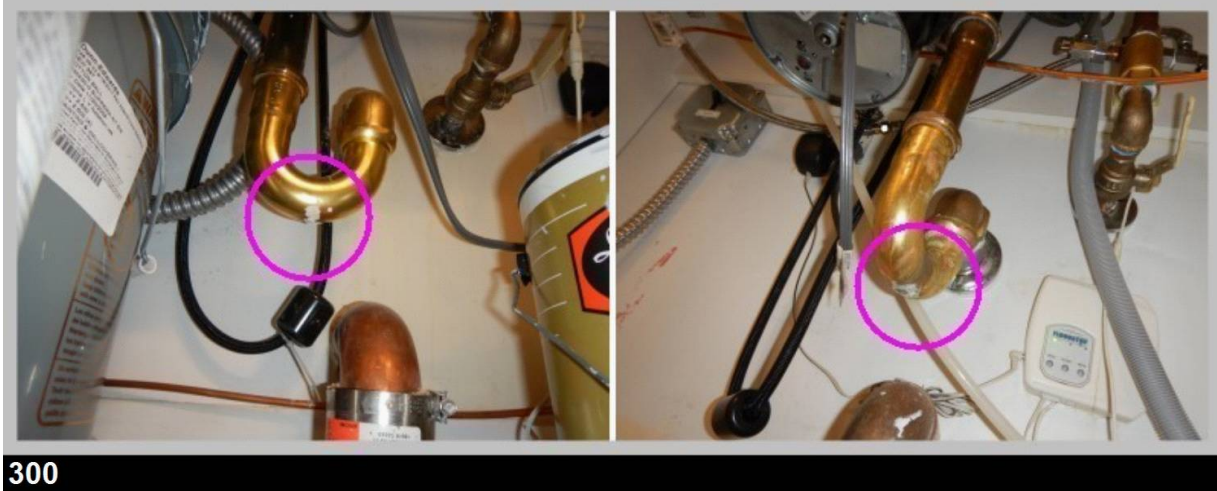
There is deterioration of the drain pipes under both sinks. Although there is currently no leak, there may be one in the future. When replacing the pipes, I recommend replacing with plastic piping which is not as affected by age and deterioration.

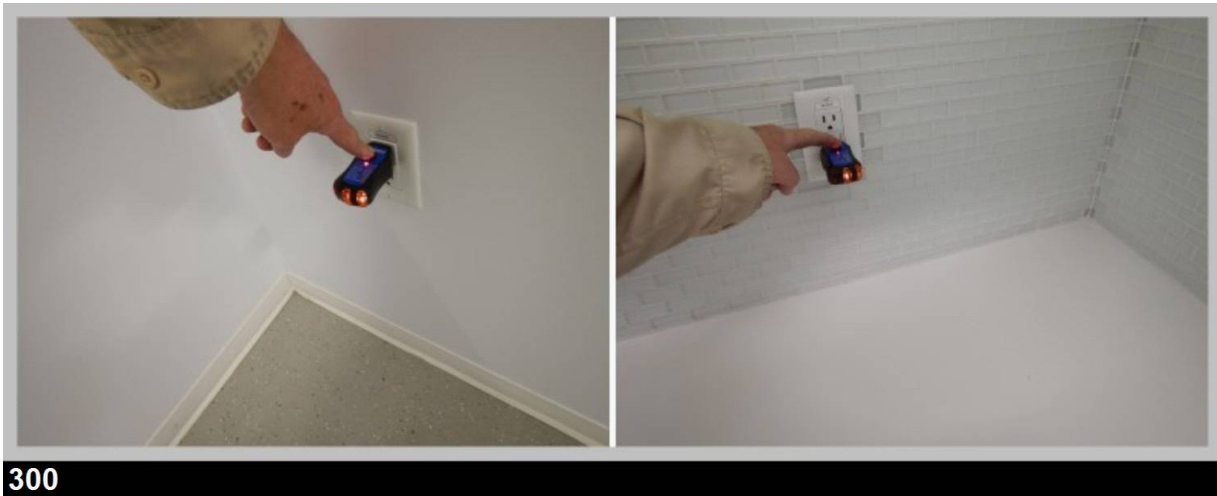
This kitchen does not have Ground Fault Circuit Interrupt outlets installed. The age of the structure may predate the required installation; however, for safety considerations, it is strongly suggested that one be installed at any location within 6 feet of a water source.

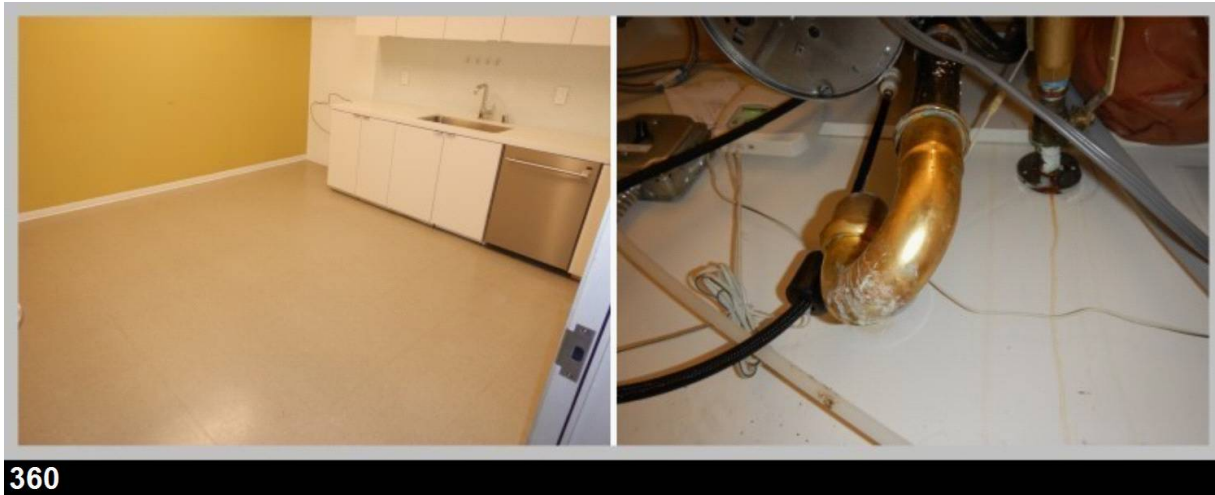
360

No hot water to faucet. Deteriorated drain, expect replacement/repairs.

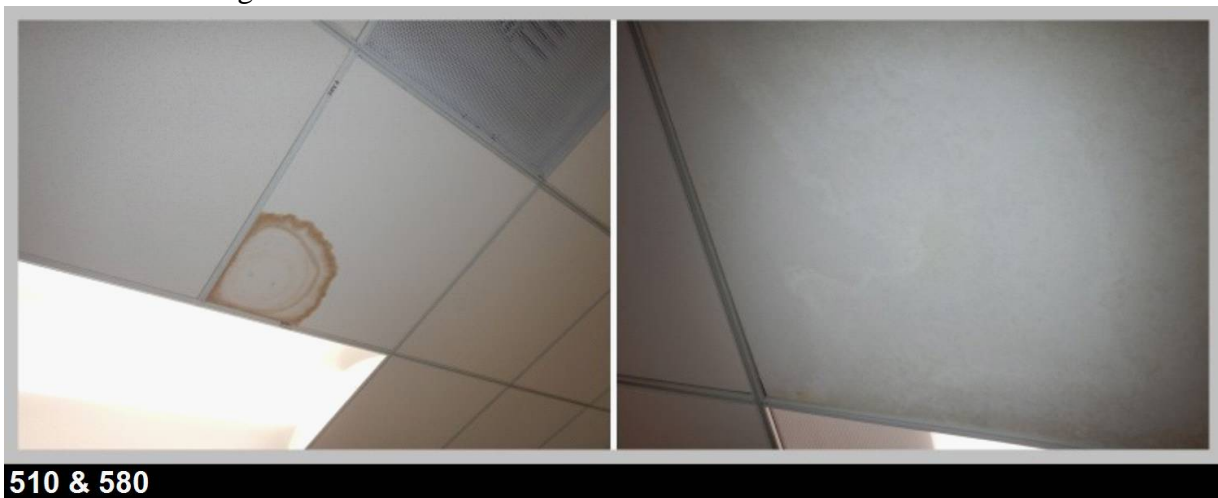
Water stains seen in ceiling of both 510 & 580.

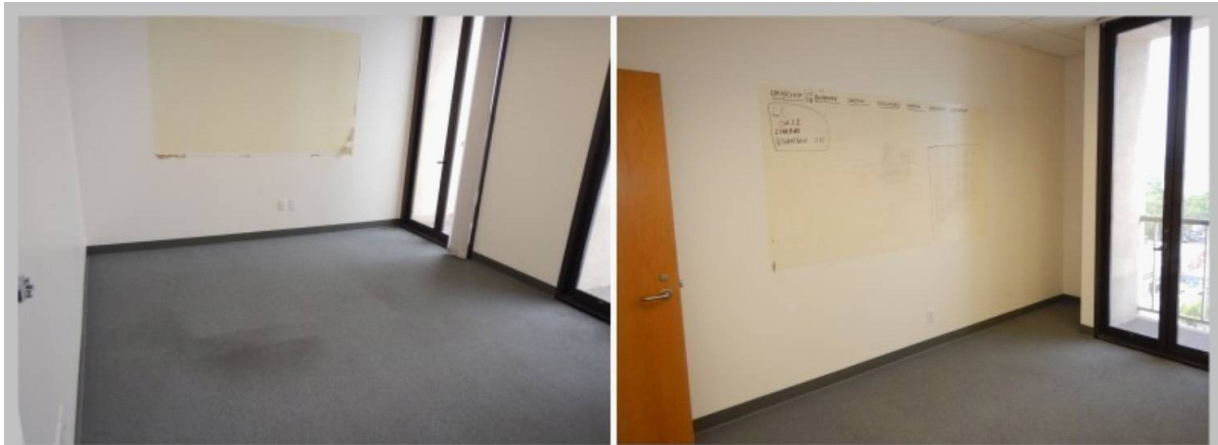
**797 Walls**

Unit interiors due for improvement and upgrades, such as paint and ceiling tiles (water stains and missing tiles).

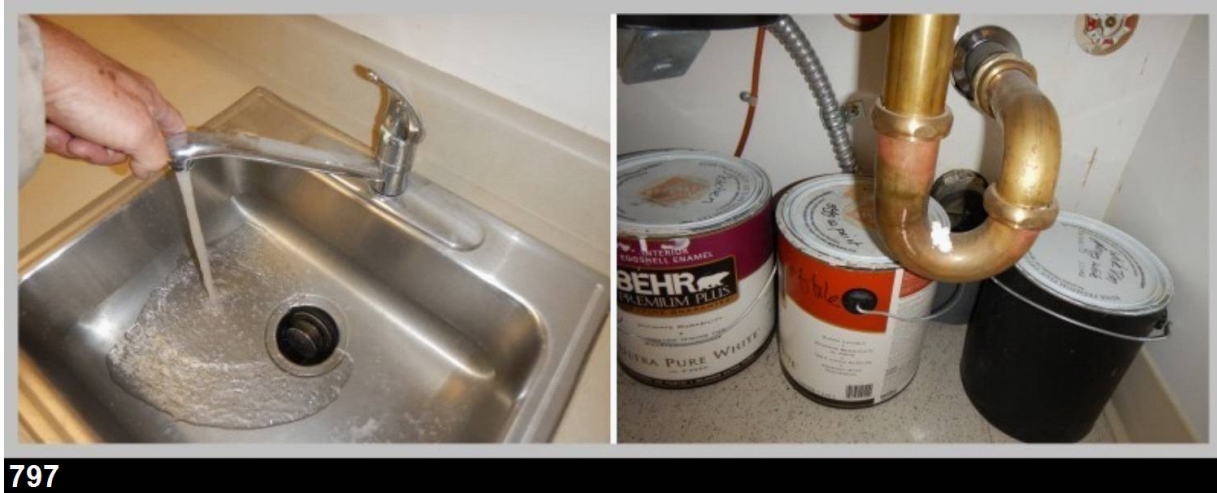
797

No hot water at faucet. Light corrosion views at P-trap or drain.

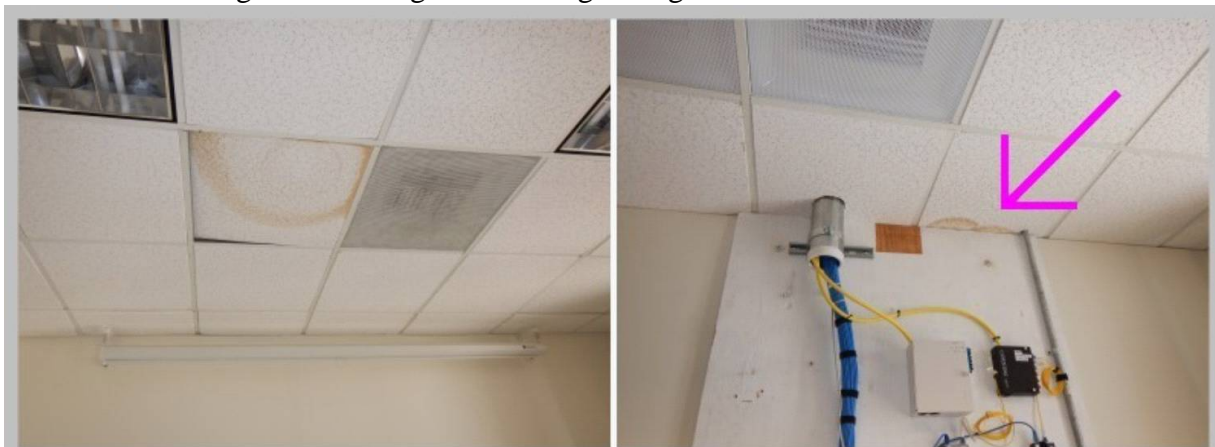
Water stains seen in ceiling tiles. Damaged & missing ceiling tiles also noted.

808 Water stains

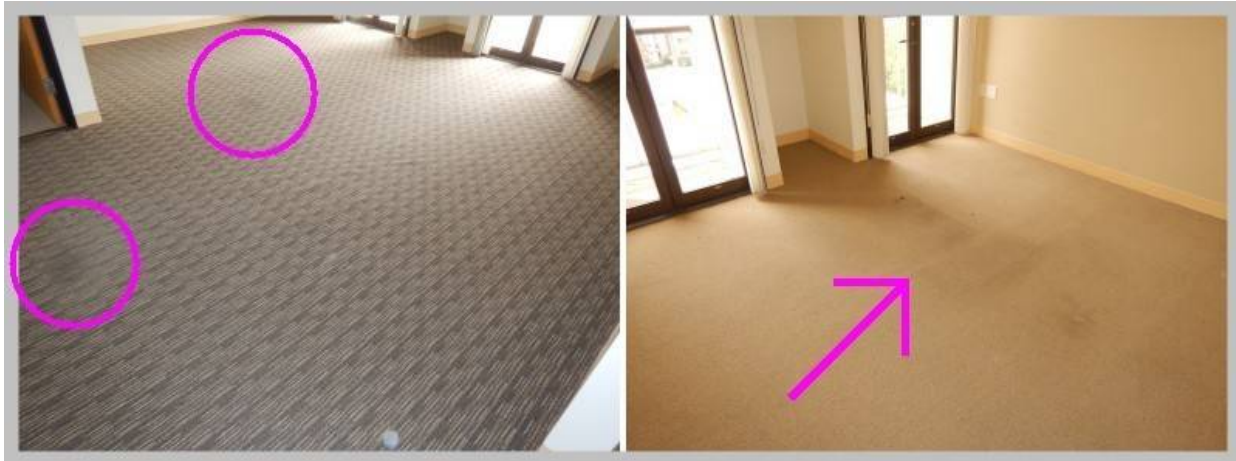
Stains area seen throughout. Consultant does not make any determination on whether or not these stains can be removed.

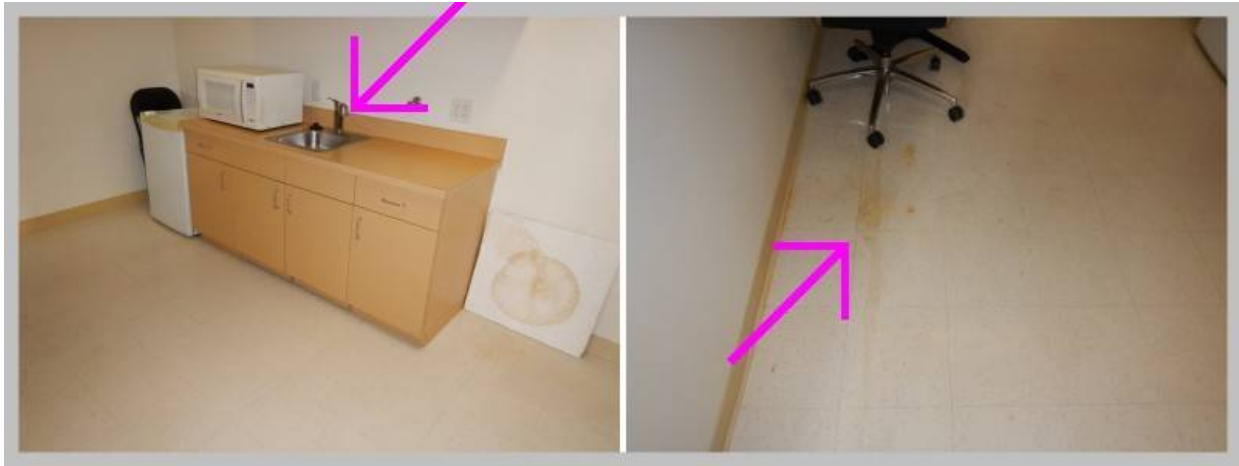
No hot water to faucet. Stains noted on flooring. Repairs needed.

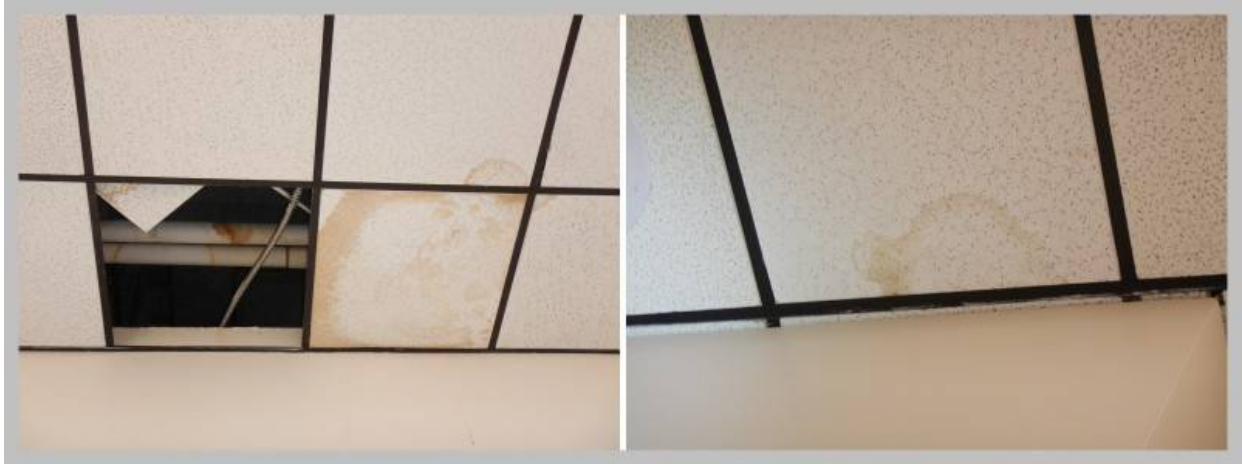
Water stains noted on ceiling tiles; expect repairs.

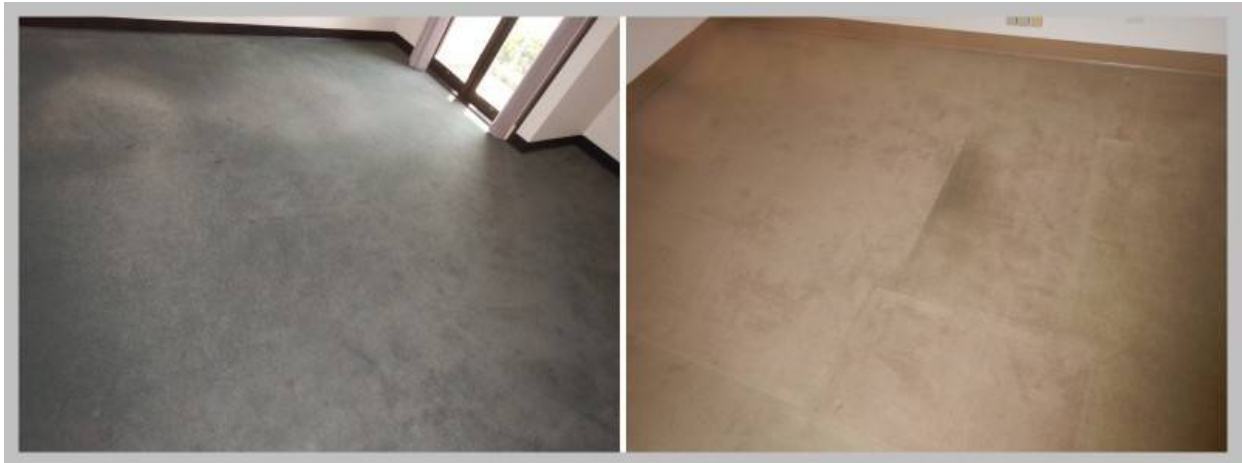
The general condition of most of the flooring is fair with some wear due to age and use. Stains area seen on carpets.

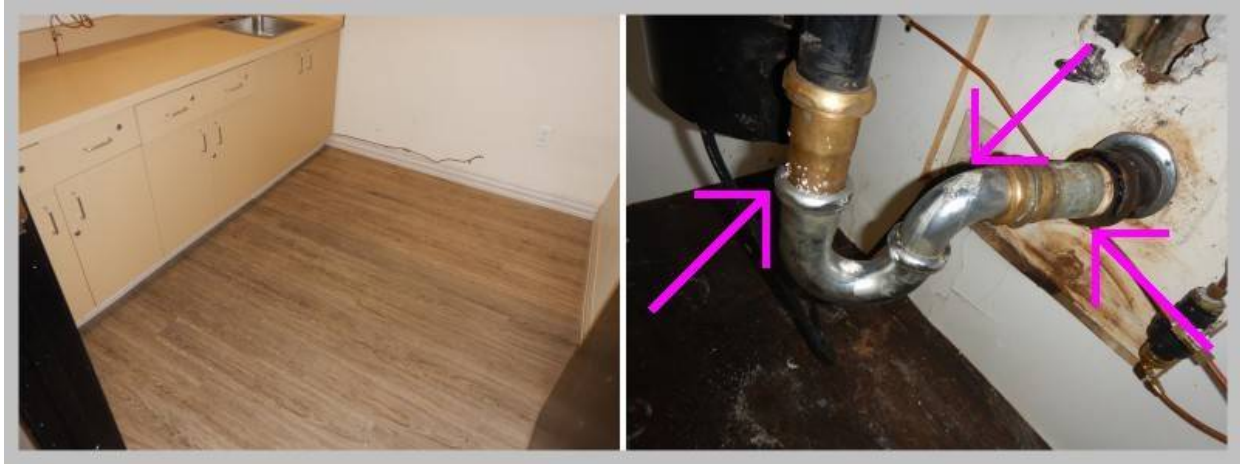
Corrosion noted to drain located under sink. Consider replacement to reduce risk of leak.

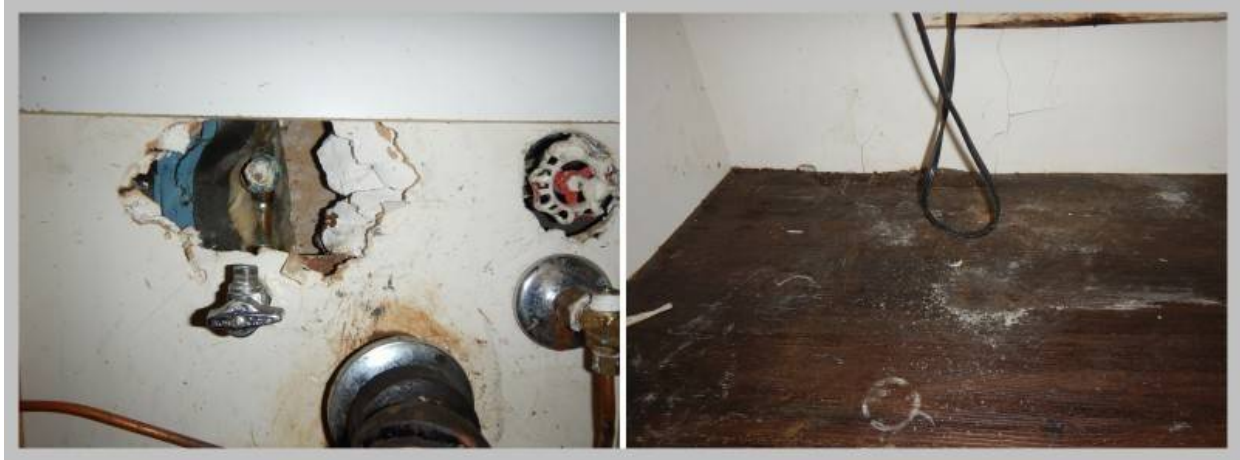
Water damage noted to cabinet bottom and there is a hole in the wall that was never patched; repairs needed.

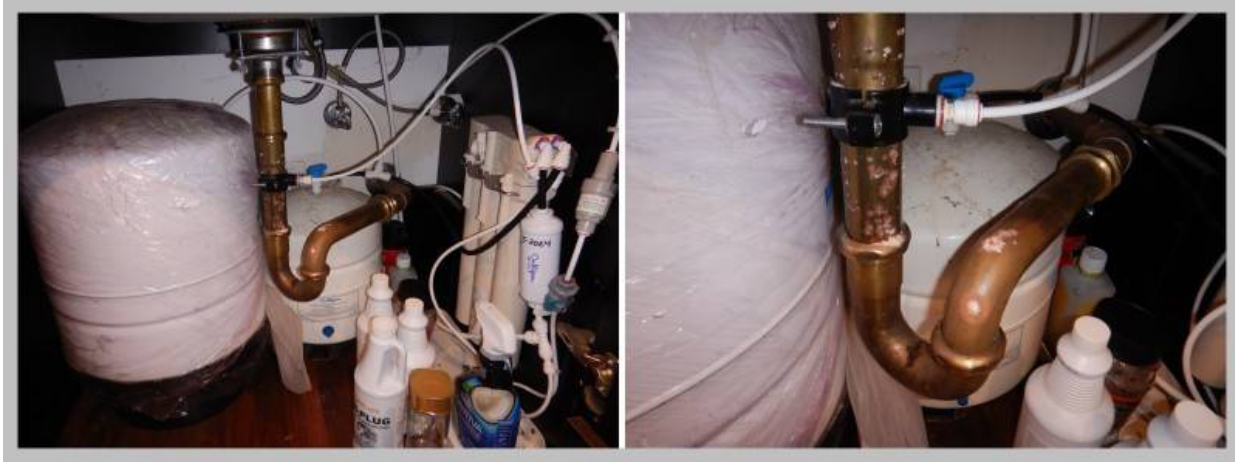
There is deterioration of the drain pipes under the sink. Recommend replacement before leaks occur.

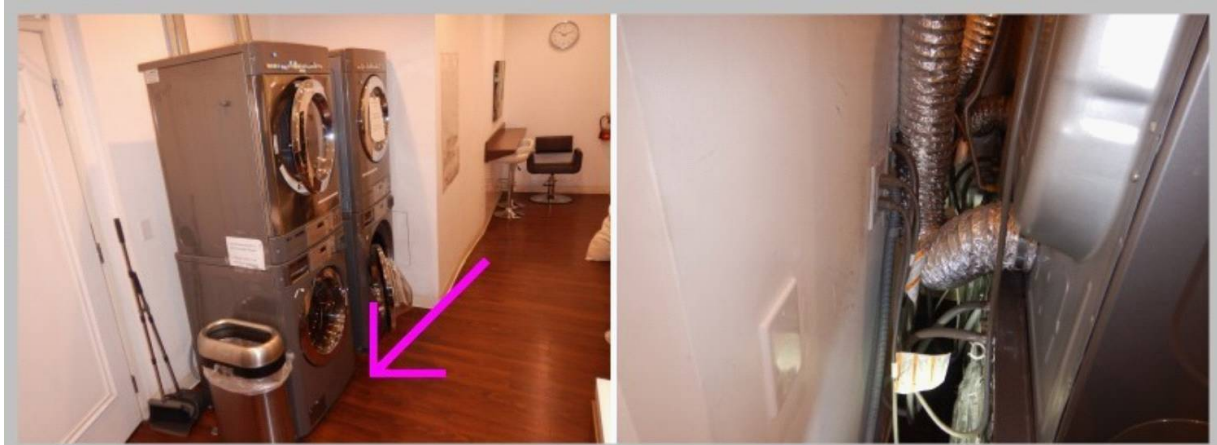
No pan under washer
