Confidential Property Condition Assessment Report

**1234 Your Drive
Simi Valley CA 93063**

**Prepared for: John Smith
Prepared By: Robert Gaudreault**

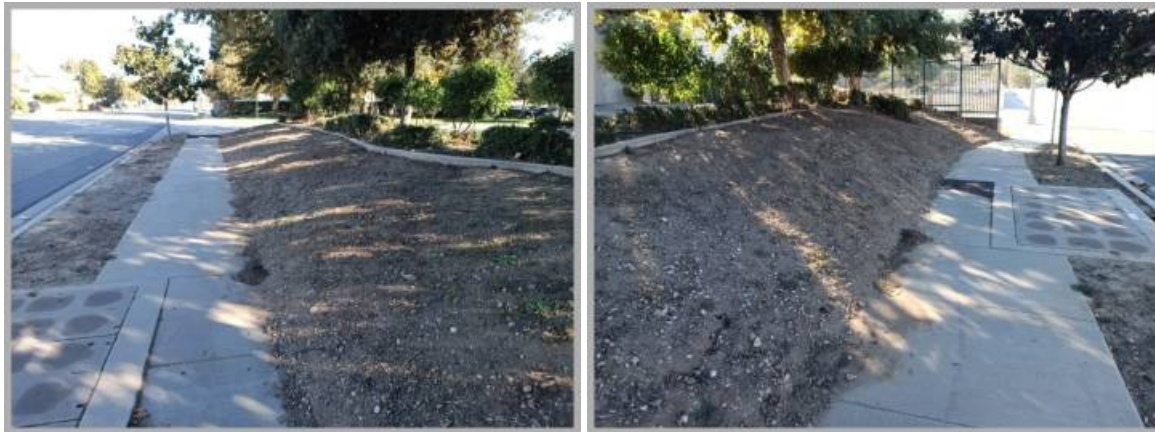
West side berm lacks planting. Signs of some erosion onto public walk seems apparent.

Possibly an HOA issue. Enquire with owner.

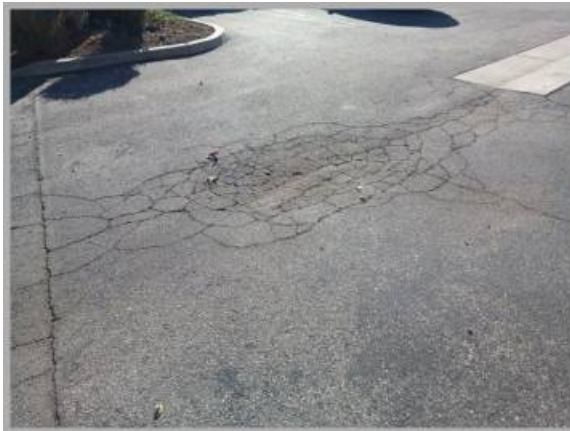
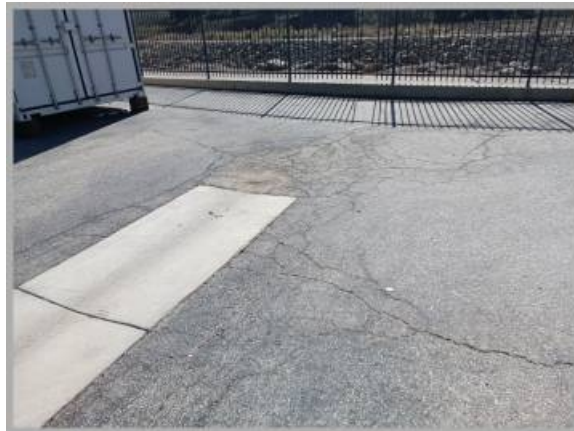
1. The parking paving area needs action. Alligatoring of moderate severity at east parking. More than likely due to structural base failure. Seal coat over all areas of parking has worn off.

The parking paving area needs action. Alligating of moderate severity at east parking. More than likely due to structural base failure. Seal coat over all areas of parking has worn off.

Patching 331 sf of segmented sections and seal coat overall 8200 sf pf paving.

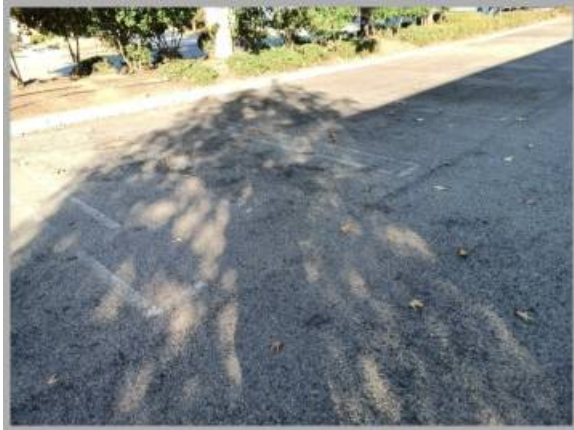
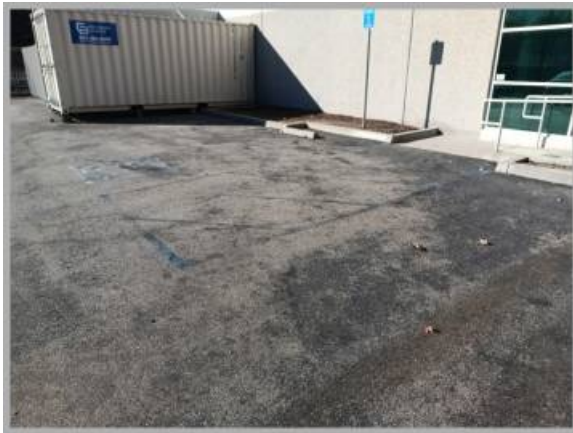
Parking lot striping was generally severely worn, faded and illegible in areas. Parking lot should be re-striped. The parking lot capacity was approximately 27 parking stalls.

Restripe parking stalls and two ADA parking stalls.

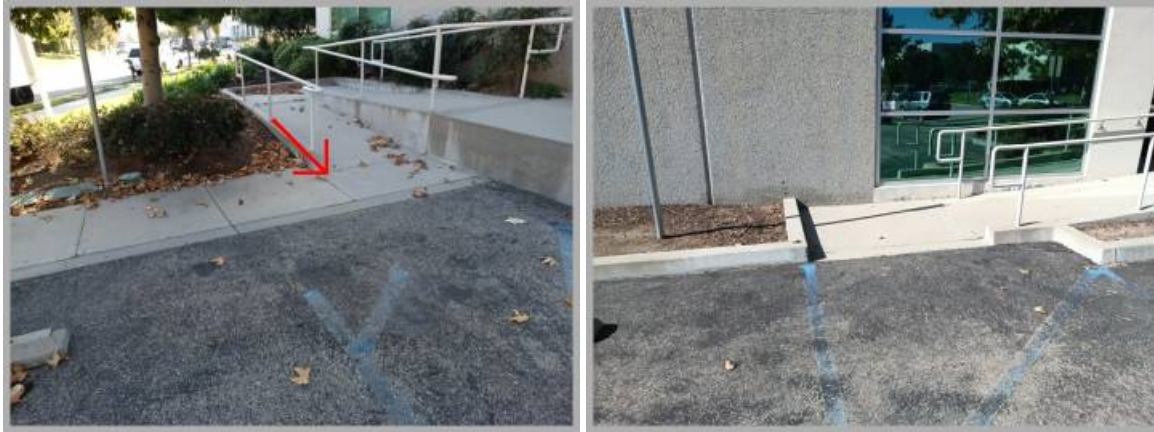
Truncated domes are lacking at the ends of each ADA ramps. AI Overview The purpose of truncated domes is to provide a tactile warning to visually impaired individuals that they are approaching a hazardous area,

Recommend corrections to ADA ramps by adding truncated domes.

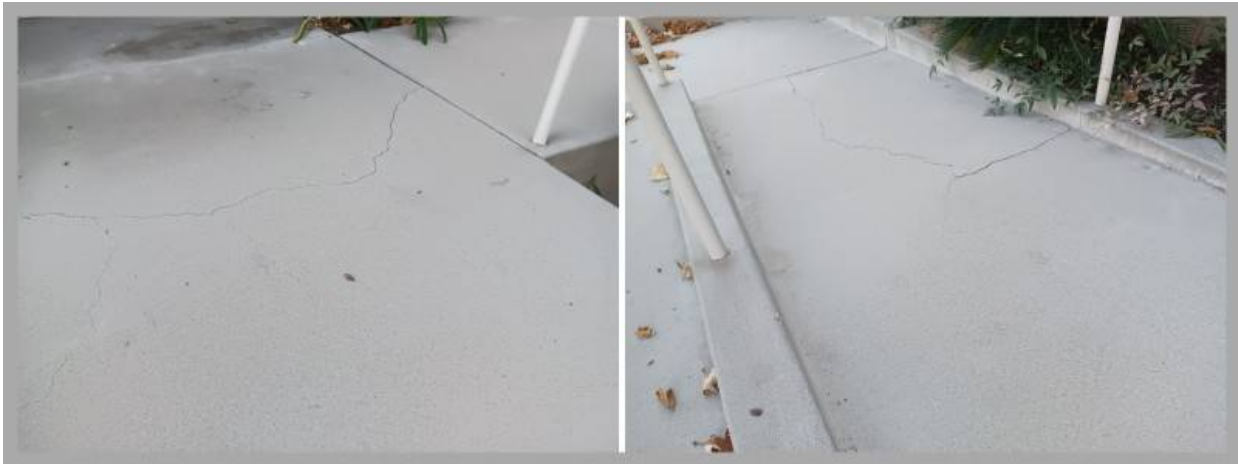
West side entrance ramp exhibited some slight settlement cracking. Maintain as needed by grinding out and slight raised section.

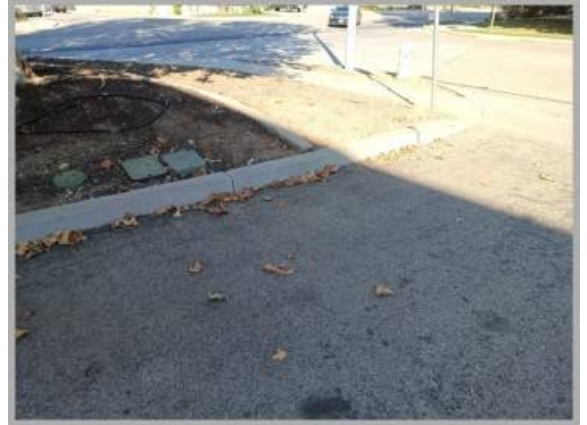
Some heaving observed at north west section of curbing.

Repair 8 feet of concrete curb.

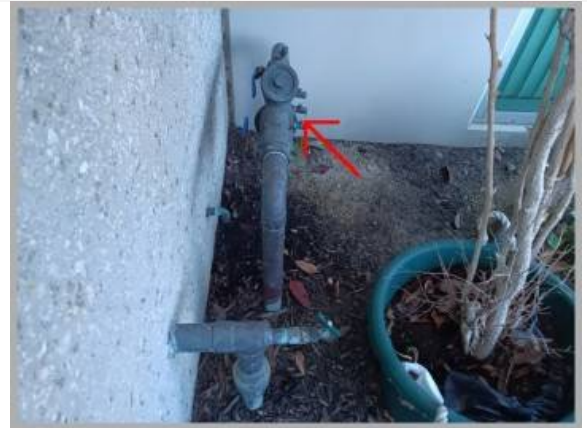
Main water supply is copper. No evidence of back flow test. Backflow testing on a commercial irrigation supply should be done annually to ensure the proper functioning of the backflow prevention device and protect the potable water supply from contamination; most local regulations require annual testing.

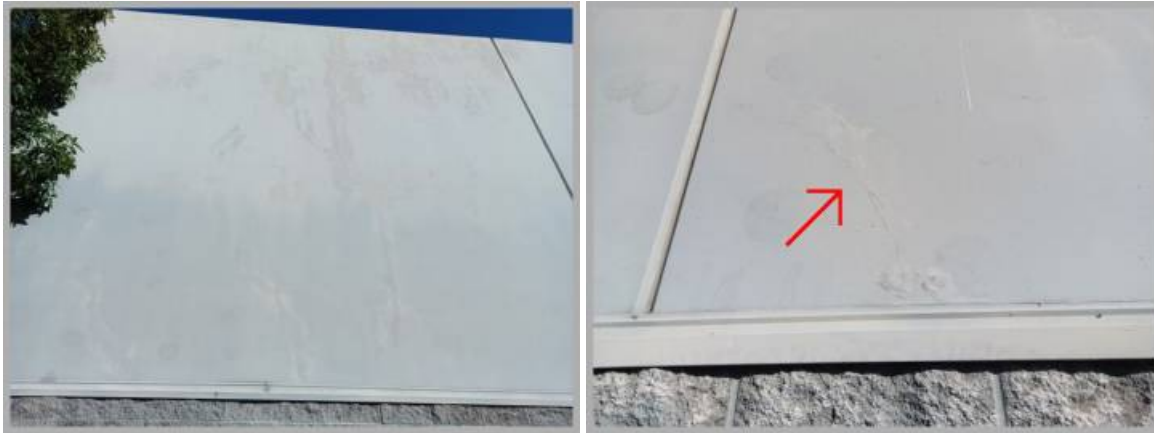
Satisfactory with only hairline cracking indicative of hydration referred to as drying shrinkage cracking. Painting and sealing cracks can help reduce any water infiltration.

Monitor and maintain.

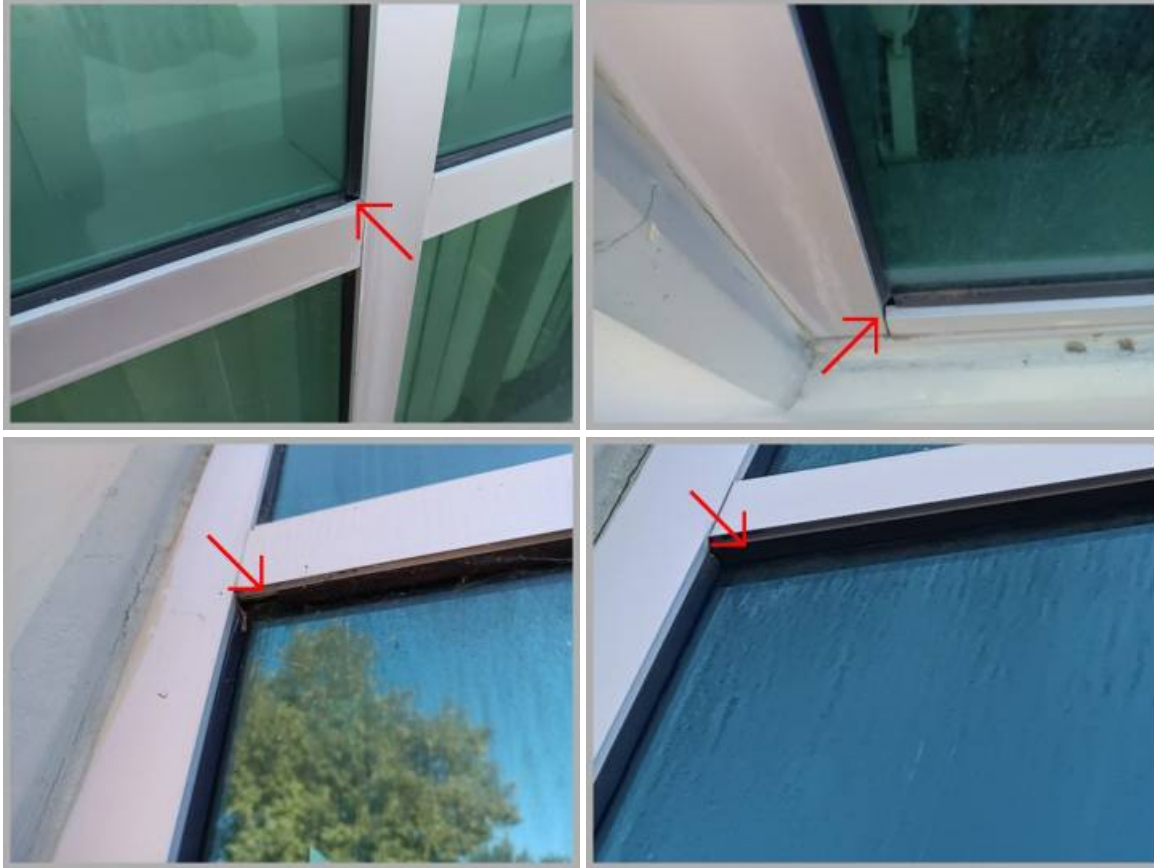
Windows are in need of maintenance. Some gasket seals are starting to show damage. The standard for repair is to remove all gaskets from that damaged window and reseal the entire window with approved caulking.

Further evaluation needed. Consult window installer, glazing contractor. Repair gaskets to at least 5 to 6 window panes.

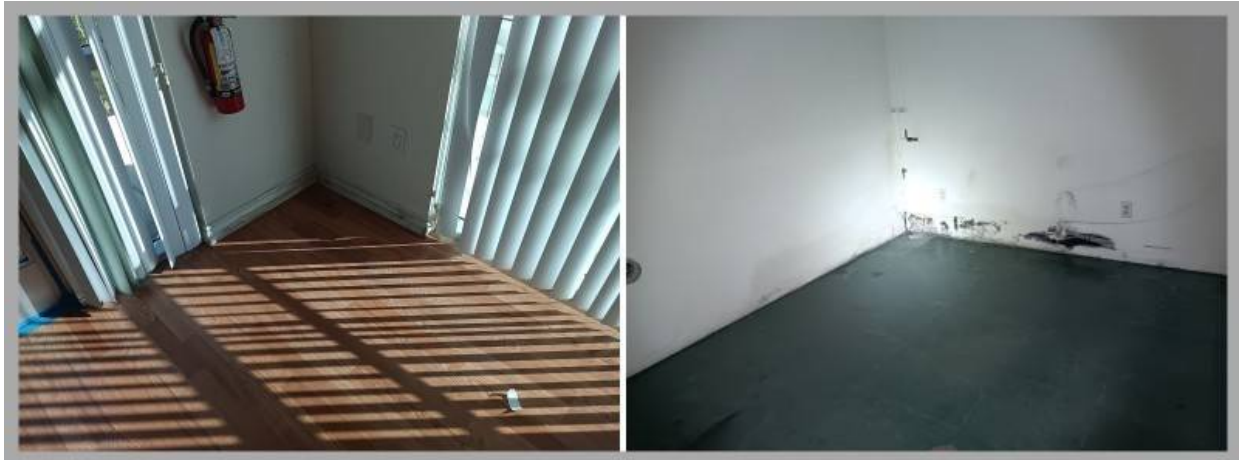
1. Water stains seen in various areas that are more than likely due to previous roof leak issues, such as one room adjacent to warehouse and north east office space. Some of the darker stains should be evaluated and tested by an environmental agency. This would determine on whether or not any special remediation procedures would need to be followed.

Water stains seen in various areas that are more than likely due to previous roof leak issues, such as one room adjacent to warehouse and north east office space. Some of the darker stains should be evaluated and tested by an environmental agency. This would determine on whether or not any special remediation procedures would need to be followed.

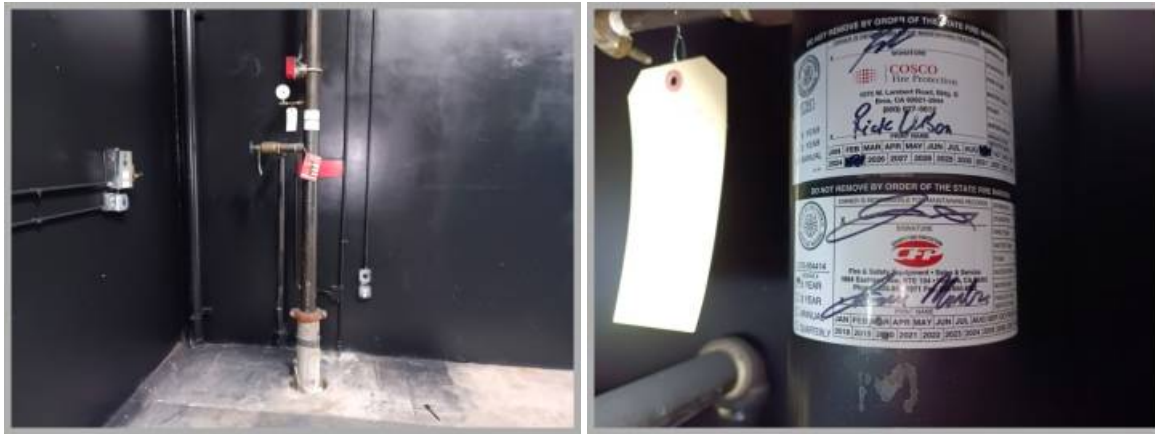
2. There is a fire sprinkler system installed. It is recommended that it be checked by a certified professional with appropriate experience. The type of system installed is referred to as a Wet Pipe System. 1 year and 5 year indicated past due.

There is a fire sprinkler system installed. It is recommended that it be checked by a certified professional with appropriate experience. The type of system installed is referred to as a Wet Pipe System. 1 year and 5 year indicated past due.

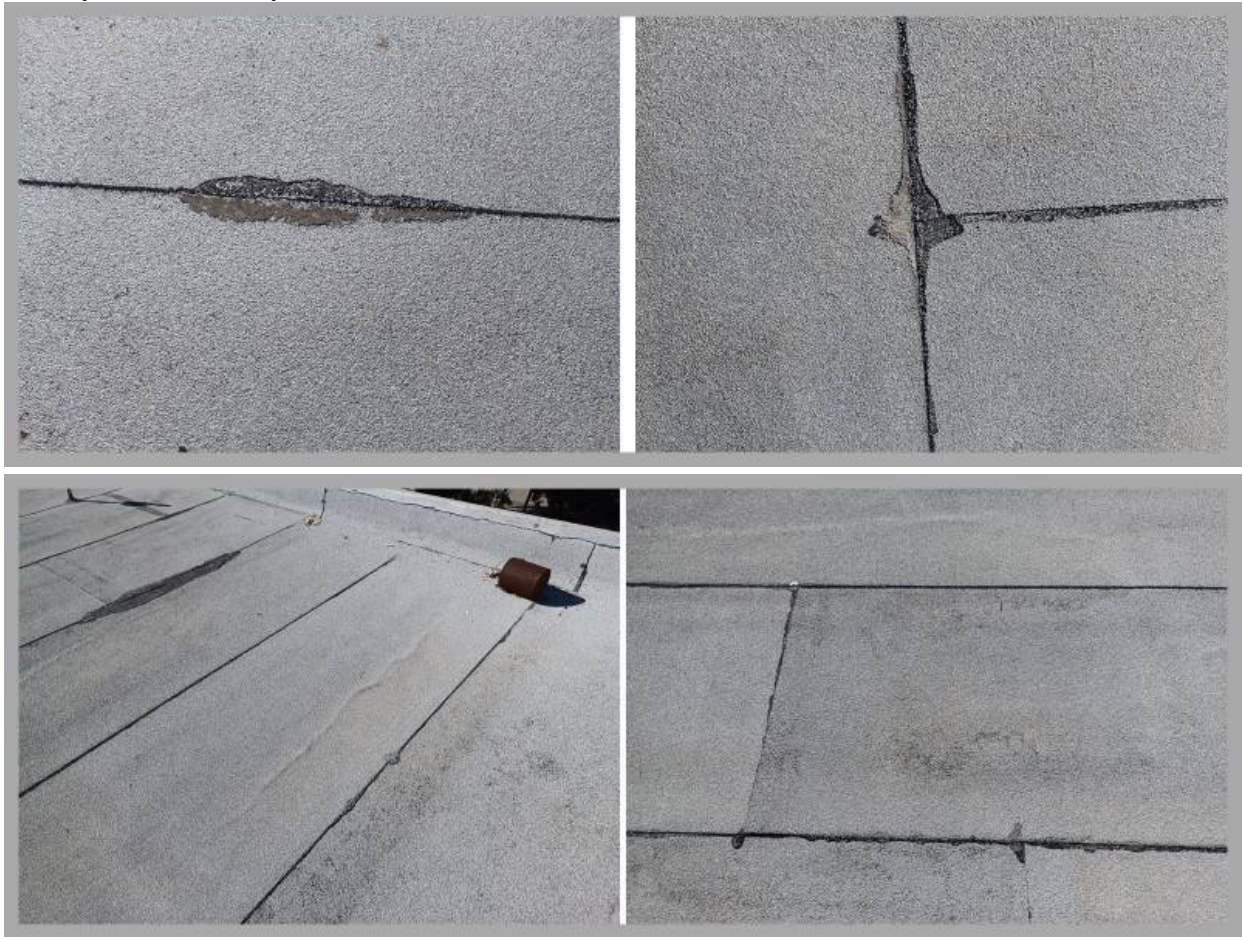
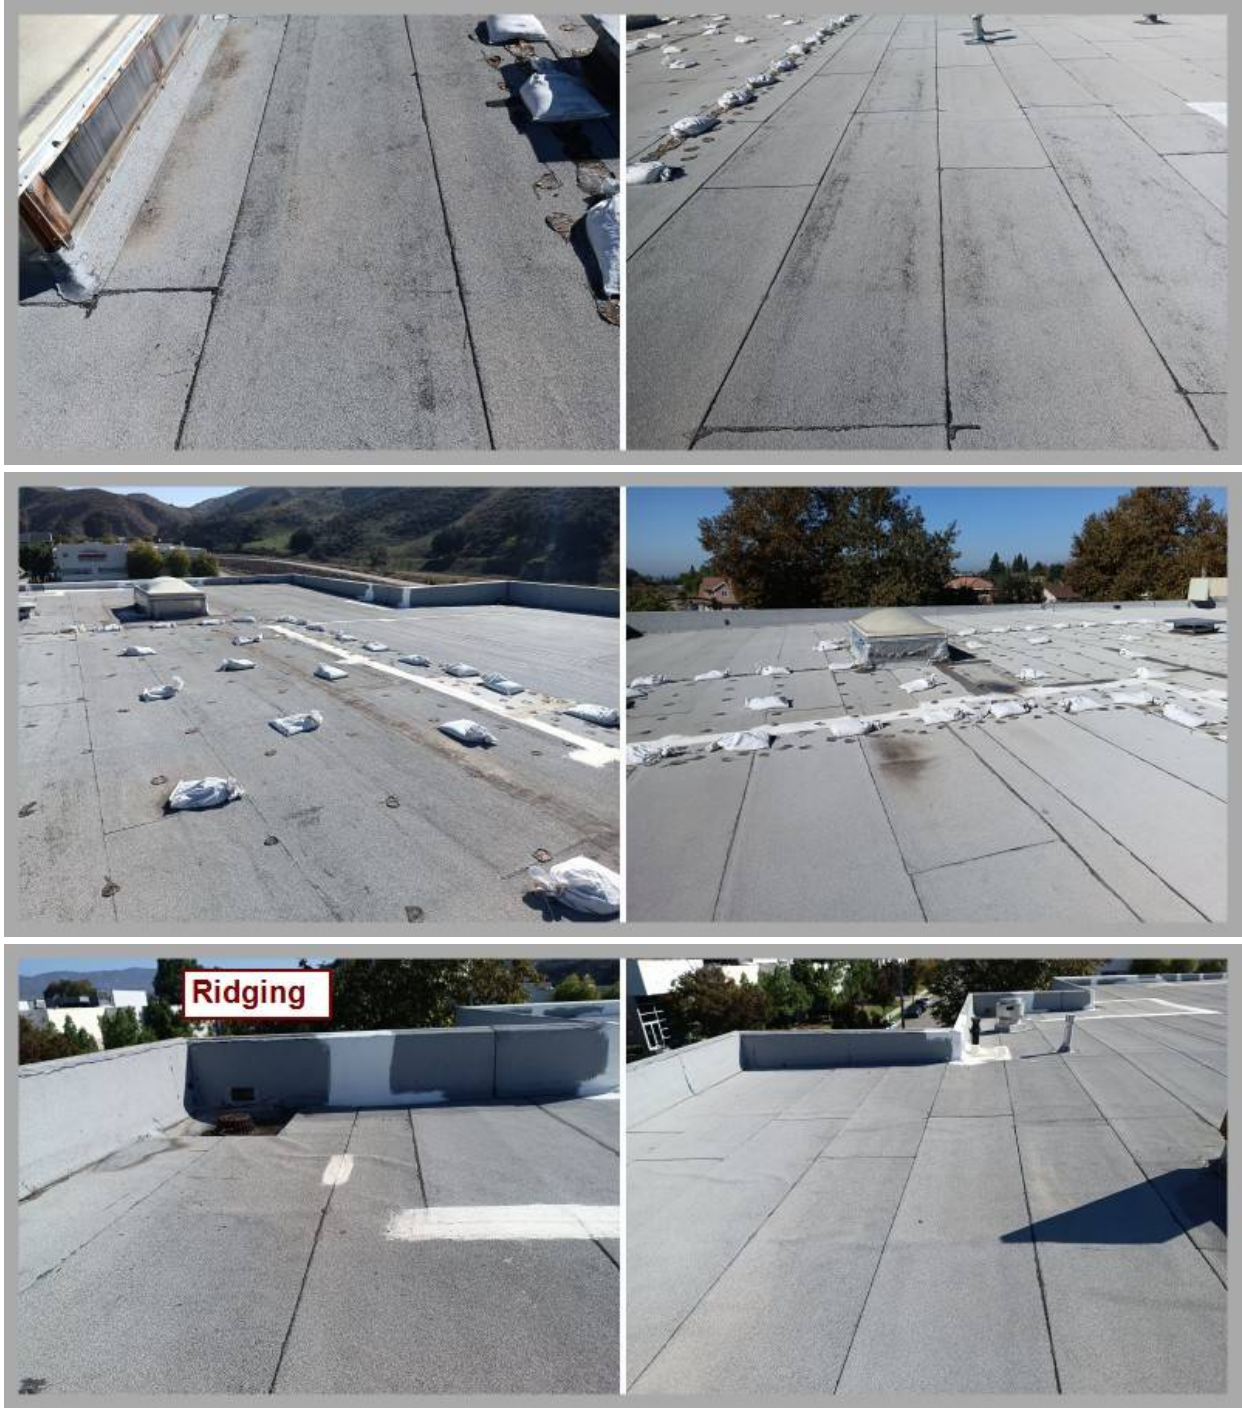
1. Moderate granular loss seen. This can either be from advanced age, manufacturer defect, foot traffic and/or incorrect installation. Asphalt matt and fiberglass is exposed as a result. Implications are shorter life span of material. Blistering or ridging noted on some of the roof material. Ridging is where the material at these blistered areas is not adhering to the roof deck and that there are air pockets.

Sand bags are seen on the roof system as well as odd patching. Uncertain as to what occurred. Enquire with seller as to any known history.

4. Roof system is in need of rehabilitation or removal and replacement due to noted issues. Consult at least two of three roofing agencies for estimates. Implications: The implications of a leaky roof are; damage to the structure as well as interior content and potential for microbial growth.

Rehabilitate roughly 7900 sf of roofing. Flat roof rehabilitation is a process of cleaning, repairing, and applying protective fluid type coatings or membranes to an existing flat roof to extend its lifespan, rather than replacing it entirely.

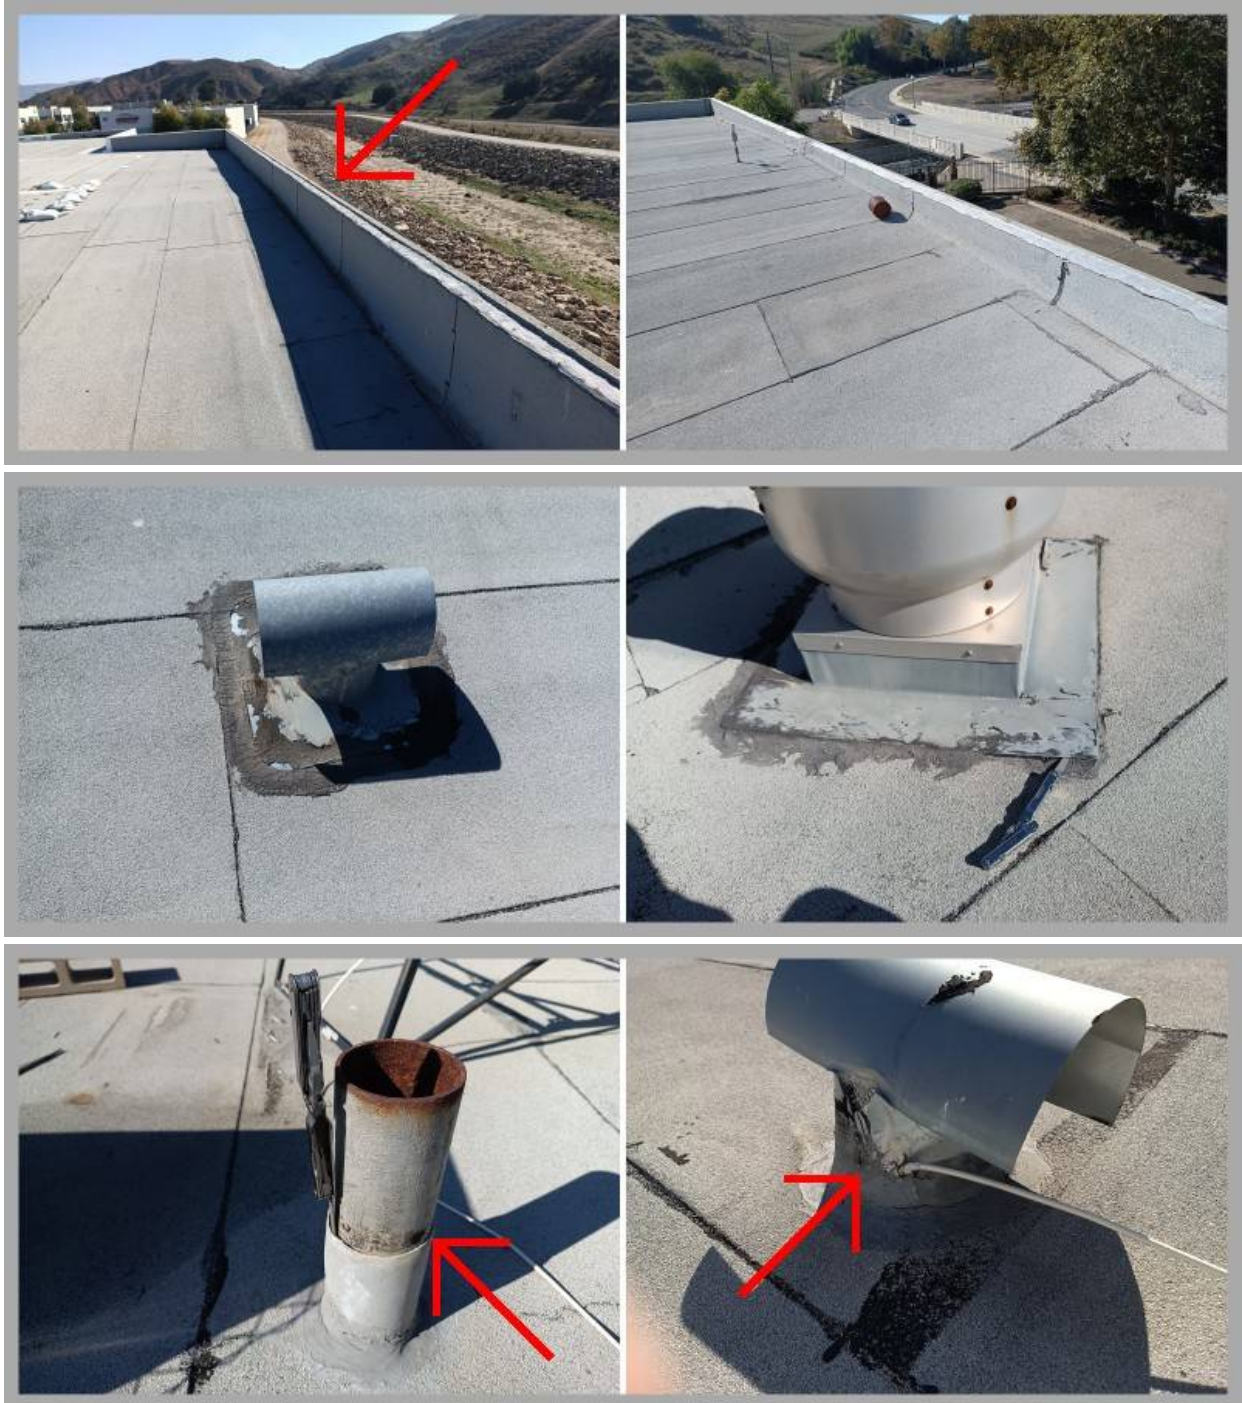
2. Parapet wall lacks coping flashing, mastic applied to some of the roof penetrations is worn and cracked and prone to leak.

Parapet wall lacks coping flashing, mastic applied to some of the roof penetrations is worn and cracked and prone to leak.

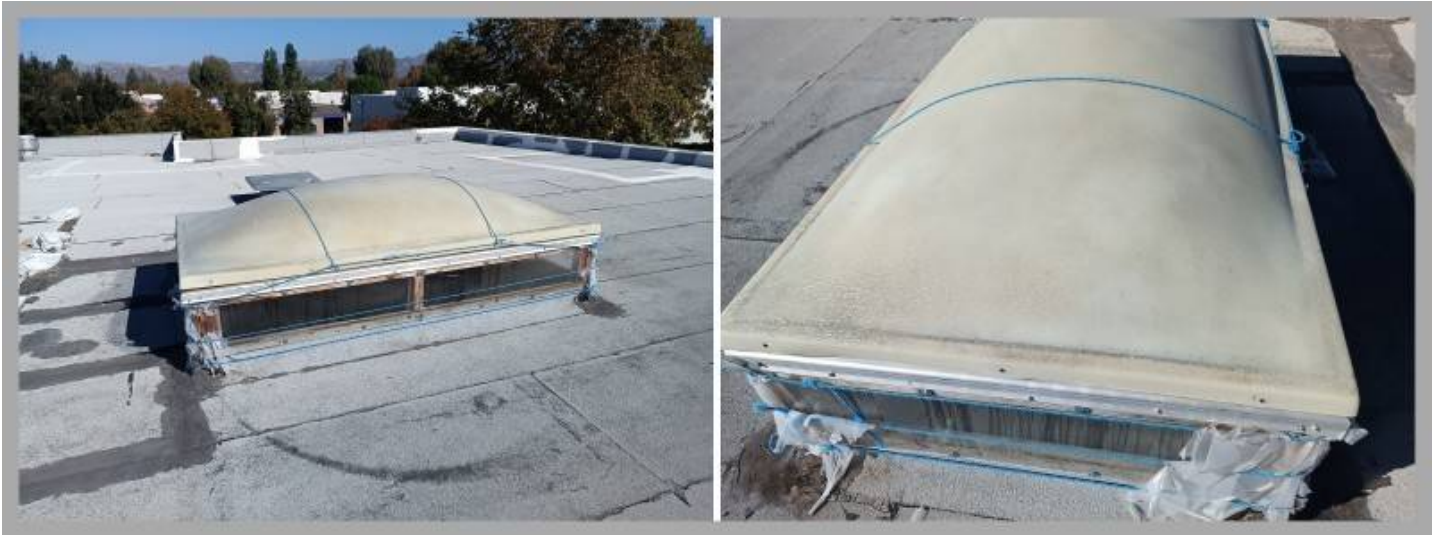
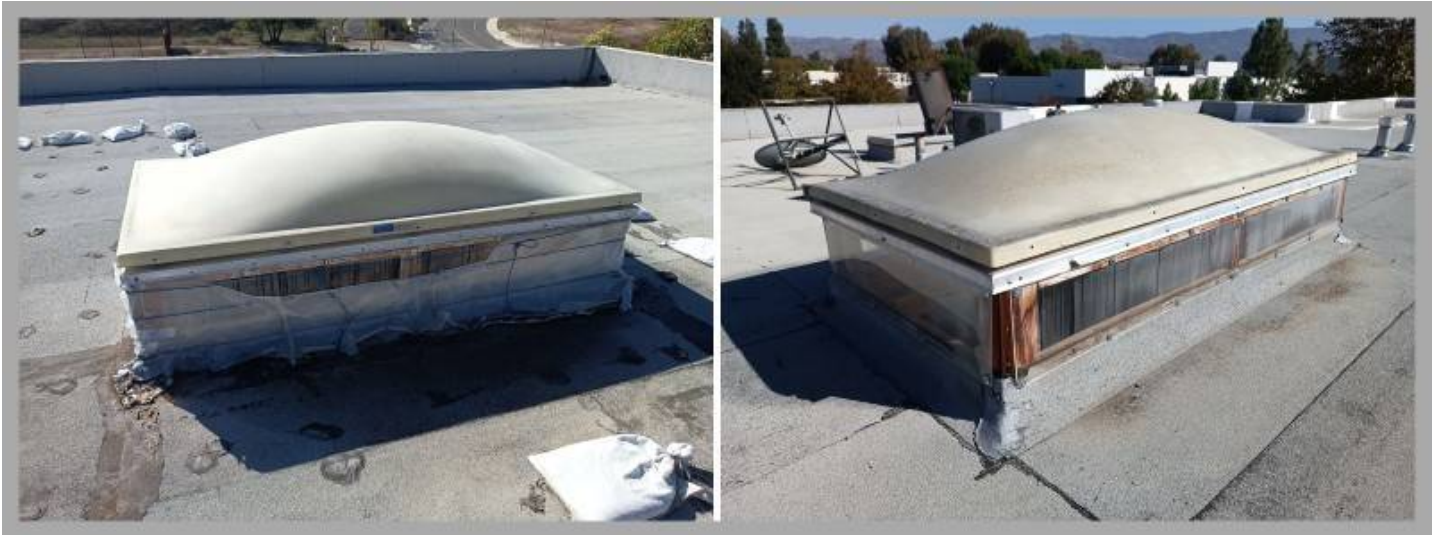
3. Skylights have been modified from their original configuration which can void any warranty or coverage. Dome lenses are deteriorated and need replacing.

Skylights have been modified from their original configuration which can void any warranty or coverage. Dome lenses are deteriorated and need replacing.

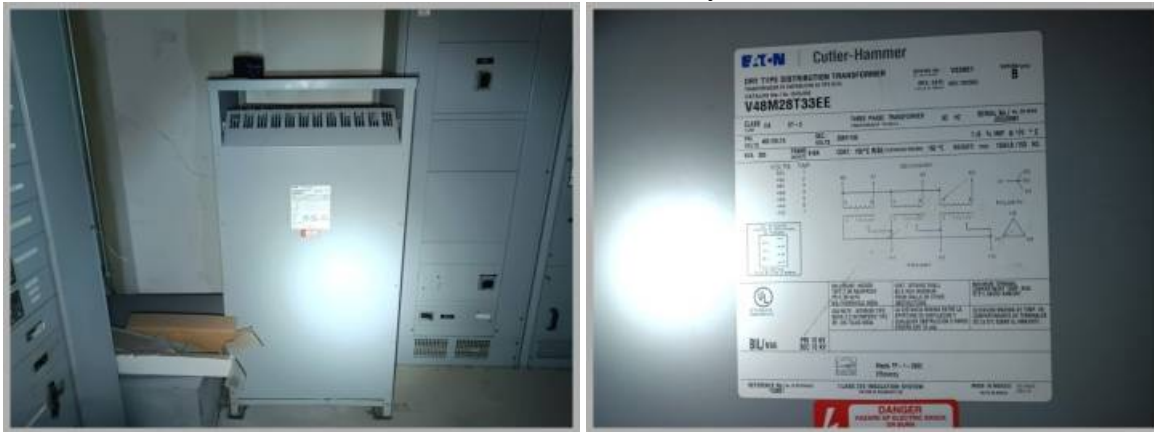
1. Some humming. Maybe normal. Transformers produce audible hum due to: Magnetostriction core laminations vibrating at 120 Hz (from 60 Hz AC). or loose mounting bolts or panels rattling. Although this humming may not be of significance it should be reviewed further.

Some humming. Maybe normal. Transformers produce audible hum due to: Magnetostriction core laminations vibrating at 120 Hz (from 60 Hz AC). or loose mounting bolts or panels rattling. Although this humming may not be of significance is should be reviewed further.

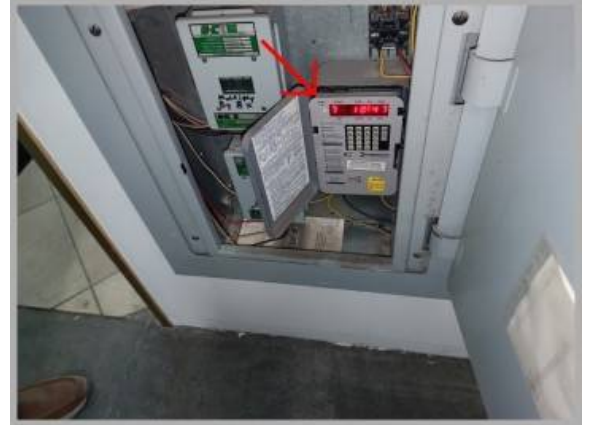
3. A representative sampling of switches was achieved. These tested appeared to be operating properly. However timer controls of office lighting is loose from within its box.

A representative sampling of switches was achieved. These tested appeared to be operating properly. However timer controls of office lighting is loose from within its box.

4. Electrical for the most part seems to be in serviceable condition with some repairs or corrections needed. Though these repairs may seem menial all electrical repairs, no matter how simple, should only be attempted by licensed and insured electrician.

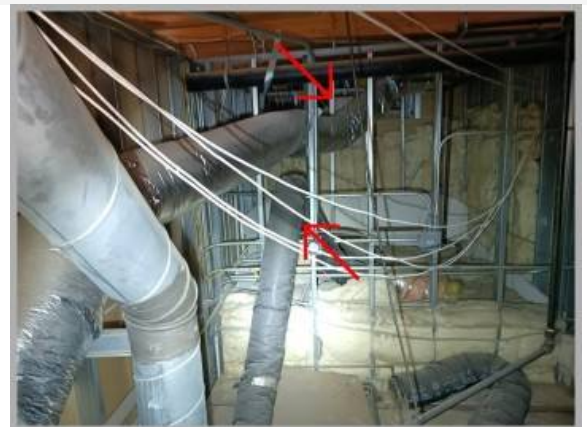
Poor. Inadequate support and sections of duct seem to sag more than one inch in 4 feet. Sagging ducts should be prevented as it can affect efficient air flow.

Replacement of 5 ton package unit.

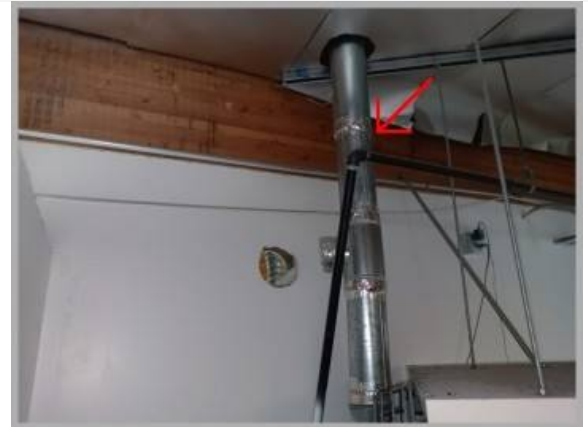
Evidence of leak seen along vent at west side unit.

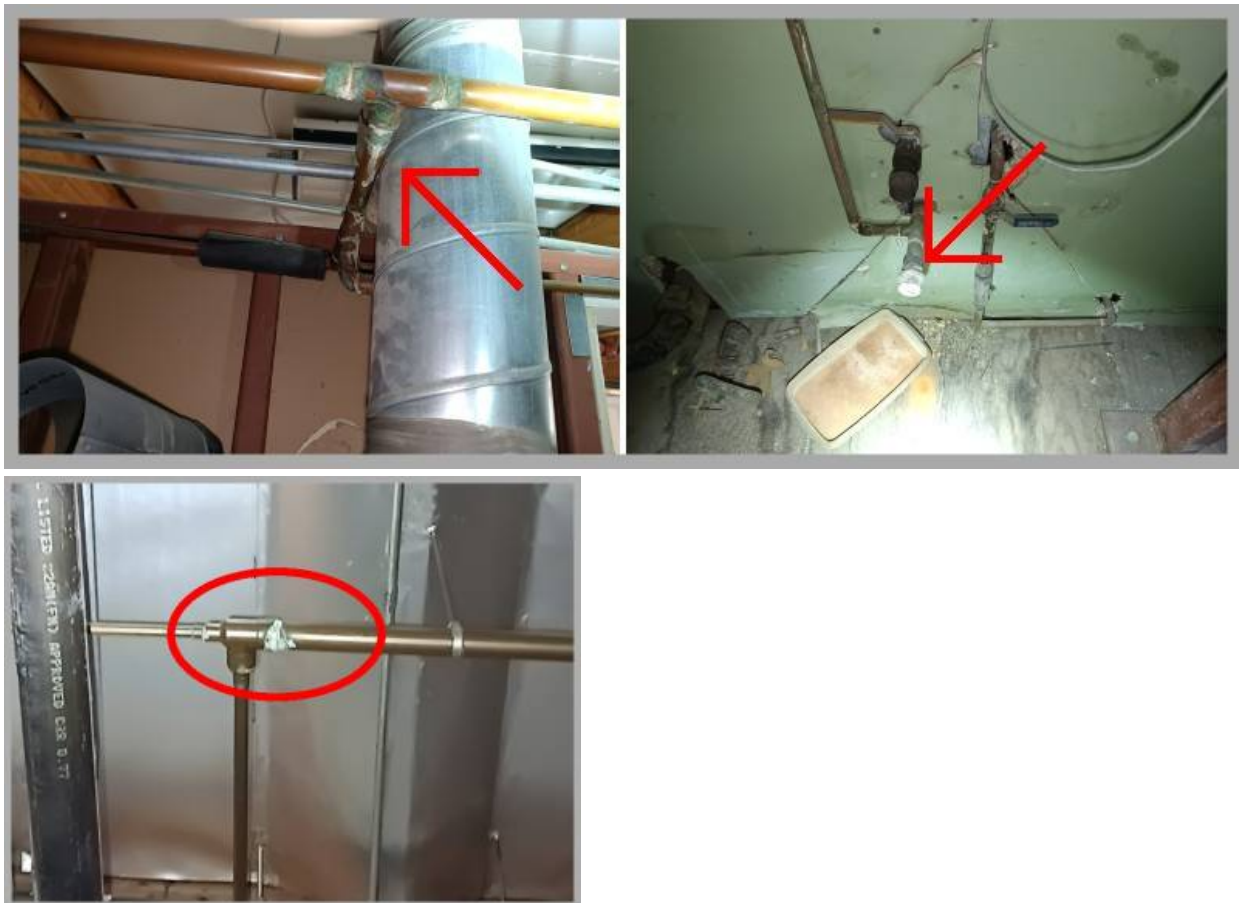
1. Copper to galvanized contact noted in areas. This does result in eventual corrosion as the more pure metal (copper) will eat away at the less pure (Galvanized). This is referred to as electrolysis. Ideally a coupler or brass would have been used between the two metals and heavy oxidation observed in at least one location. Implications are greater potential for leaks posing water damage to structure as well as interior content. This condition is noted at ceiling above office area.

Implications are greater potential for leaks posing water damage to structure as well as interior content. This condition is noted at ceiling above office area.

Further evaluation needed by a licensed plumber.

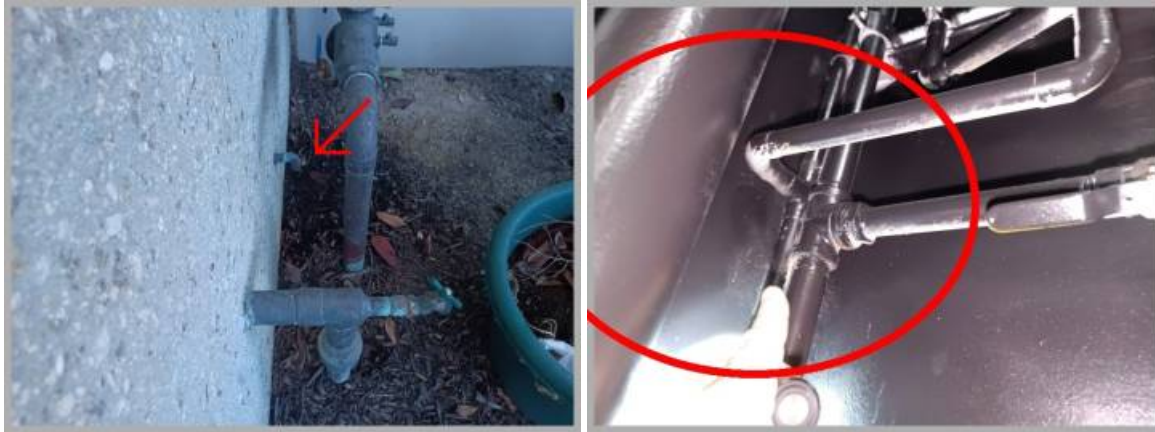
4. This water heater discharge pipe served multiple such as A/C condensation discharge drain. This condition is improper and potentially unsafe. The temperature pressure relief valve should have its own discharge pipe that empties to a distinct location.

Further evaluation needed. Contact and schedule a licensed plumber to inspect issues and or conduct necessary corrections.

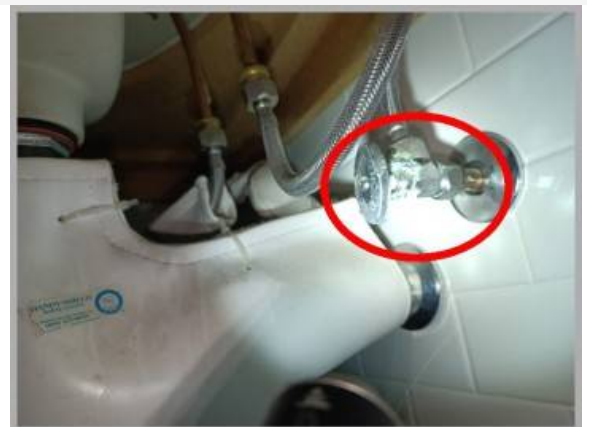
ADA pads are missing from angle stops. These exposed valves exhibited oxidation. No leak at this time however maintenance should be achieved.

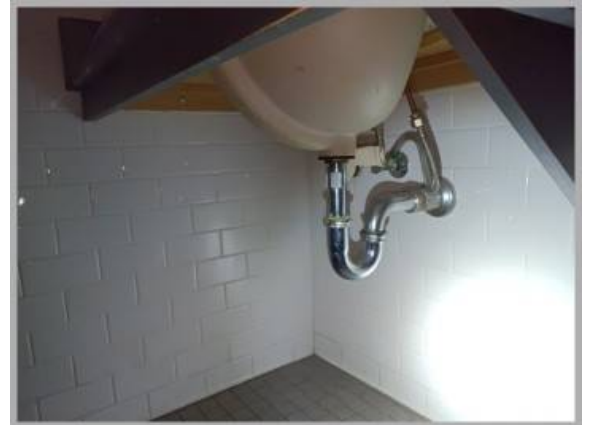
11.12 VANITY CABINETS:
ADA protection pads missing.

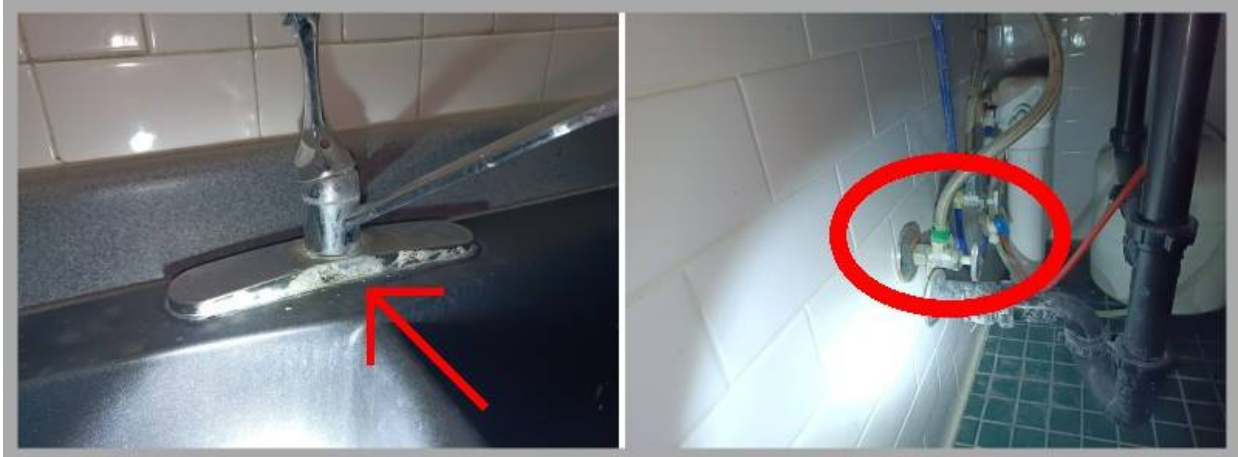
Heavy oxidation at angle stop valves and faucet is excessively corroded and needs replacing.

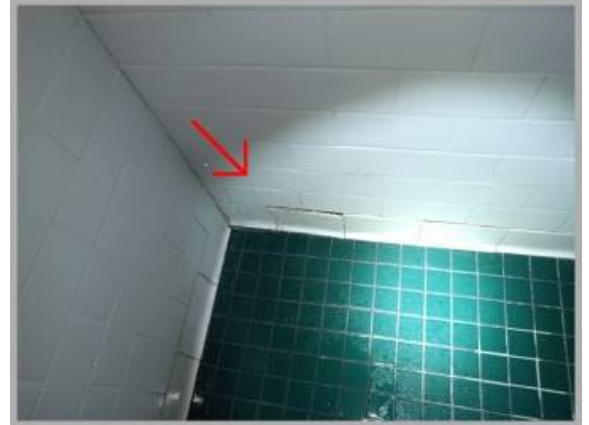
Damaged wall tile. Implications are potential for leak into substrate.

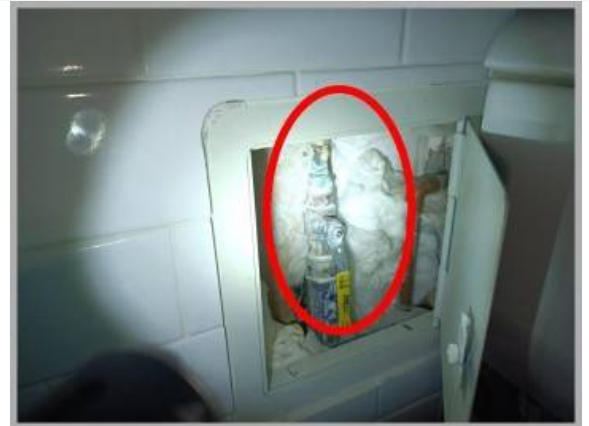
Corrosion is noted to fill valve located behind toilet. Further evaluation needed. Consult plumber.

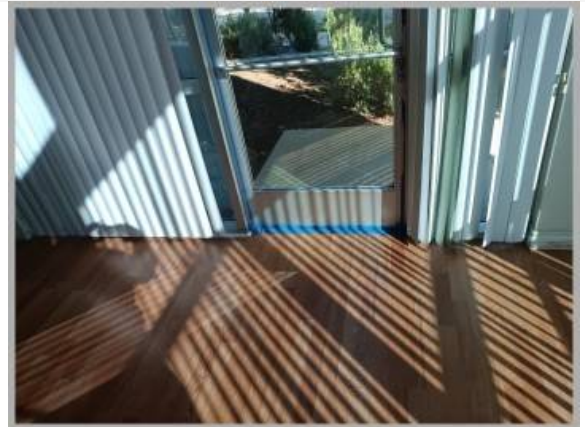
A representative sampling of interior doors was achieved. Those operated were in serviceable condition. However entry door of north east office is tapped over apparently to prevent water or dirt entry.

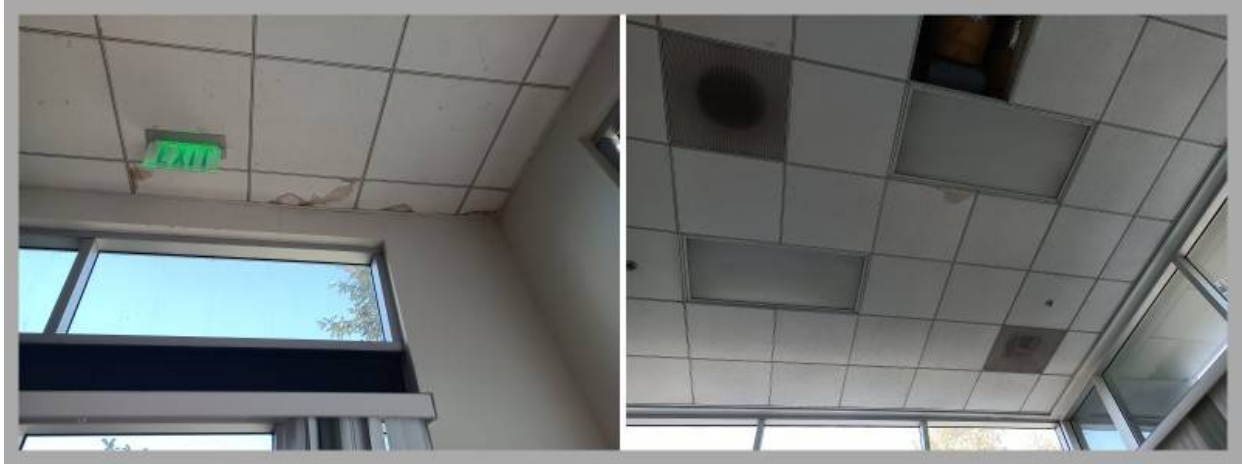
Water stains seen at various locations.

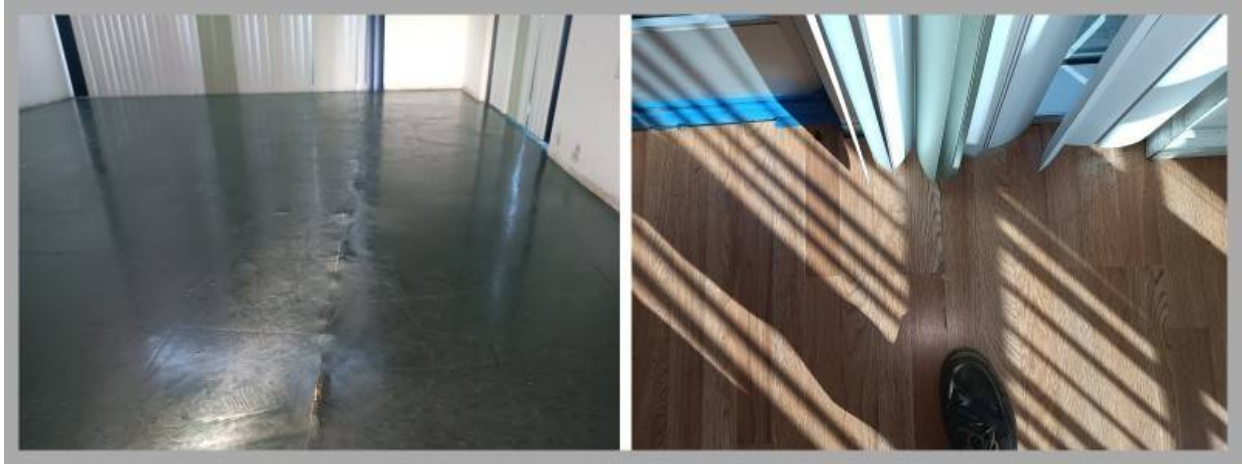
Resilient flooring exhibited damage, such as curling which is indicative of water related damage, water damage also apparent at wood flooring of north east office.
