Alliance Inspections

Report: Sample Condo Report, 19231 Anywhere Avenue, Reseda, CA 91335

Confidential Inspection Report 19231 Anywhere Ave. Reseda, CA 91335

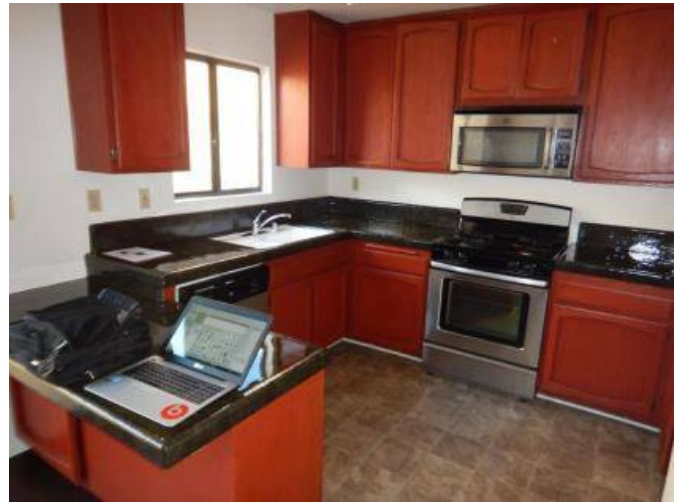
Main level, back right.

Attention Needed- Rust or corrosion seen on one of the water shut off valves under the sink.

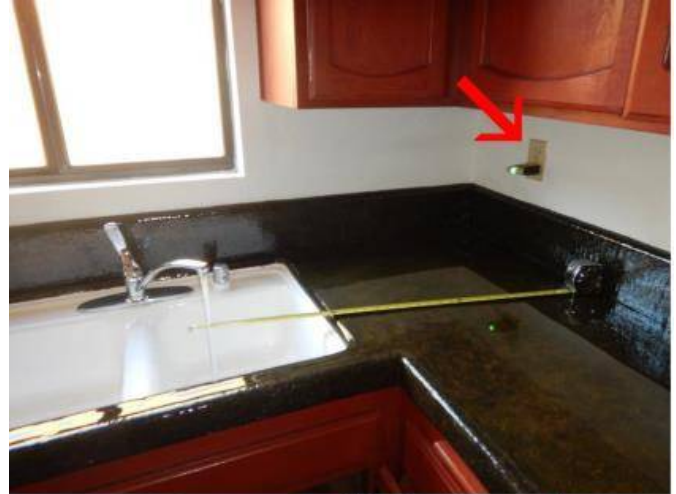
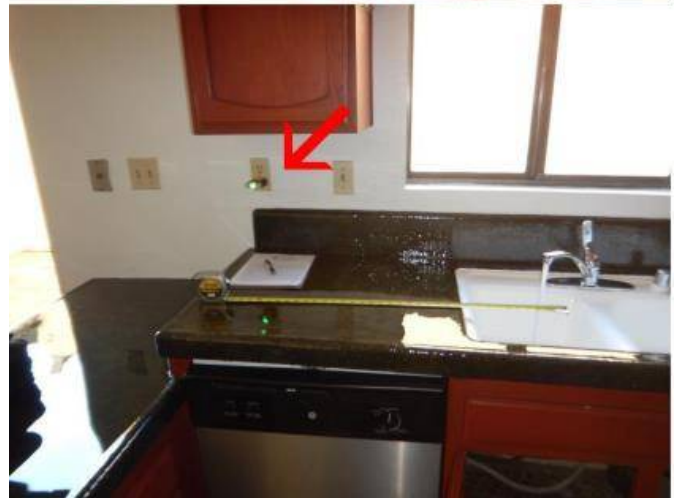
Attention Needed- This kitchen does not have Ground Fault Circuit Interrupt outlets installed. The age of the structure may predate the required installation; however, for safety considerations, it is strongly suggested that one be installed at any location within 6 feet of a water source. Satisfactory.

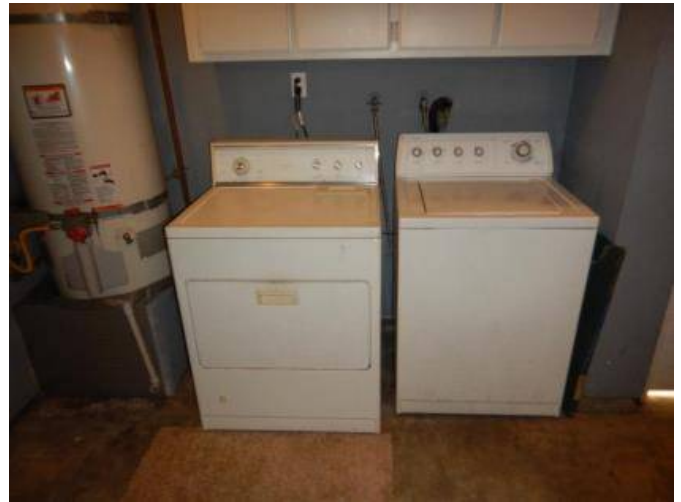
5.1 LOCATION:

Washer hook ups provided. These valves are not tested. Inspector simply notes the presence of fill valves and drainage. **Attention Needed-** One of the shut off valve handles are missing, replacement needed.

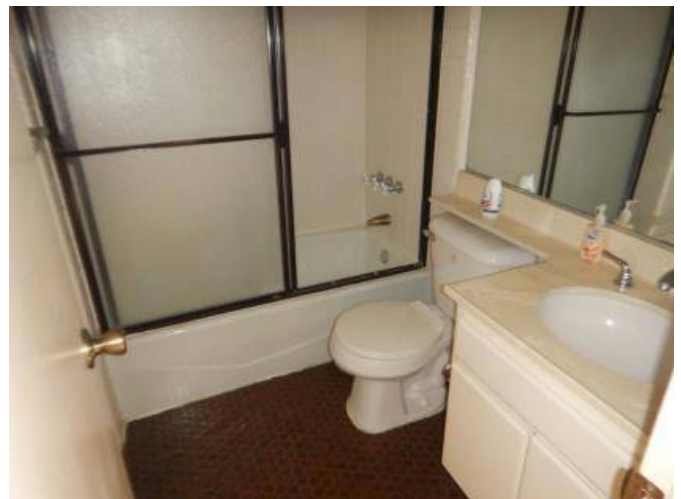
6.11 LOCATION:

Attention Needed - Water damage noted within cabinet under sink.

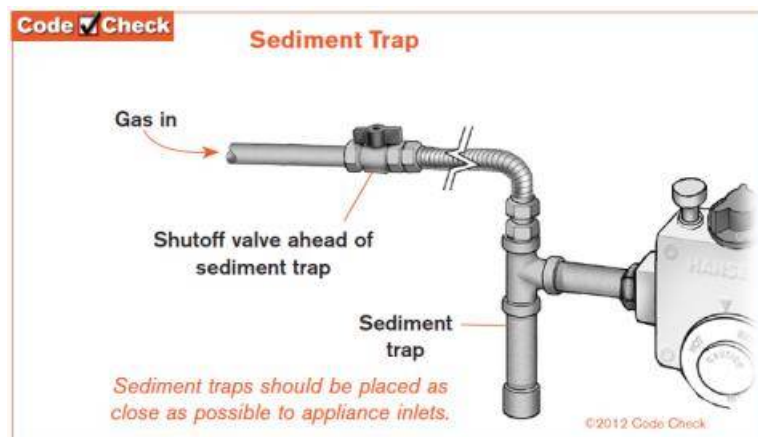
7.22 CONDITION:

Though not required in some municipalities most manufacturers recommend that a sediment trap be installed at each fuel burning appliance, such as water heaters and furnaces. We always recommend that these be installed as they are requested by the manufacturer. Some insurances will not cover an appliance that is not installed per the manufacturers specifications.

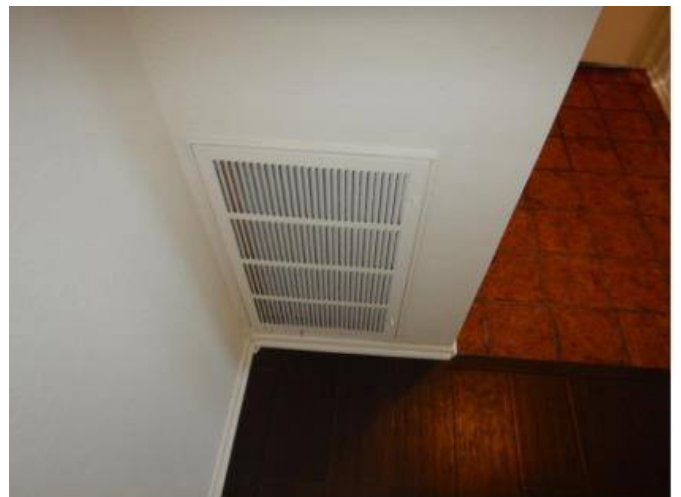
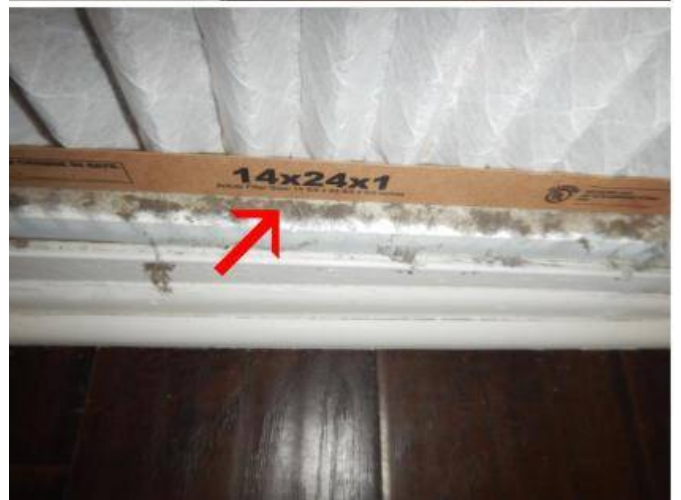
8.12 FILTER TYPE AND SIZE:

The filter at lower floor is. 14 x 24 x 1. Disposable.

The filter at upper hall is incorrectly sized.
Improvements needed.
