Report: Sample

Confidential Inspection Report

**1234 Sample Address
Sample City CA. 12345**

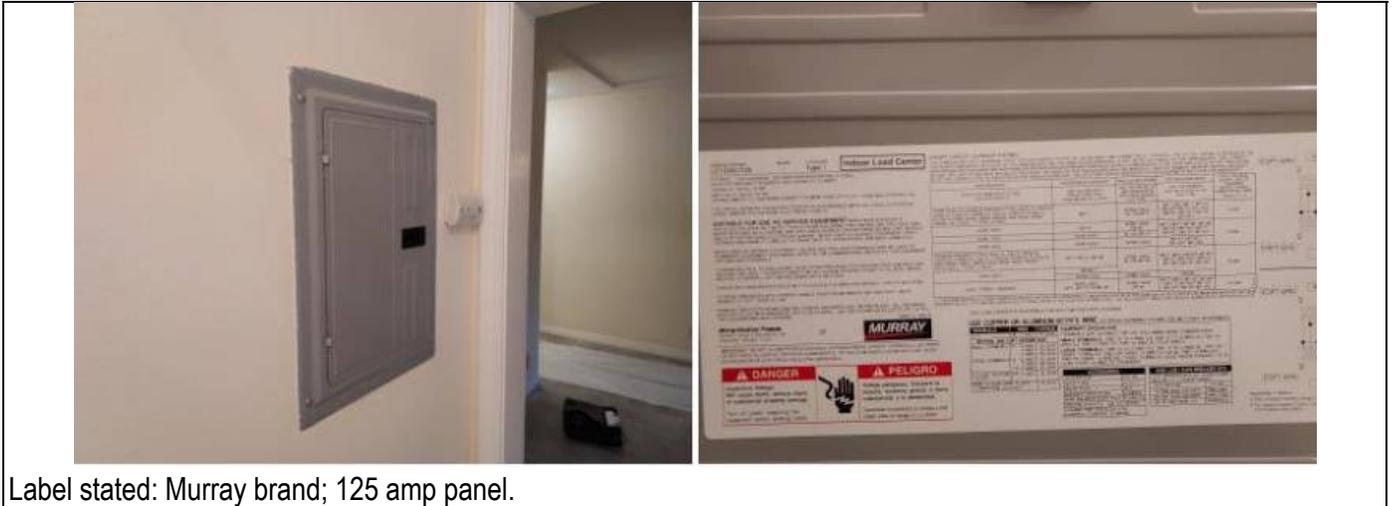
4.4 SIZE:

Label stated: Murray brand; 125 amp panel.

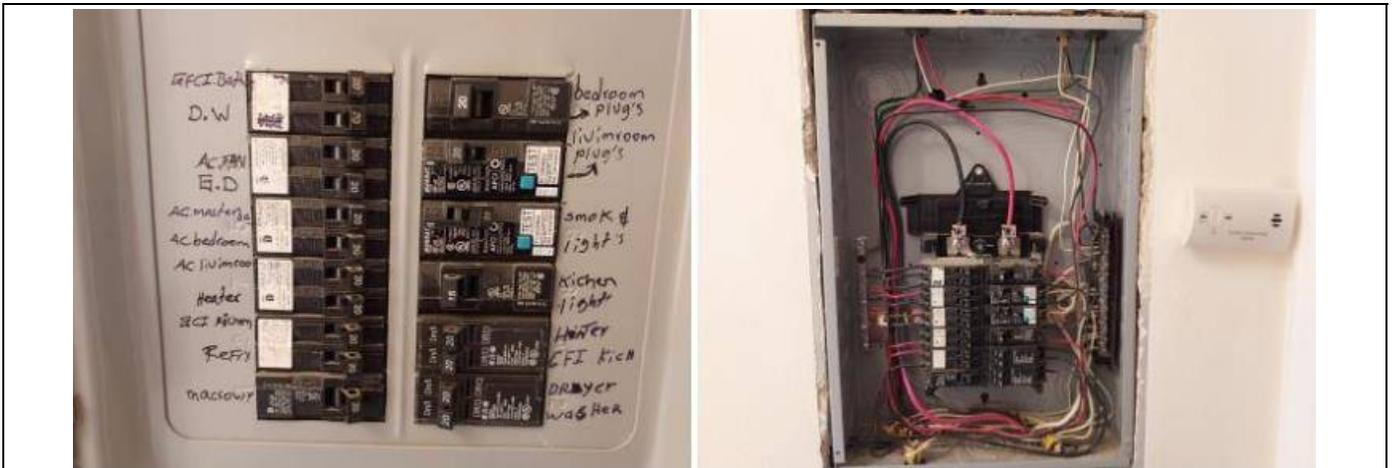
4.8 BREAKER/WIRING

Breakers/fuses in the main power panel appear to be appropriately matched to the circuit wire gauge.

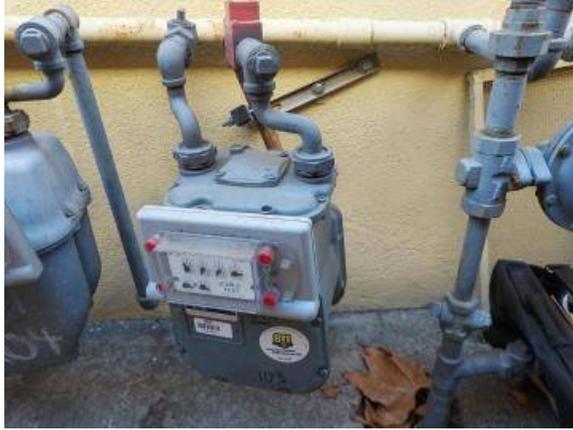
5.9 METER LOCATION:

Common area maintained by HOA. An automatic seismic gas shut off valve is installed.

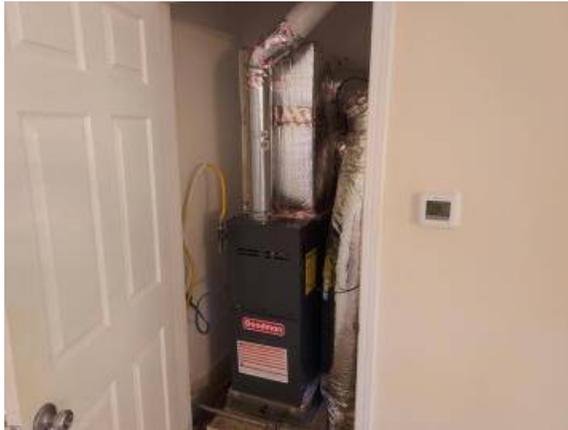
6.1 Type and Location:

A forced air furnace is installed as the primary source of heat located in living room closet.

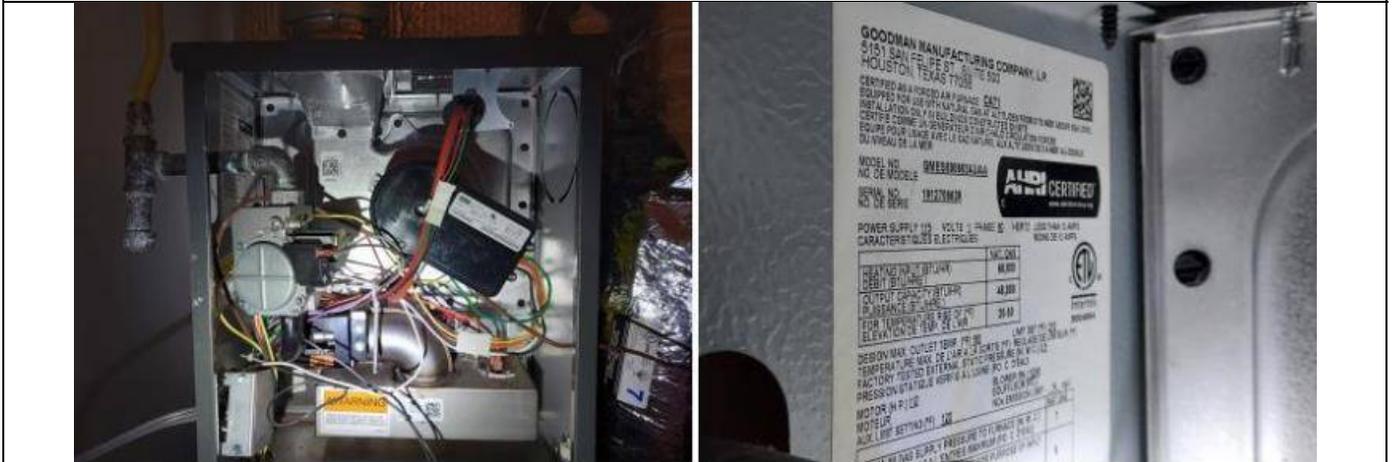
6.2 Equipment Description:

Tag on unit said: Goodman brand; 60,000 btu; gas; manufactured Dec 2019. Typical service life for a forced air natural gas furnace is 18 - 20 years.

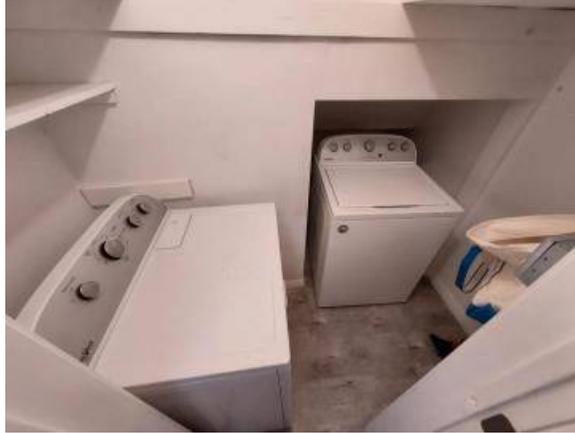
10.1 LOCATION:

There is a connection box installed in the wall with both hot and cold water and a drain pipe. The drain pipe was not flood tested.
