Professional Commercial & Residential Inspections

Confidential Inspection Report

4321 N. Anywhere St.
Los Angeles CA 90000
June 5, 2024

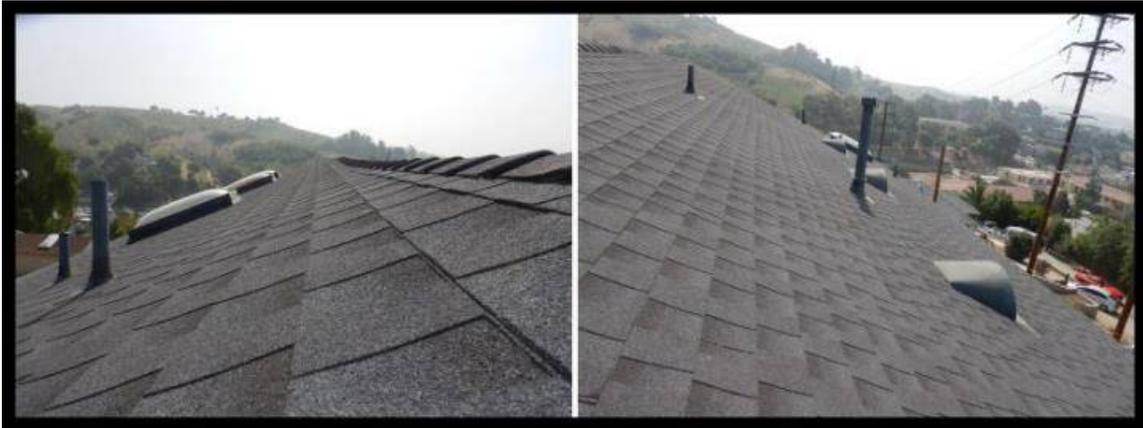
5.1 CONFIGURATION & MATERIAL:

Gable, Fiberglass composition shingles. Fiberglass mat, asphalt impregnated. Shingles are applied in horizontal rows.

The roof edge was the location of the inspection of the roof covering.

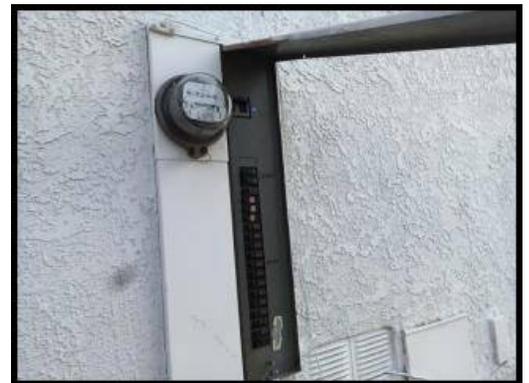
7.3 MAIN PANEL LOCATION:

Exterior right side.

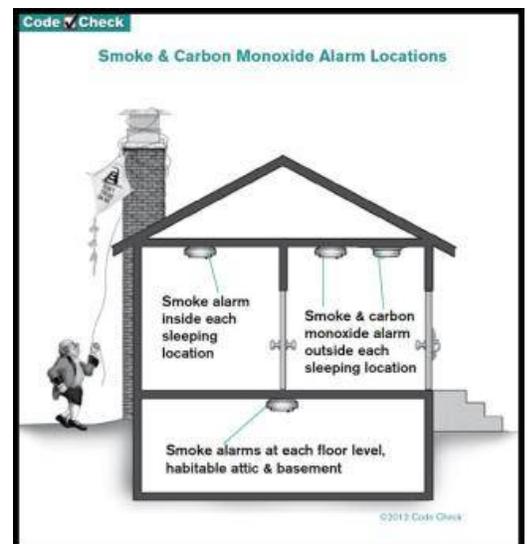
7.19 SMOKE DETECTORS:

Disclaimer - The existing smoke detectors were not tested, but they are only noted as to presence. We do not test the smoke detectors because they may work today but not work when you need them to work. This is why it is important for **you** to test them on a regular basis, monthly at least. Carbon monoxide alarms were also noted at both upper and lower levels.

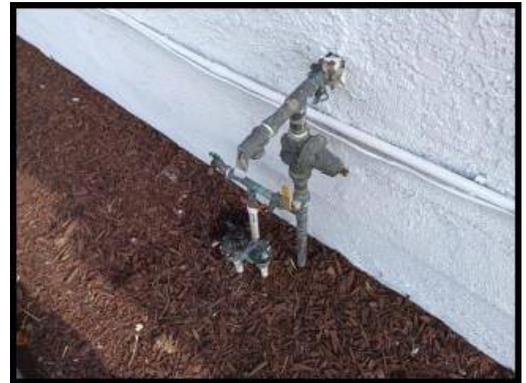
8.1 SOURCE::

City. Local utility provider, Meter is located at Front parkway, Shut valve is located, at right side.

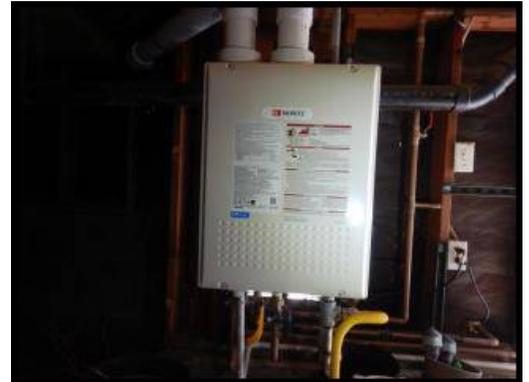
8.12 LOCATION:

Under the dwelling.

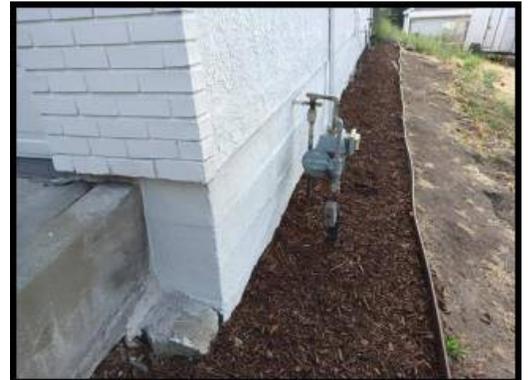
8.21 METER LOCATION:

Right side. An automatic seismic gas shut off valve is installed. Natural gas is used as source of fuel.
