**Report:** Mr. Customer PCR **Address:** 1234 Commercial St.

# Confidential Property Condition Assessment Report

**1234 Commercial St.  
Los Angeles CA 90000**

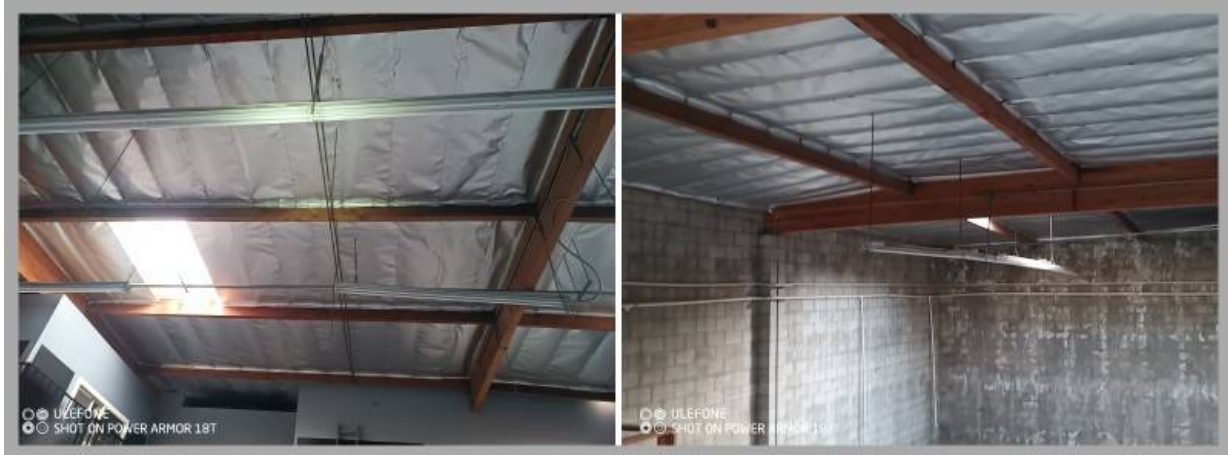
### 3.14 FLOOR/CEILING FRAMING:

Glulam beams supported by walls which are supporting ceiling joists and roof deck. The inspection only refers to the exposed ceiling/floor framing members. This is only a visual inspection and does not comment on unexposed framing members.

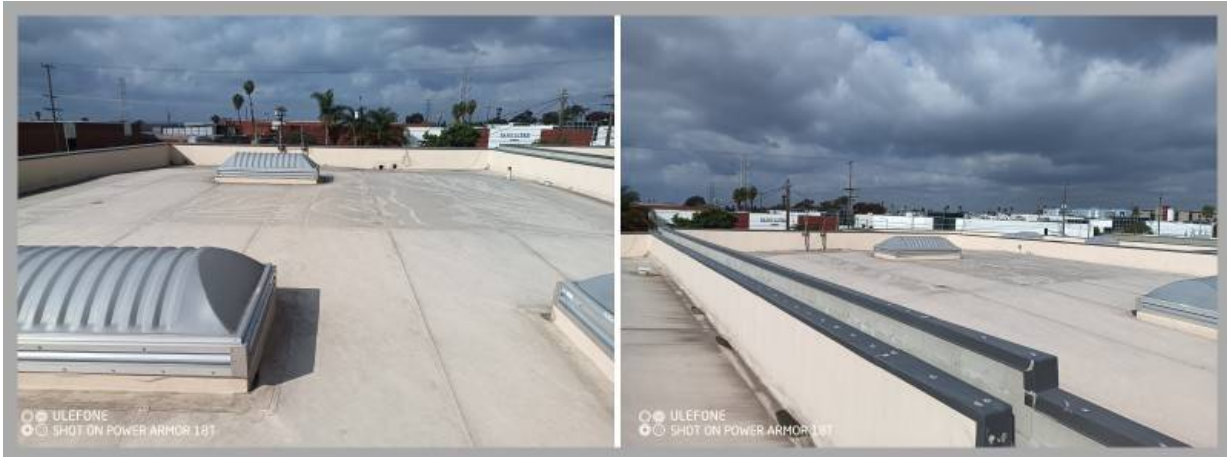
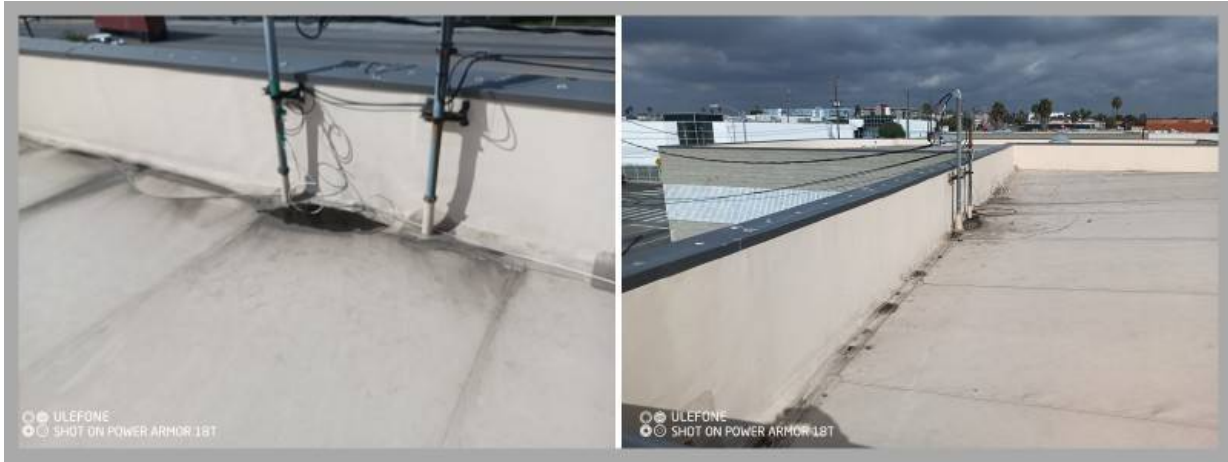
### 5.2 CONDITION:

1. The roof covering material is in a condition that is consistent with its age and method of installation. Mild areas of ponding noted. Water should not sit onto a roof surface for more than 48 hours as this promotes deterioration and leak potential.

No Action as a result of this assessment. Maintain as needed.

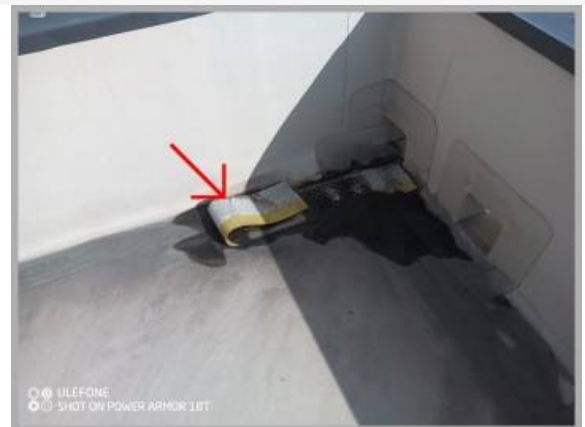
### 5.7 Gutters & Downspouts:

Satisfactory however remove any obstructions that can affect efficient drainage.

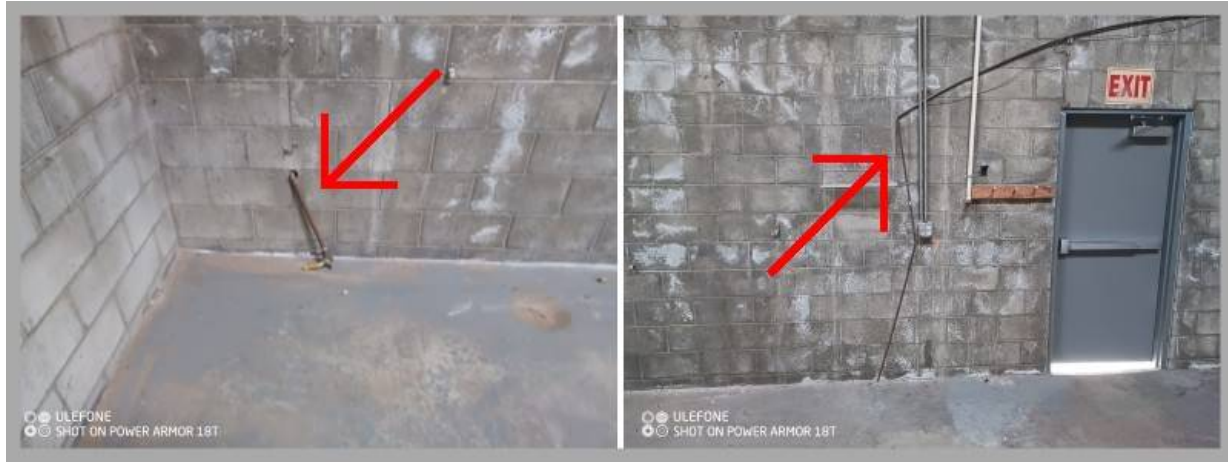
**8.6 CONDITION:**

1. Some sections of water pipe were removed for some reason. As noted at Unit 2.

Repair section of water pipes at building 1.

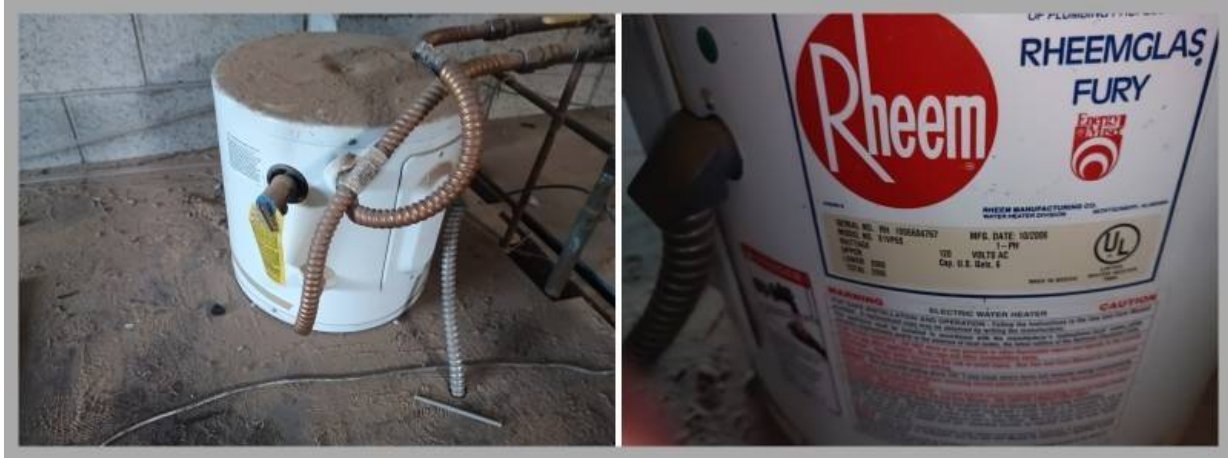
### 8.13 AGE & CAPACITY:

21 year old 6 gallon water heater. Average life span of a water heater is 12 to 15 years.

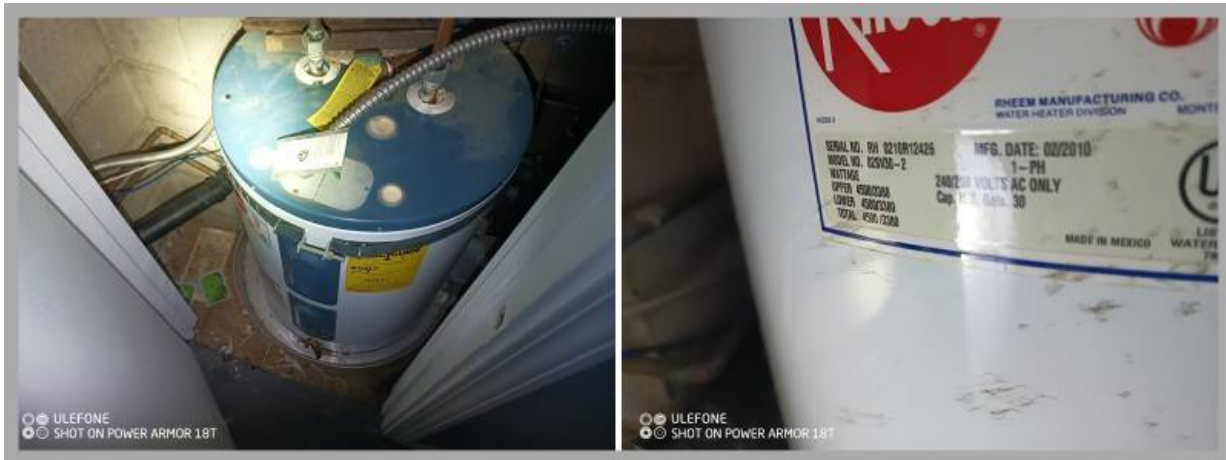
### 8.23 AGE & CAPACITY:

A 30 gallon water heater is installed. 15 year old. Average life span of a water heater is 12 to 15 years. The

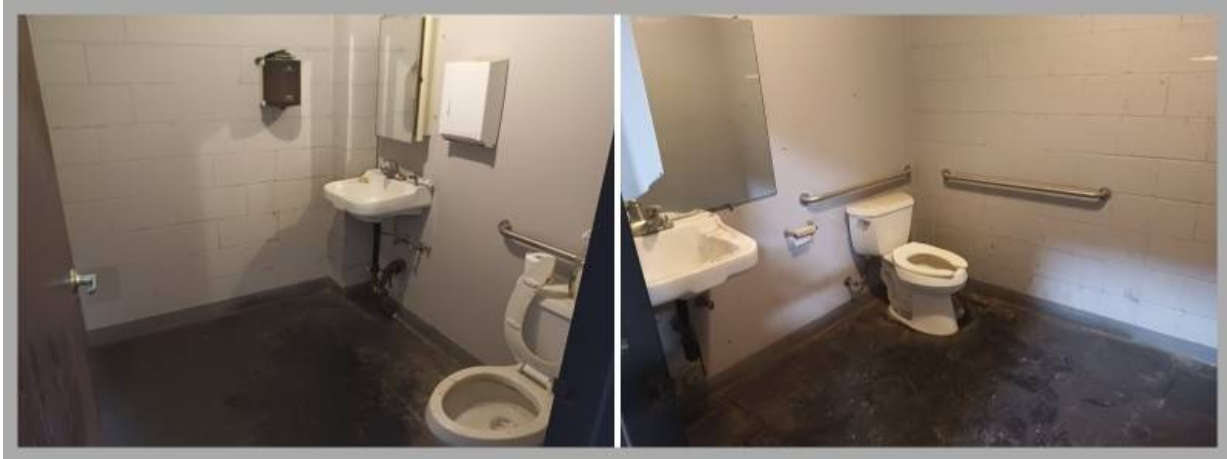
#### 9.2 BASIN & DRAIN:

Slightly loose from the wall. ADA pads missing from sink drains and angle stop valves. Corrections needed to prevent injury to disable personnel.

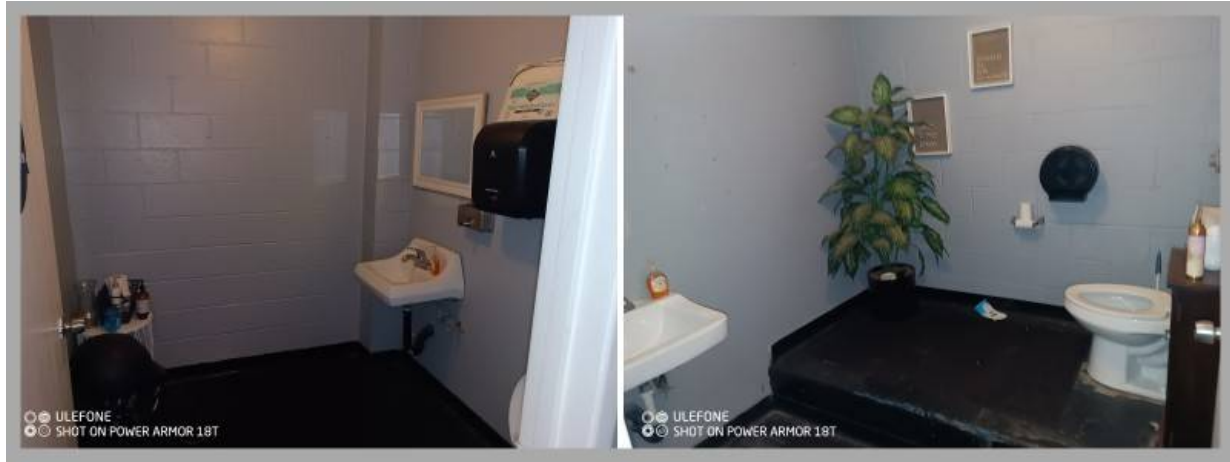
### 9.13 BASIN & DRAIN:

ADA pads missing from sink drains and angle stop valves. Corrections needed to prevent injury to disable personnel.
