ALLIANCE  
REAL ESTATE  
INSPECTIONS

# Confidential Property Condition Assessment Report

**Prepared for: Sample Client  
Prepared By: Robert Gaudreault**

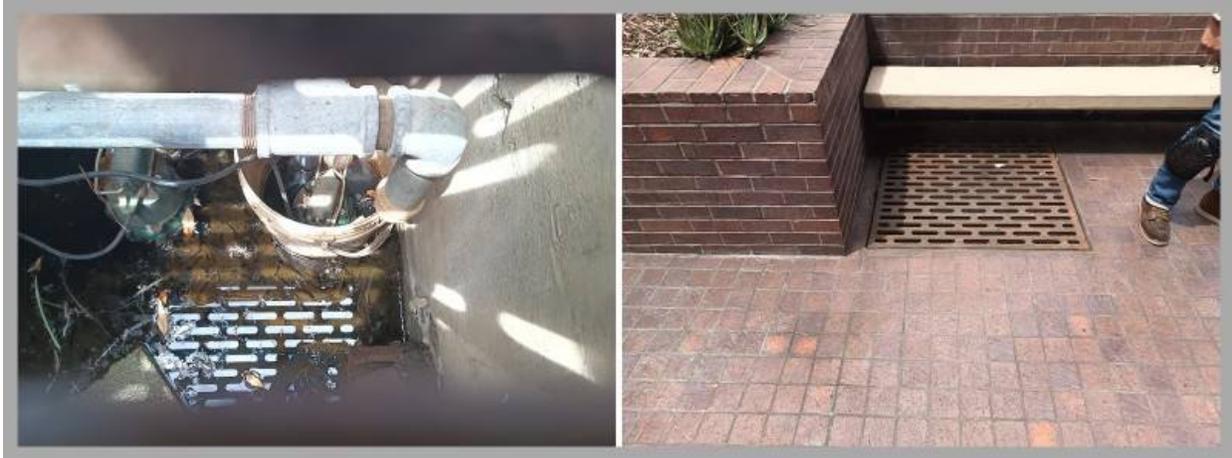
### 2.2 SUMP PUMP:

The sump pump installed at north west portion of front patio is functional.

Monitor and maintain.

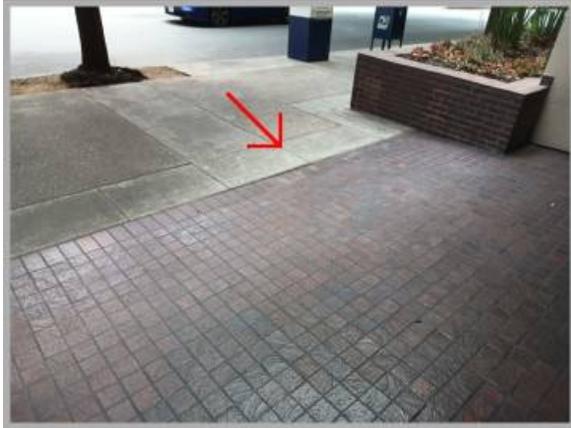
### 2.10 CONDITION:

Uplifted or uneven areas of walkway can pose a potential trip hazard. Smooth out as needed. Any variation more than one inch and less than 3 inches can pose a trip hazard.

Repairs needed by a concrete contractor. Smooth out raised sections that could pose a trip hazard along east side.

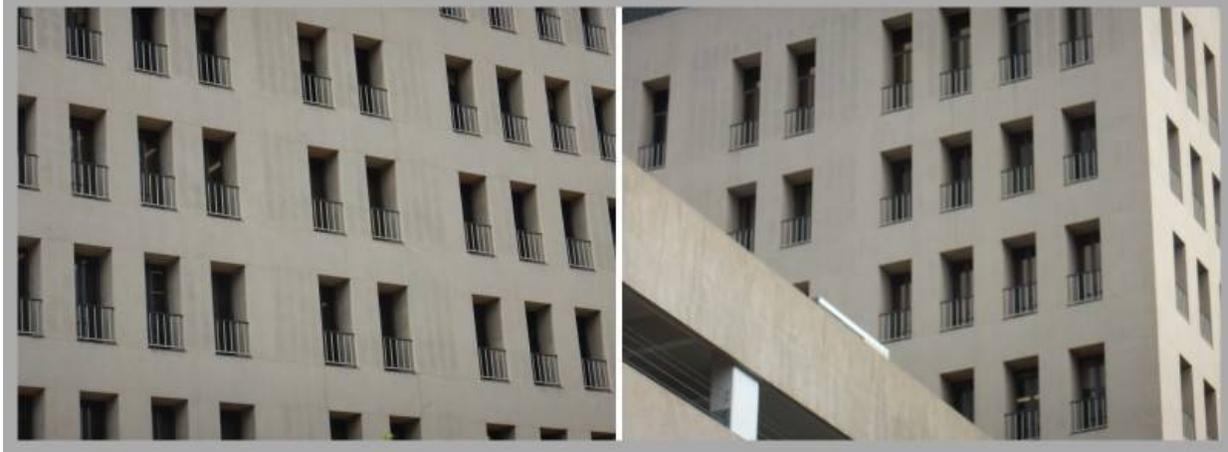
**Stucco cracks**

1. "Ghosting" in the context of stucco refers to the visible outlines of the underlying wall framing, often appearing as a darker or different shade of color on the stucco surface. This can occur due to various factors, primarily related to moisture, heat, and the accumulation of airborne particles. Some slight stucco cracking at north side center section. These cracks seem to be cosmetic in nature. Further evaluation needed. Consult commercial stucco contractor. It would behoove you to have a qualified specialist determine what the underlying cause of the discoloration, referred to as shadowing or ghosting, is and remedy.

Further evaluation needed. Consult commercial stucco contractor. It would behoove you to have a qualified specialist determine what the underlying cause of the discoloration, referred to as shadowing or ghosting, is and remedy.

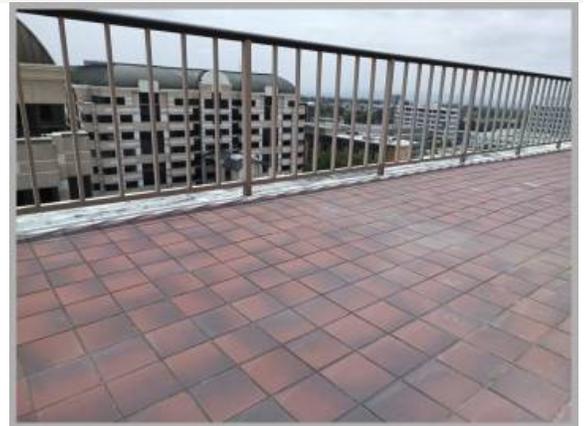
#### 4.26 RAILINGS:

10. Ceramic tile is used at 9th floor balconies. Patching noted due to prior apparent leak issues. Tile is aged and starting to exhibit displacement or grout cracks.

The railings are in place; however, client should be aware that spacing between rails exceed current child safety standards. Only moderate pressure was applied to these railings to test resistance.

Conditions noted that could affect use. Consult qualified licensed contractor for further evaluation and advice. Removal and replacement of roughly 1100 sf of tile decking indicated. Sub deck waterproof membrane may be failing.

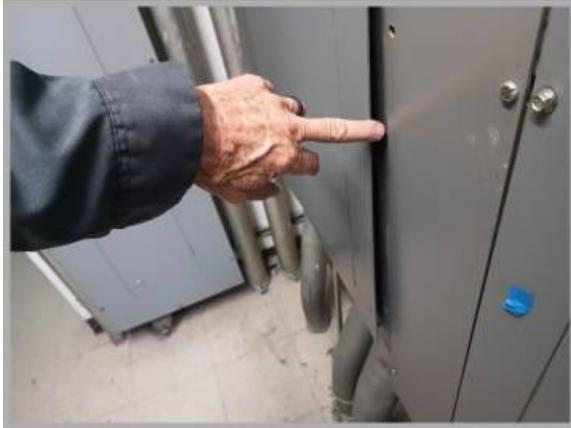
### 6.24 CONDITION:

The power panels, as a containers for safely covering electrical circuitry and components, is functioning as intended, minimizing the risk of electrical shock. Except one panel lacks cover fasteners.

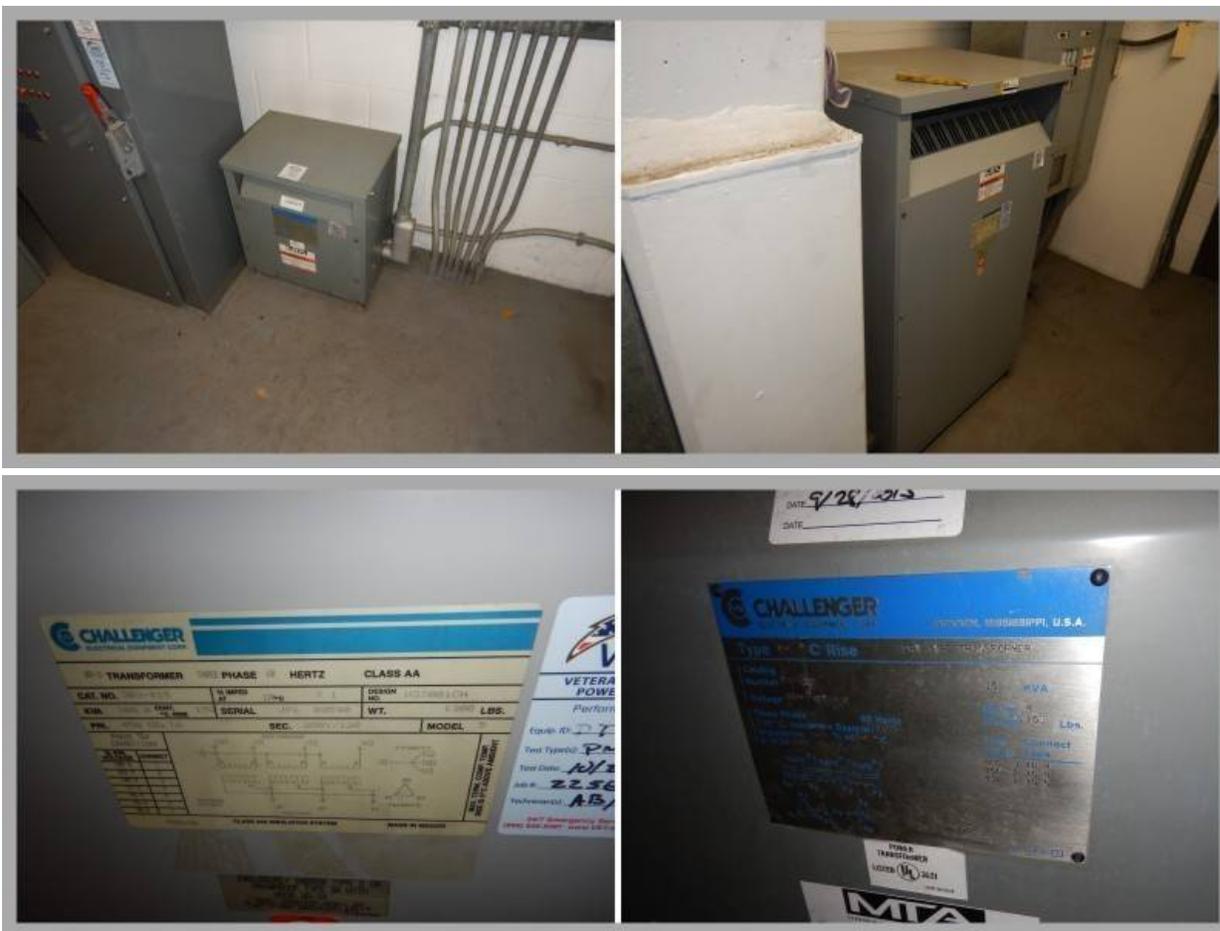
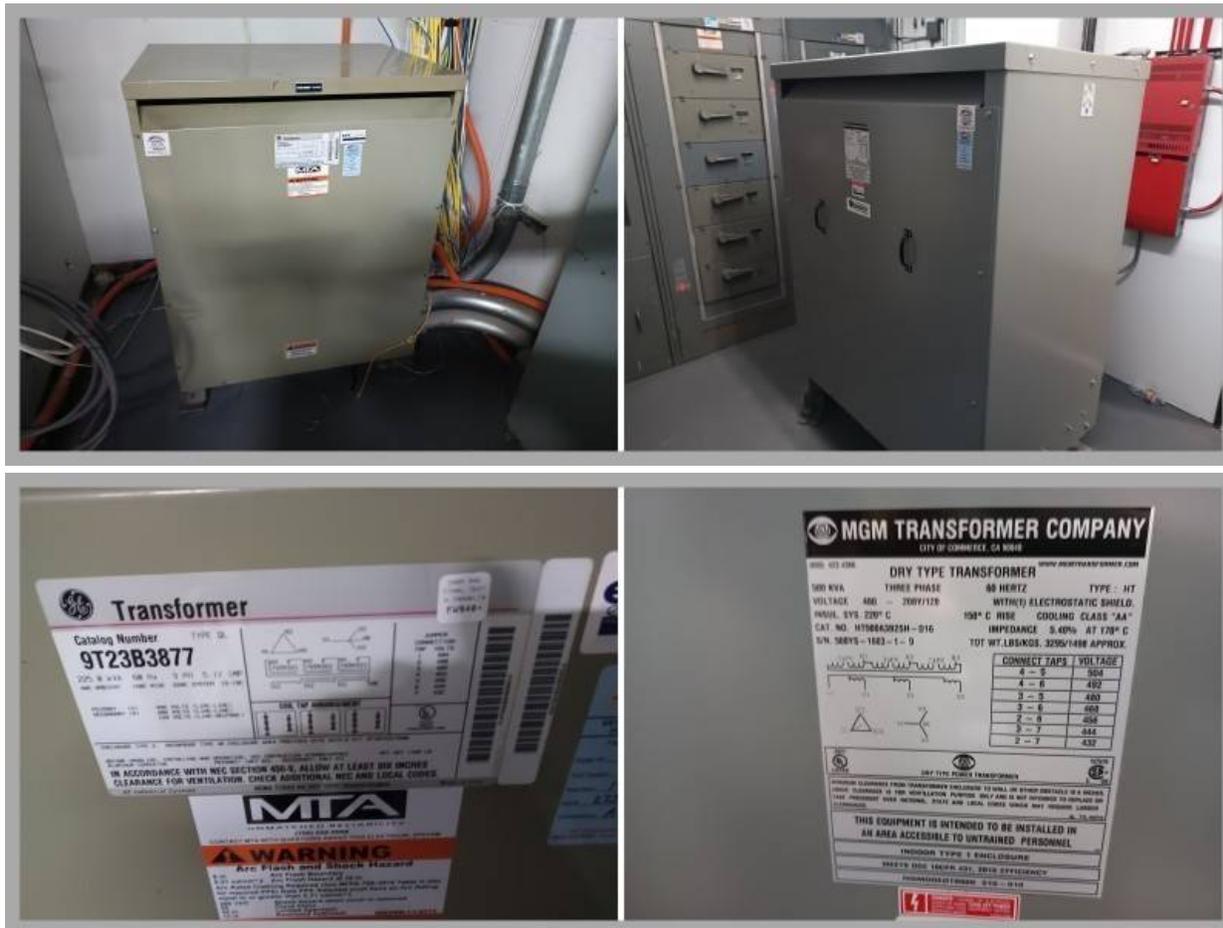
**6.33 CONDITION:**

Dry Type Transformers by ElSCO Transformer. The typical life expectancy of a dry-type electrical transformer is between 20 to 30 years. However, with proper maintenance and ideal operating conditions, they can last much longer, potentially exceeding 35 years,

Satisfactory. Transformers seemed to be monitored annually and performing as intended. At least two are older however and will be due for replacing within the next few years. Transformer T-2A and 225 transformer at roof top chiller room.

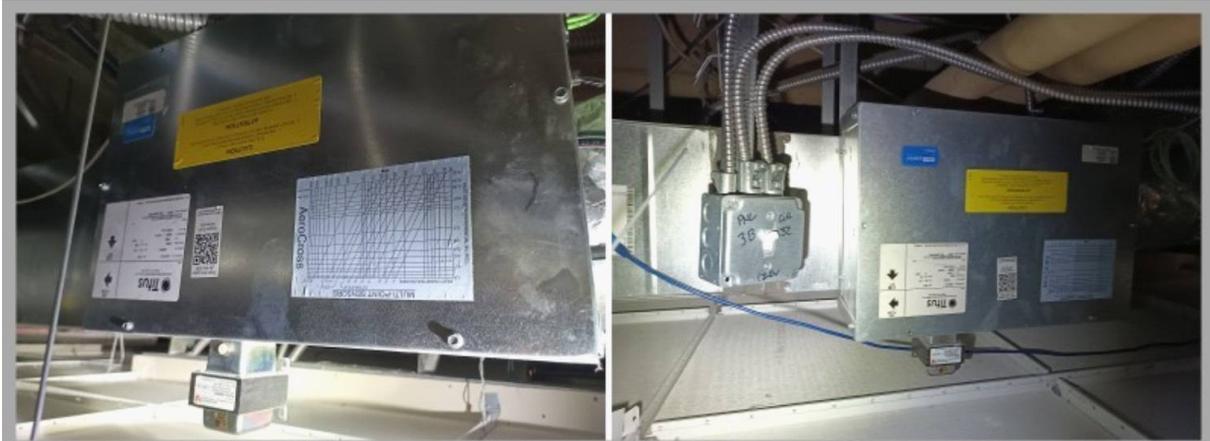
**Unit 300**

1. VAV 15 in unit 360 has a displaced cover and one VAV in unit 400 seems to have leaked onto ceiling panel. VAV5 in unit 510 did appear to have a leak though looks as though it was recently repaired. Corrosion was also noted to section of water line at VAV 20 in suite 580. Most of the VAVs at 7th, 8th and 9th floor appear to be from original installation and are more than likely near or at the end of their serviceable lives.

VAV Boxes: These terminal units, which control airflow to different zones, last 15-20 years with regular maintenance. Actuators and dampers may need repairs or replacement sooner, around 10-15 years. Therefore based on the existing age anticipate upgrades in the next few years. Such as VAV replacement, reconditioning cooling tower, replacing at least one chiller etc.

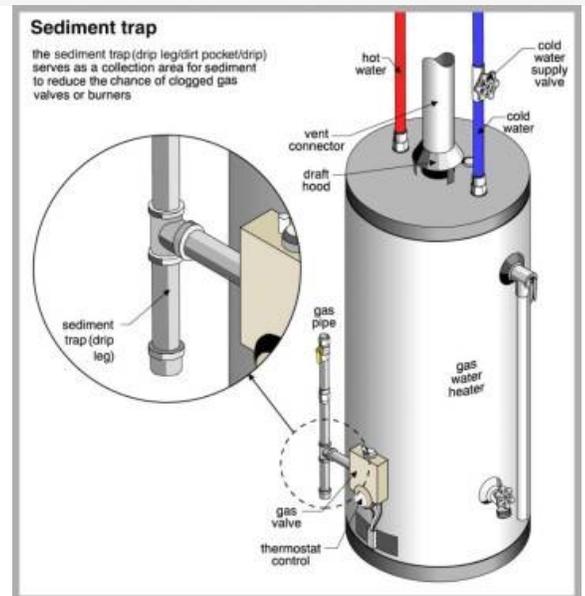
There is no drip leg (sediment trap) installed on the incoming gas line to the water heaters. Installation of a drip leg is recommended to prevent debris from getting into the gas valve.

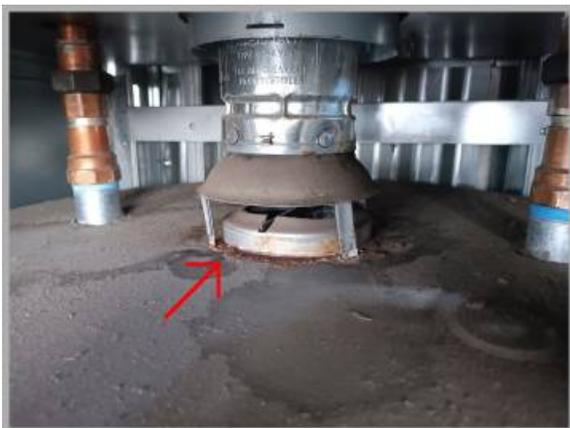
There is evidence of poor drafting at left water heater. This means that the gases are spilling back down rather than expelling to the exteriors. Drafter diverter is displaced resulting in condensation spillage which can shorten the life of this water heater.

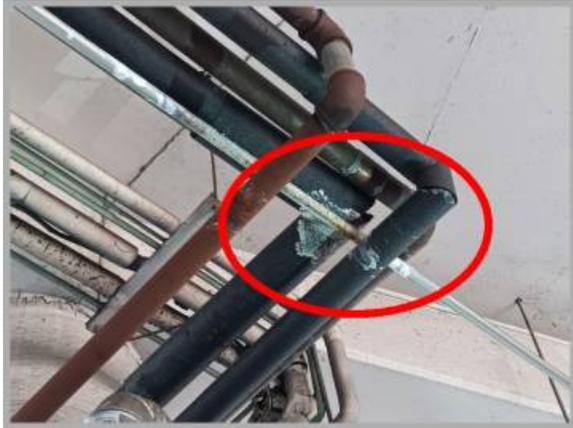
Corrosion and leak noted above water heaters.

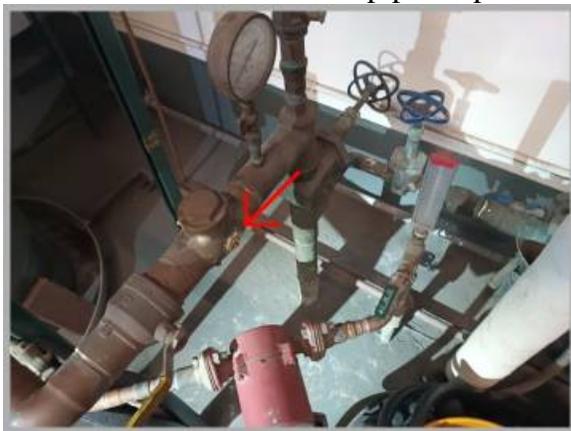
Corrosion noted to section of water pipe. Repairs are needed to prevent any potential for leaks.

Monitor and maintain. Budget and anticipate for replacement of at least on 1/2 HP pump and have plumber repair any corrosion at water pipes.

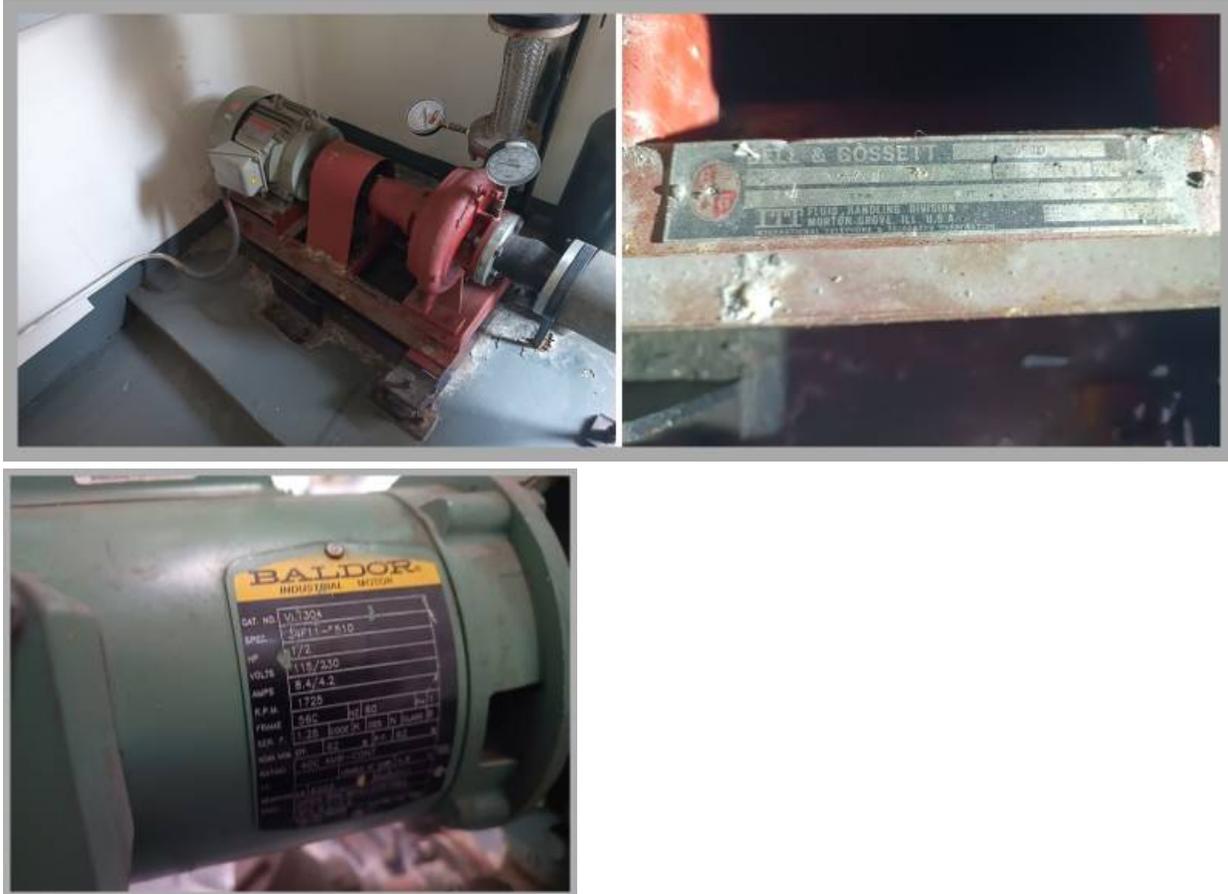
Operational however one 1/2 HP pump is near the end of its serviceable life.

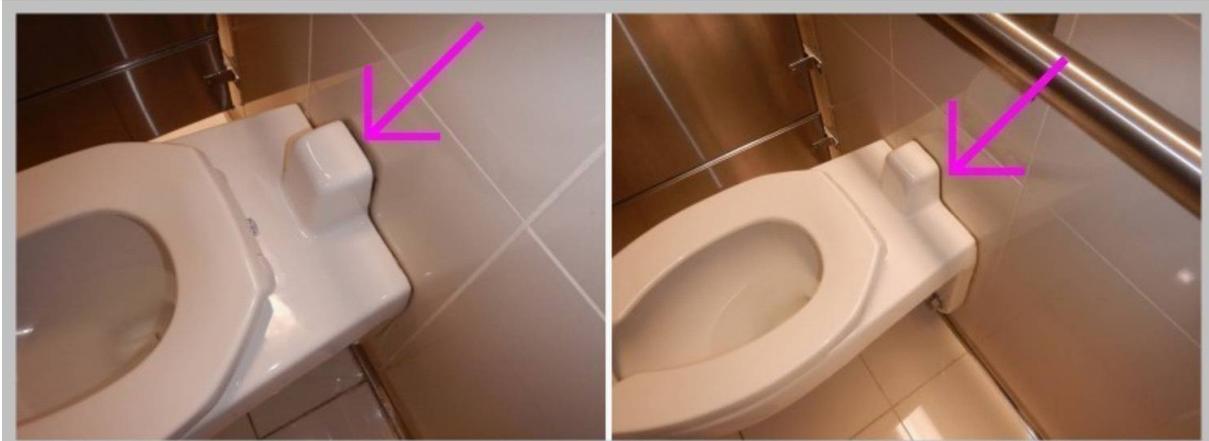
The toilets in these bathrooms needs repair. The toilets are not secure to the wall allowing them to wobble and possibly leak. Action should be taken to re-secure and caulk.

**Men's & Women's loose & lack caulking**

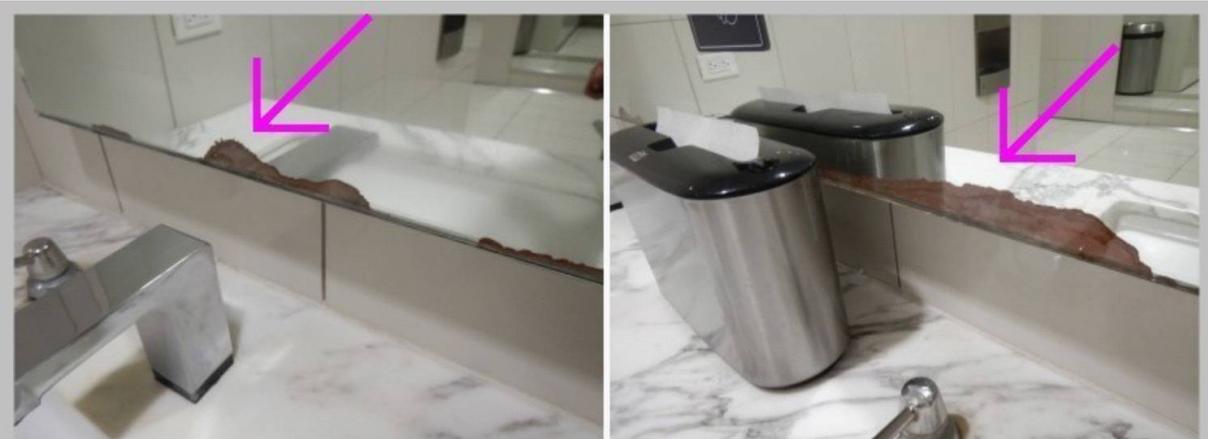
2nd floor Men's

Vanity cabinets and tops are satisfactory. Some blemishes noted at men's mirror. Replacement should be considered.

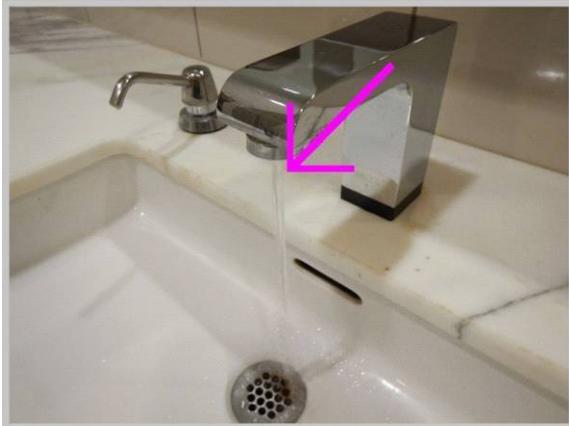
**2nd floor Women's**

Poor flow noted at women's faucet.

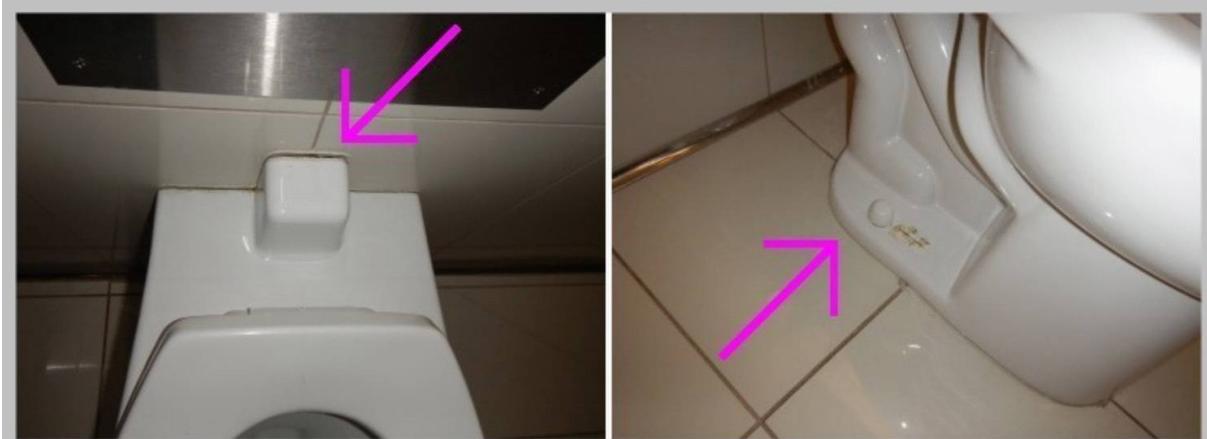
**2nd floor Men's & Women's**

Men's & women's: The toilet is not secure to the floor/wall, allowing it to wobble and possibly leak. Action should be taken to re-secure it to the floor.

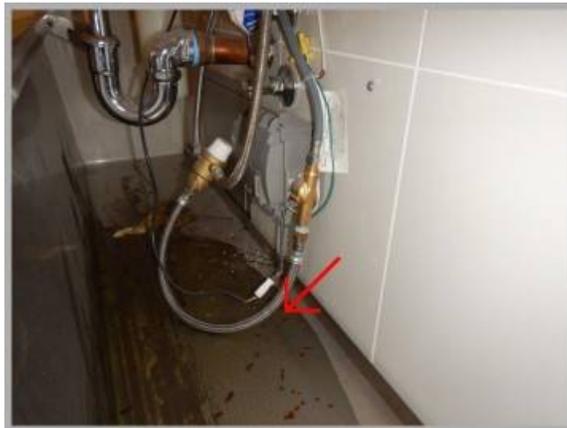
Evidence of a leak noted from fixture within cabinet of women's bath.

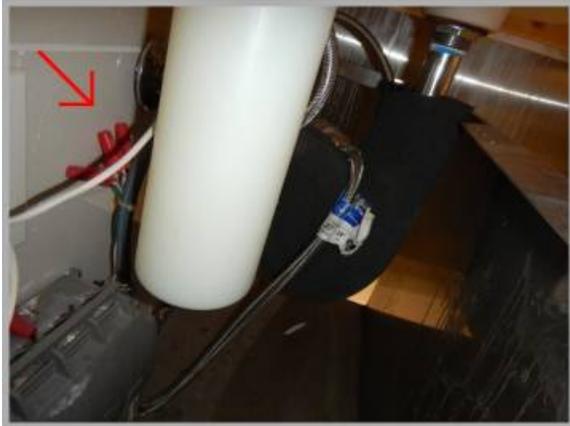
Faucets and supply lines appear satisfactory. Improve wiring to auto fixtures. Ideally wiring either low voltage or higher voltage should be contained with a box to prevent shock risk.

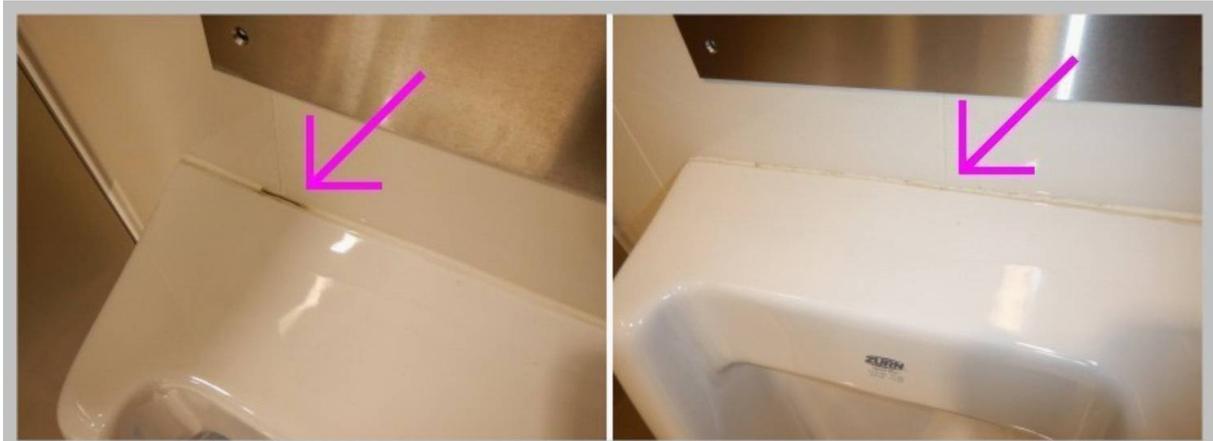
**4th floor Men's**

Maintenance of urinal seal needed.

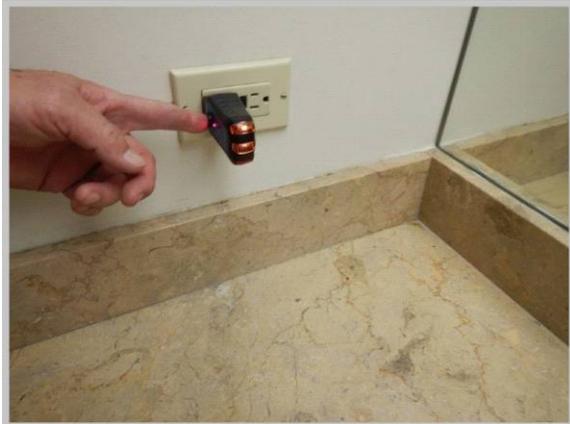
**Men's 8th floor**

There is a Ground Fault Circuit Interrupt outlet installed in the area of the bathroom lavatory. However, it failed to stop the current flow or did not reset after testing. Replacement is necessary.

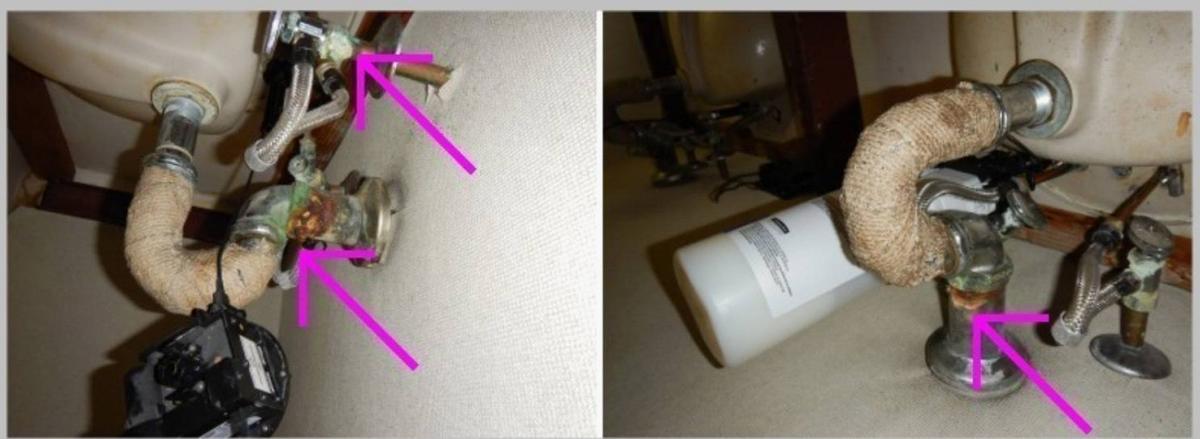
**9th floor Men's & Women's**

The angle stop and drainage fixture needs attention. There is corrosion on the angle stop and drain line. This is an early warning of future failure. It may be currently leaking (bucket under drain) and it will need to be replaced. Noted in men's & women's.

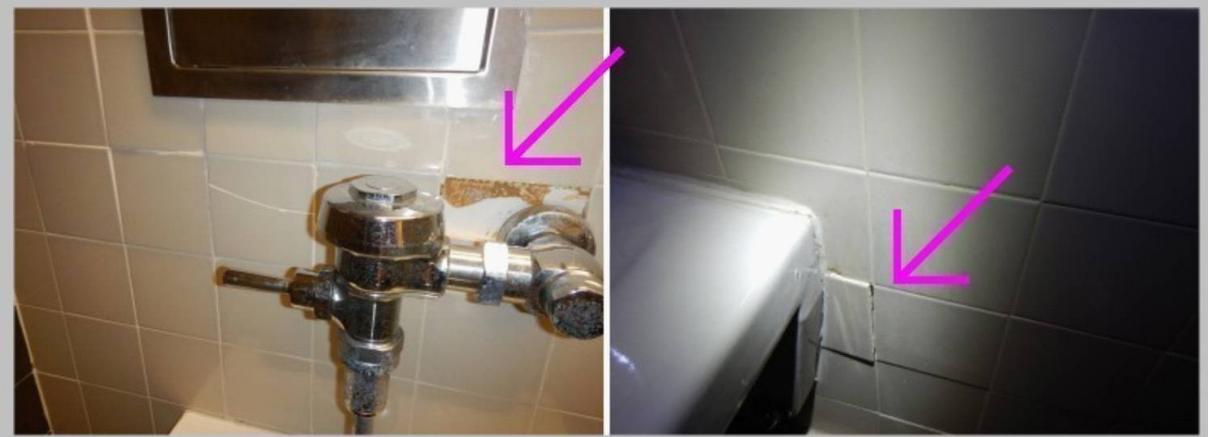
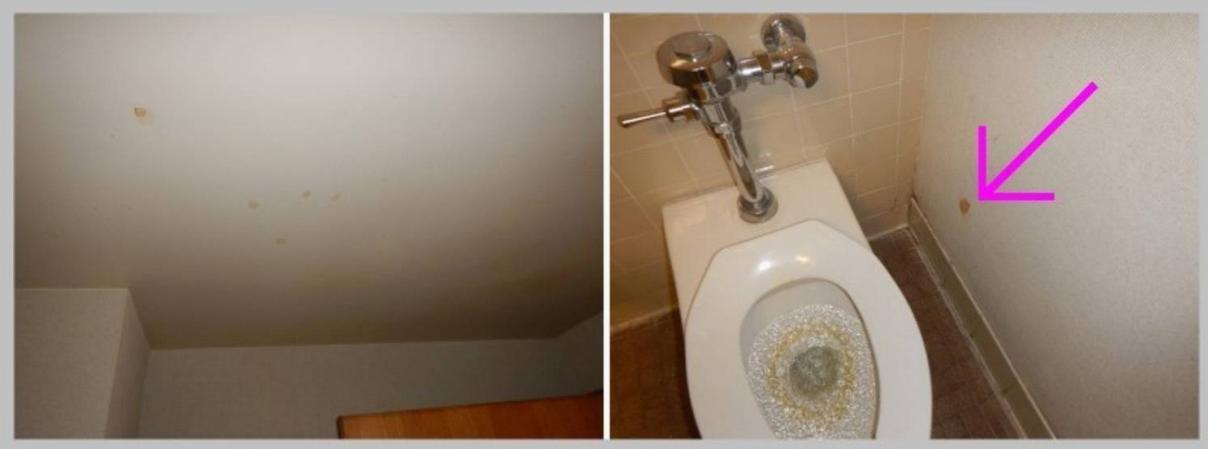
Broken tiles noted throughout. Stains on wall paper and ceiling also noted.

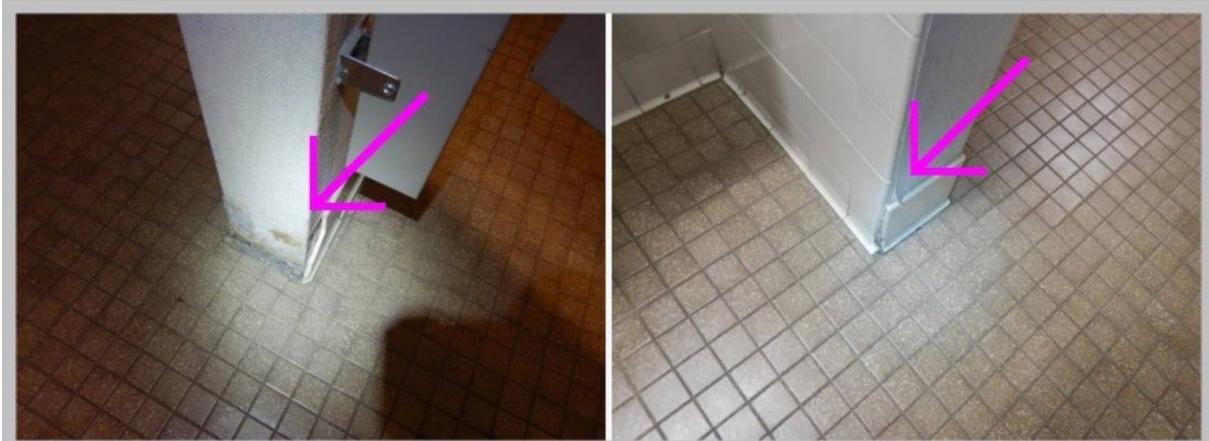
**9th floor Men's**

Cove base tiles broken and missing.

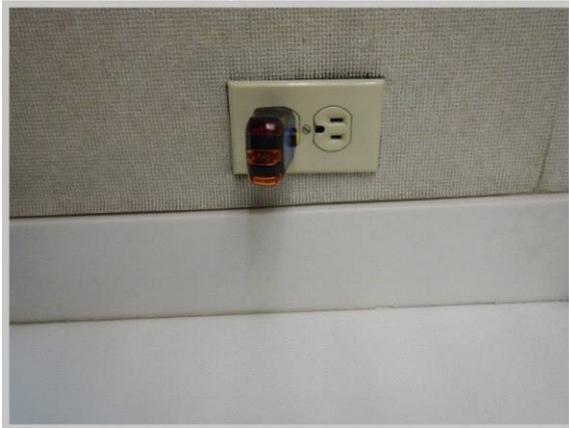
**Men's 9th floor**

Recommend - This bathroom does not have a Ground Fault Circuit Interrupt outlet installed. The age of the structure may predate the required installation. However, for safety considerations, it is strongly recommended that one be installed at any location within 6 feet of a water source. No power noted to receptacle.

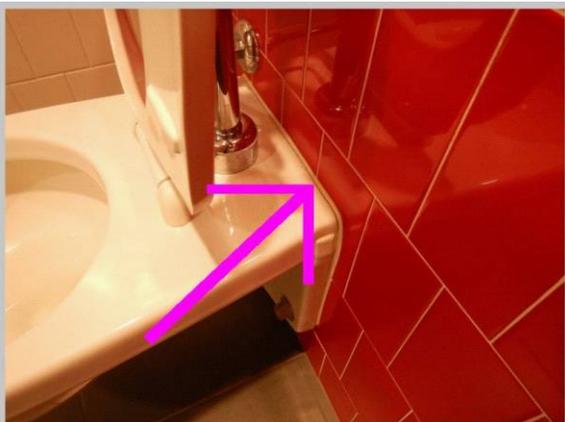
**Men's**

Toilet in Men's bathroom in need of caulking.

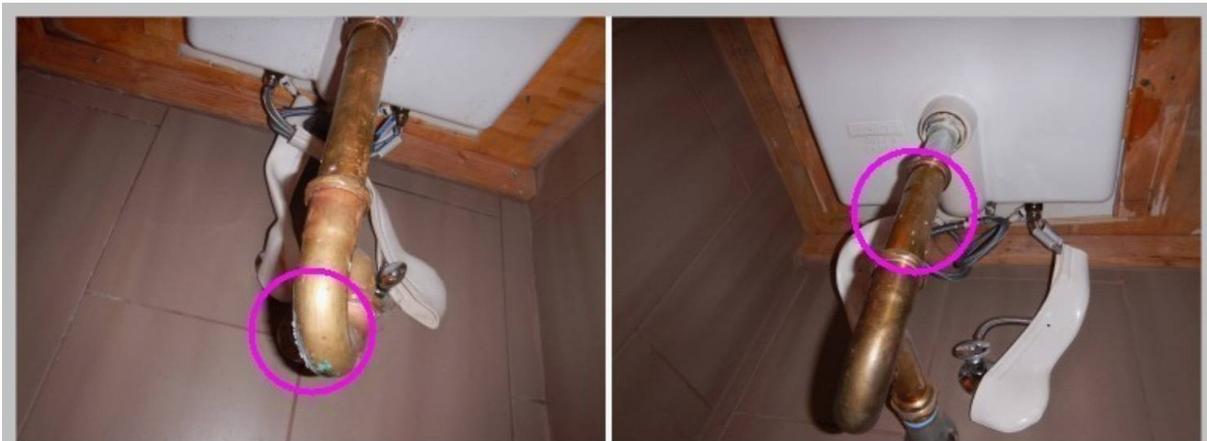
**Regency Both**

There is corrosion on the traps or drain line. They are not be currently leaking but will need to be replaced in the near future.

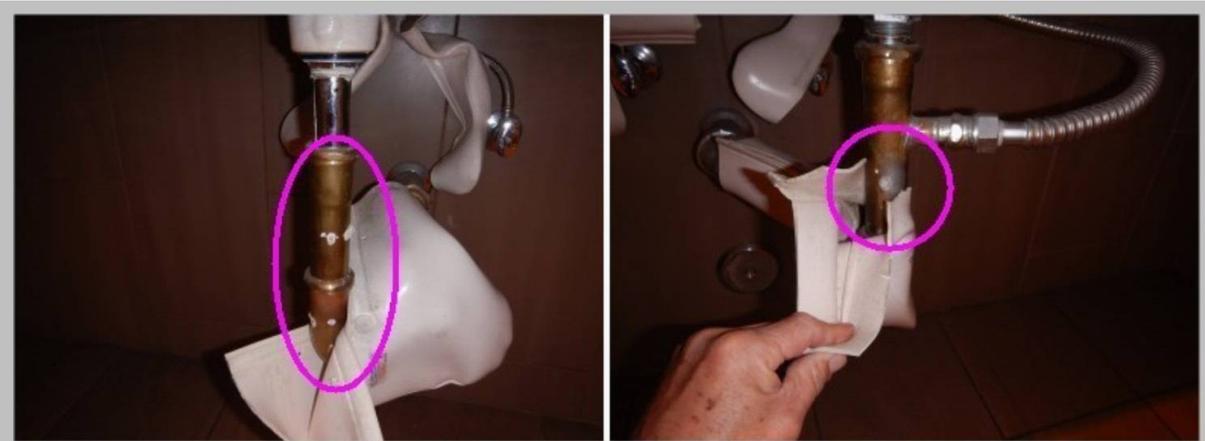
**Men's & Women's**

There is deterioration of the drain pipes under the basin. Although there is currently no leak, expect replacement in the future.

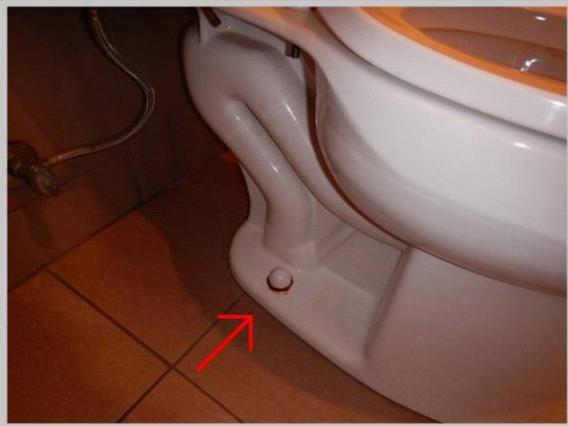
**Men's**

The toilet in Men's restroom needs repair. The toilet is not secure to the floor, allowing it to wobble and possibly leak. Action should be taken to re-secure it to the floor. Base of the toilet should be caulked. The base of a toilet should be caulked, according to the International Plumbing Code and the International Residential Code. Caulking the toilet to the floor helps to create safety and provide sanitary protection. It's also generally recommended to caulk or seal the bottom of the toilet if there is a gap between the toilet and the floor.

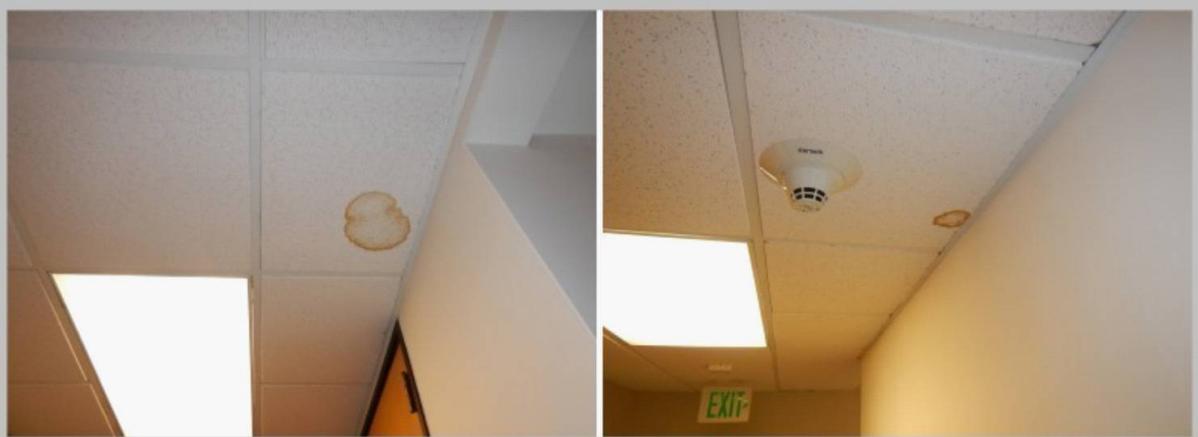
8th floor hall

Water stains noted on 8th floor. Apparent leaks noted in drain pipes above the stained tiles. Open pull boxes seen compromising safe installation. All enclosures should seal tight to prevent dust and animal entry.

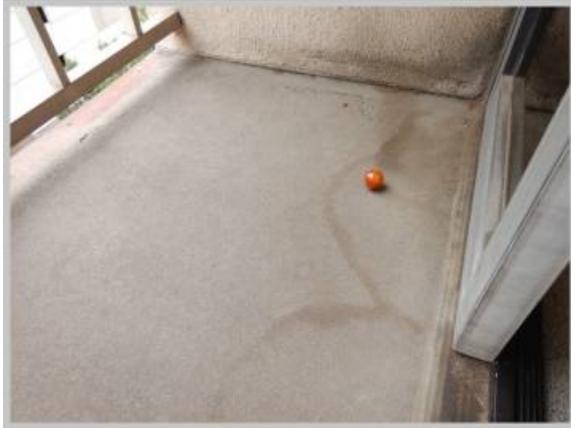
Water stains noted on some of the balcony floors indicating poor slope. Some of the floors have poor slope which can allow water into the substrate; corrections needed.

Further evaluation needed. Services of an qualified professional needed.

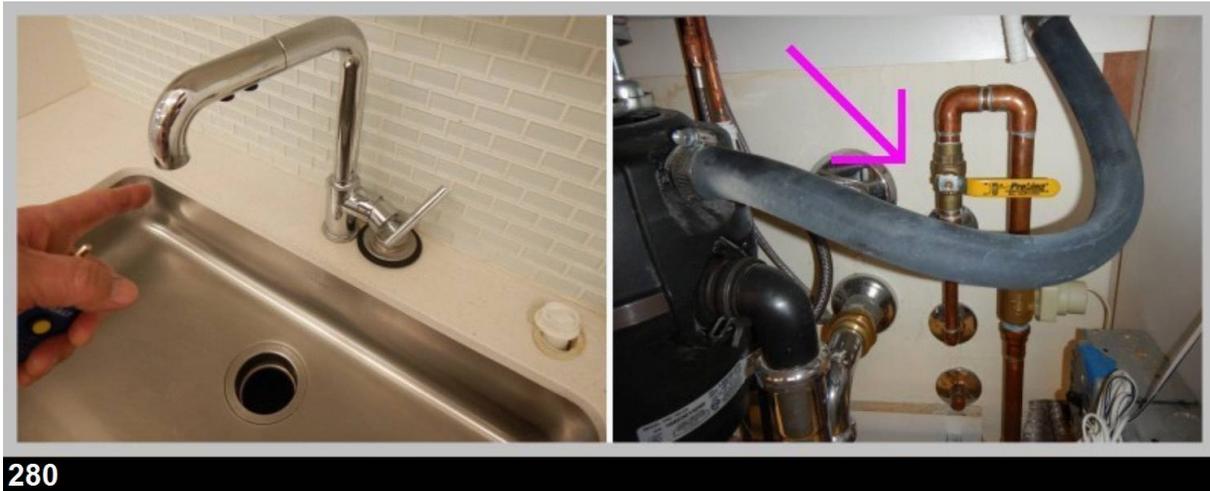
280

Water off at the time of inspection; reason not known; further evaluation needed, inspector does not turn on water valves which have been turned off.

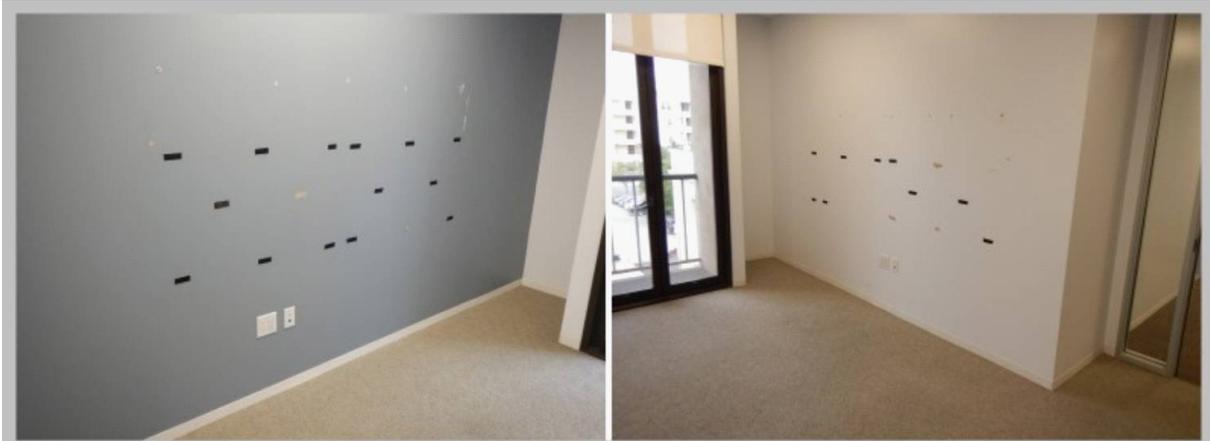
**300**

300: Satisfactory with general wear from previous tenant. 360: Unit interiors due for tenant improvement upgrades; damaged walls noted.

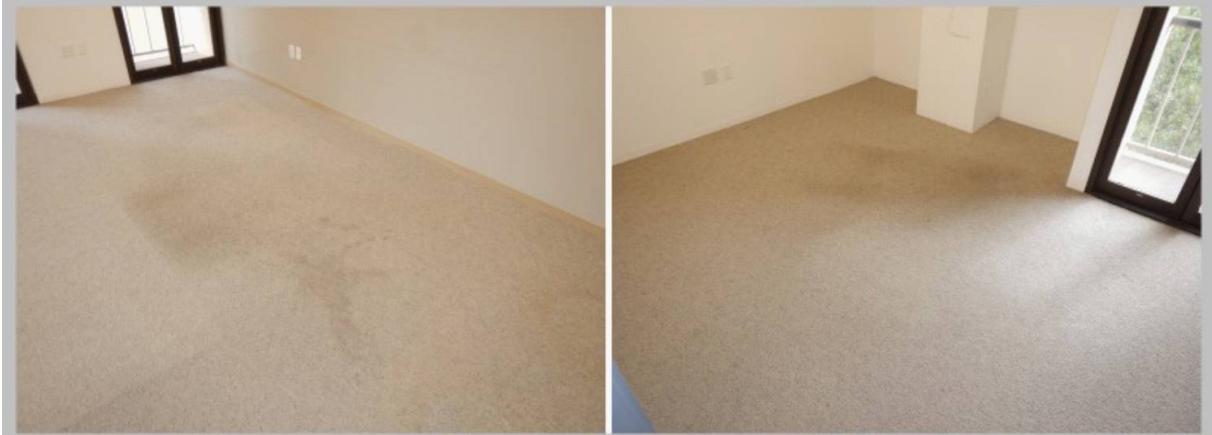
**360**

Stains area seen throughout. Inspector does not make any determination on whether or not these stains can be removed.

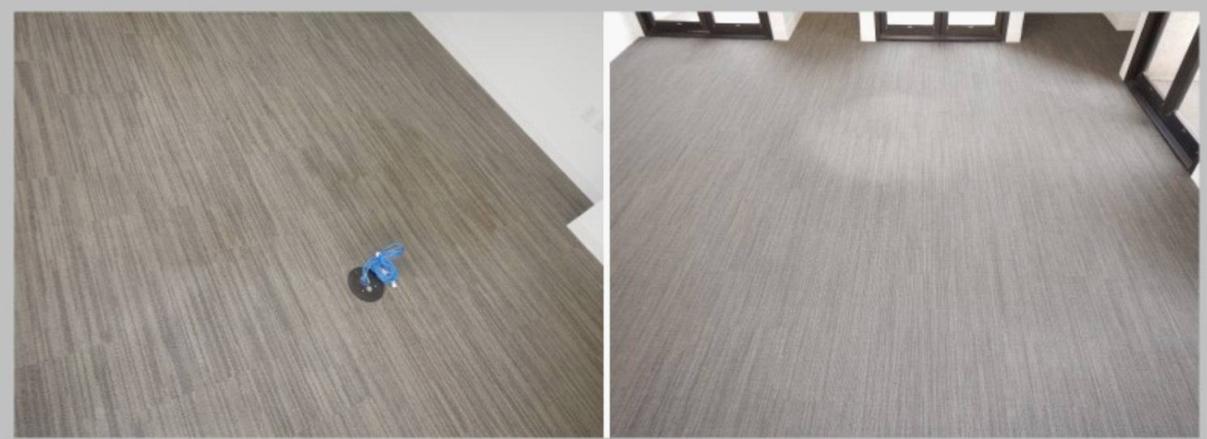
**510**

The general condition of flooring is fair with some wear due to age and use. Minor stains seen. Consultant does not make any determination on whether or not these stains can be removed.

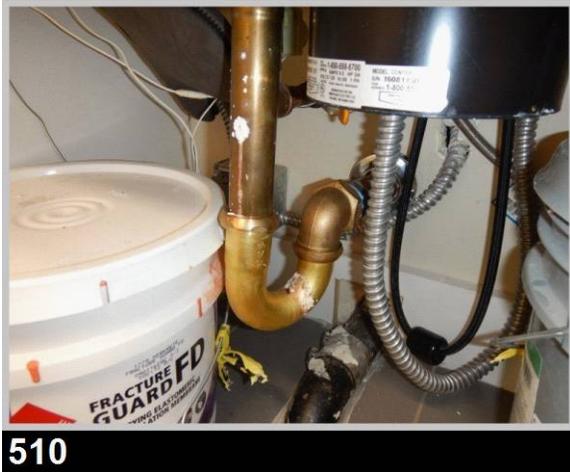
There is deterioration of the drain pipes under the 510 sink. No water noted during inspection. Recommend replacement.

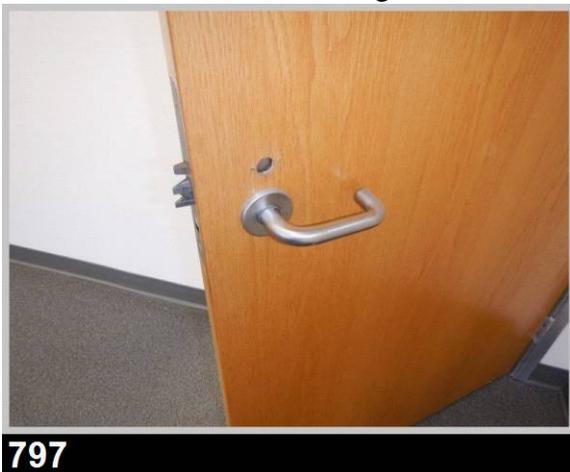
Some of the interior doors are missing hardware from one of the offices.

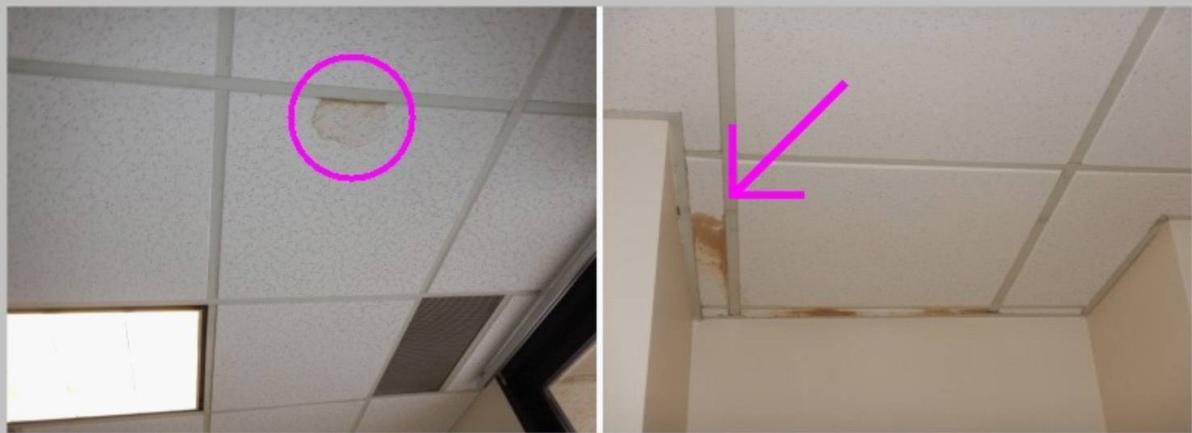
**797 Water Stains****5.45 Floor Condition:**

Unit interiors due for improvement and upgrades, such as paint and ceiling tiles (water stains and missing tiles).

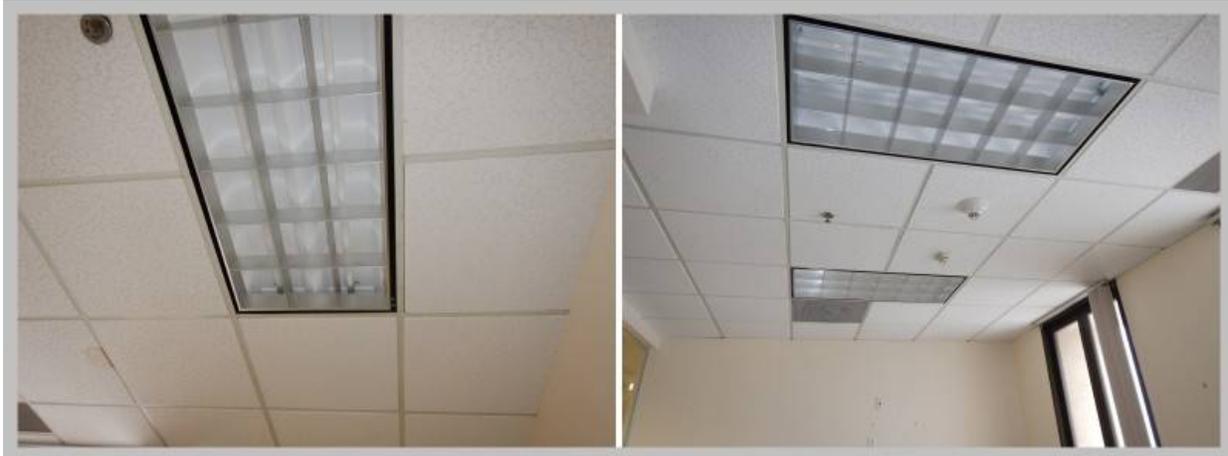
Some of the lighting was not functional during inspection; could be bad tubes or ballasts; further evaluation needed.

Further evaluation needed by licensed electrical and plumbing contractor.

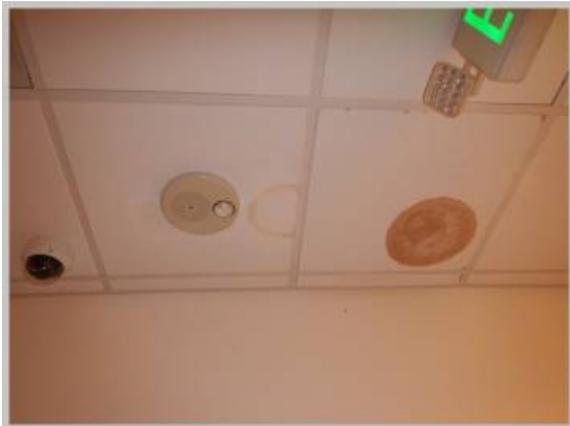
Units were well maintained and clean. Water stains noted in hall ceiling near the Private restrooms; further evaluation needed.

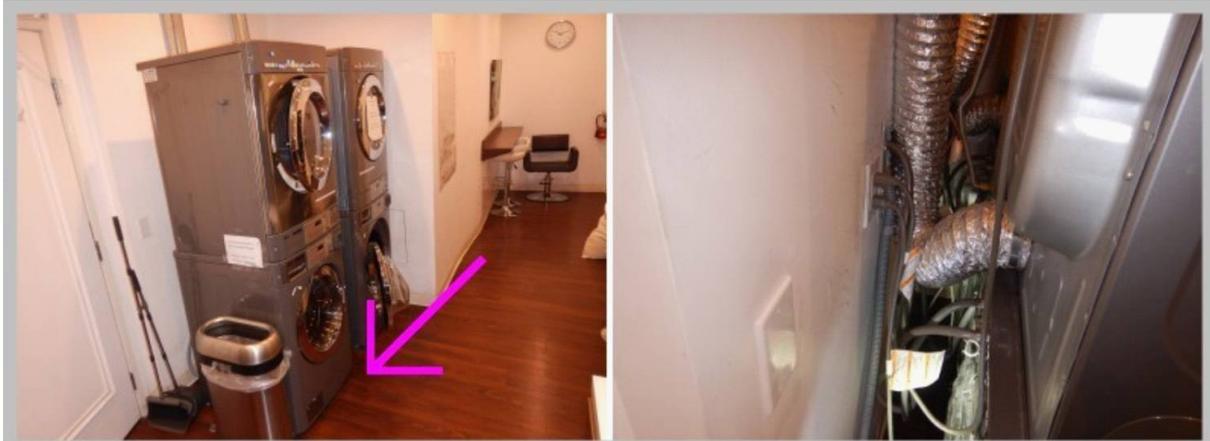
**No pan under washer**

There is no washer pan installed under the washing machine. Any time the washing machine is installed on a floor level above another finished floor, a washer pan should be installed to prevent damage caused by an overflowing washer or a leak.

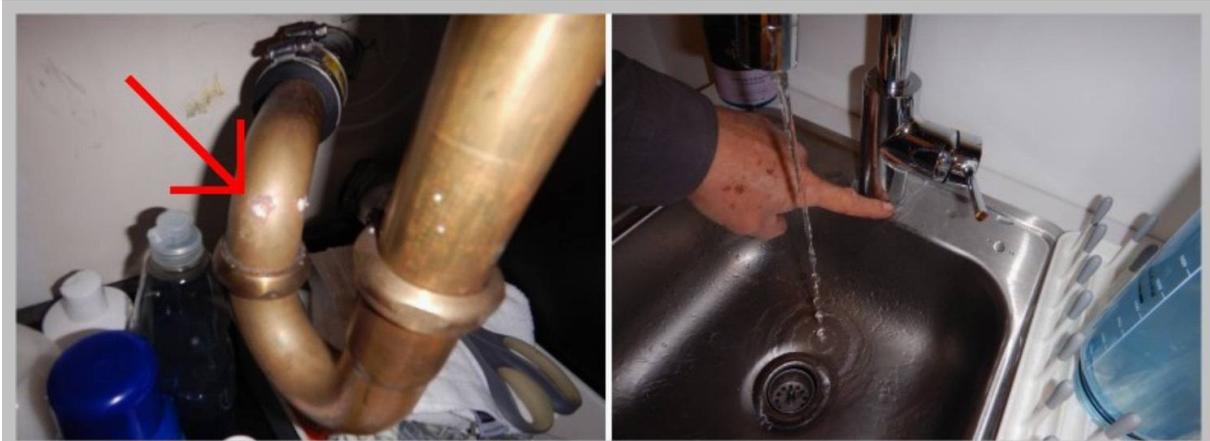
**25**

Unit 25: Deterioration of the drain visible. Loose faucet and poor flow also noted.
