ALLIANCE
REAL ESTATE
INSPECTIONS

Confidential Property Condition Assessment Report

**1234 Your Drive
Simi Valley CA 93063**

**Prepared for: John Smith
Prepared By: Robert Gaudreault**

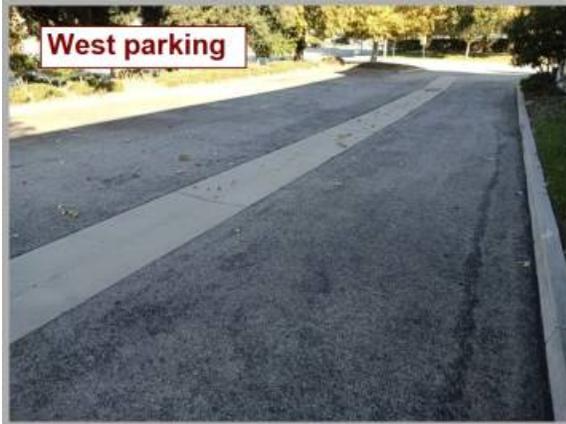
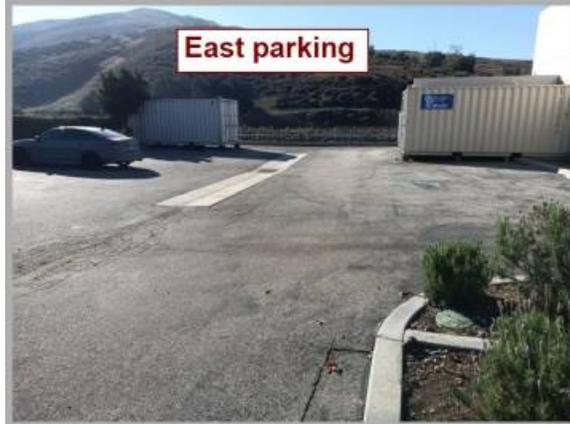
2.6 MATERIAL:

2.7 CONDITION:

The parking paving area needs action. Alligating of moderate severity at east parking. More than likely due to structural base failure. Seal coat over all areas of parking has worn off.

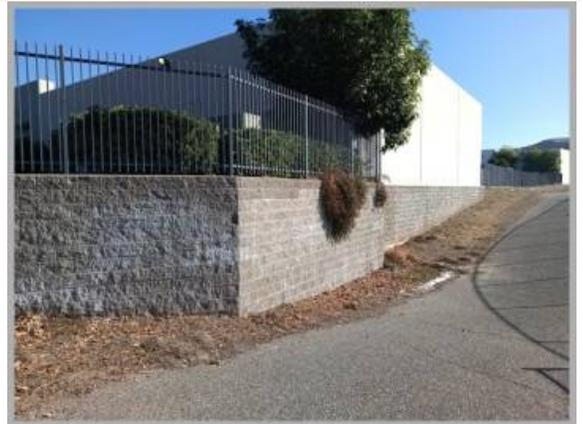
2.18 LOCATION OF WALL:

South side. The retaining wall is made of concrete masonry units.

Satisfactory - The retaining wall is in functional condition.

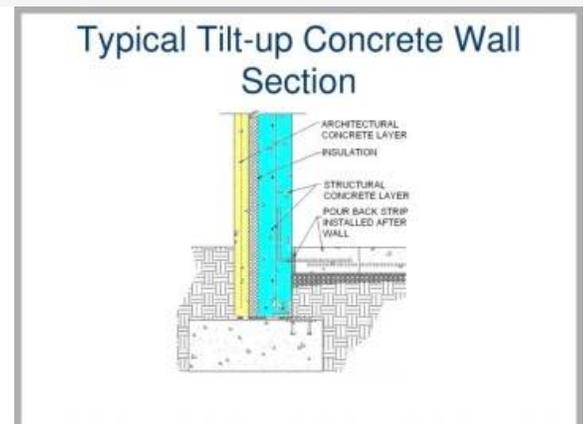
4.1 TYPE & MATERIAL:

These types of tilt up foundations are not visible to inspect however from a simple visual survey it can be determined that the foundation is performing the job it was intended to do in supporting the structure. There are no signs of settlement or significant settlement.

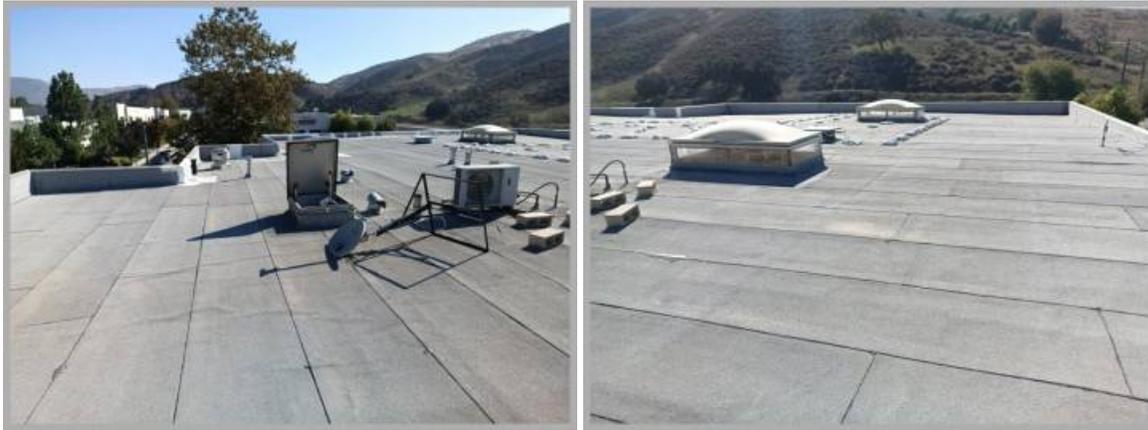
6.1 CONFIGURATION:

1. Moderate granular loss seen. This can either be from advanced age, manufacturer defect, foot traffic and/or incorrect installation. Asphalt matt and fiberglass is exposed as a result. Implications are shorter life span of material. Blistering or ridging noted on some of the roof material. Ridging is where the material at these blistered areas is not adhering to the roof deck and that there are air pockets.

2. Parapet wall lacks coping flashing, mastic applied to some of the roof penetrations is worn and cracked and prone to leak.

3. Skylights have been modified from their original configuration which can void any warranty or coverage. Dome lenses are deteriorated and need replacing.

4. Roof system is in need of rehabilitation or removal and replacement due to noted issues. Consult at least two of three roofing agencies for estimates. Implications: The implications of a leaky roof are; damage to the structure as well as interior content and potential for microbial growth.

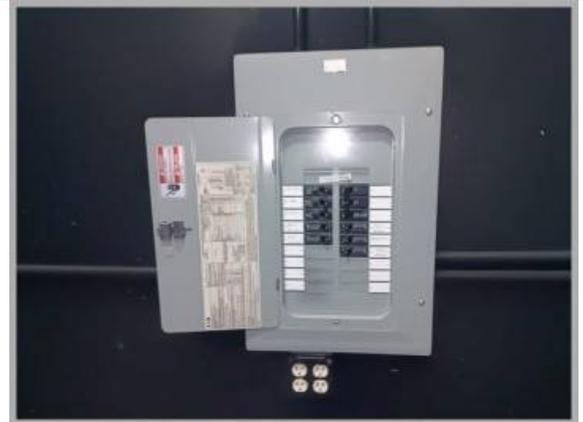
7.29 LOCATION:

Interiors black room.

Panel, as a container for safely covering electrical circuitry and components, is functioning as intended, minimizing the risk of electrical shock. Balance of multi wire components not verified.

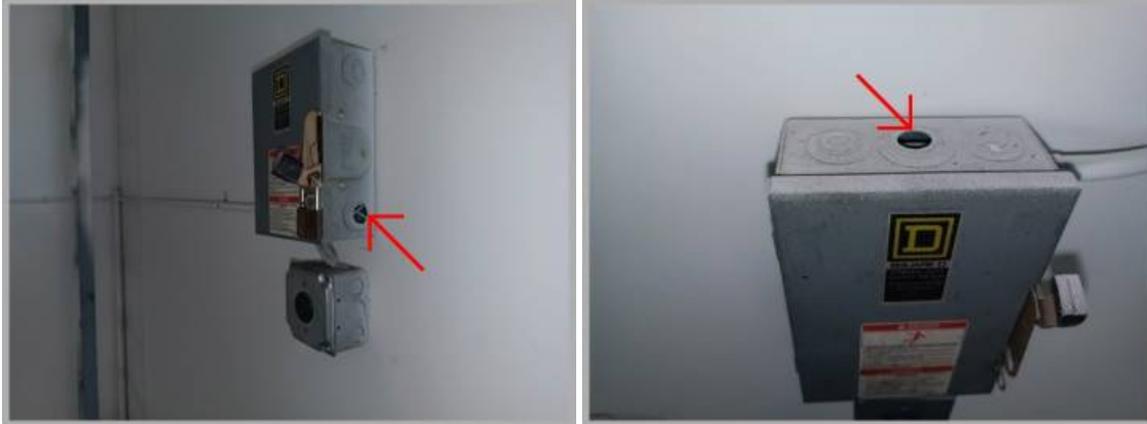
Knock out holes viewed within the main panel All panel boxes should be sealed tight to prevent any potential

for animal entry which could result in a potential fire hazard.

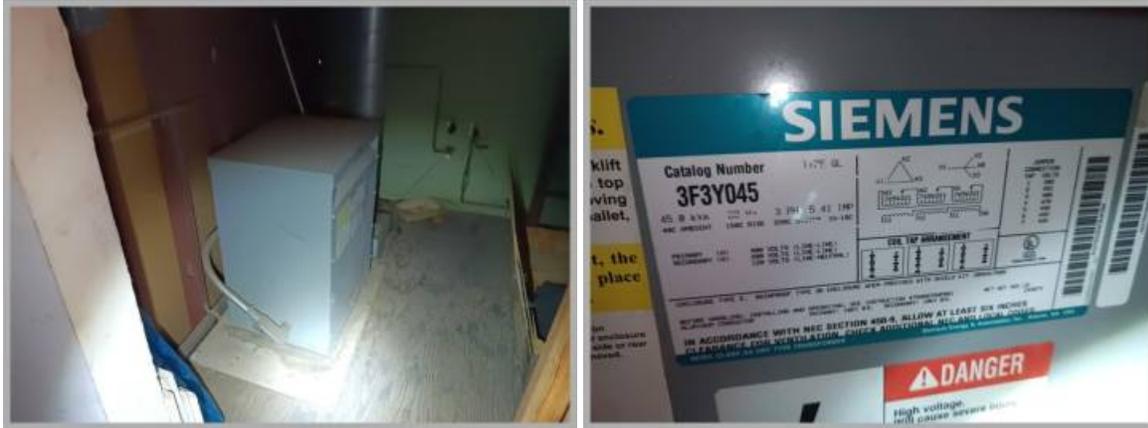
1. Some humming. Maybe normal. Transformers produce audible hum due to: Magnetostriction core laminations vibrating at 120 Hz (from 60 Hz AC). or loose mounting bolts or panels rattling. Although this humming may not be of significance it should be reviewed further.

Satisfactory. Transformer is performing as intended.

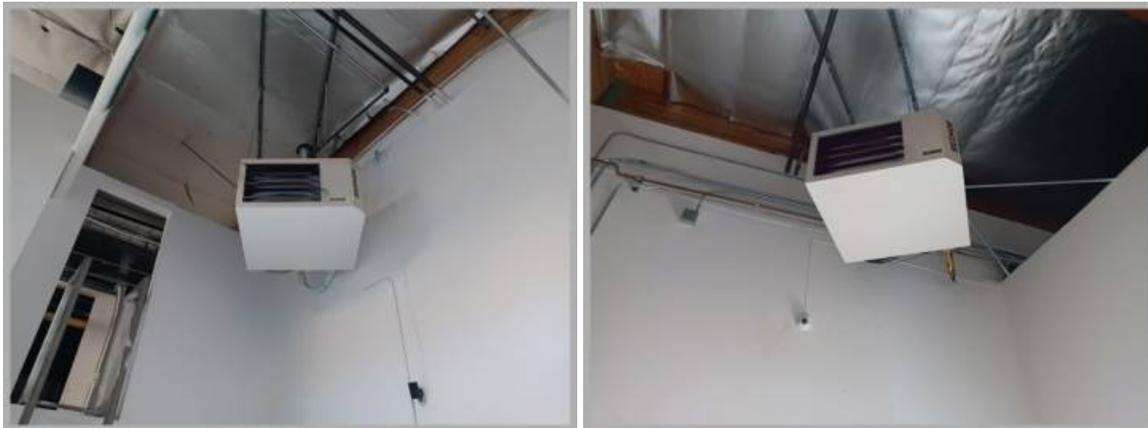
9.1 HEATING TYPE:

3. The existing heating components are at the end of their serviceable life. Replacement should be considered at this time. Contact heating agencies for estimates.

Fan assisted gas fired space heaters.

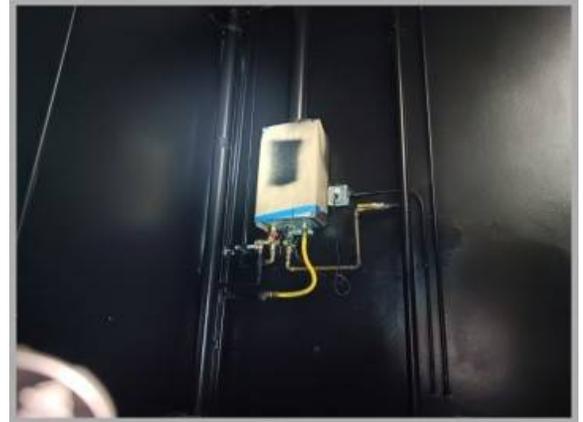
North wall interiors. Water heater may need to be relocated to meet current installation guidelines. Consult licensed plumber.

A tankless water heater should be readily accessible in California, as local codes require adequate working space, access for maintenance, and specific clearances for safety.

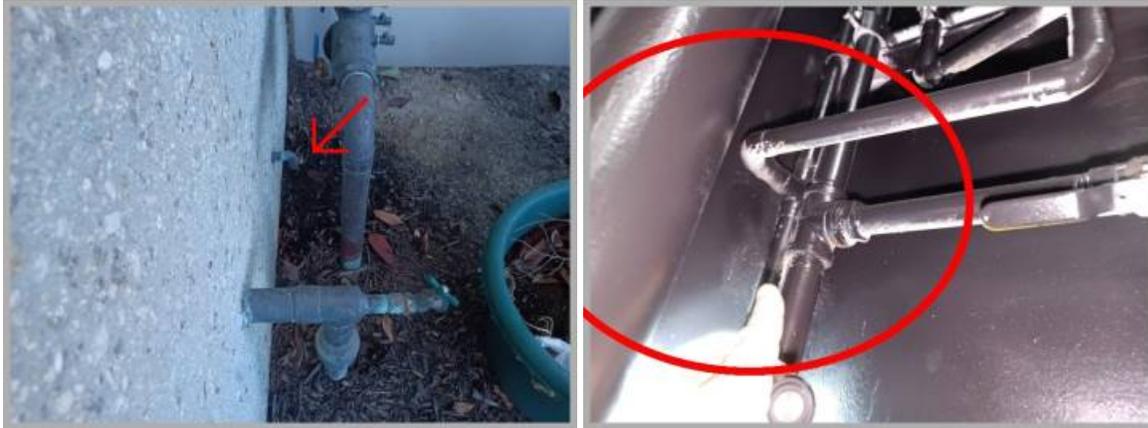
1. Copper to galvanized contact noted in areas. This does result in eventual corrosion as the more pure metal (copper) will eat away at the less pure (Galvanized). This is referred to as electrolysis. Ideally a coupler or brass would have been used between the two metals and heavy oxidation observed in at least one location. Implications are greater potential for leaks posing water damage to structure as well as interior content. This condition is noted at ceiling above office area.

4. This water heater discharge pipe served multiple such as A/C condensation discharge drain. This condition is improper and potentially unsafe. The temperature pressure relief valve should have its own discharge pipe that empties to a distinct location.

10.18 ACTION:

Further evaluation needed. Contact and schedule a licensed plumber to inspect issues and or conduct necessary corrections.

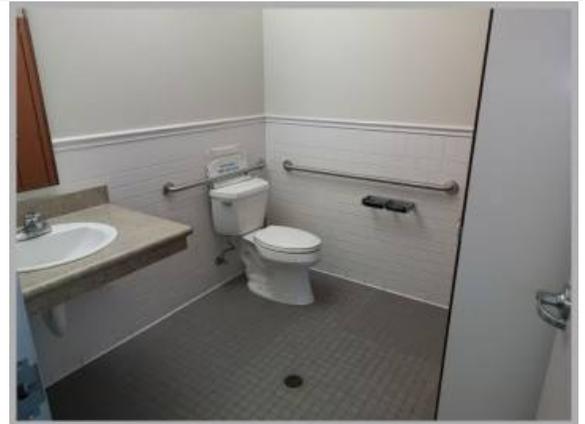
11.1 LOCATION:

Women West office side.

ADA pads are missing from angle stops. These exposed valves exhibited oxidation. No leak at this time however maintenance should be achieved.

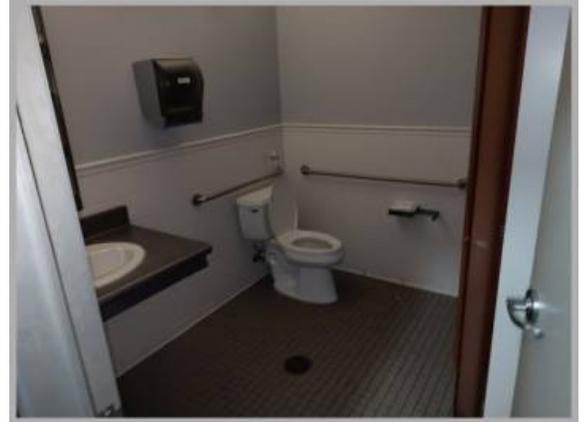
11.11 LOCATION:

Dark room.

11.12 VANITY CABINETS:
ADA protection pads missing.

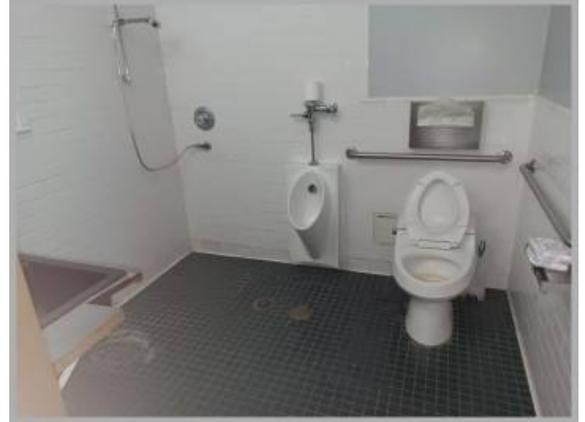
11.18 LOCATION:

Warehouse men bath.

Heavy oxidation at angle stop valves and faucet is excessively corroded and needs replacing.

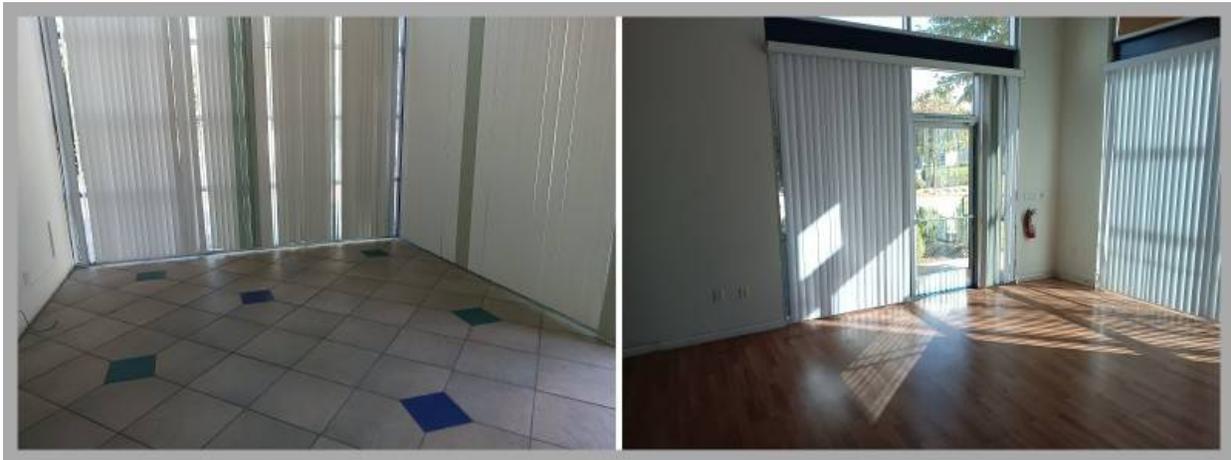
12.4 Office spaces:

A representative sampling of interior doors was achieved. Those operated were in serviceable condition. However entry door of north east office is tapped over apparently to prevent water or dirt entry.

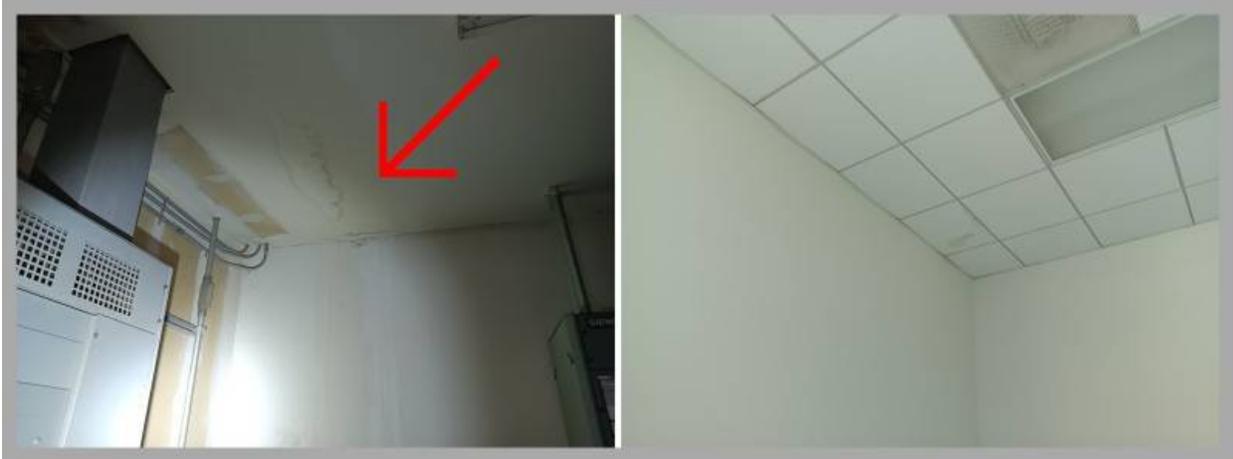
12.7 Condition of interiors:

1. Water stains seen in various areas that are more than likely due to previous roof leak issues, such as one room adjacent to warehouse and north east office space. Some of the darker stains should be evaluated and tested by an environmental agency. This would determine on whether or not any special remediation procedures would need to be followed.

Resilient flooring exhibited damage, such as curling which is indicative of water related damage, water damage also apparent at wood flooring of north east office.
