ALLIANCE
REAL ESTATE
INSPECTIONS

Confidential Property Condition Assessment Report

**Prepared for: Sample Client
Prepared By: Robert Gaudreault**

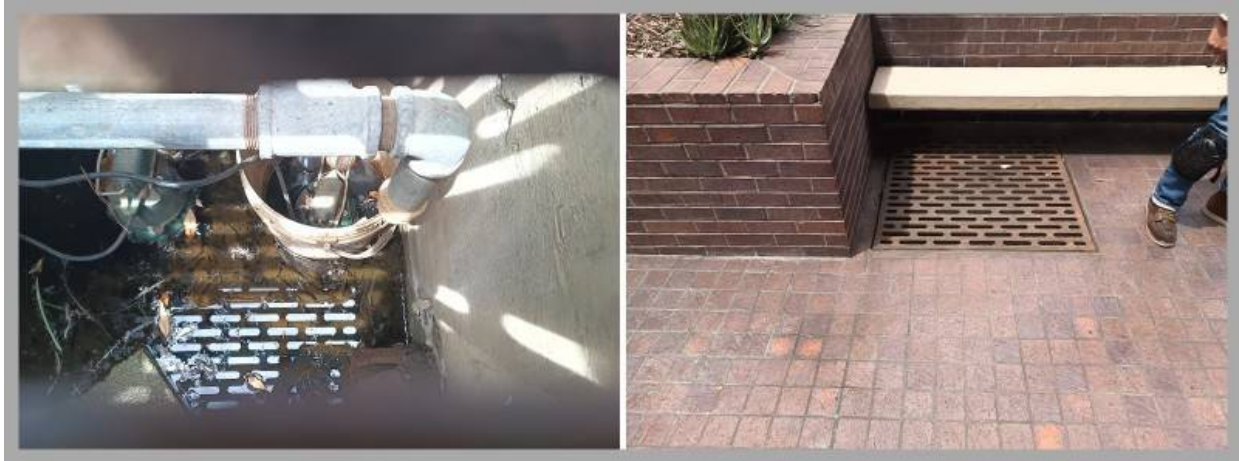
2.2 SUMP PUMP:

The sump pump installed at north west portion of front patio is functional.

Monitor and maintain.

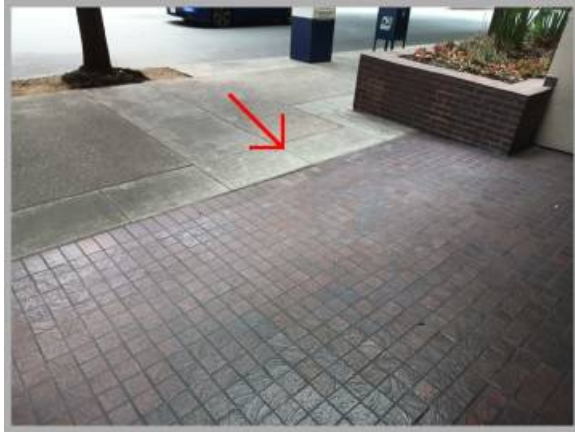
2.10 CONDITION:

Uplifted or uneven areas of walkway can pose a potential trip hazard. Smooth out as needed. Any variation more than one inch and less than 3 inches can pose a trip hazard.

Repairs needed by a concrete contractor. Smooth out raised sections that could pose a trip hazard along east side.

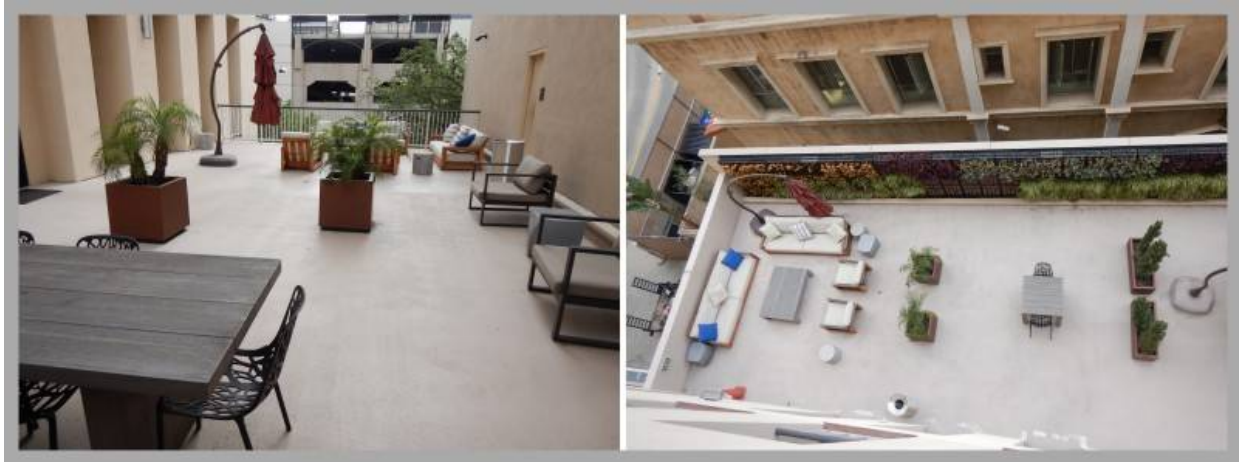
4.21 LOCATION:

8. There is concrete material used. Cracking and evidence of leak as seen from ceiling of loading dock.

There is concrete material used. Cracking and evidence of leak as seen from ceiling of loading dock.

9. Seal cracks and resurface 18000 sf of lower west concrete decking.

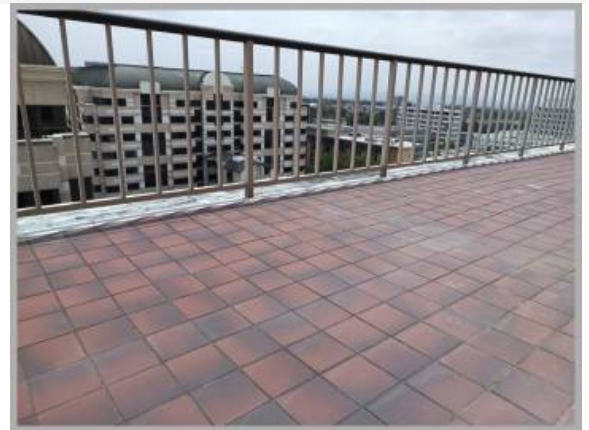
4.26 RAILINGS:

10. Ceramic tile is used at 9th floor balconies. Patching noted due to prior apparent leak issues. Tile is aged and starting to exhibit displacement or grout cracks.

The railings are in place; however, client should be aware that spacing between rails exceed current child safety standards. Only moderate pressure was applied to these railings to test resistance.

Conditions noted that could affect use. Consult qualified licensed contractor for further evaluation and advice. Removal and replacement of roughly 1100 sf of tile decking indicated. Sub deck waterproof membrane may be failing.

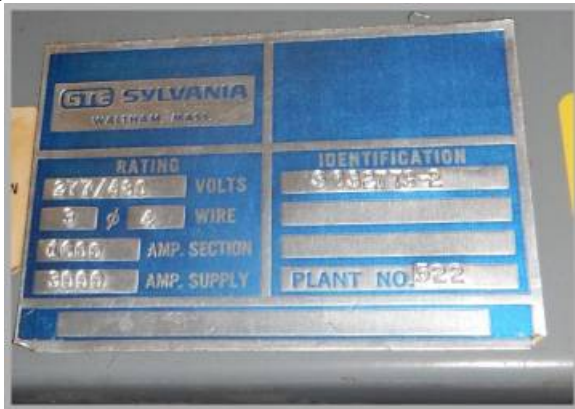
6.7 MANUFACTURER:

1. The power panel, as a container for safely covering electrical circuitry and components, is functioning as intended, minimizing the risk of electrical shock and there is evidence of annual thermal inspections and equipment seems well maintained. While not all GTE Sylvania 3-phase commercial switchgear can be problematic as stated by some electricians, models incorporating Zinsco designs are high-risk due to breaker failures, overheating, arcing, and fire hazards. Non-Zinsco Sylvania switchgear however can be reliable with proper maintenance, but age, obsolescence, and code compliance remain concerns.

Another consideration is that typically, electric panels last 30-40 years, more or less. That means even the electrical panel built as recently as the late 80s could be worn out. Implications are potential failure of devices and components. Consult licensed electrician or two for advice and obtain estimates.

GTE Sylvania.

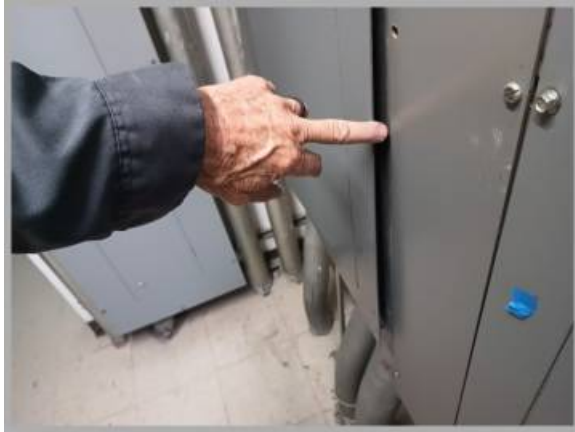
6.24 CONDITION:

The power panels, as a containers for safely covering electrical circuitry and components, is functioning as intended, minimizing the risk of electrical shock. Except one panel lacks cover fasteners.

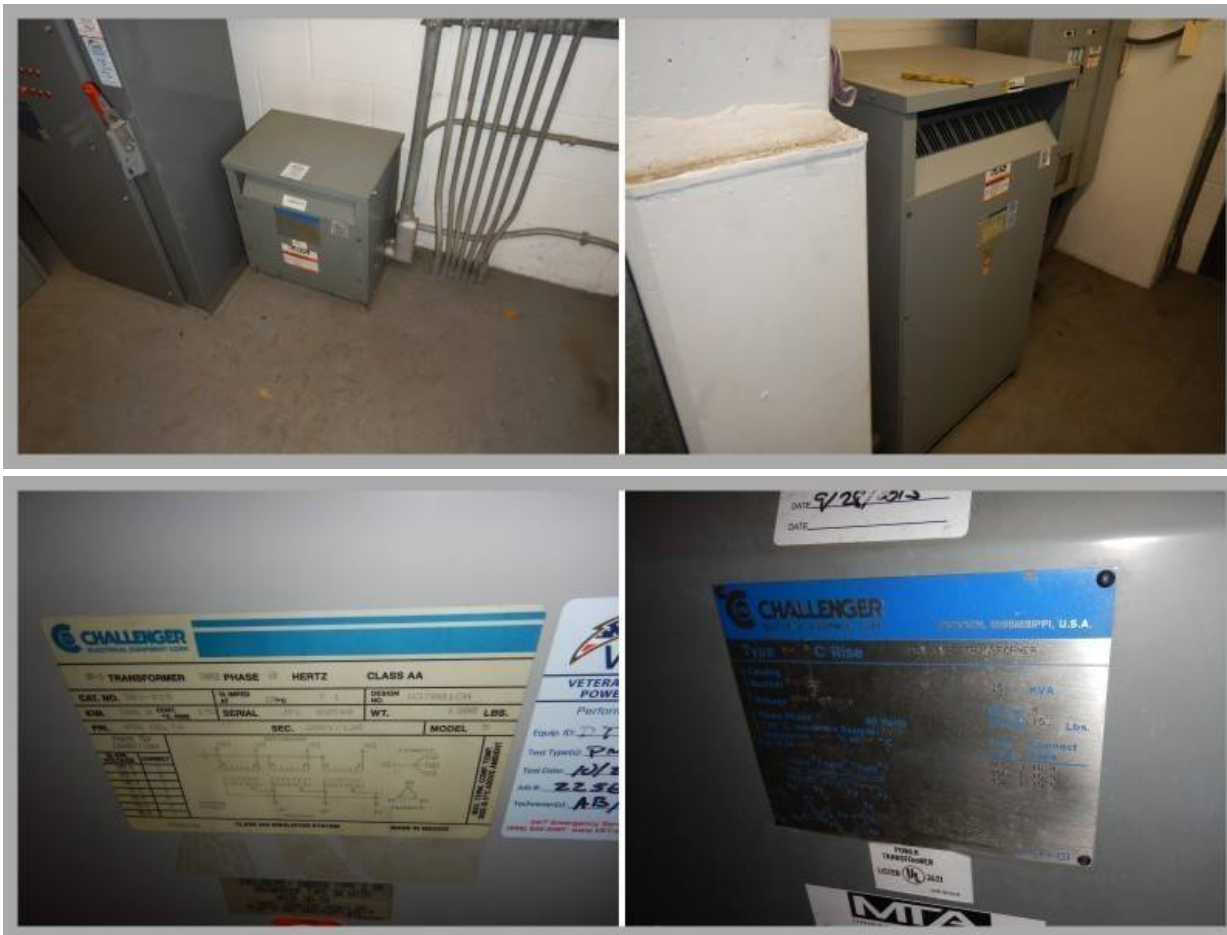
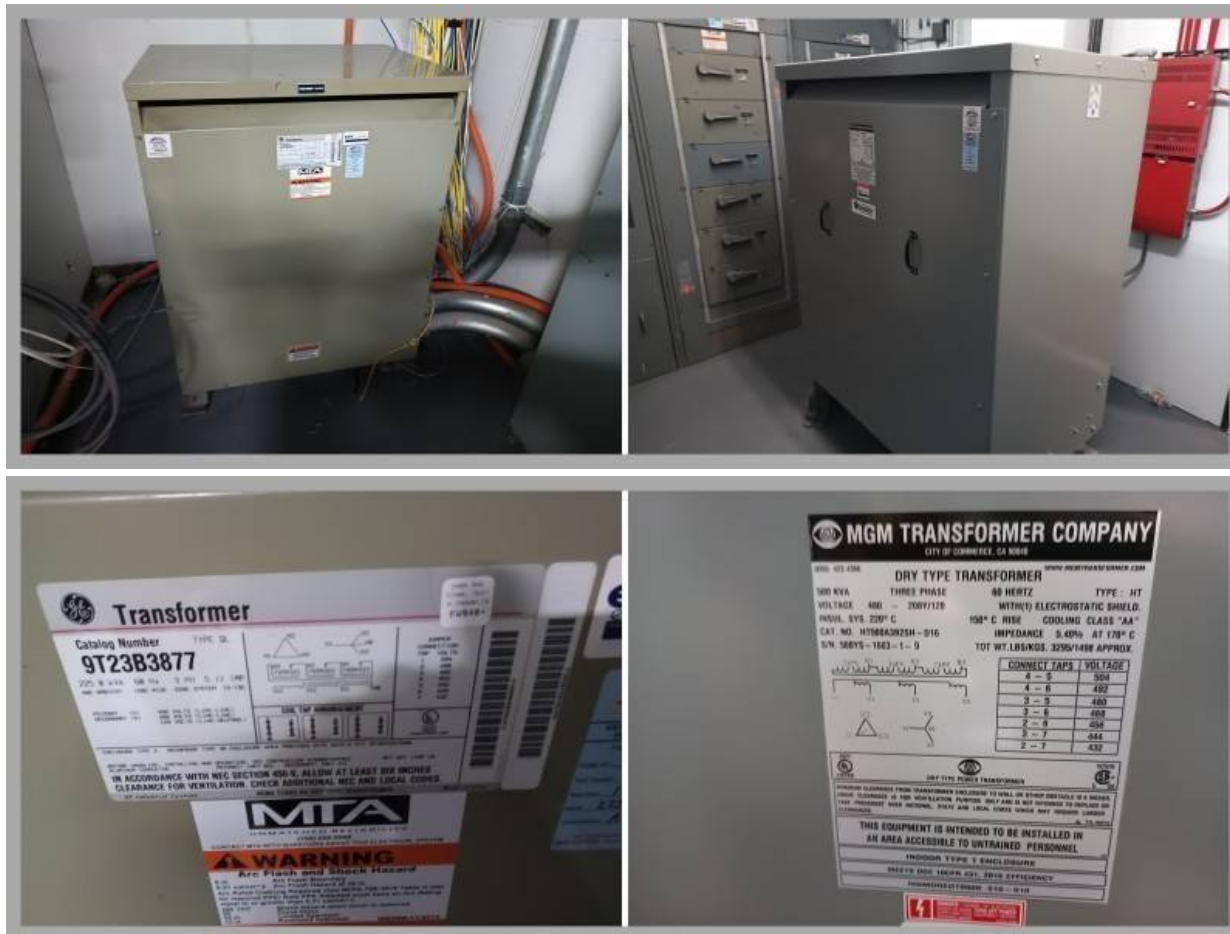
Dry Type Transformers by ElSCO Transformer. The typical life expectancy of a dry-type electrical transformer is between 20 to 30 years. However, with proper maintenance and ideal operating conditions, they can last much longer, potentially exceeding 35 years,

Satisfactory. Transformers seemed to be monitored annually and performing as intended. At least two are older however and will be due for replacing within the next few years. Transformer T-2A and 225 transformer at roof top chiller room.

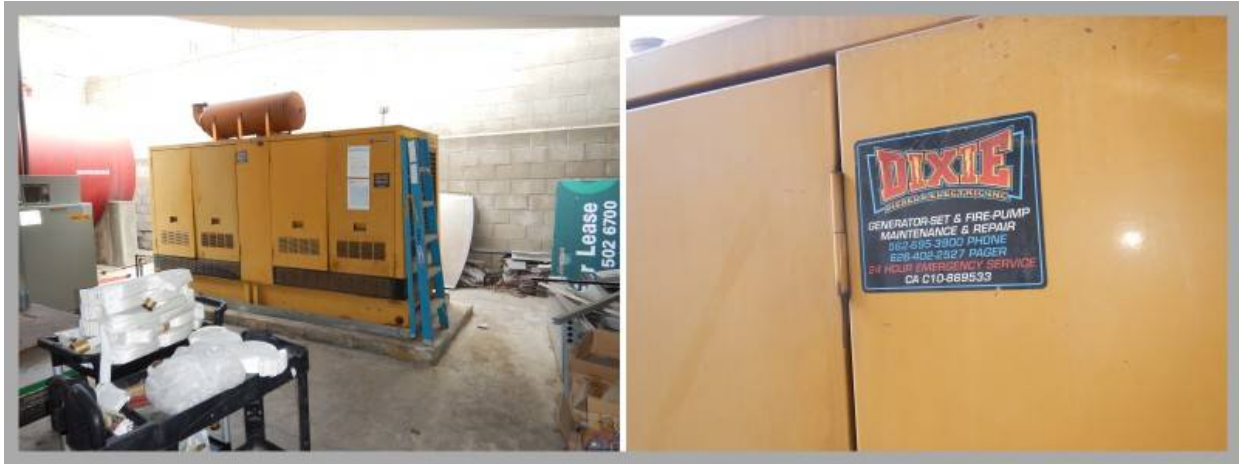
6.34 LOCATION:

Exterior storage parking garage. Fire pump and diesel generator. Fire pump and generator equipment is well beyond the scope of this assessment other than to note that it exist and seems to have maintenance and inspection records that are current.

Obtain service records from owner or operator.

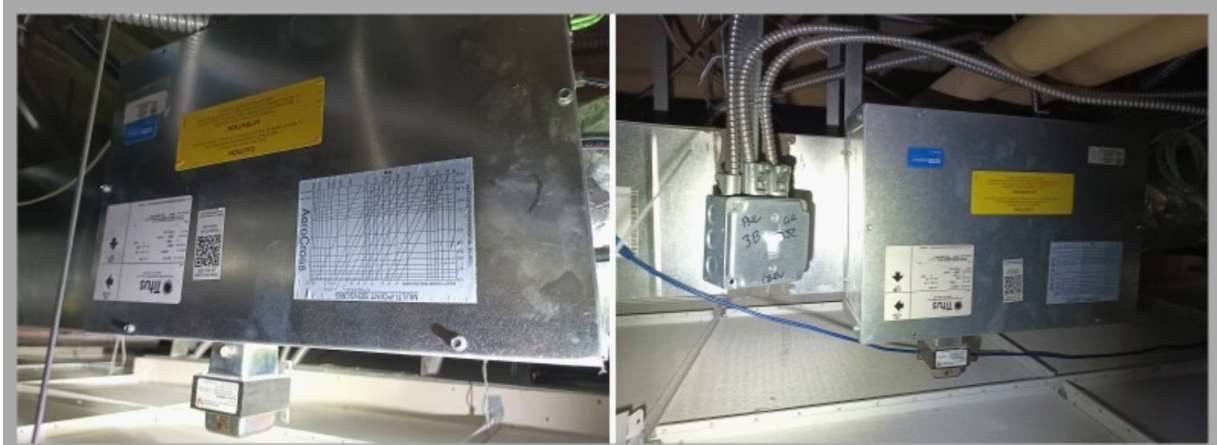
Unit 300

1. VAV 15 in unit 360 has a displaced cover and one VAV in unit 400 seems to have leaked onto ceiling panel. VAV5 in unit 510 did appear to have a leak though looks as though it was recently repaired. Corrosion was also noted to section of water line at VAV 20 in suite 580. Most of the VAVs at 7th, 8th and 9th floor appear to be from original installation and are more than likely near or at the end of their serviceable lives.

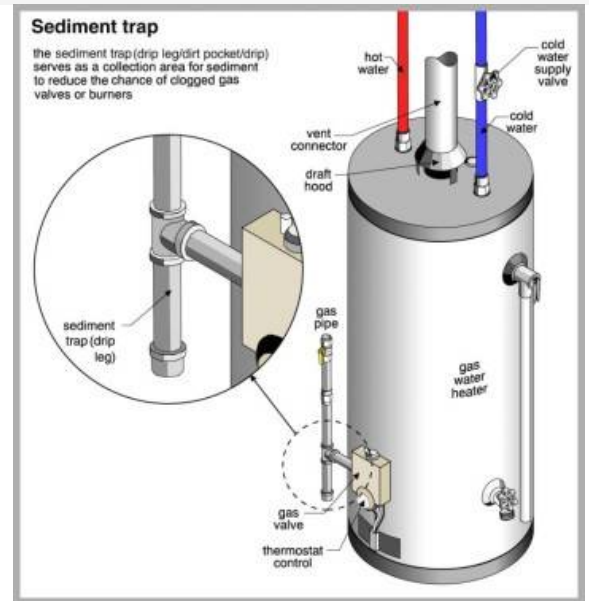
9.29 DRIP LEG?

There is no drip leg (sediment trap) installed on the incoming gas line to the water heaters. Installation of a drip leg is recommended to prevent debris from getting into the gas valve.

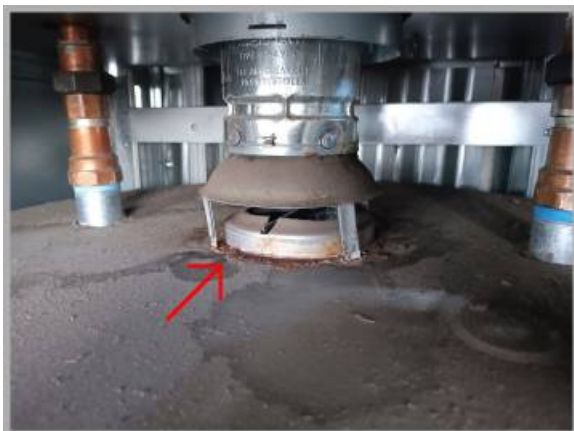
9.30 VENT/FLUE CONDITION:

There is evidence of poor drafting at left water heater. This means that the gases are spilling back down rather than expelling to the exteriors. Drafter diverter is displaced resulting in condensation spillage which can shorten the life of this water heater.

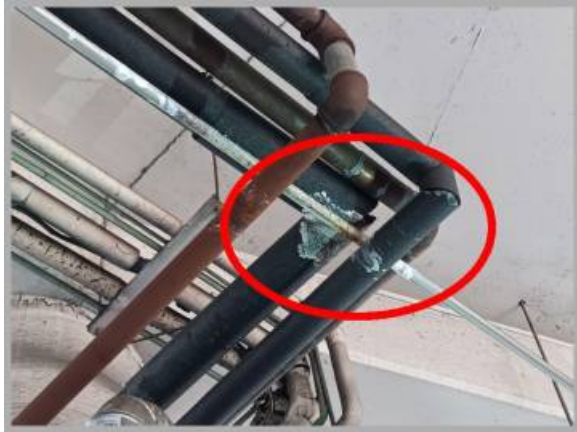
9.31 WATER PIPES:

Corrosion and leak noted above water heaters.

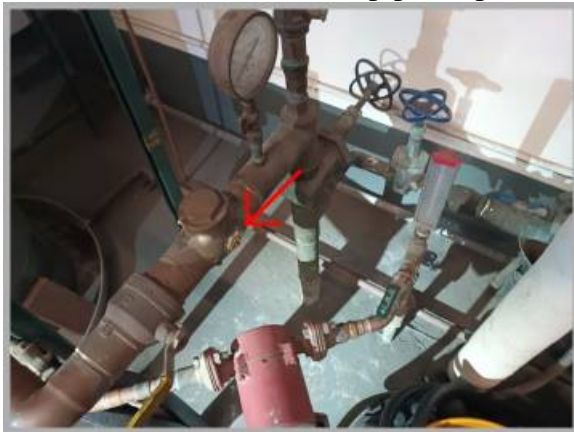
9.43 WATER PIPES:

Corrosion noted to section of water pipe. Repairs are needed to prevent any potential for leaks.

Monitor and maintain. Budget and anticipate for replacement of at least on 1/2 HP pump and have plumber repair any corrosion at water pipes.

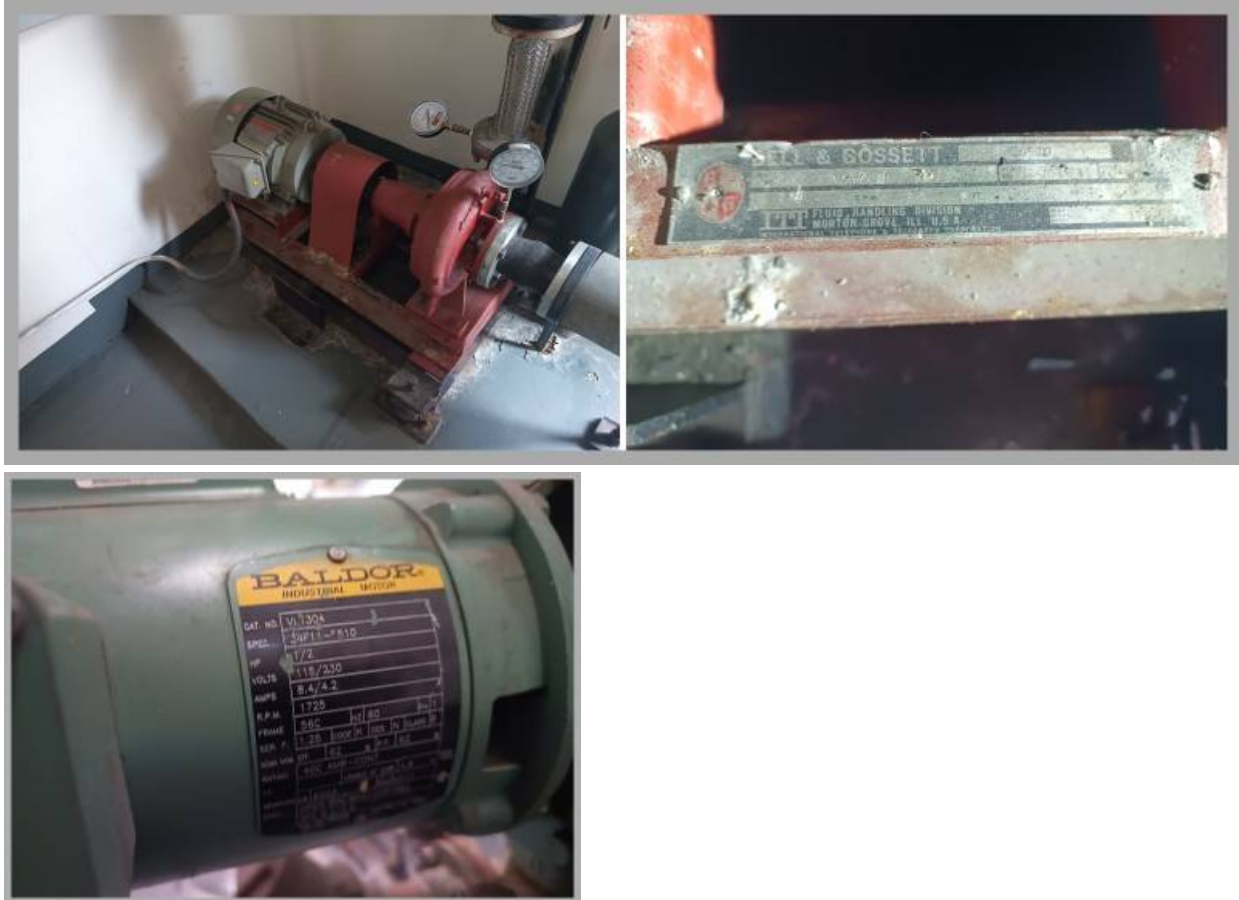
9.44 PUMPS:

Operational however one 1/2 HP pump is near the end of its serviceable life.

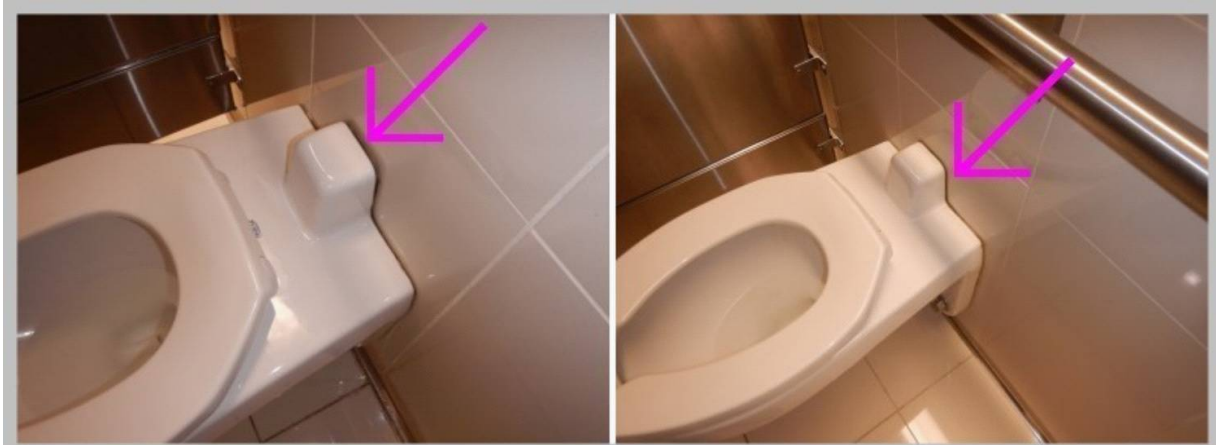
The toilets in these bathrooms needs repair. The toilets are not secure to the wall allowing them to wobble and possibly leak. Action should be taken to re-secure and caulk.

Men's & Women's loose & lack caulking

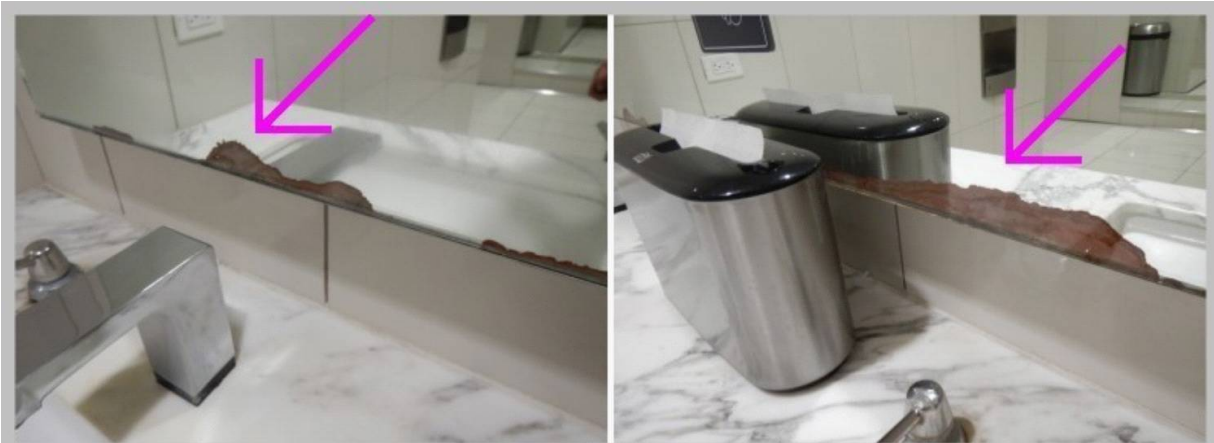
2nd floor Men's

Vanity cabinets and tops are satisfactory. Some blemishes noted at men's mirror. Replacement should be considered.

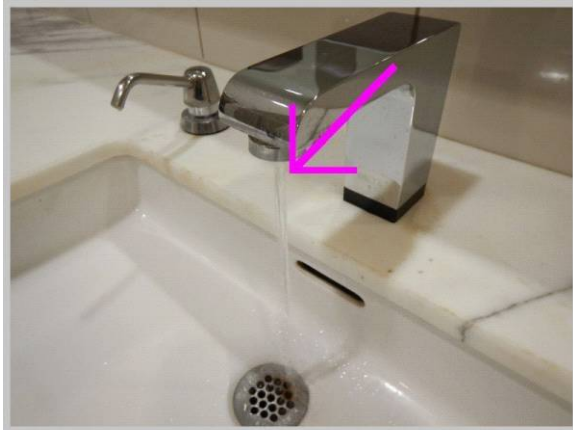
2nd floor Women's

Poor flow noted at women's faucet.

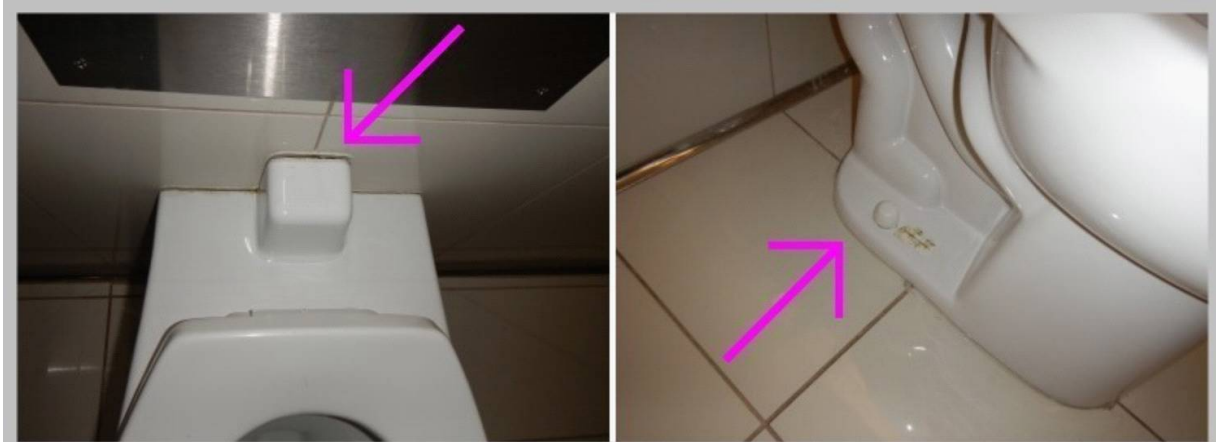
2nd floor Men's & Women's

Men's & women's: The toilet is not secure to the floor/wall, allowing it to wobble and possibly leak. Action should be taken to re-secure it to the floor.

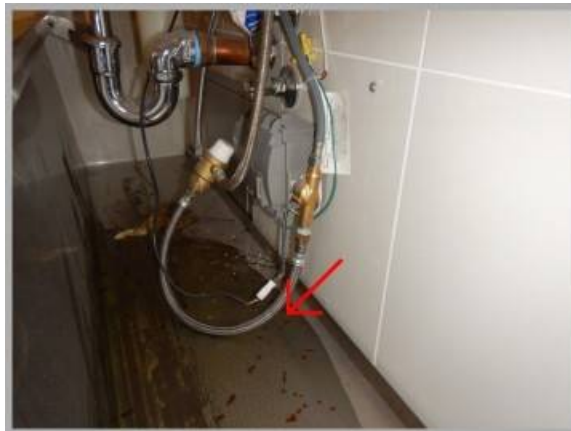
3.27 BASIN & DRAIN:

Evidence of a leak noted from fixture within cabinet of women's bath.

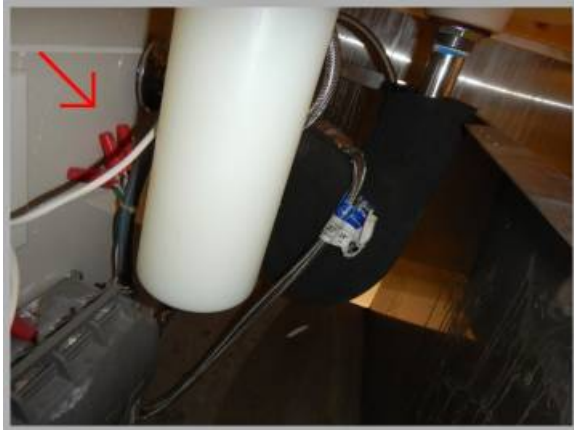
3.28 FAUCET:

Faucets and supply lines appear satisfactory. Improve wiring to auto fixtures. Ideally wiring either low voltage or higher voltage should be contained with a box to prevent shock risk.

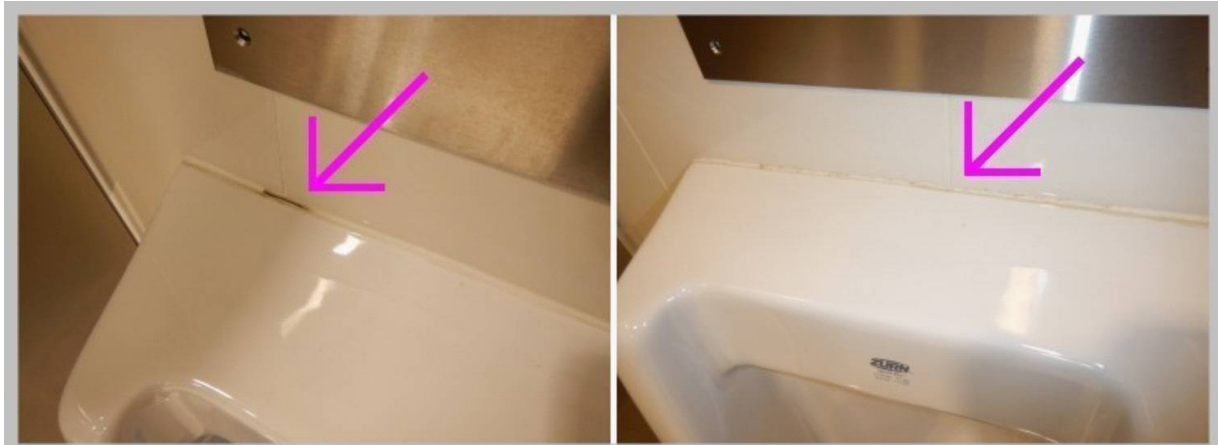
4th floor Men's

Maintenance of urinal seal needed.

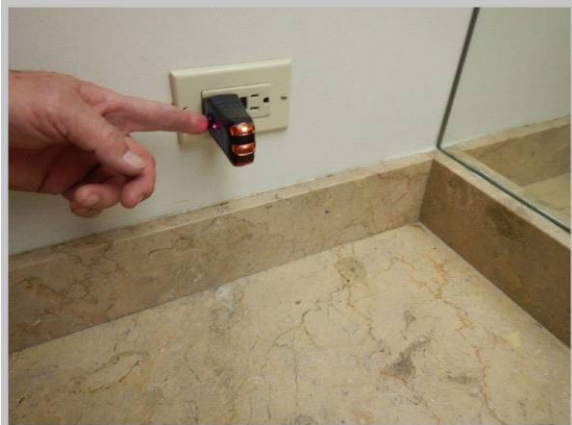
Men's 8th floor

There is a Ground Fault Circuit Interrupt outlet installed in the area of the bathroom lavatory. However, it failed to stop the current flow or did not reset after testing. Replacement is necessary.

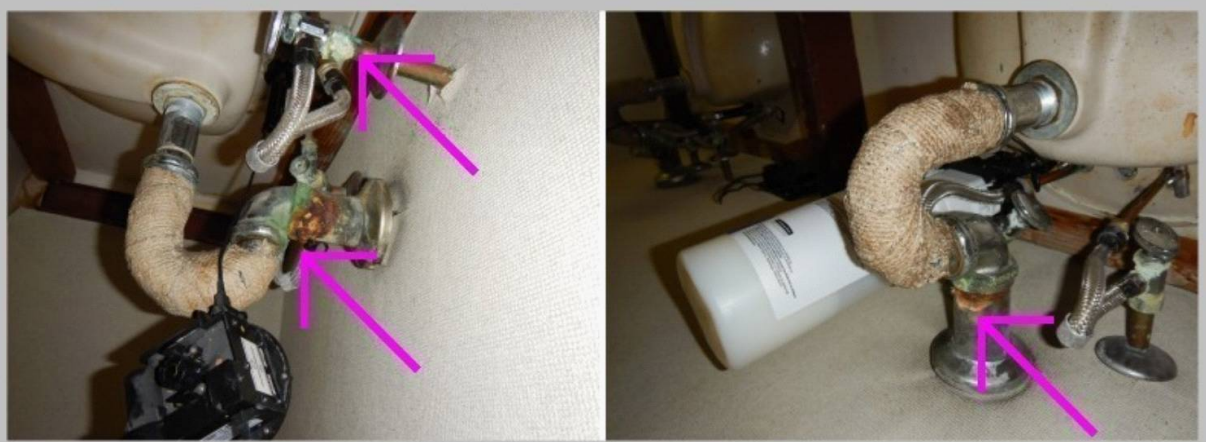
9th floor Men's & Women's

The angle stop and drainage fixture needs attention. There is corrosion on the angle stop and drain line. This is an early warning of future failure. It may be currently leaking (bucket under drain) and it will need to be replaced. Noted in men's & women's.

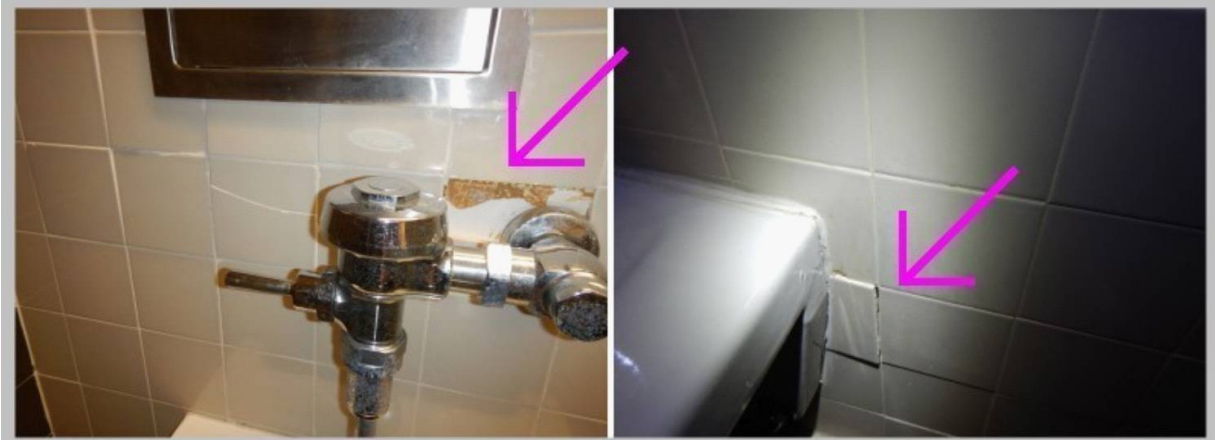
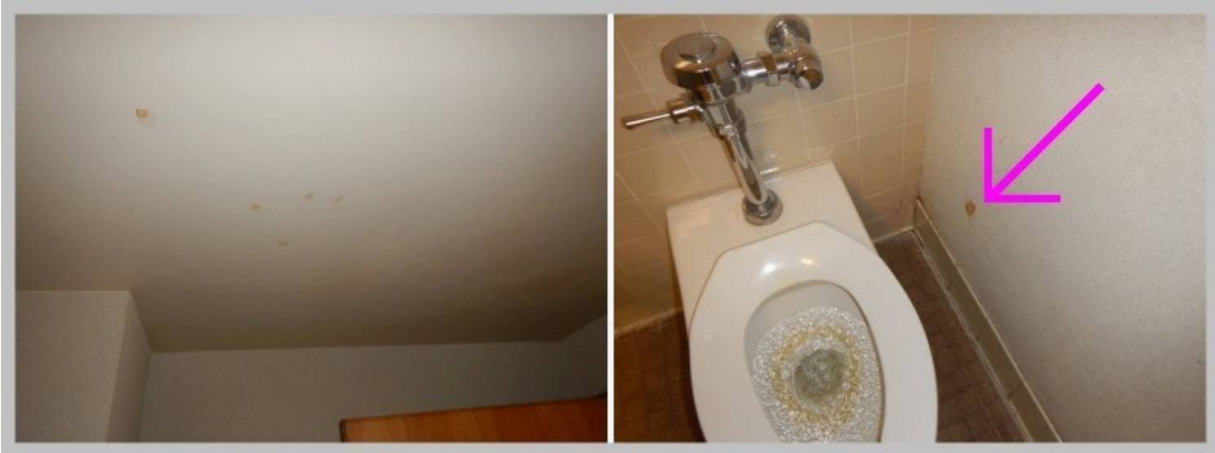
3.94 WALLS/CEILING:

Broken tiles noted throughout. Stains on wall paper and ceiling also noted.

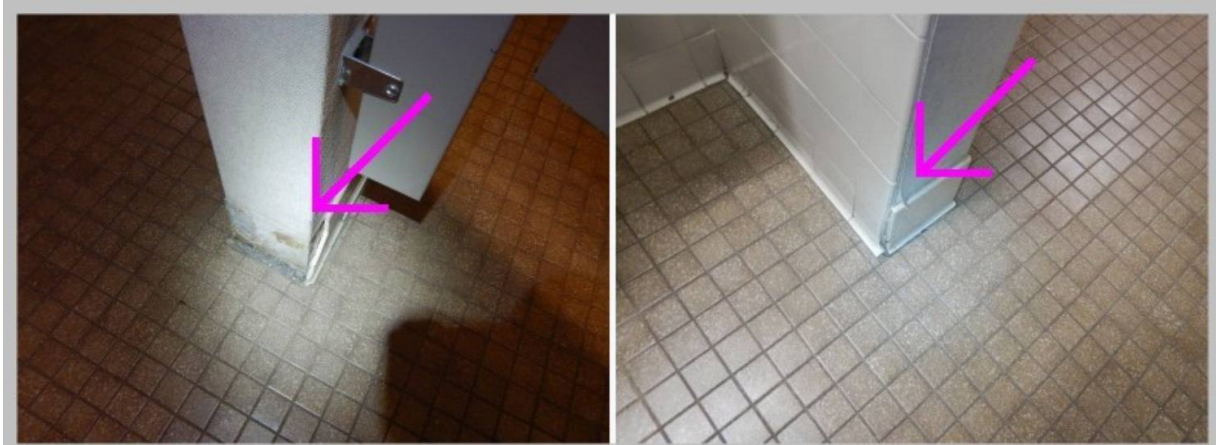
9th floor Men's

Cove base tiles broken and missing.

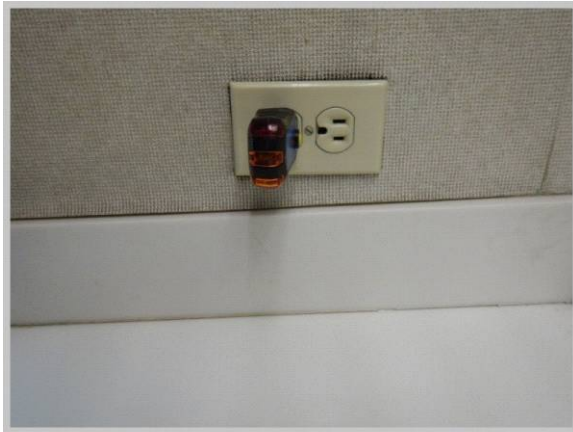
Men's 9th floor

Recommend - This bathroom does not have a Ground Fault Circuit Interrupt outlet installed. The age of the structure may predate the required installation. However, for safety considerations, it is strongly recommended that one be installed at any location within 6 feet of a water source. No power noted to receptacle.

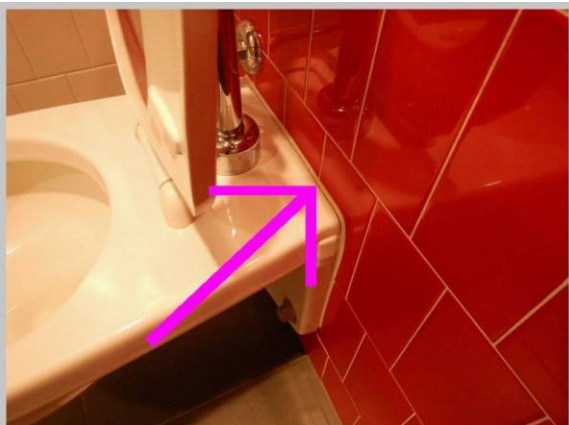
Toilet in Men's bathroom in need of caulking.

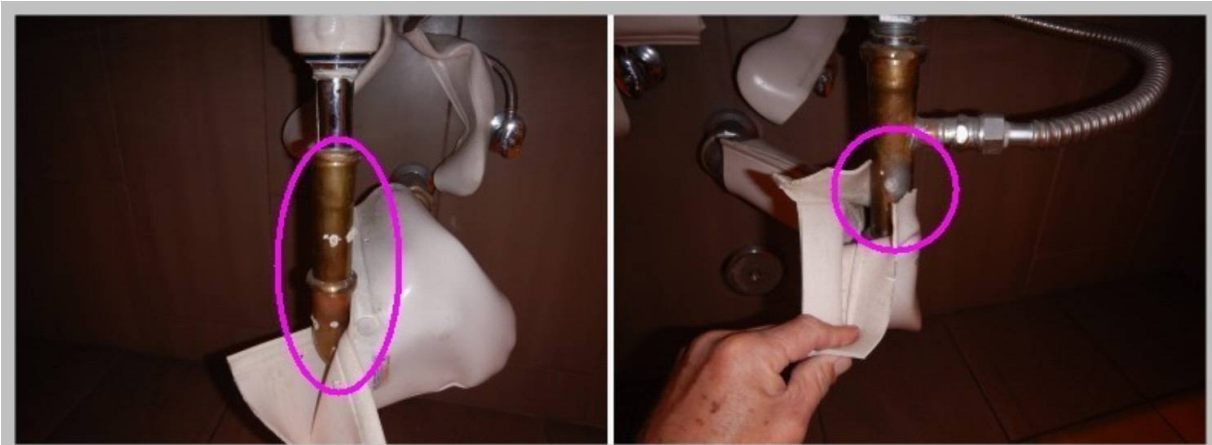
Men's & Women's

There is deterioration of the drain pipes under the basin. Although there is currently no leak, expect replacement in the future.

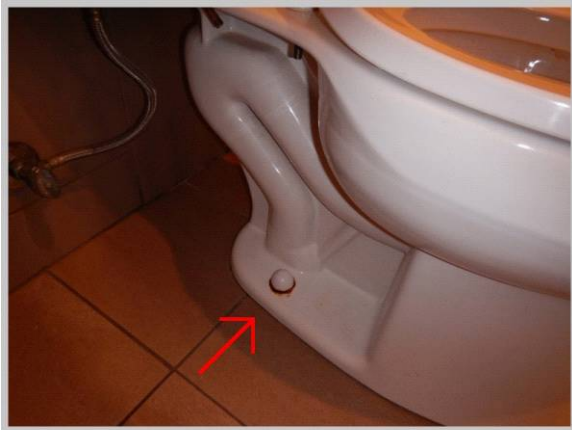
The toilet in Men's restroom needs repair. The toilet is not secure to the floor, allowing it to wobble and possibly leak. Action should be taken to re-secure it to the floor. Base of the toilet should be caulked. The base of a toilet should be caulked, according to the International Plumbing Code and the International Residential Code. Caulking the toilet to the floor helps to create safety and provide sanitary protection. It's also generally recommended to caulk or seal the bottom of the toilet if there is a gap between the toilet and the floor.

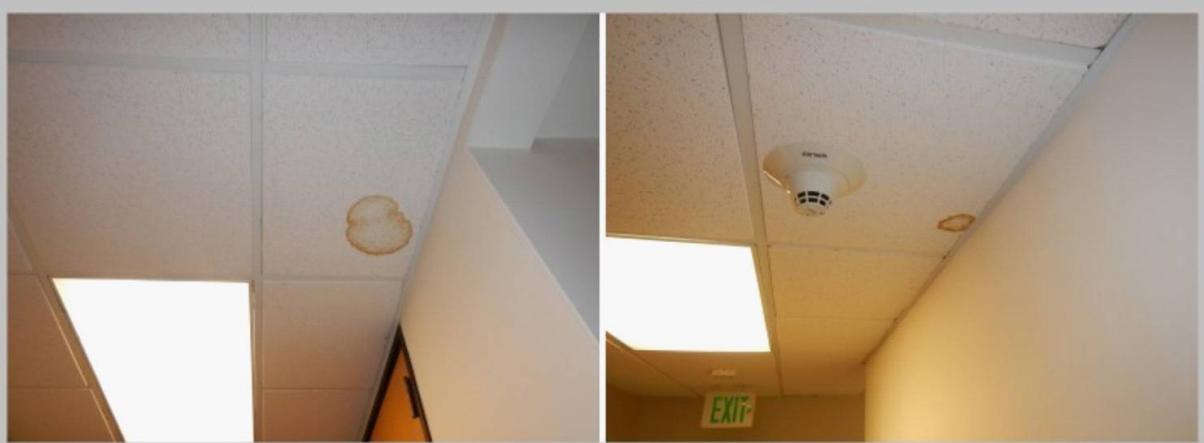
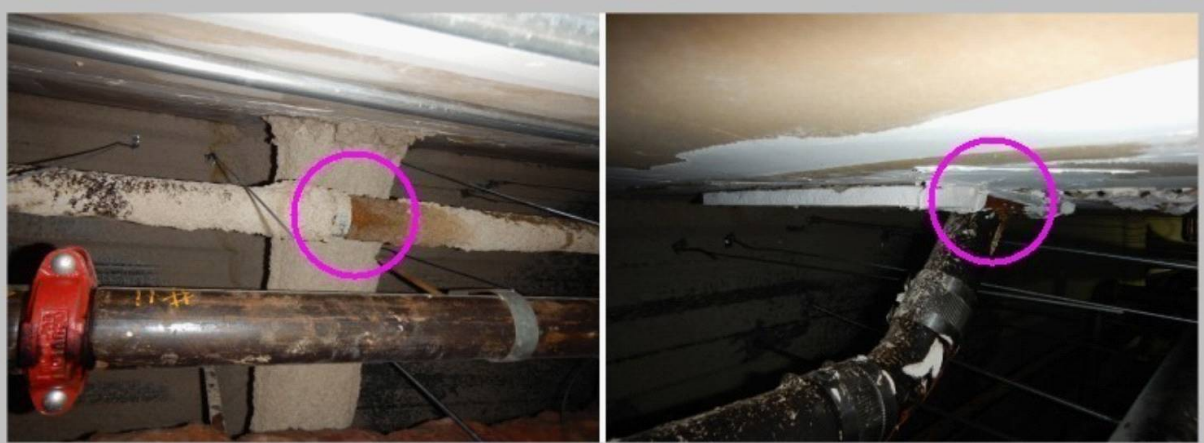
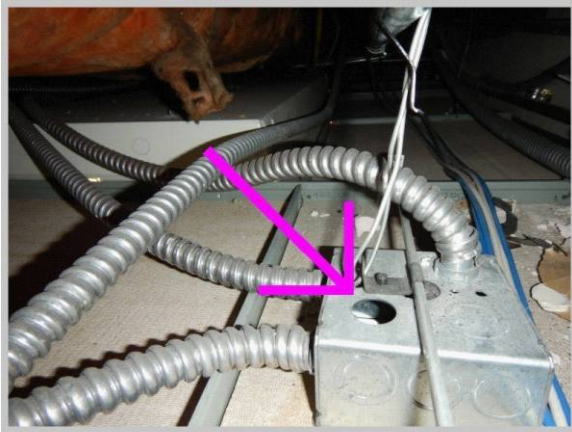
4.1 CEILING

Water stains noted on 8th floor. Apparent leaks noted in drain pipes above the stained tiles. Open pull boxes seen compromising safe installation. All enclosures should seal tight to prevent dust and animal entry.

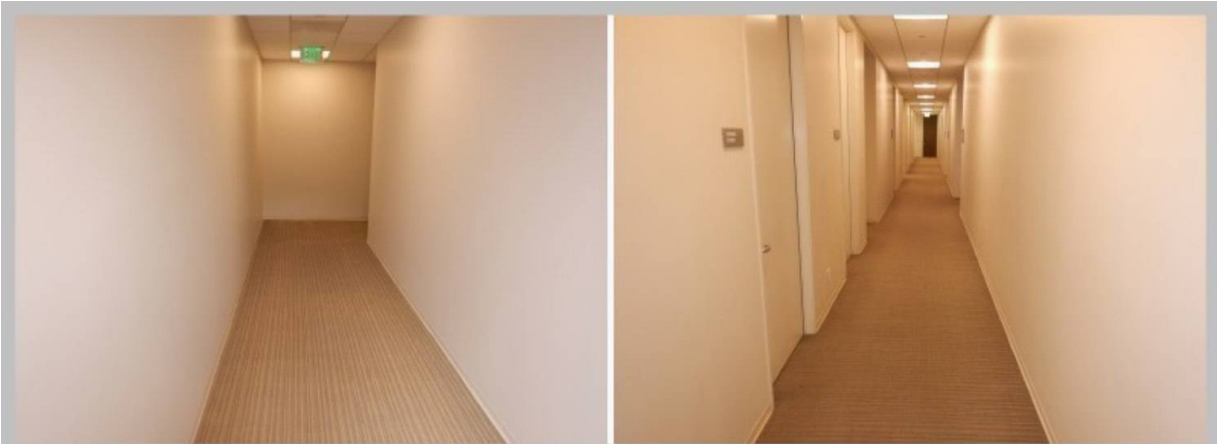
Overall satisfactory. Some staining noted on carpet by patio door and some paint damage in 2nd floor hall noted.

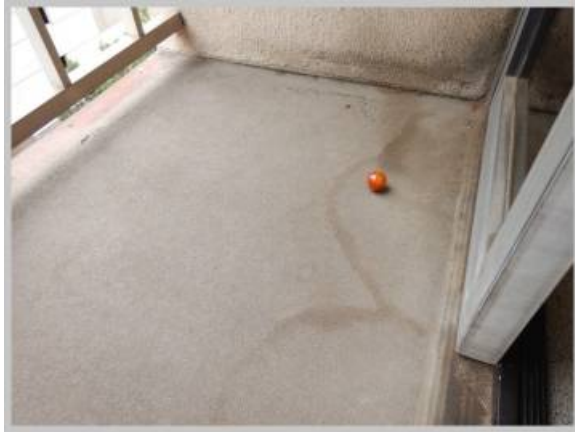
Water stains noted on some of the balcony floors indicating poor slope. Some of the floors have poor slope which can allow water into the substrate; corrections needed.

Further evaluation needed. Services of an qualified professional needed.

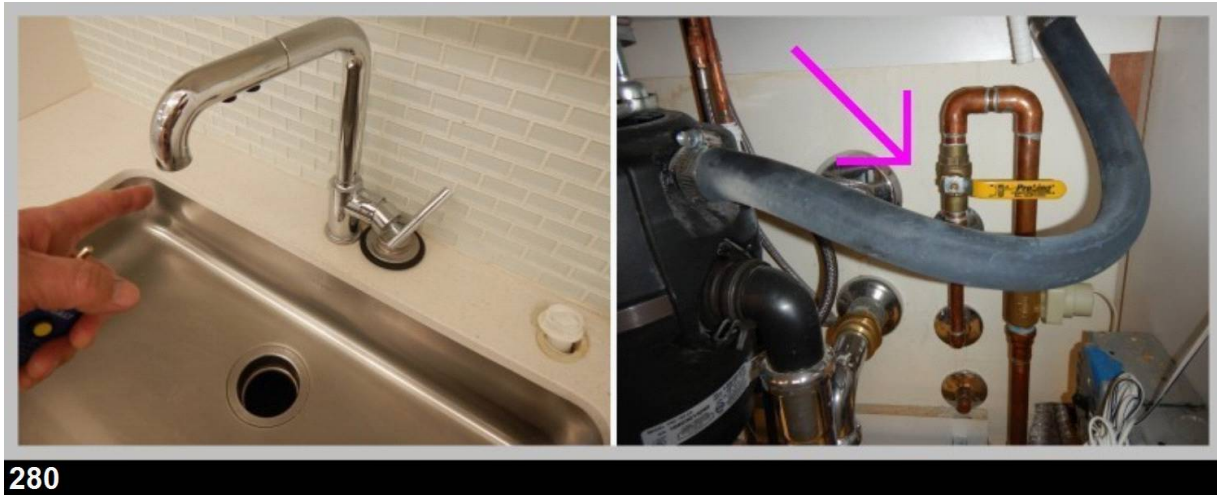
280

Water off at the time of inspection; reason not known; further evaluation needed, inspector does not turn on water valves which have been turned off.

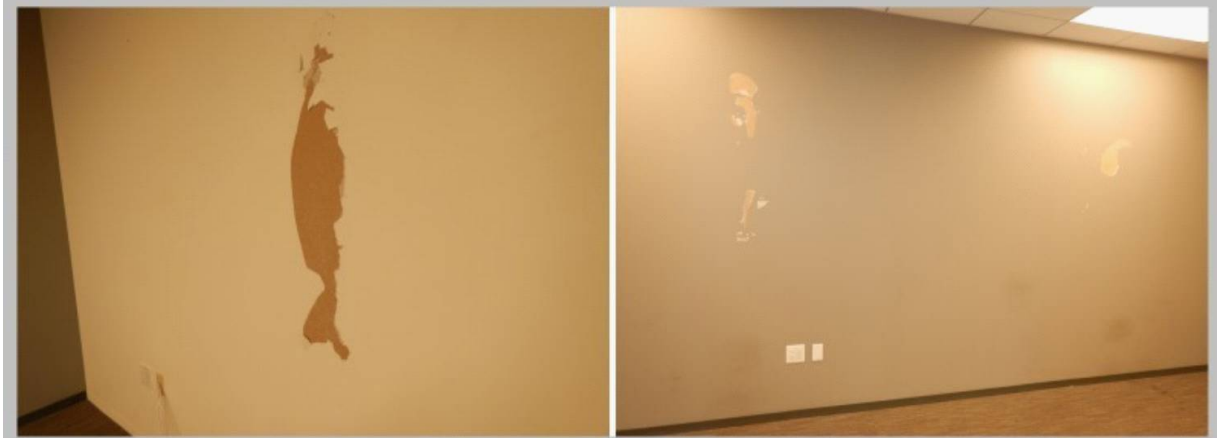
360

300: Satisfactory with general wear from previous tenant. 360: Unit interiors due for tenant improvement upgrades; damaged walls noted.

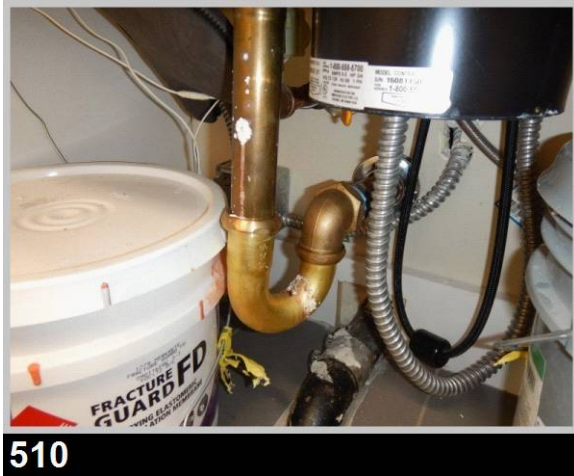
There is deterioration of the drain pipes under the 510 sink. No water noted during inspection. Recommend replacement.

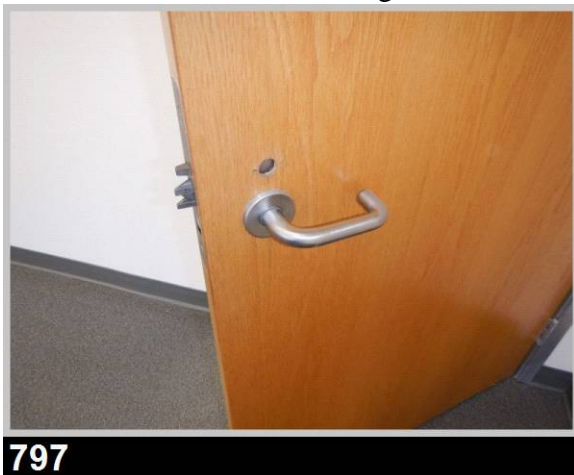
Some of the interior doors are missing hardware from one of the offices.

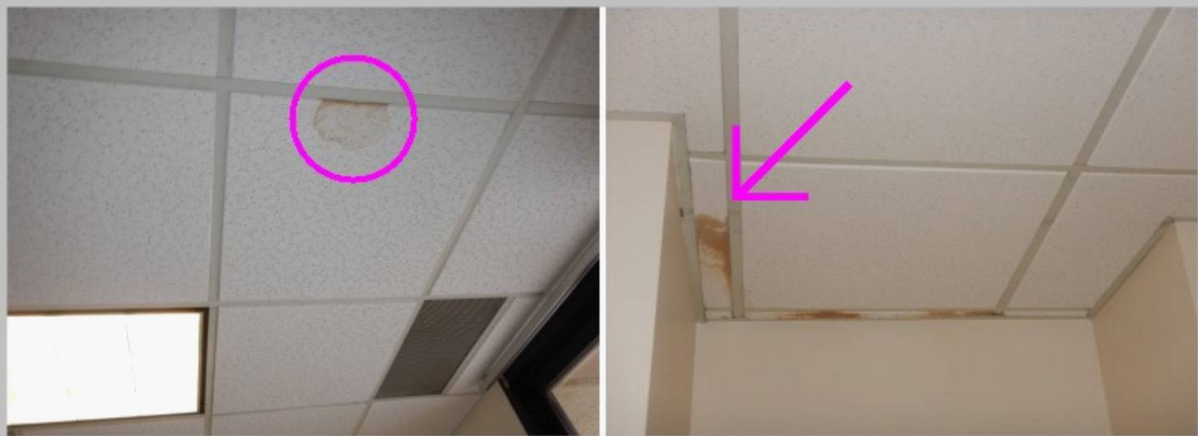
**797 Water Stains****5.45 Floor Condition:**

Unit interiors due for improvement and upgrades, such as paint and ceiling tiles (water stains and missing tiles).

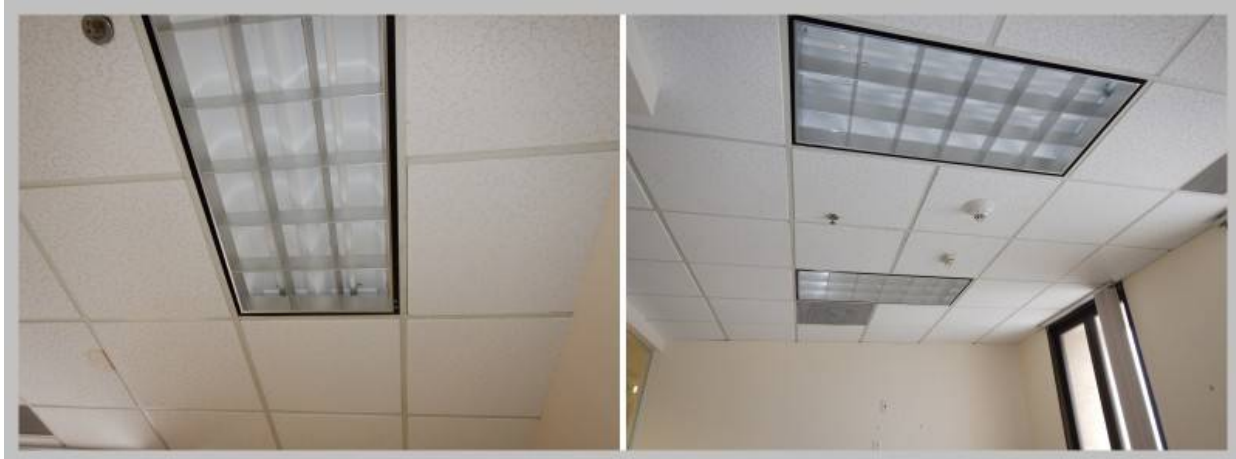
Some of the lighting was not functional during inspection; could be bad tubes or ballasts; further evaluation needed.

Further evaluation needed by licensed electrical and plumbing contractor.

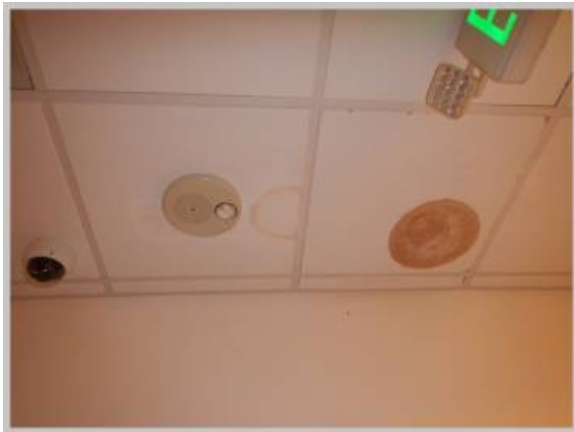
Units were well maintained and clean. Water stains noted in hall ceiling near the Private restrooms; further evaluation needed.

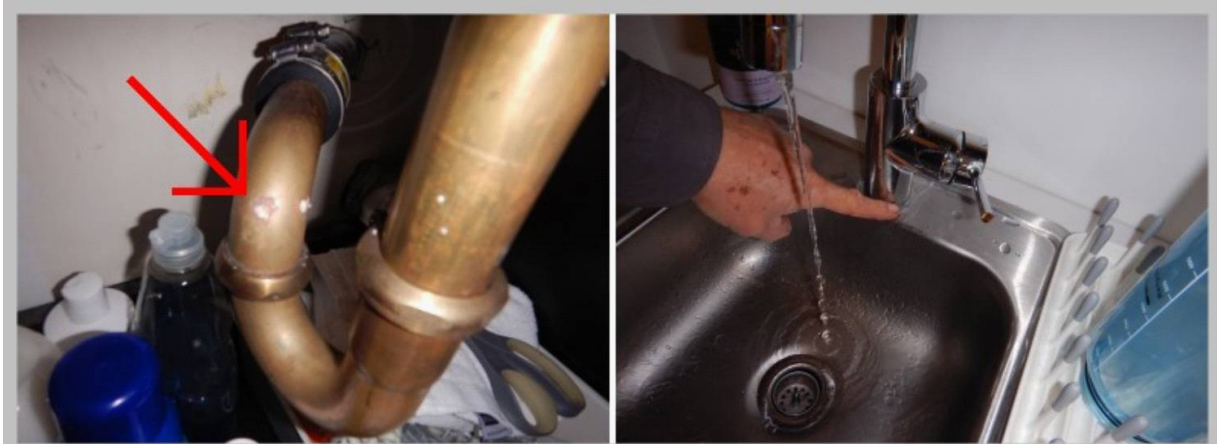
25

Unit 25: Deterioration of the drain visible. Loose faucet and poor flow also noted.
