Confidential Property Condition Assessment Report

**1234 Your Drive
Simi Valley CA 93063**

**Prepared for: John Smith
Prepared By: Robert Gaudreault**

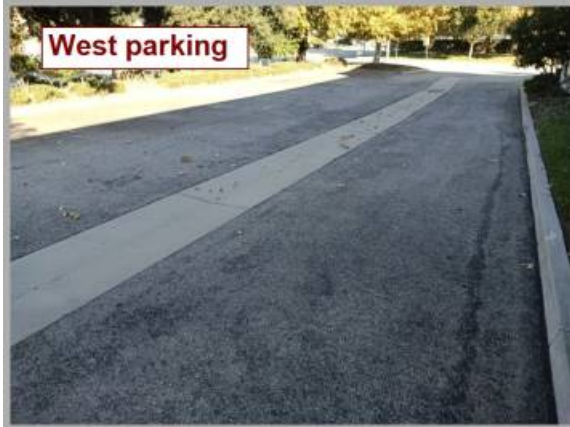
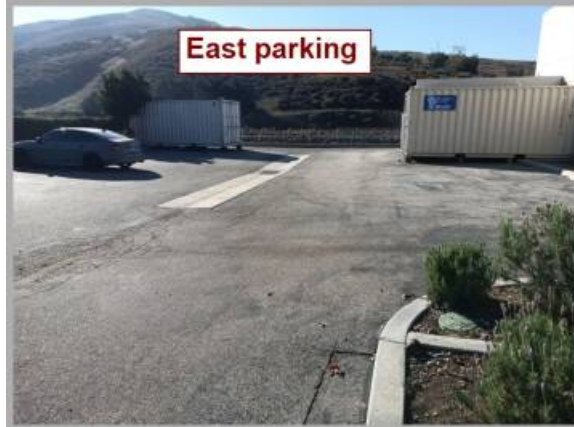
2.7 CONDITION:

1. The parking paving area needs action. Alligatoring of moderate severity at east parking. More than likely due to structural base failure. Seal coat over all areas of parking has worn off.

The parking paving area needs action. Alligating of moderate severity at east parking. More than likely due to structural base failure. Seal coat over all areas of parking has worn off.

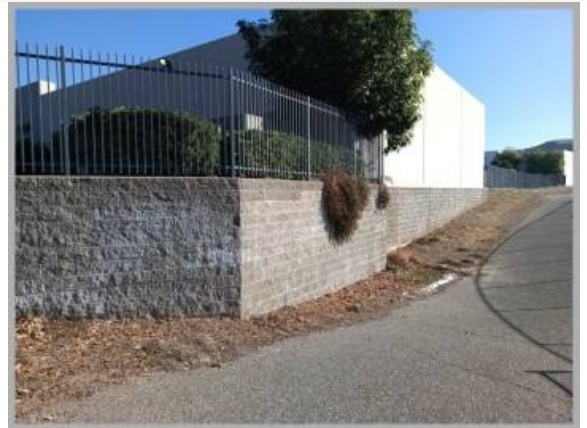
2.18 LOCATION OF WALL:

Satisfactory - The retaining wall is in functional condition.

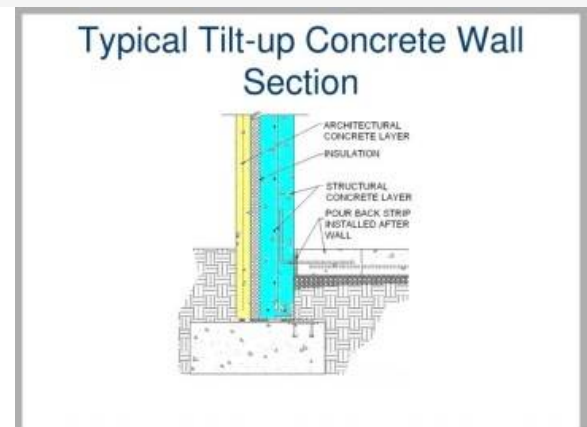
These types of tilt up foundations are not visible to inspect however from a simple visual survey it can be determined that the foundation is performing the job it was intended to do in supporting the structure. There are no signs of settlement or significant settlement.

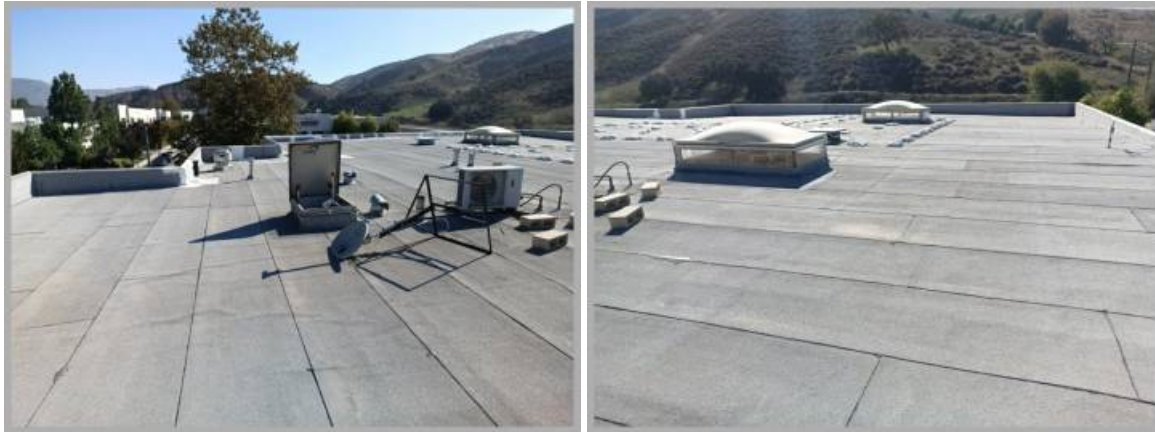
1. Moderate granular loss seen. This can either be from advanced age, manufacturer defect, foot traffic and/or incorrect installation. Asphalt matt and fiberglass is exposed as a result. Implications are shorter life span of material. Blistering or ridging noted on some of the roof material. Ridging is where the material at these blistered areas is not adhering to the roof deck and that there are air pockets.

2. Parapet wall lacks coping flashing, mastic applied to some of the roof penetrations is worn and cracked and prone to leak.

3. Skylights have been modified from their original configuration which can void any warranty or coverage. Dome lenses are deteriorated and need replacing.

4. Roof system is in need of rehabilitation or removal and replacement due to noted issues. Consult at least two of three roofing agencies for estimates. Implications: The implications of a leaky roof are; damage to the structure as well as interior content and potential for microbial growth.

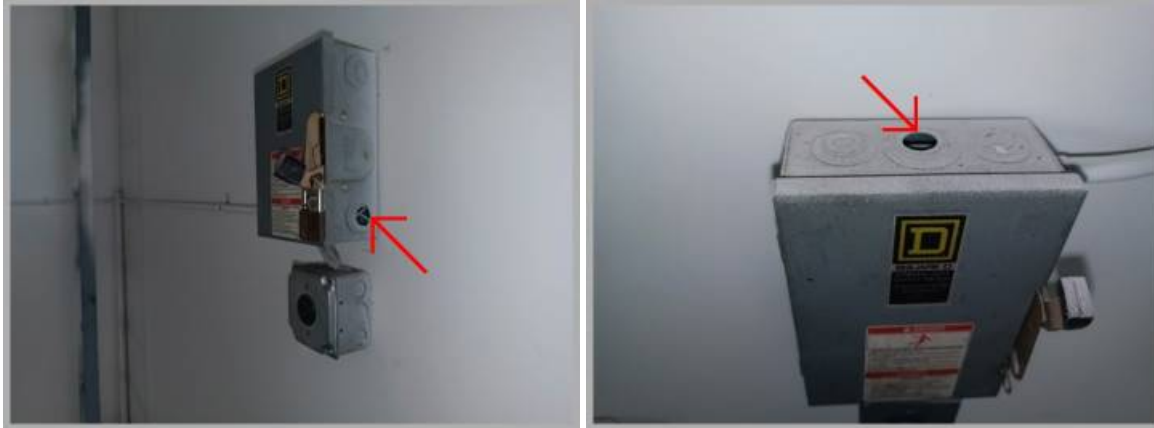
Knock out holes viewed within the main panel All panel boxes should be sealed tight to prevent any potential

for animal entry which could result in a potential fire hazard.

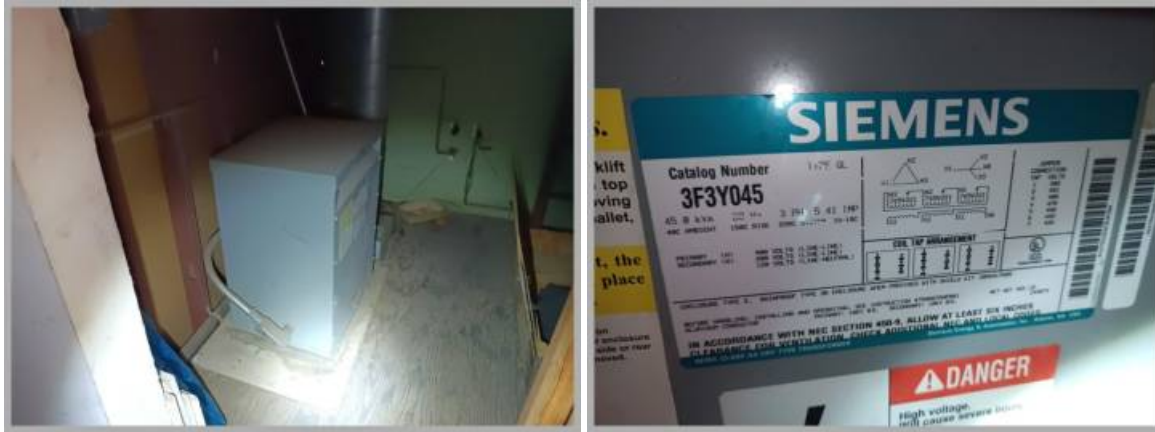
1. Some humming. Maybe normal. Transformers produce audible hum due to: Magnetostriction core laminations vibrating at 120 Hz (from 60 Hz AC). or loose mounting bolts or panels rattling. Although this humming may not be of significance it should be reviewed further.

Satisfactory. Transformer is performing as intended.

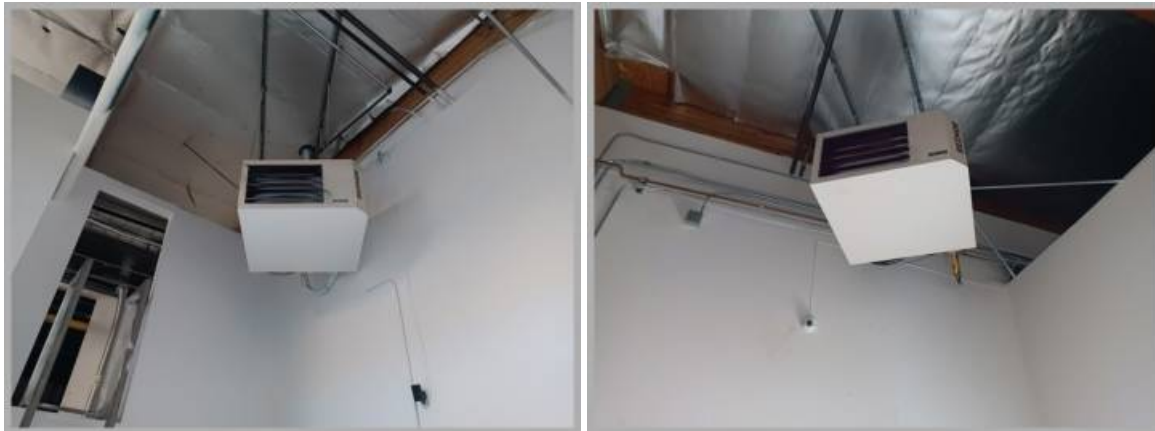
3. The existing heating components are at the end of their serviceable life. Replacement should be considered at this time. Contact heating agencies for estimates.

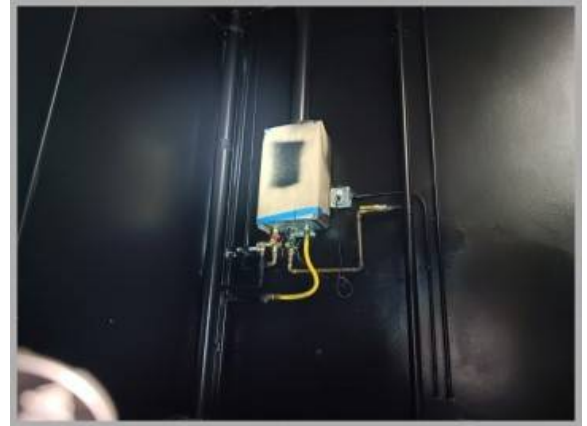
North wall interiors. Water heater may need to be relocated to meet current installation guidelines. Consult licensed plumber.

A tankless water heater should be readily accessible in California, as local codes require adequate working space, access for maintenance, and specific clearances for safety.

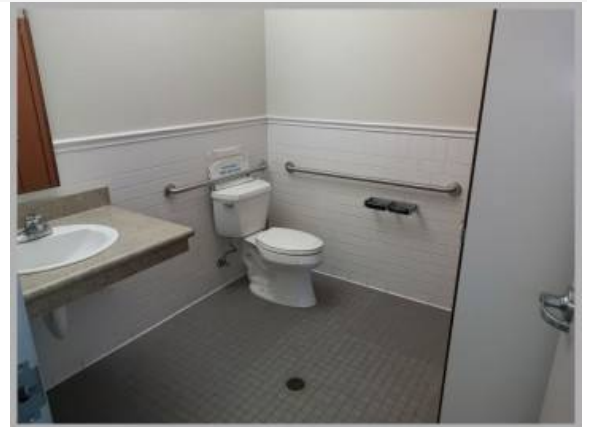
11.1 LOCATION:

ADA pads are missing from angle stops. These exposed valves exhibited oxidation. No leak at this time however maintenance should be achieved.

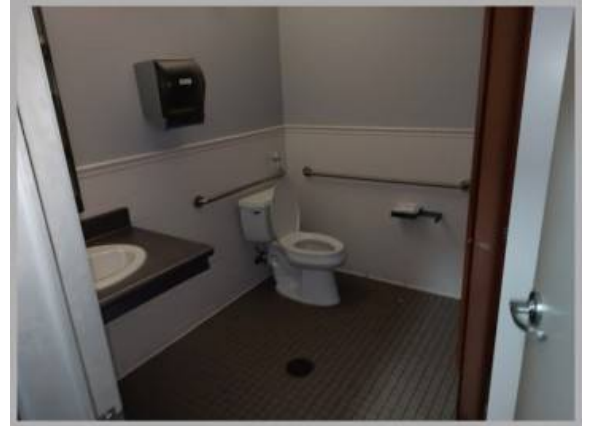
11.11 LOCATION:

11.12 VANITY CABINETS:
ADA protection pads missing.

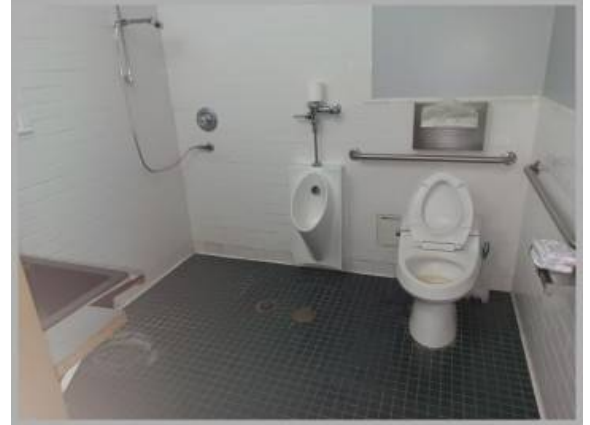
11.18 LOCATION:

Heavy oxidation at angle stop valves and faucet is excessively corroded and needs replacing.

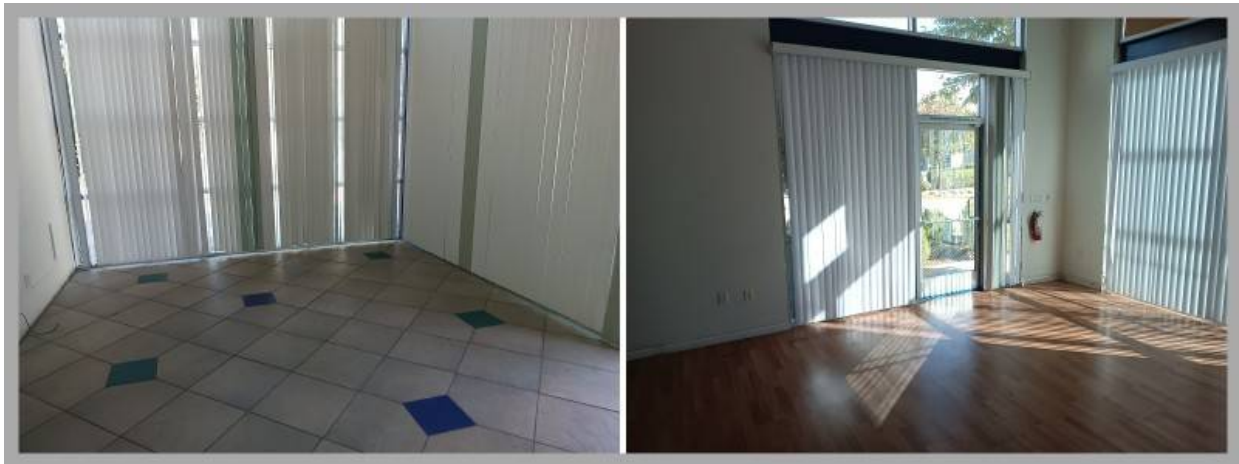
A representative sampling of interior doors was achieved. Those operated were in serviceable condition. However entry door of north east office is tapped over apparently to prevent water or dirt entry.
