Professional Commercial & Residential Inspections

## Confidential Inspection Report

**1234 Sample Address  
Sample City CA. 12345**

**Prepared for: Sample Client  
Prepared By: Robert Gaudreault**

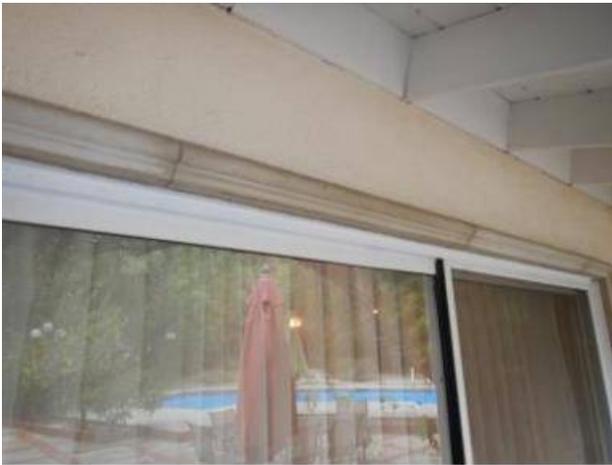
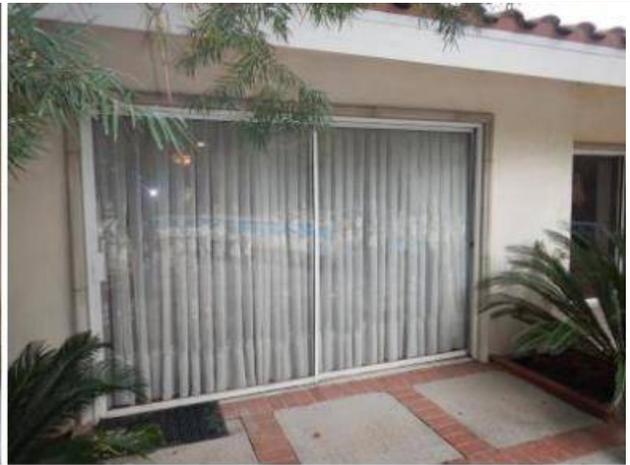
**Attention Needed** -Evidence of some trim corbel movement. Monitor as needed.

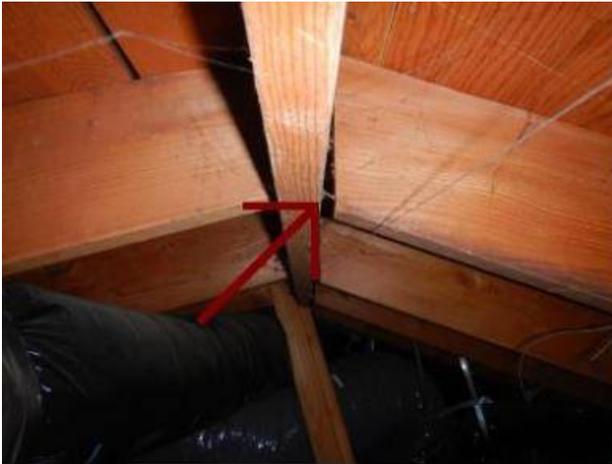
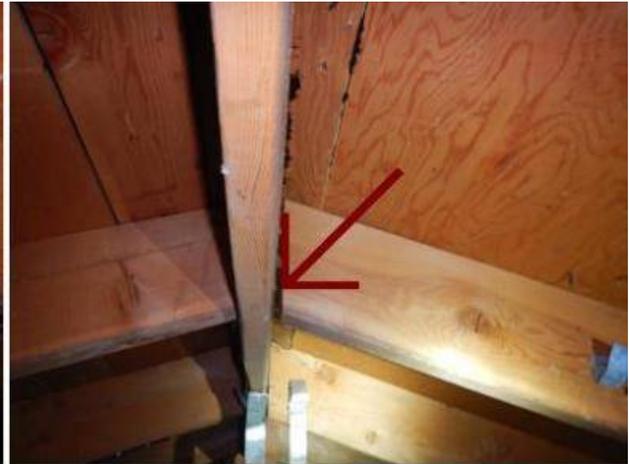
### 6.7 FRAMING:

Attention Needed-Rafters are pulling apart from the ridge.

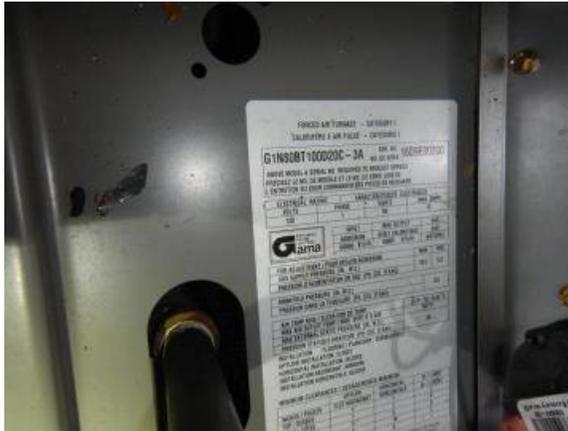
### 8.4 Approximate Age:

13 year old gas fired. The typical service life for a forced air natural gas furnace is 18 - 20 years.

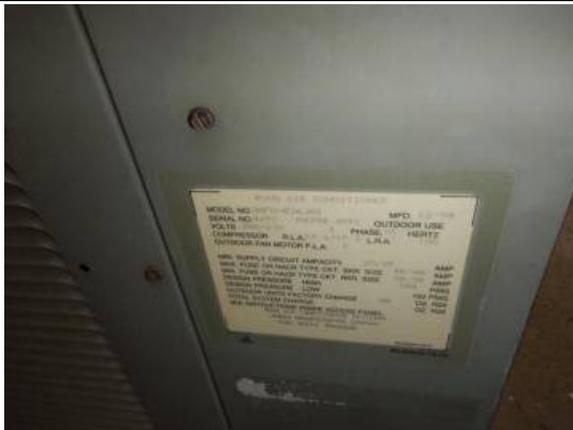
**8.22 Model/ Serial Number/ Size:**

31 year old 3 ton. The typical service life for an AC unit is 12 - 15 years.

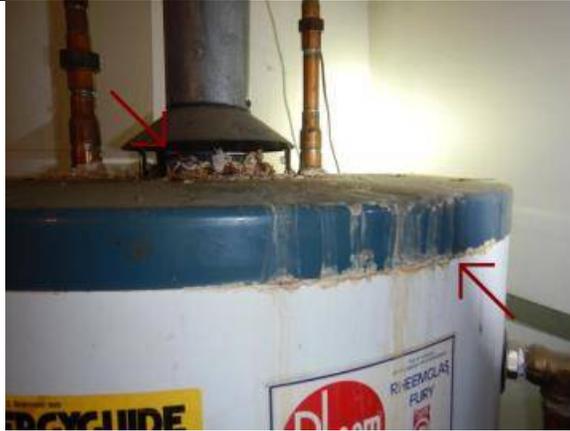
**10.16 VENT PIPE CONDITION:**

**Unsatisfactory-** There is evidence of poor drafting. This means that the gases are spilling back down rather than expelling to the exteriors.

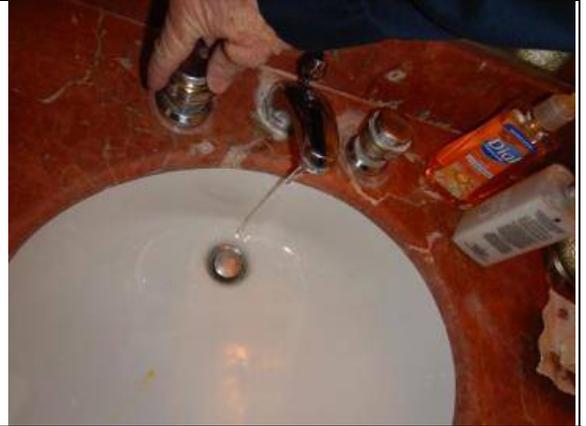
**Attention Needed** - Low water flow from left fixture of left sink. Such as east bath.

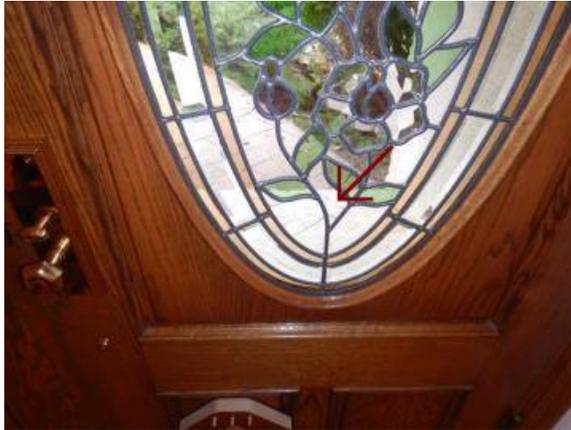
Cracked leaded glass at entry door.

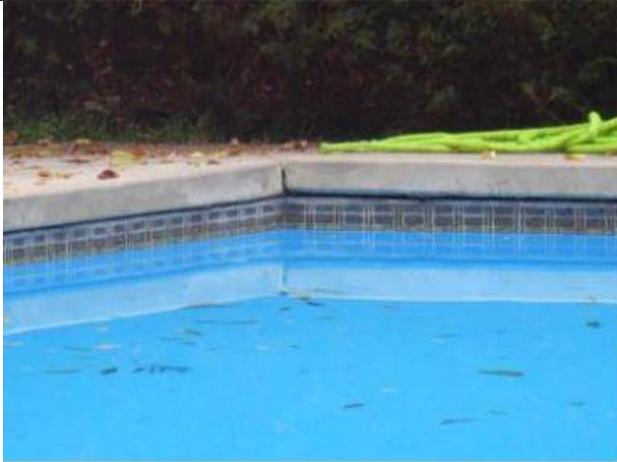
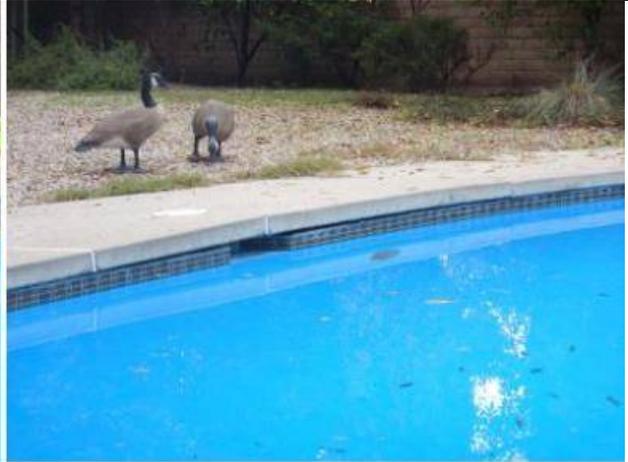
#### 15.3 COPING:

**Attention Needed**-General heaving of cantilever decking throughout pool perimeter.
